# K.C Jacket Wear Company

Ratuti, Katchkura, Uttarkhan, Uttara, Dhaka

30<sup>th</sup> June 2019

# Apparently non-engineered fire escape stair of utility building.

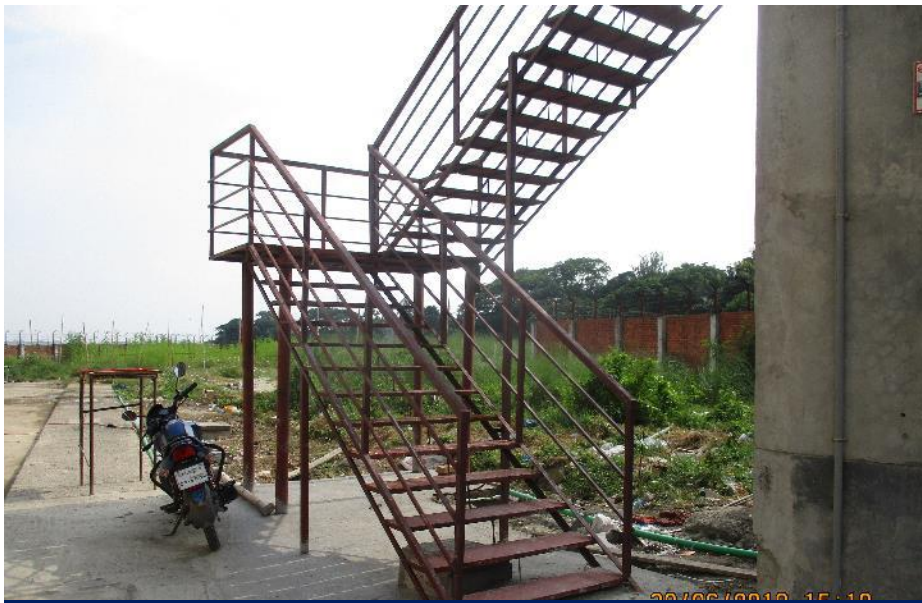
Apparently non- engineering stair. Building engineer is required to check the adequacy of the stair.

| Item No. | Observation | Recommended Action Plan | Recommended Timeline |
|---|---|---|---|
| 1 | Apparently non-engineered fire escape stair of utility building | Building engineer is required to check the adequacy of the fire escape stair. | 6-weeks |
| 2 | Apparently non-engineered fire escape stair of utility building | Carry out any remedial works where necessary | 6-months |

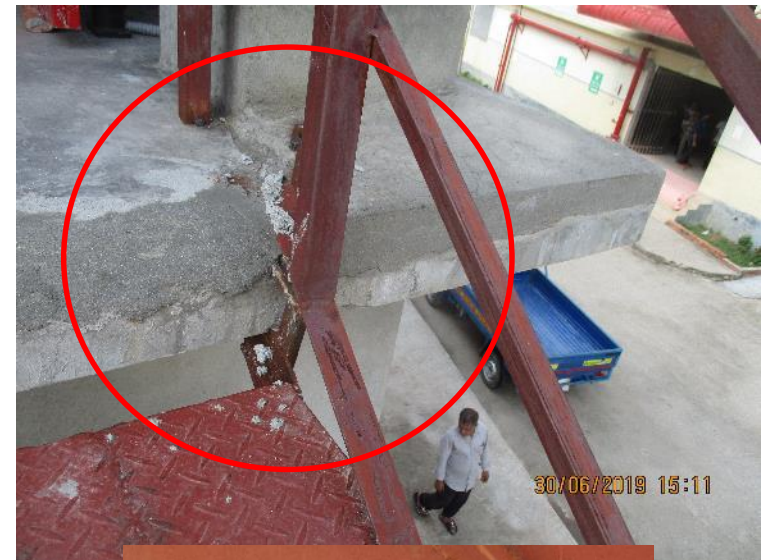
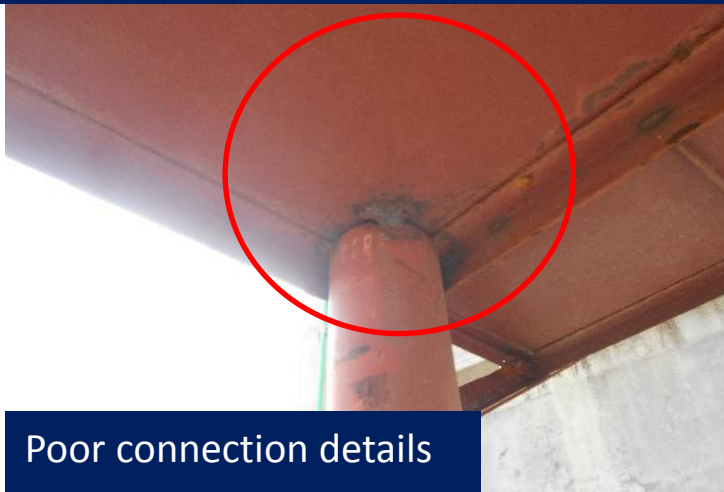
Poor connection details

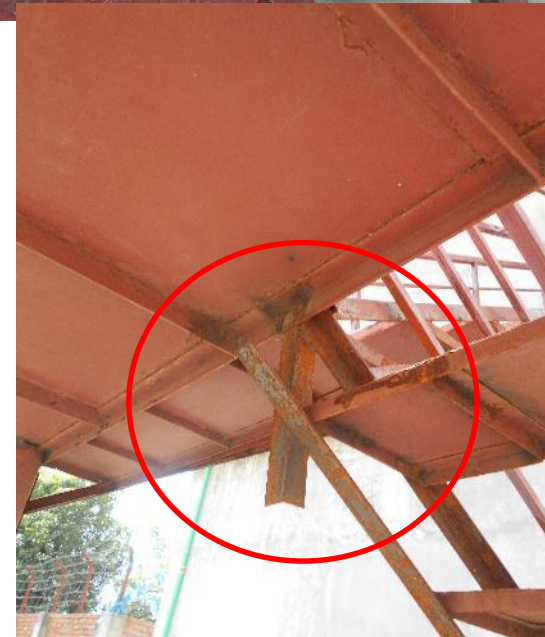
Poor connection details

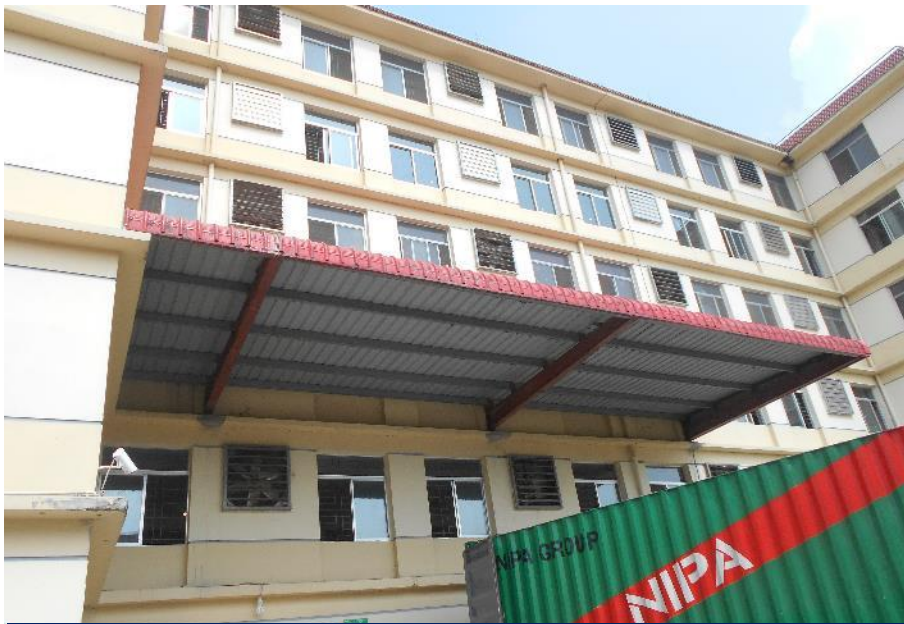
Canopy structure

| Item No. | Observation | Recommended Action Plan | Recommended Timeline |
|---|---|---|---|
| 3 | Connection of the canopy | Building engineer is required to check the adequacy of the connection of canopy structure for the uplift force. | 6-weeks |
| 4 | Connection of the canopy | Carry out any remedial works where necessary | 6-months |

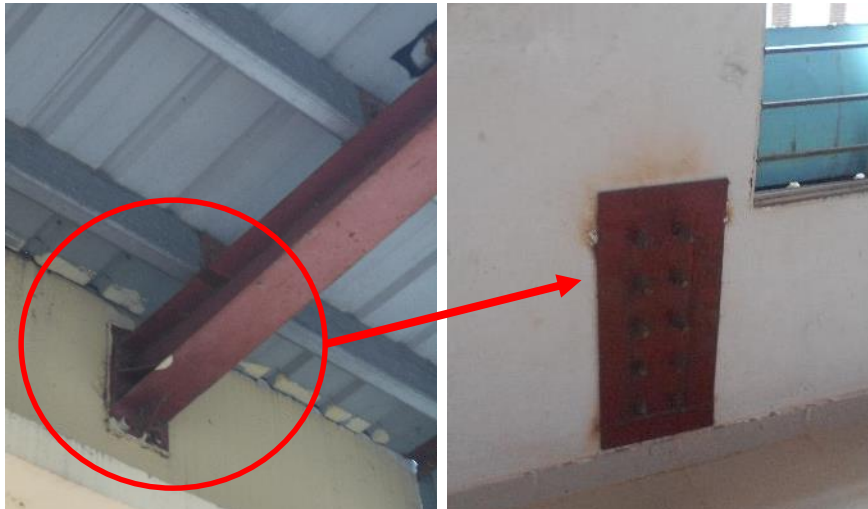
Rafter connected with brick façade.

Apparently inadequate connection of the canopy structure. Building engineer is required to check the connection for the uplift force.

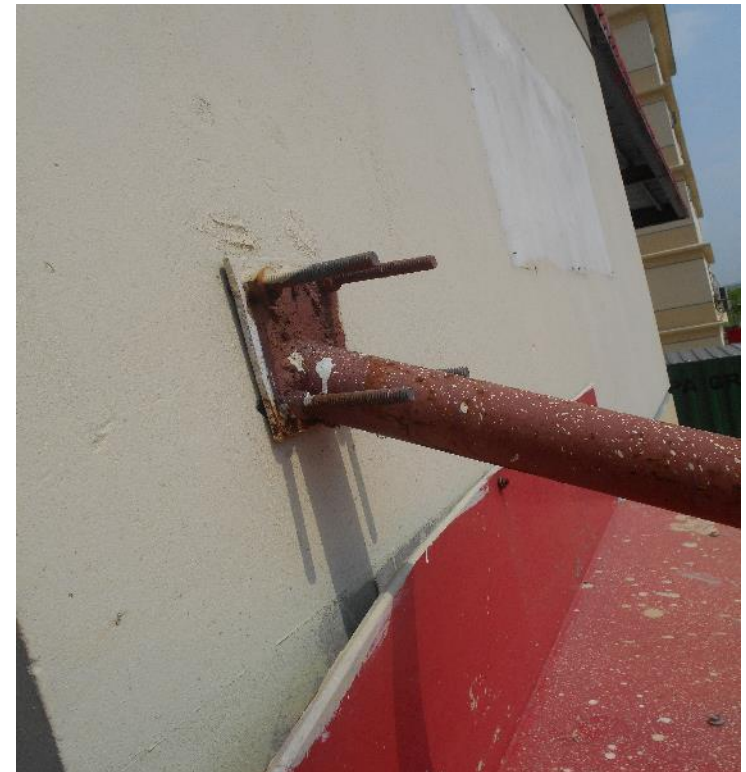
Connection between tension member and the brick façade wall.
