# Kadena Sportswear Ltd.

Comilla EPZ, Old Airport Area, Comilla -3500  
(23.442649, 91.184187) 18 March 2015

# Observations

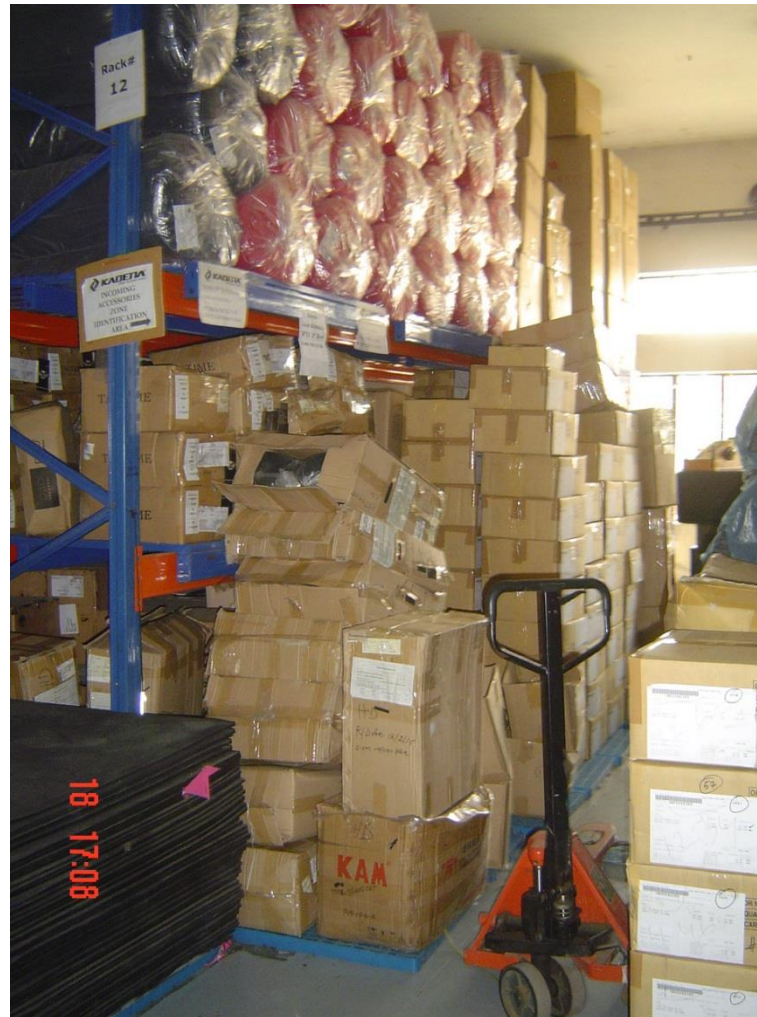
# **Loading on ground floor, ground slab deflection and racking stability**

**Heavy loading on ground floor. Ground floor slab deflections and relatively high racking. Ensure racking stability.**

**ITEM 2:** Heavy loading on ground floor, deflection of ground floor slab, racking stability

| Item No. | Observation | Recommended Action Plan | Recommended Timeline |
|---|---|---|---|
| 3 | Building 1<br>Heavy loading on ground floor, deflection of ground floor slab, racking stability | Stability of racking to be reviewed given slab deflections | 6-months |
