# **FIRE SAFETY INSPECTION REPORT**

## **ELITE GARMENTS INDUSTRIES LTD. (New Building)**

**ACCORD ID: 23831**

**Inspected By: Md. Anayet Hossain and A.K.M. Monoarul Huda**  
**Date: 29 September, 2019**

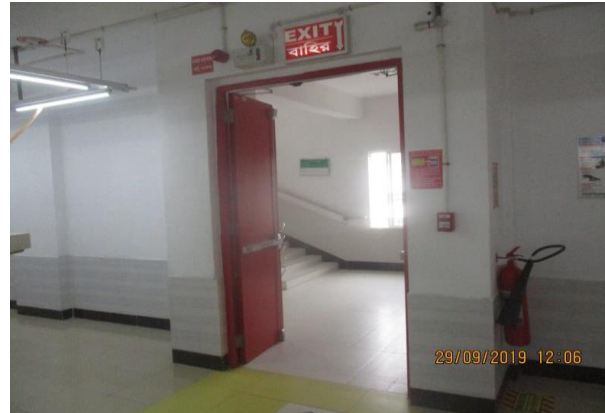
| Sl No. | Category | Findings | Required Action | Remediation Time Frame |
|---|---|---|---|---|
| 1 | Fire Rated Construction | The exit stairs are not separated from [work areas, other spaces] on each floor by fire rated construction. | <p>Separate the exit stairs from work areas and other building spaces on all floor levels by minimum 2- hr fire-rated construction.</p> <p>Provide minimum 1.5- hr fire rated doors and seal all unprotected openings and penetrations to maintain the fire separation.</p> <p>Ensure that all fire doors are self-closing and positive latching, and are provided with fire exit (panic) hardware where serving production floors or assembly occupancies.</p> <p>If fire doors are required to be held open for functional reasons, provide automatic-closing devices tied to the fire alarm system.</p> <p>Once fire doors are installed, every door in a stair enclosure serving more than 5 stories shall be provided with re-entry unless it meets ACCORD standard 6.8.3.1.</p> | Within 3 months |

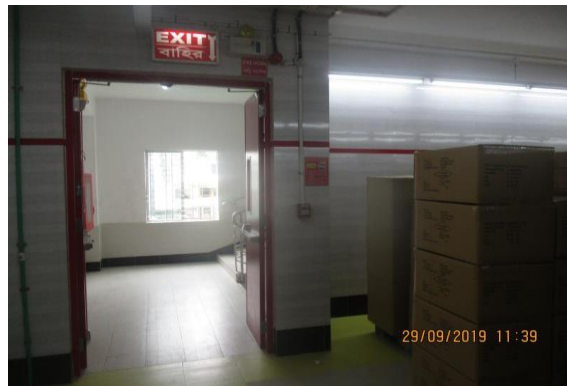
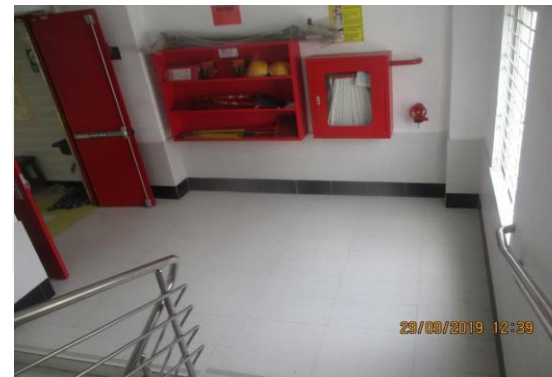
| 2 | Fire Rated Construction | Storage room discharges directly into the exit stair enclosures.<br>Locations: Ground and 1st floor. | Openings from exit enclosure to storage spaces shall be provided with a vestibule with fire rated construction and openings.<br>Provide a 1.5-hr. fire rated door on the exit stair side and a 1-hr. fire rated door on the storage room side. Ensure that the fire rating of the vestibule construction matches that of the exit stair enclosure. | Within 3 months |

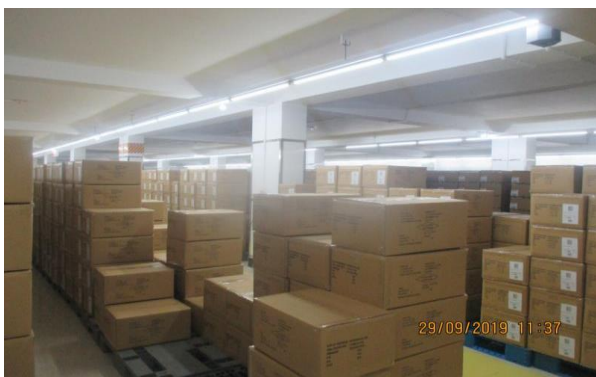
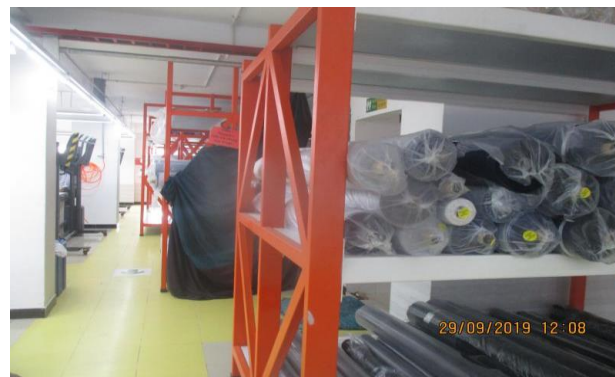
| 3 | Fire Rated Construction | Areas used for combustible storage are not separated by fire rated construction. | <p>Provide dedicated storage rooms separated by minimum 1-hr fire-rated construction.</p> <p>Where separate storage rooms are not feasible, provide defined storage areas and limit the storage arrangement as follows:</p> <ul style="list-style-type: none"> <li>- Maximum height of 2.4m and maximum area of 23m<sup>2</sup></li> <li>- If sprinkler protected: maximum height of 3.66m and maximum area of 93m<sup>2</sup></li> </ul> <p>Separate areas of unenclosed combustible storage by a minimum clear distance of 3m.</p> | Within 3 months |

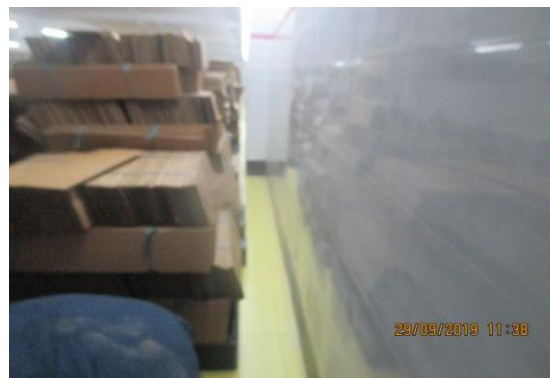
| 4 | Egress | The width of egress aisles is less than 36-inch. | Aisles shall be provided with a minimum unobstructed clear-width of 0.9 m (36 in.). | Within 3 months |

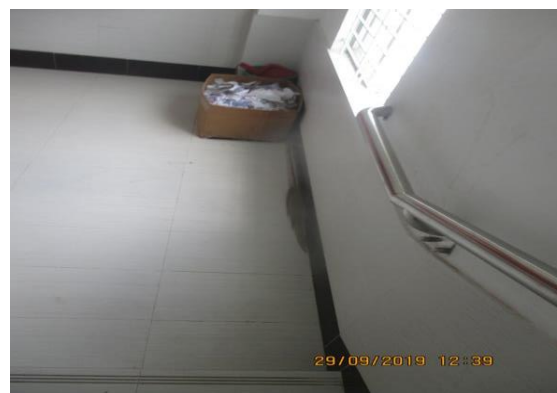
| 5 | Egress | Storage was located in exit stairs. | Remove storage from the exit stairs and egress path | Immediate |

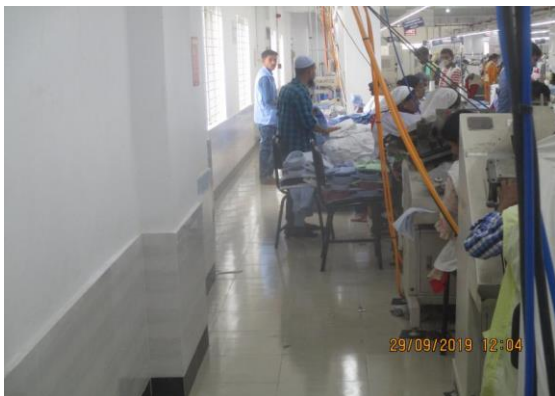
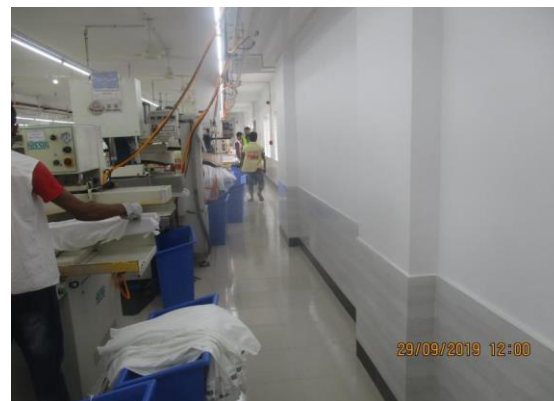
| 6 | Egress | Storage was located in the egress path. | Keep egress path and stair clear of storage | Immediate |

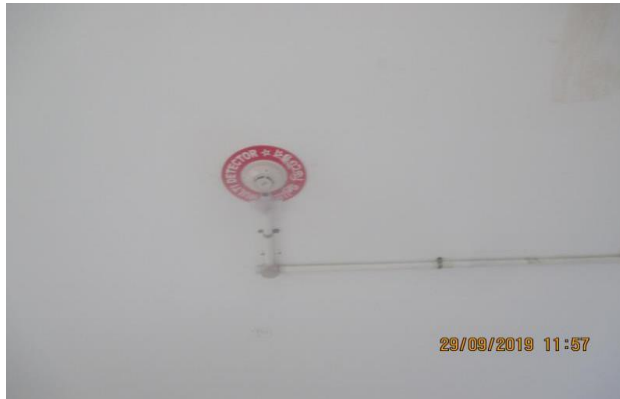
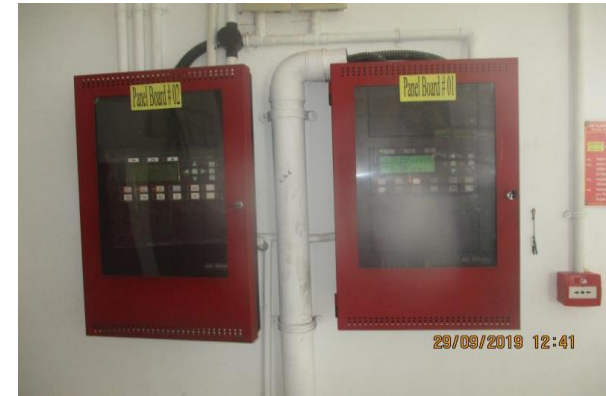
| 8 | Fire Detection and Alarm System | Fire detection system installation requires detailed review to confirm compliance with NFPA 72 and ACCORD standards. | Submit as-built drawings, testing records, equipment certification and other relevant documentation to the ACCORD for review and approval. Installation or modification shall be as per the reviewed design with a listed Addressable Fire Alarm System. | Design within 2 months, Install within 4 months (If modification required) |

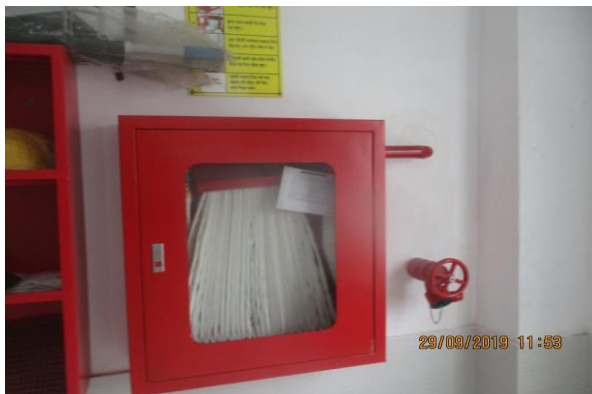
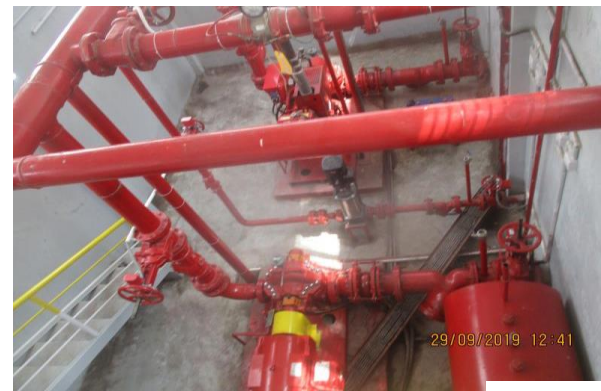
| 10 | Fire Protection | Fire pump, water supply & standpipe system installation requires detailed review to confirm compliance with NFPA 14, 20, 22, 25 and ACCORD standards. | Submit as built drawings, testing records, listing information and other relevant documentation to the ACCORD for review and approval, modification shall have to done as per the reviewed design (if required). | Design within 2 months, Install/Modify within 4 months |
