# INITIAL FIRE SAFETY ASSESSMENT

Factory Name: **MHC Apparels (Pvt.) Ltd.**  
Address: **Holding-297/1, Block-B Ward# 4, Vangnahati, Sreepur  
Gazipur Dhaka Bangladesh**  
Assessor: **Uttaron Technologies**  
Date: **19 Aug 2018**

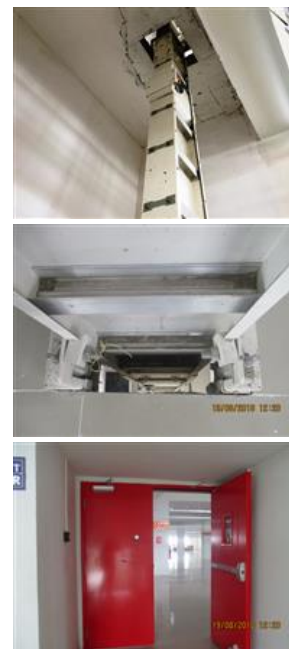
| Description: | All the openings were found fire rated but penetrations have been seen around the BBT Riser which is vertically connected to all floors of "Garments building 01". |
| Source of Findings: | Visual Assessment: Penetrations (holes) through fire-rated assemblies are not properly sealed with firestop system at "Garments building 01". |

| Suggested Plan of Action: | Provide fire-resistive rated penetration protection for rated walls and assemblies in accordance with Alliance Standard Sections 4.6 and 4.7. Consult a qualified fire protection engineer to design the required penetration systems. |

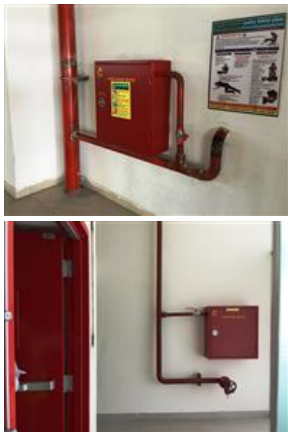
| Description: | Standpipe systems have installed throughout the facility. But the proposed design was not reviewed/approved by Alliance. Standpipe System installation is done but Commissioning and Testing are not done yet. | |
| Source of Findings: | Visual Assessment: Standpipe System has been seen on site during the assessment. | |

| Suggested Plan of Action: | Complete Commissioning and Testing of standpipe system by a qualified fire protection engineer. Standpipe system must comply with the requirements of NFPA 14. | |

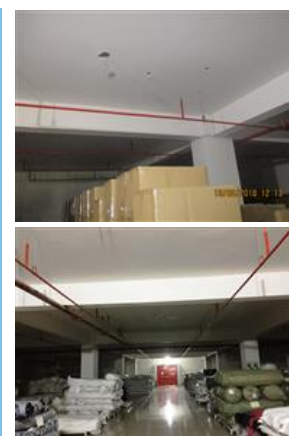
| Description: | The highest occupied floor level of the "Garments Buildings 01" is less than 75 feet. Considering buildings height, Sprinkler system is not required in this Factory. But, they have installed Sprinkler system at their "Finished goods Store & Bonded Warehouse" in Ground floor for additional protection. Proposed design of Automatic Sprinkler System was not reviewed/approved by Alliance. |
| Source of Findings: | Photograph: Automatic Sprinkler System at "Finished goods Store & Bonded Warehouse" in Ground floor "Garments Buildings 01". |

| Suggested Plan of Action: | The Proposed/As-built design of Automatic Sprinkler System should be sent for Alliance review. |

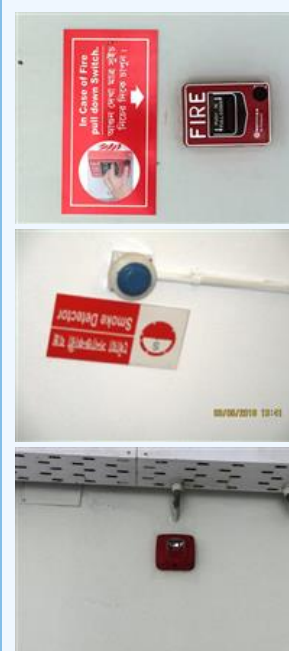
| Description: | The Proposed design of fire detection system is not reviewed or approved by Alliance. Notification and initiation devices have been seen in the factory during the assessment, but those have not addressable identification. |
| Source of Findings: | Photograph: Notification and initiation devices. |

| Suggested Plan of Action: | Install initiating devices and notification appliances as required by the Alliance Standard and NFPA 72. Devices should be part of an automatic fire alarm and detection system for the facility. All fire alarm installations shall be submitted for review by the Alliance prior to the commencement of installation. |

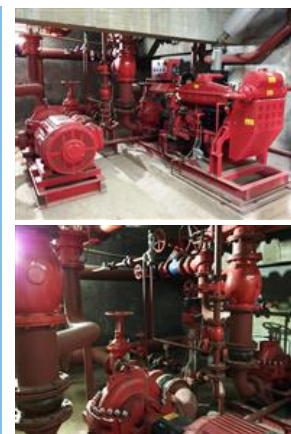
| Description: | Fire pump System installation is done but Commissioning and Testing are not done yet. |
| Source of Findings: | Visual Assessment: A fire pump system has been seen during the assessment. |

| Suggested Plan of Action: | Once a dedicated fire pump is installed, Fire pump installation is to be tested for final acceptance in presence of Alliance and a final inspection of the installation shall be conducted by the Alliance prior to final acceptance of the installation by the Alliance as per clause 5.5.5. Acceptance testing of the installation shall be in accordance with NFPA 20, 22, and 25 testing requirements. Documentation of all testing shall be submitted to the Alliance for review prior to final acceptance by the Alliance. |

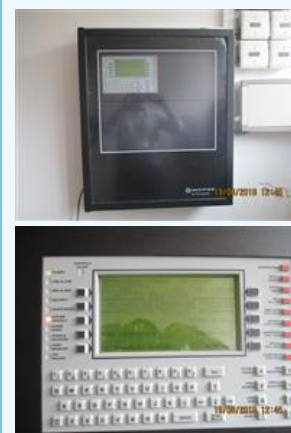
| Description: | The automatic fire alarm system installation is going on. The proposed design of Fire detection system was not reviewed/approved by Alliance moreover they are installing fire detection system. |
| Source of Findings: | Visual Assessment: The automatic fire alarm system installation is going on and the system is monitored by a central station monitoring service. |

| Suggested Plan of Action: | Once installed, arrange for direct connection of the fire alarm and detection system to a central station monitoring service or the Fire Service and Civil Defense as per Alliance Standard Part 5 Section 5.7.5 Monitoring. The completed As-built drawing of fire detection system throughout the buildings should be sent for Alliance review. |

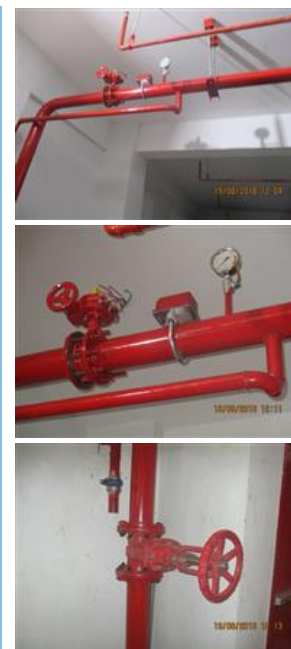
| Description: | Valves control of automatic sprinkler systems and water supply systems have not electrically supervised by a listed fire alarm system control unit. Sprinkler system final testing & commissioning process have not yet completed. |
| Source of Findings: | Visual Assessment: Control valves are not electrically supervised by a listed fire alarm system control unit. |

| Suggested Plan of Action: | Provide electrically supervised devices on the valves controlling the automatic sprinkler systems. Devices are to be supervised by a listed fire alarm system control unit. |

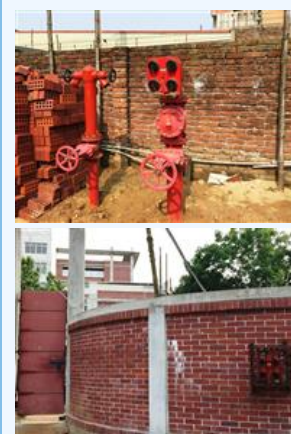
| Description: | Connections for Fire department (Siamese) is provided but it is not clearly identified for the Fire Protection System. |
| Source of Findings: | Visual Assessment: No signage on the Fire Department (Siamese) outlet connection provided for easy identification. |

| Suggested Plan of Action: | Provide Fire Department (Siamese) connections in accordance with Alliance Standard Section 5.5.4. Connections shall match the Fire Service and Civil Defence hose thread standard. |

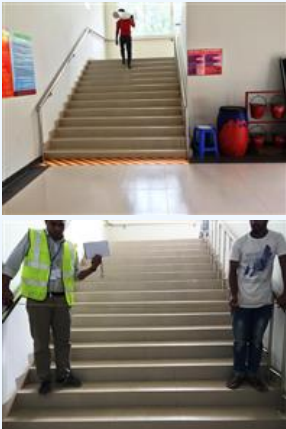
| Description: | "Garments Building 01" are provided with 3 exit stairs, which every stair width is greater than 90 inch. but there are no intermediate handrails found. | |
| Source of Findings: | Visual Assessment: Handrails are provided on both sides of each stairway. No intermediate handrails have not been found. | |

| Suggested Plan of Action: | Provide handrails on both sides of each stairway. Intermediate handrails shall be provided when the stair width exceeds 87 inch. in accordance with Alliance Standard Part 6 Section 6.12. | |

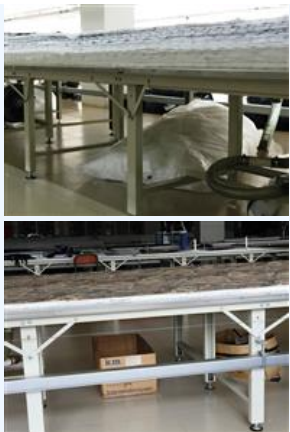
| Description: | Storage areas underneath the cutting tables are not free from combustibles materials. | |
| Source of Findings: | Visual Assessment: Storage has been seen under the cutting tables. | |

| Suggested Plan of Action: | Remove all combustibles stored underneath the cutting tables in accordance with Alliance Standard Section 13.7.2. | |
