**FIRE SAFETY INSPECTION REPORT**  
**Interfab Shirt Manufacturing Ltd (Unit-2)**  
**Stoffatex Fashion Ltd.**

**ACCORD ID: 23717**

## Fire Safety Inspection Report

**Factory Name: Interfab Shirt Manufacturing Ltd (Unit-2)**

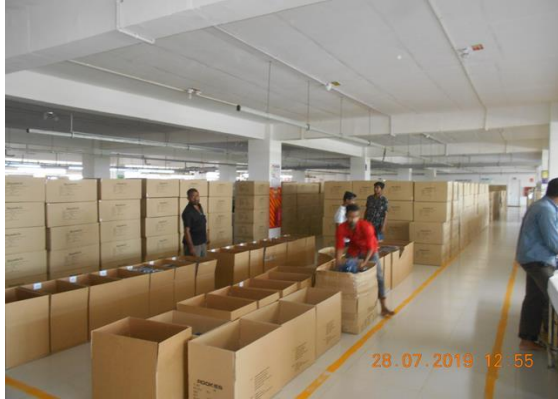
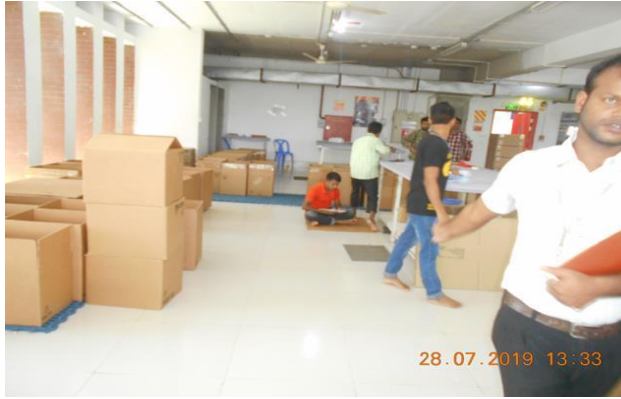
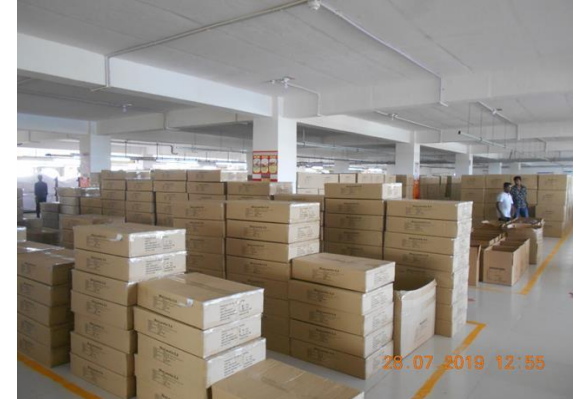
| Sl No. | Category | Findings | Required Action | Remediation Time Frame |
|---|---|---|---|---|
| F-1 | Fire Rated Construction | Areas used for in-process storage of combustible materials are open to the surrounding occupancy . | <p>Provide defined storage areas and limit the storage arrangement as follows:-</p> <ol style="list-style-type: none"> <li>1. General Condition: Maximum height of 2.4m and maximum area of 23m<sup>2</sup>. Separate areas of unenclosed combustible storage by a minimum clear distance of 3m.</li> <li>2. If sprinkler protected: maximum height of 3.66m and maximum area of 93m<sup>2</sup>. Separate areas of unenclosed combustible storage by a minimum clear distance of 3m.</li> </ol> <p>or</p> <ol style="list-style-type: none"> <li>3. Enclose the storage area from the surrounding occupancy with a minimum 1 hour construction.</li> </ol> | Within 3 months |

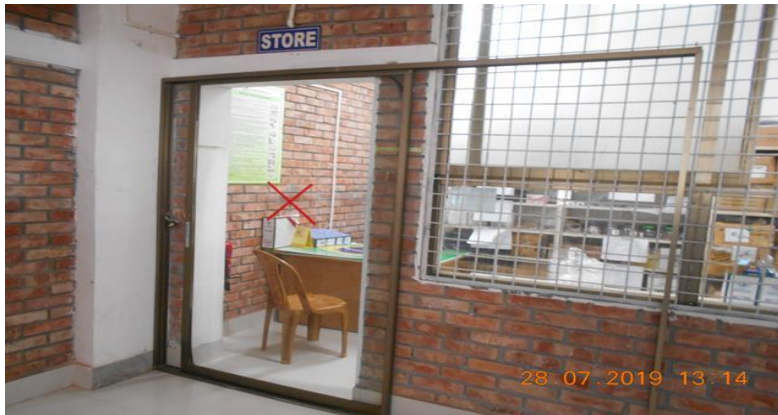
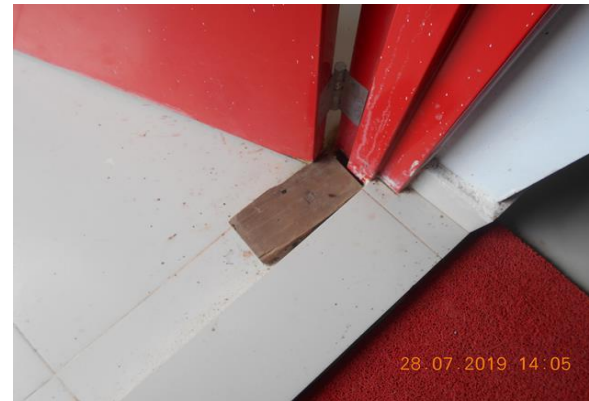
| F-2 | Fire Rated Construction | <p>Rooms used for storage of combustible materials are not separated from the surrounding occupancy/areas .</p> <p>Location: Building 01 &amp; building 02.</p> | <p>Rooms used for storage of combustible materials shall be separated from the surrounding occupancy with a minimum 1 hour construction.</p> | <p>Within 3 months</p> |

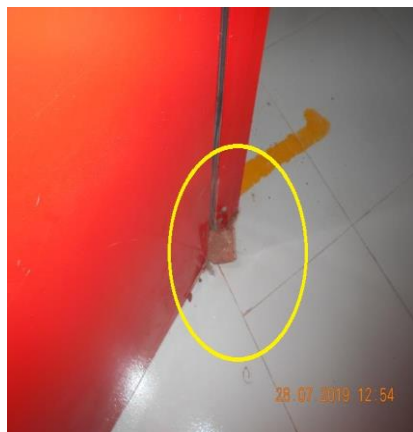
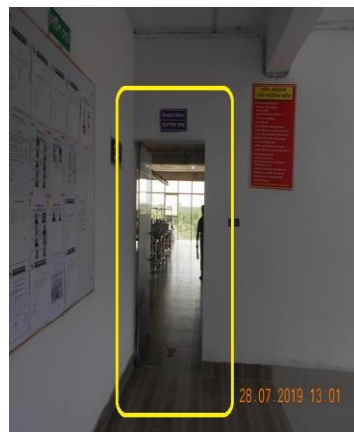
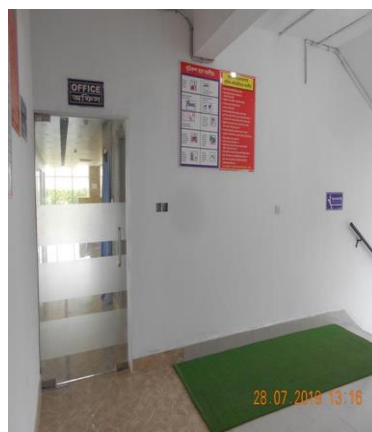
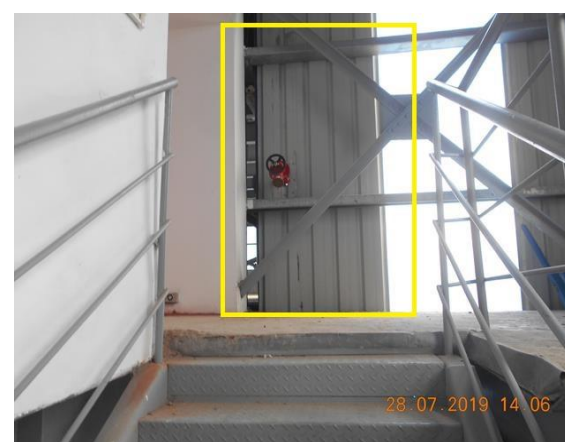
| F-3 | Fire Rated Construction | <p>The exit stairs are not separated from [work areas &amp; other spaces] on each floor by fire-rated construction.</p> <p>Location: Building 01 &amp; Building 02</p> | <p>Stairs shall be enclosed with a minimum 2-hr fire-rated construction. Seal all unprotected openings and provide minimum 1.5-hr fire rated doors to separate the exit stairs from work areas and other building spaces on all floor levels. Ensure that the fire doors are self-closing, positive latching and that they are provided with fire exit (panic) hardware where serving production floors.</p> <p>If fire doors are required to be held open for functional reasons, provide automatic-closing devices tied to the fire alarm system.</p> | Within 3 months |

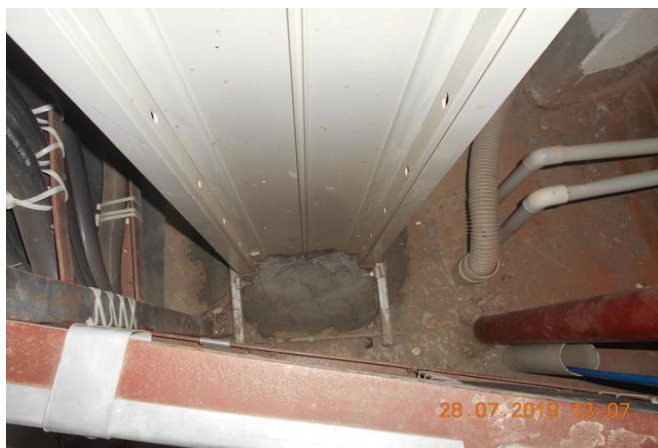
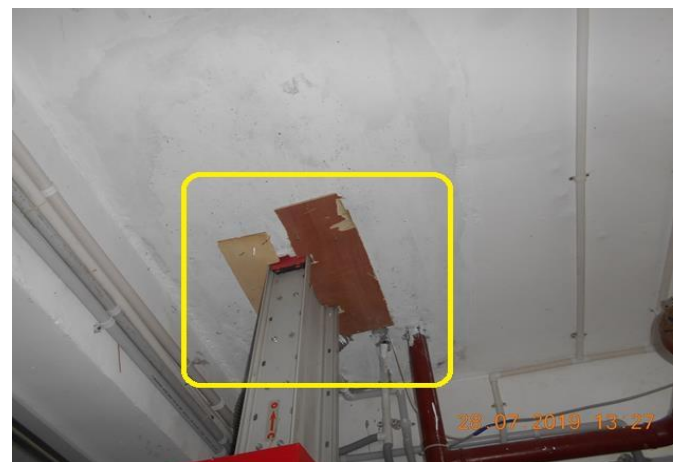
| F-4 | Fire Rated Construction | <p>Penetrations through floor/ceiling assemblies are found unsealed.</p> <p><b>Location:</b> Electrical riser.</p> | <p>Seal all penetrations and openings in floor/ceiling (full thickness of the floor/ceiling) assemblies by fire rated materials to maintain the fire resistance rating.</p> <p>Provide a minimum 2-hr fire rated shaft to separate the utility risers from each floor if required.</p> | Within 3 months |

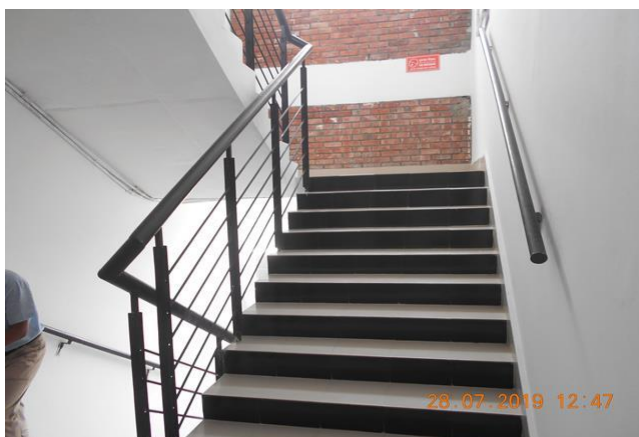
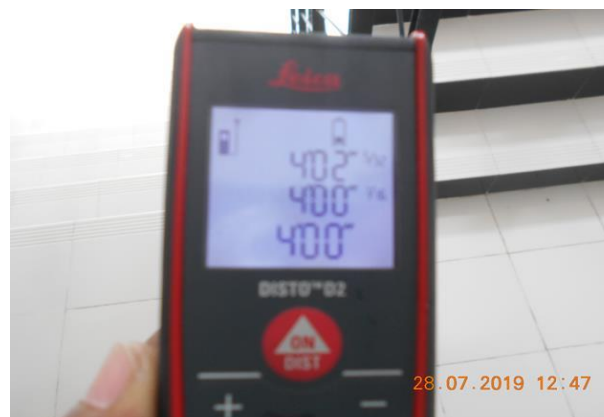
| F-5 | Egress | Handrails are provided in the exit stair but height is 48 inch from the leading edge of the tread. | Provide handrails have a minimum height of 865 mm (34 in.) and a maximum height of 965 mm (38 in. as measured from the leading edge of the tread. | Within 3 months |

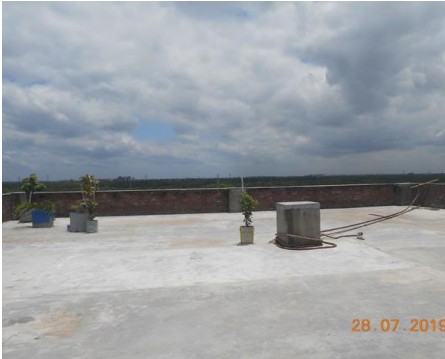
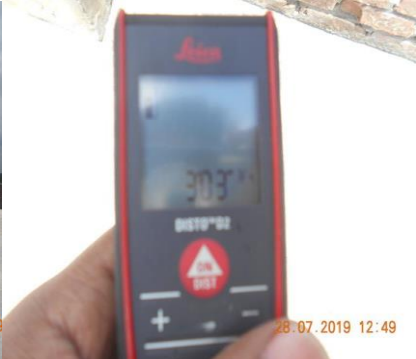
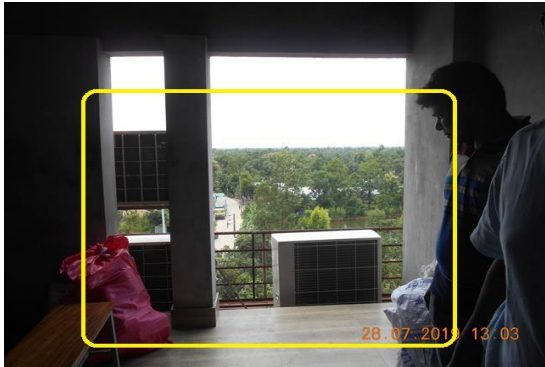
| F-6 | Egress | <p>Parapets or guards are provided which is less than 1067mm (42 inch.).</p> <p>Location: Roof , 5th Floor sample</p> | Provide parapets or guards with a minimum height of 1067mm (42 inch.). | Within 3 months |

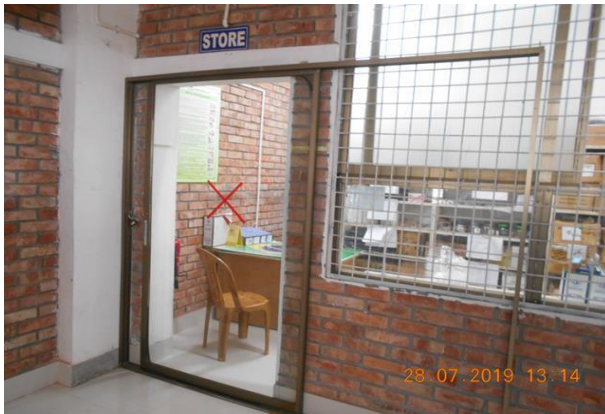
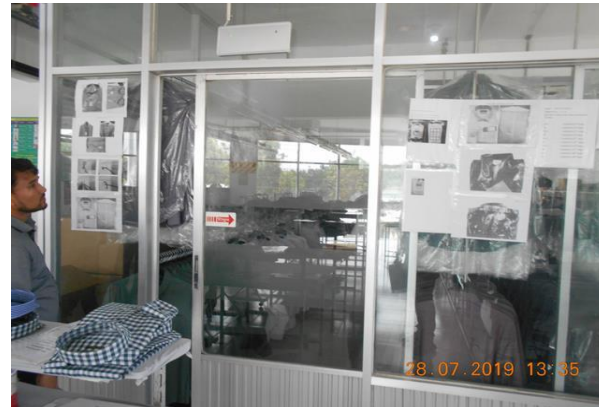
| F-7 | Egress | <p>Collapsible gates / sliding doors are provided at production floor, store etc.</p> | <p>Replace all gates / sliding doors along the means of egress with side-hinged, swinging egress doors.</p> <p>If locks are required for security reasons, utilize special door locking features complying with NFPA 101</p> | Immediate |

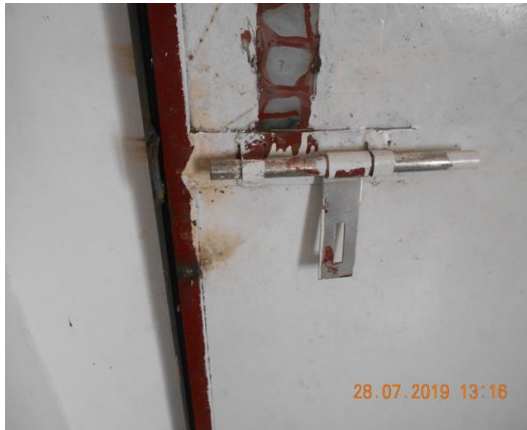
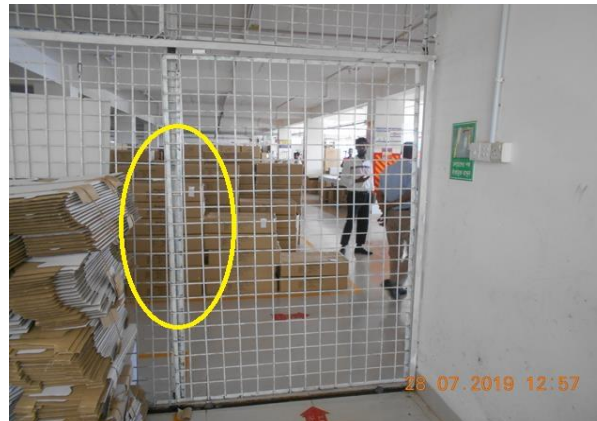
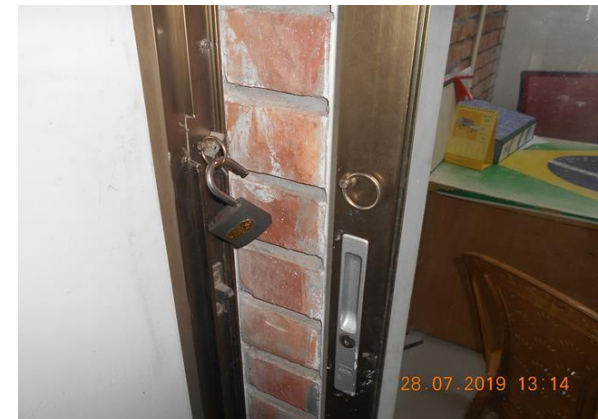
| F-8 | Egress | Egress doors/gates with locking features not complying with NFPA 101 are provided at [building exits, along egress routes, exit discharge] | Remove locking features from all egress doors/gates.<br>If locks are required for security reasons, utilize specialized door locking features complying with NFPA 101. | Immediate |

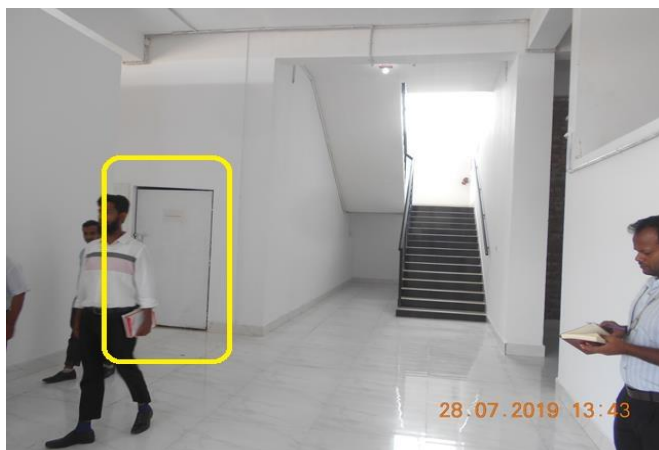
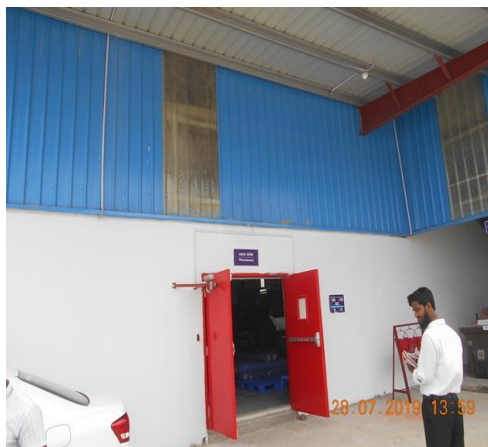
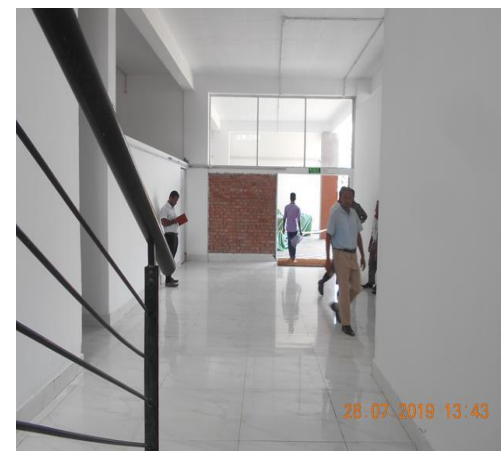
| F-10 | Egress | Exit stairs discharge inside the building.<br><br>Location: Building 01 stair no 02 | Specify appropriate upgrade based on conditions:<br>- Modify stair to discharge directly outside.<br>- Provide 2-hr fire-rated exit passageway leading directly outside (vestibules to separate any storage areas).<br>- Provide sprinkler protection for discharge floor in accordance with NFPA 13. | Within 3 months |

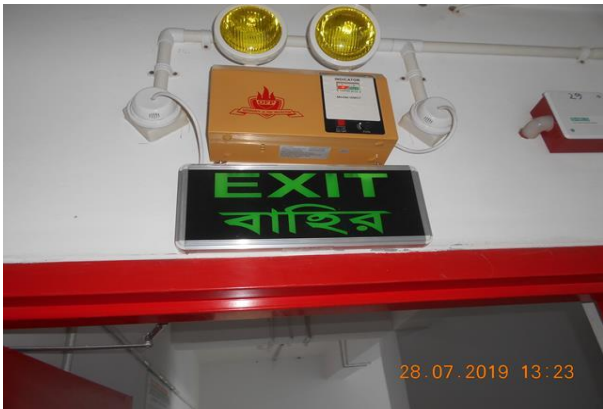
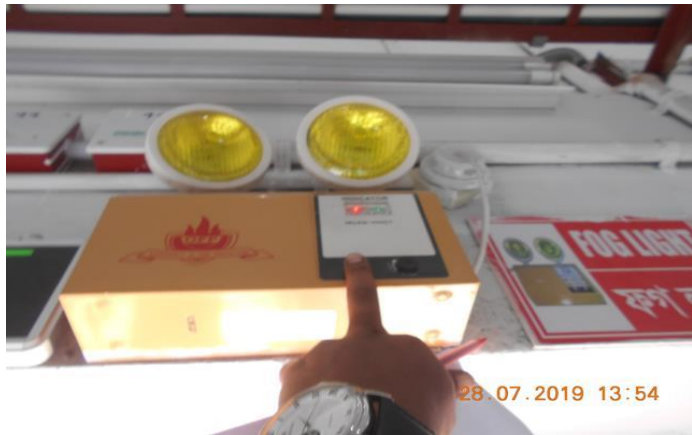
| F-11 | Egress Lighting | Exit signage & emergency light not illuminated (burned out, broken, etc.). | Regularly inspect all exit signage and replace/install lights as needed to illuminate signs | Within 3 Months |

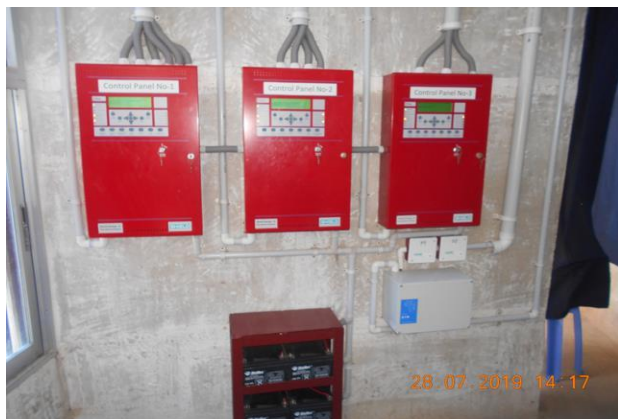
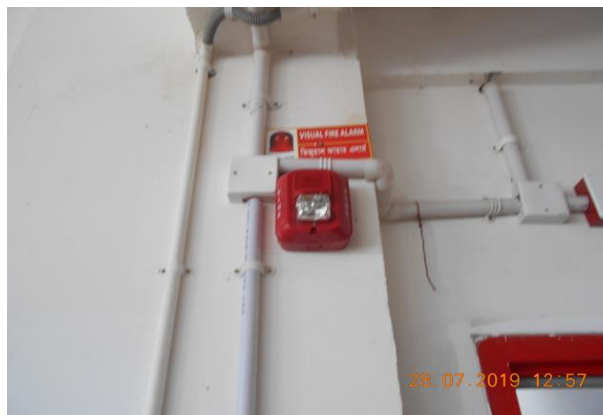
| F-12 | Fire Protection System | Fire detection system installation requires detailed review to confirm compliance with NFPA 72 and ACCORD standards. | Submit as-built drawings, testing records, equipment certification and other relevant documentation to the ACCORD for review and approval. | Design within 2 months, Install within 4 months (If modification required) |

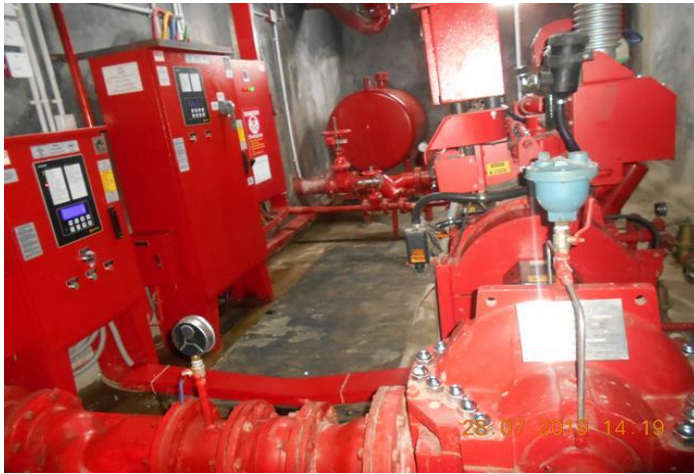
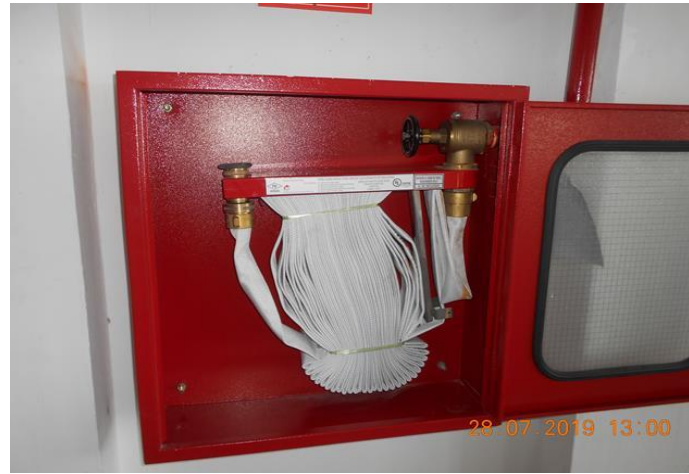
| F-14 | Fire Protection System | Fire pump, water supply & standpipe system installation requires detailed review to confirm compliance with NFPA 14, 20, 22, 25 and ACCORD standards. | Submit as built drawings, testing records, listing information and other relevant documentation to the ACCORD for review and approval, modification shall have to done as per the reviewed design (if required). | Design within 2 months, Install within 4 months (If modification required) |

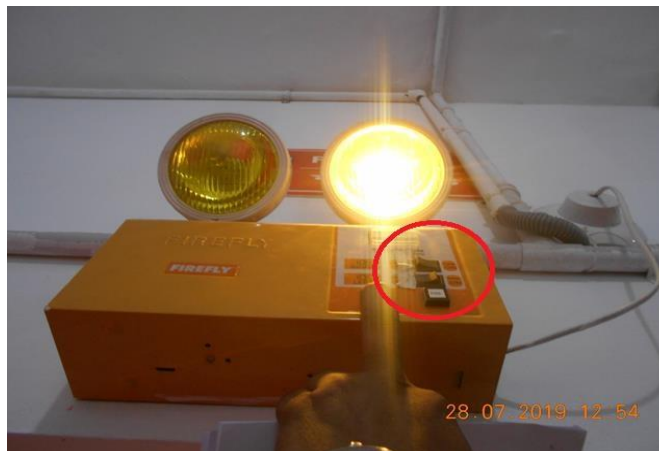
| F-15 | Egress Lighting | Manual on-off switch facility available for emergency lights & exit sign. | Remove manual on/off switches from emergency lighting units to prevent them from being switched off. | Within 1 month |

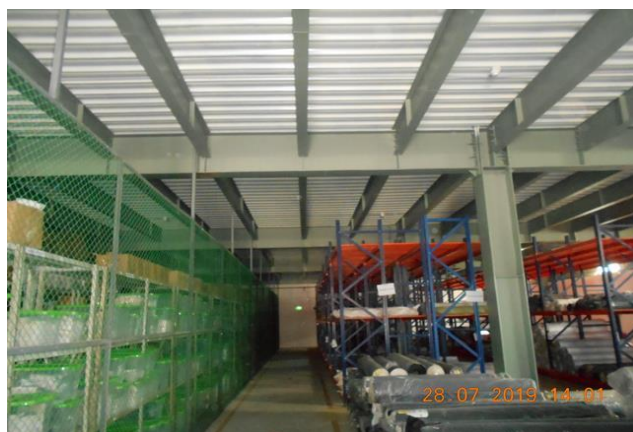
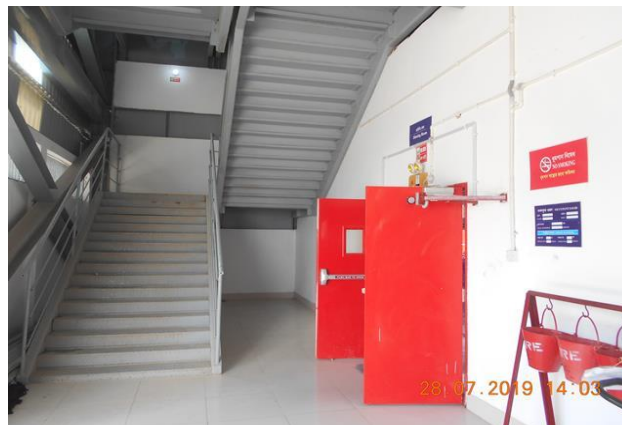
| F-17 | Fire Rated Construction | The construction period of steel structure building (Warehouse & dining building) is from February 2016 to December 2018. Factory has occupied the structure since January 2018. The main structural element of the building is constructed by steel which is non-rated and were found in exposed condition without any fire protection which is a violation of BNBC-2006. | The building shall be type-I or II construction. So, provide require rating in the structural elements of the building. Consult with a qualified fire protection engineer. Follow BNBC 2006-Table 3.2.4 & 3.1.9. | Within 6 months |

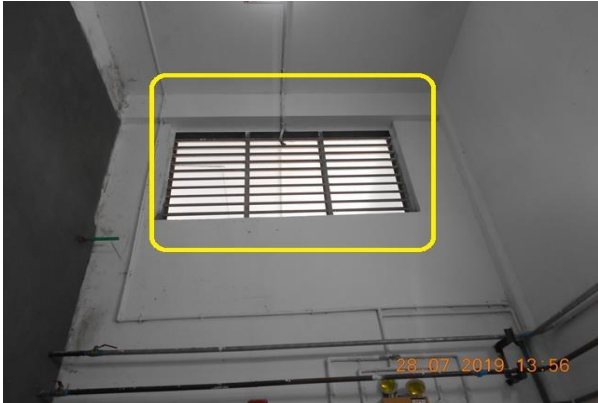
| F-18 | Fire Rated Construction | The boiler and compressor rooms are not separated by fire rated construction (openings, non-rated doors, penetrations). | Separate the boiler and transformer rooms by a minimum 2-hr fire-rated construction. Seal and/or protected all openings to maintain the required fire separations. | Within 3 months |
