# INITIAL FIRE ASSESSMENT REPORT (FAR)

Factory Name: **Kenpark Bangladesh (PVT), Ltd.**  
Address: **Sector 8, Plot 31-42 Export Processing Zone KEPZ,  
Chittagong Chittagong Chittagong Bangladesh**  
Assessor: **Emkay Enterprises LTD**  
Date: **26 Feb 2014**

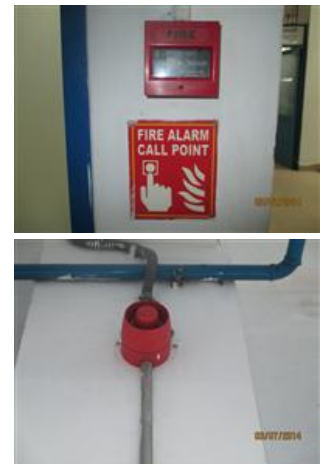
Question:	Are notification and initiation devices for the fire alarm system installed at required locations based on occupancy type?
Priority Level:	High
Non-Compliance Level:	3
Description:	Pull stations at egress points: Manual fire alarms were installed. Push switches were used as fire alarm call points. Smoke detectors: Centralized detection system was available but the numbers of smoke alarms were not sufficient. Audible and Visual devices: No visual alarm was found during this assessment.
Source of Findings:	Photograph: 01. Manual alarm call point. 02. Audible devices.
Suggested Plan of Action:	Design and install automatic fire detection and alarm system by a qualified fire protection engineer throughout the building. Notification devices shall be spaced appropriately based on NFPA 72.
Suggested Deadline Date:	02 Oct 2014
Standard:	Pull stations at egress points, smoke detectors in air handling equipment,

visual and audible devices spaced appropriately based on occupancy type.  
 Reference NFPA 72
