# Interfab Shirt Manufacturing Ltd. (Unit-2) Stoffatex Fashion Ltd.

580/1, Uttar Shalna, ward 23, Ipsha, Gazipur  
(24.047712, 90.379556)  
28<sup>th</sup> July & 9<sup>th</sup> August 2019

# Discrepancies between structural drawings and on-site observations

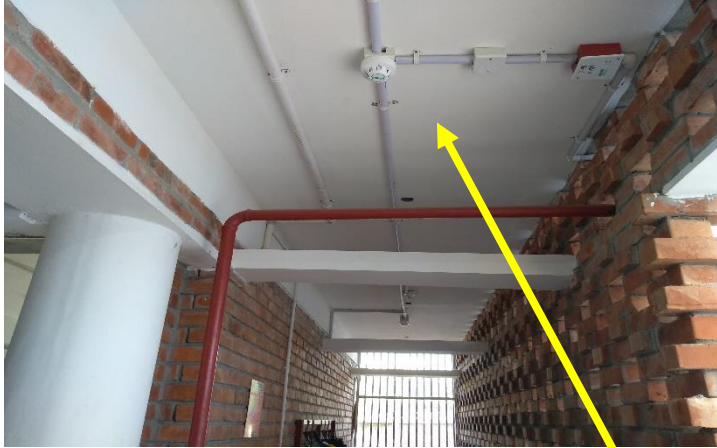
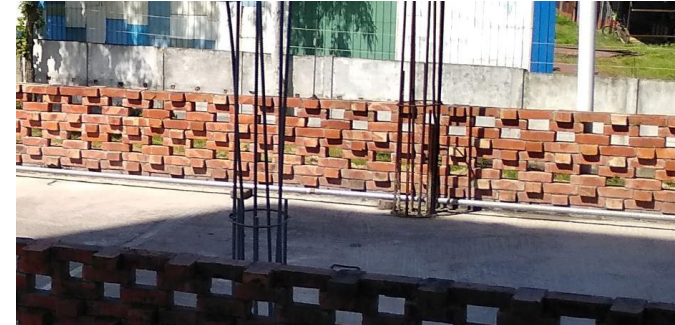
Number of rebar does not match with column schedule. 9 number of exposed rebars were found instead of 12 at roof level. Also, cantilever beam was shown in beam layout plan which was not found on site.

| Item No. | Observation | Recommended Action Plan | Recommended Timeline |
|---|---|---|---|
| 1 | Discrepancies between Structural drawings and on-site observations | The factory engineer is required to survey the structure and produce as-built drawings with complete structural information. | 6-weeks |

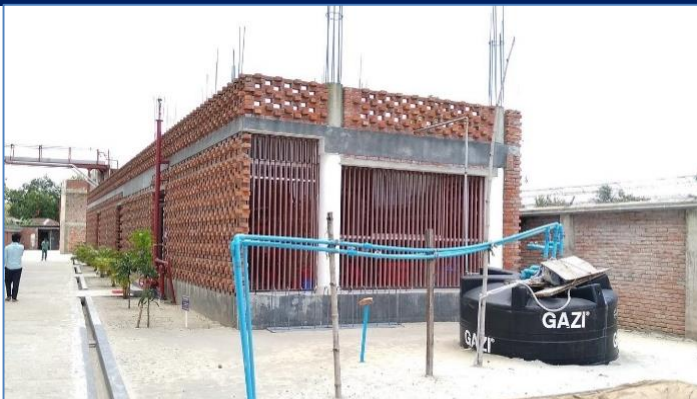
Existing One Storied Building

This building is permitted for three (G+2) storied from local authority. Currently, the building is one storied. Factory owner has plan to extend the building vertically up to three storey. Extended portion of column rebar was found at roof level which indicates the possibility of vertical extension. The factory engineer is required to carried out a Detail Engineering Assessment considering BNBC provision prior to any extension work.

| Item No. | Observation | Recommended Action Plan | Recommended Timeline |
|---|---|---|---|
| 2 | Possible vertical extension | The factory engineer is required to carry out a Detail Engineering Assessment considering BNBC provision prior to any extension work. | 6-weeks |
| 3 | Possible vertical extension | Follow the recommendations of Detail Engineering Assessment report. | 6-months |

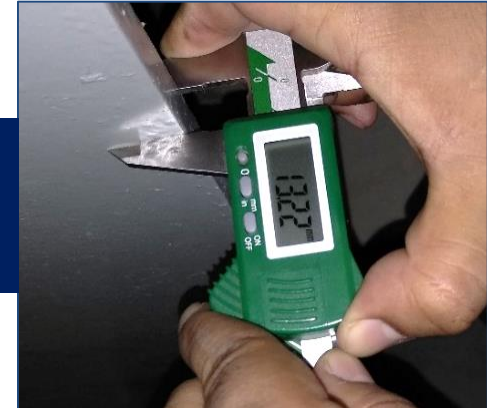
Flange thickness of stair column did not match with the provided drawings. Also, bracing at ground floor stair was not being installed as per bracing layout. The factory engineer is required to produce an “as constructed” drawings with complete structural information.

13 mm thickness  
of column flange  
instead of 14 mm

| Item No. | Observation | Recommended Action Plan | Recommended Timeline |
|---|---|---|---|
| 4 | Discrepancies between drawings and on-site condition | The factory engineer is required to survey the structure and produce as-built drawings with complete structural information. | 6-weeks |

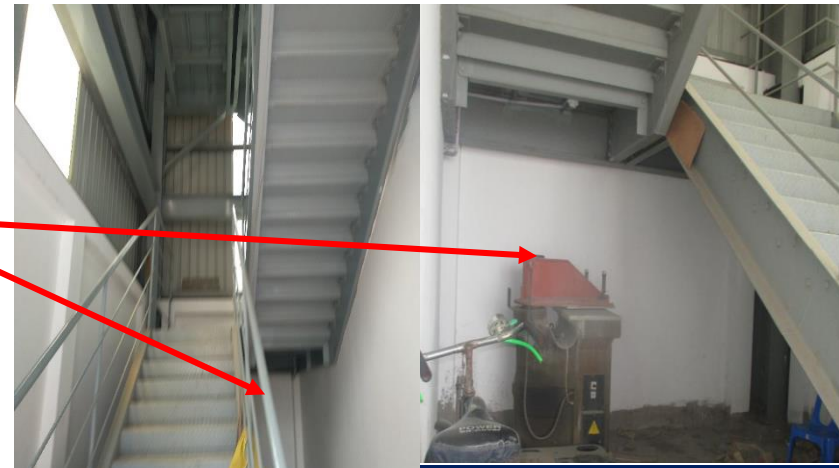
No Bracing at GF level

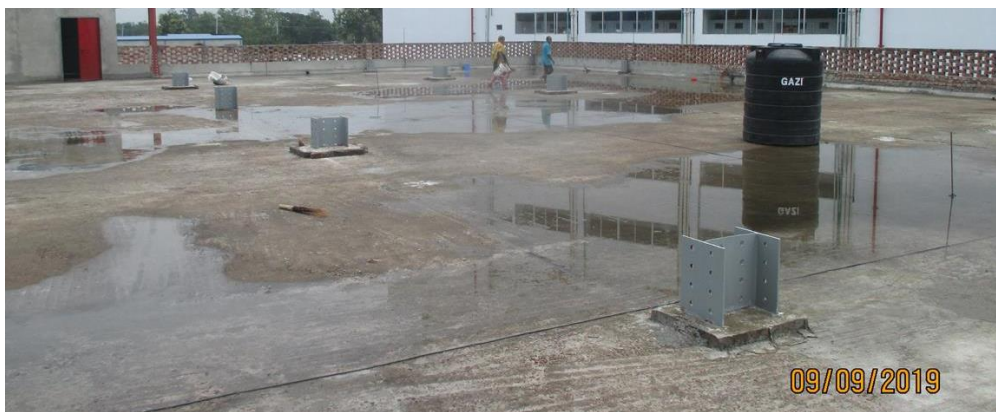
This building is permitted for five (G+4) storied from local authority. Currently, the building is two storied. The factory owner has plan to extend the building vertically up to five storey. Extended portion of steel column was found at roof level which indicates the possibility of vertical extension. The factory engineer is required to carry out a Detail Engineering Assessment considering BNBC provision prior to any extension work.

Steel column extension at roof level

| Item No. | Observation | Recommended Action Plan | Recommended Timeline |
|---|---|---|---|
| 5 | Possible vertical extension | The factory engineer is required to carry out a Detail Engineering Assessment considering BNBC provision prior to any extension work. | 6-weeks |
| 6 | Possible vertical extension | Follow the recommendations of Detail Engineering Assessment report. | 6-months |
