# RAM Apparel Ltd.

Block# A, Plot# 49/1, Ward# 20 P.O.# Salna Bazar 1703 Tak Kathora  
(24.028530, 90.378460)

8<sup>th</sup> March 2020

# Observations

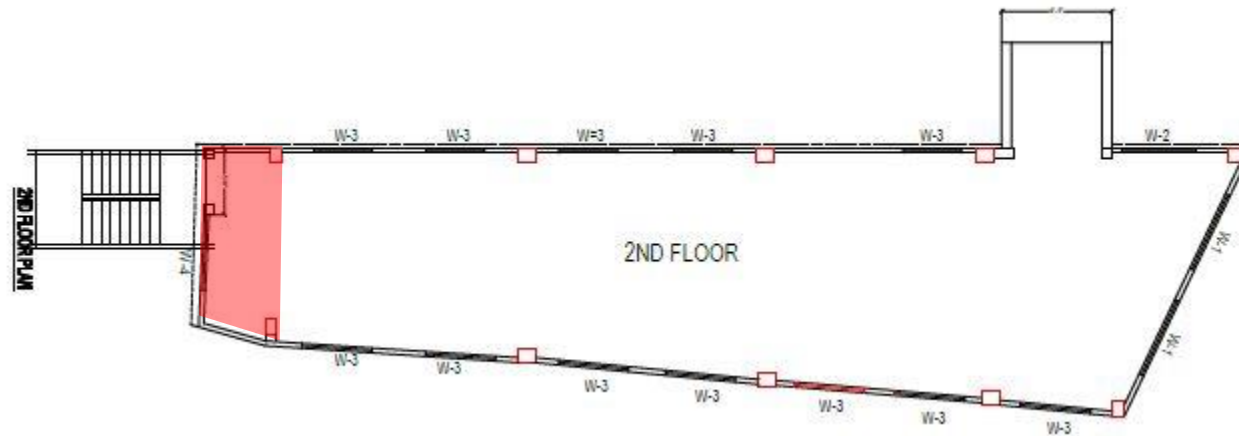
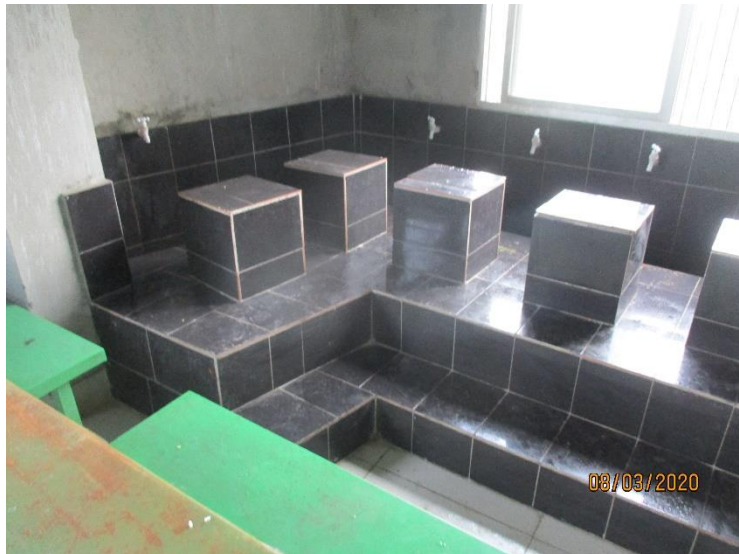
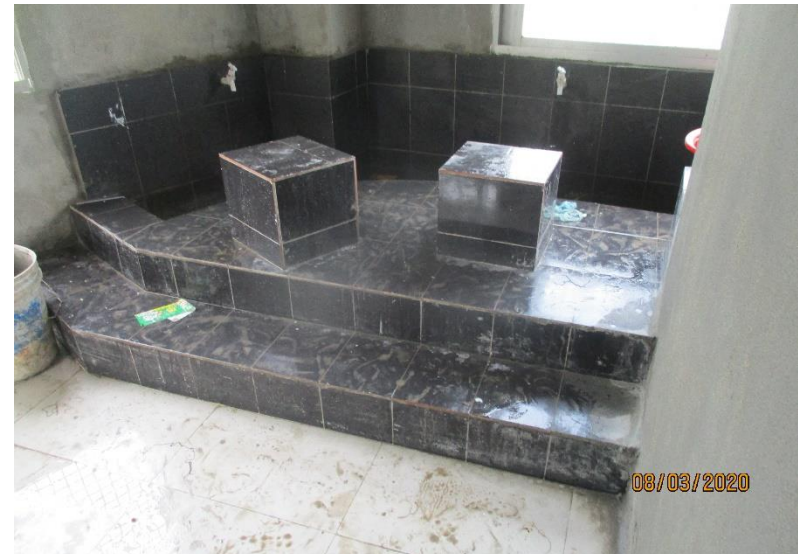
## **Additional imposed load on the cantilever**

Additional build-up constructed on the cantilever slab. Building engineer is required to check the slab adequacy for this additionally imposed dead loads.

01: Additional imposed load on the cantilever.

| Item No. | Observation | Recommended Action Plan | Recommended Timeline |
|---|---|---|---|
| 1 | Additional imposed load on the cantilever | Building engineer is required to check the slab adequacy for this additionally imposed loads. | 6-weeks |
| 2 | Additional imposed load on the cantilever | Carry out any remedial works where necessary. | 6-months |
