# **FIRE SAFETY INSPECTION REPORT**

**DRAGONI FASHIONS LTD.  
KULGAON, BALUCHARA, CHITTAGONG**

**ACCORD**  
on Fire and Building Safety in Bangladesh

May 18, 2014

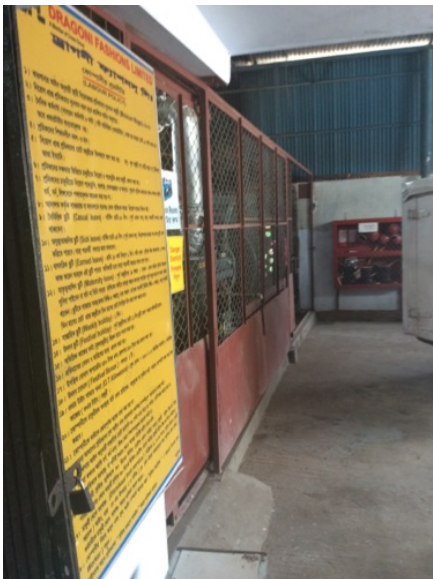
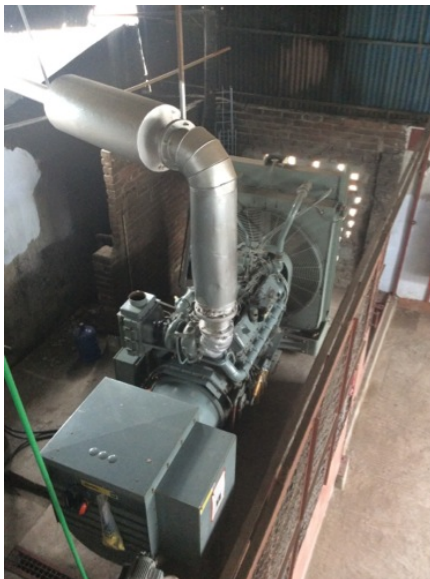
| No. | Category | Finding | Recommendation | Remediation Timeframe |
|---|---|---|---|---|
| F-1 | Fire Rated Construction | The boiler, generator and transformer are not separated by fire-rated construction (openings, non-rated doors, penetrations). Located on the ground floor in close proximity to main exit discharge. | Separate the boiler / generator and transformer area by a minimum 2-hr fire-rated construction. Seal and/or protected all openings to maintain the required fire separations | Within 3 months |

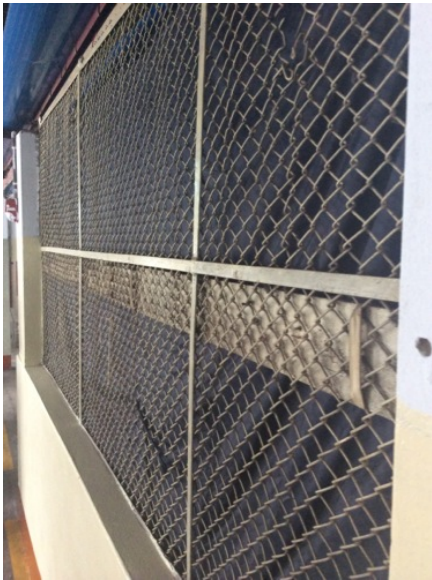
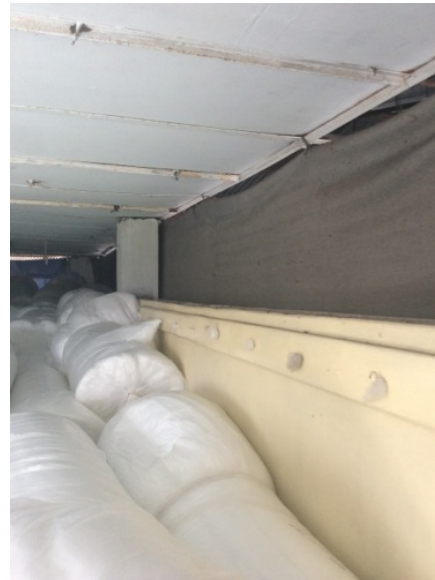
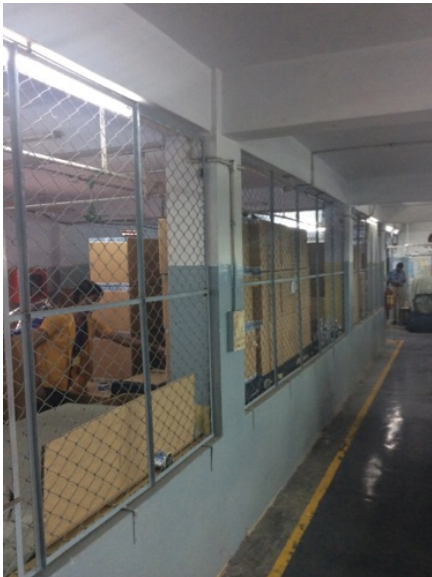
| No. | Category | Finding | Recommendation | Remediation Timeframe |
|---|---|---|---|---|
| F-2 | Fire Rated Construction | Areas used for combustibles storage are not separated by fire-rated construction on the ground and fourth floors. | Provide dedicated storage rooms separated by minimum 1-hr fire-rated construction. | Within 3 months |

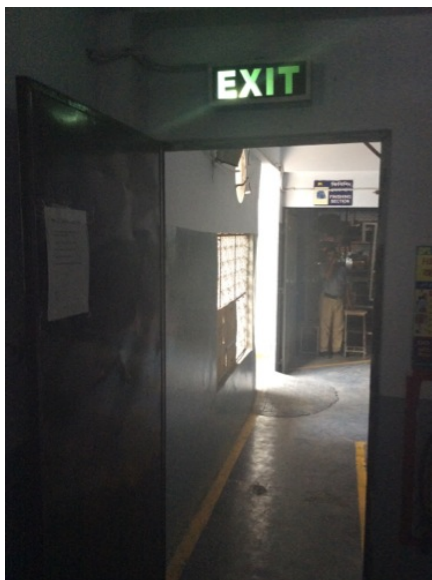
| F-3 | Fire Rated Construction | The exit stairs are not separated from work areas, other spaces on each floor by fire-rated construction. | <p>Provide minimum 1.5-hr fire rated doors and seal all unprotected openings to separate the exit stairs from work areas and other building spaces on all floor levels. Ensure that the fire doors are self-closing and positive latching and that they are provided with fire exit (panic) hardware where serving production floors.</p> <p>If fire doors are required to be held open for functional reasons, provide automatic-closing devices tied to the fire alarm system.</p> | Within 3 months |

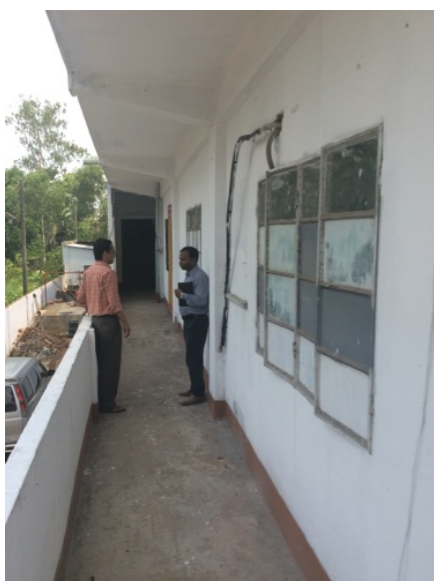
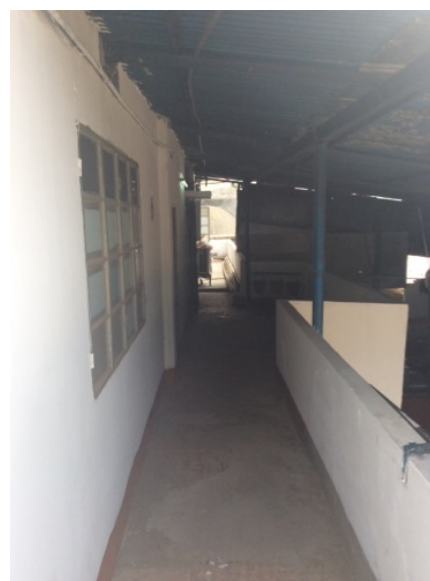
| F-4 | Fire Rated Construction | The exit discharge path from the West egress stair is less than 10 ft wide and is not separated from the building interior on the first floor. | <p>Seal all penetrations and openings to the interior of the building along the discharge path, up to a height of 10 ft., to provide a minimum 1-hr fire separation.</p> <p>Alternatively, provide a second remote discharge path to the public way (only include this if feasible).</p> | Within 6 months |

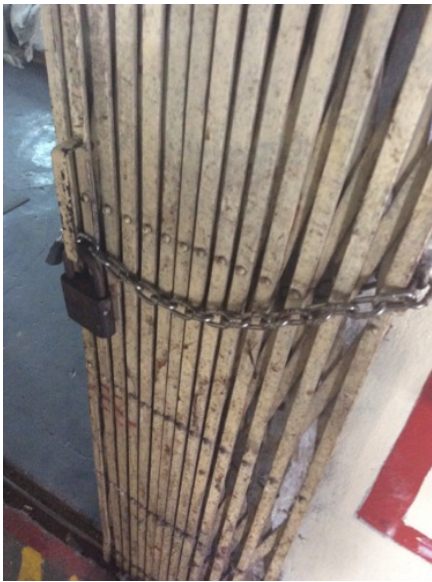
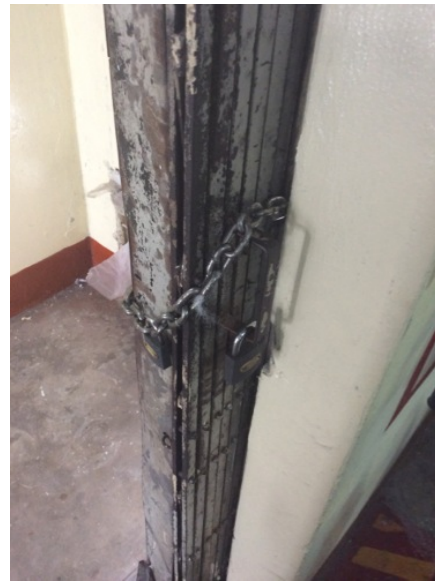
| F-6 | Egress | Egress doors / gates with locking features are provided at all building exits, exit stairs, along egress routes, exit discharge throughout the factory. All gates/doors were open and unlocked during the inspection. | Remove locking features from all egress doors / gates.<br><br>If locks are required for security reasons, utilize special door locking features complying with NFPA 101. | Immediate |

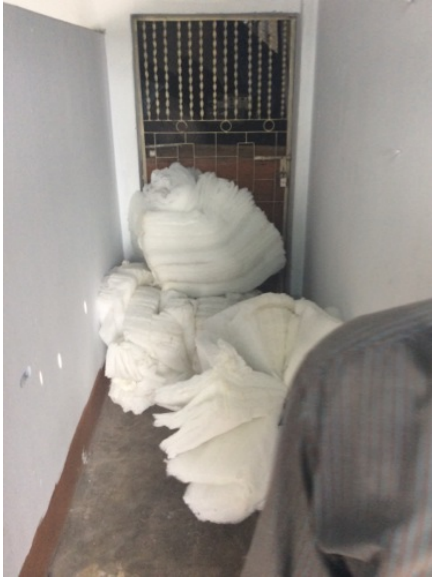
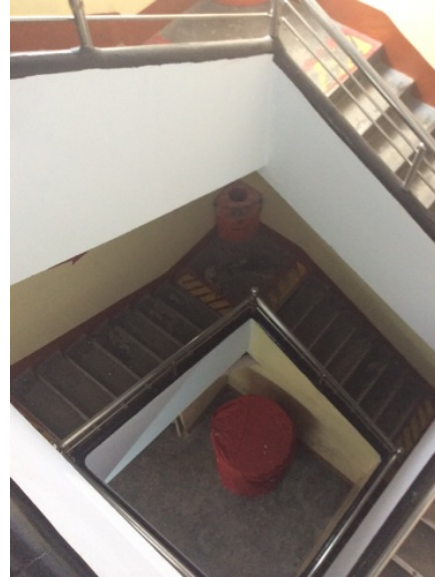
| F-7 | Egress | Storage was located in the South facing exit stair such as trash cans and other combustible materials on the fourth floor landing. | Remove all storage from exit stairs and egress paths. | Immediate |

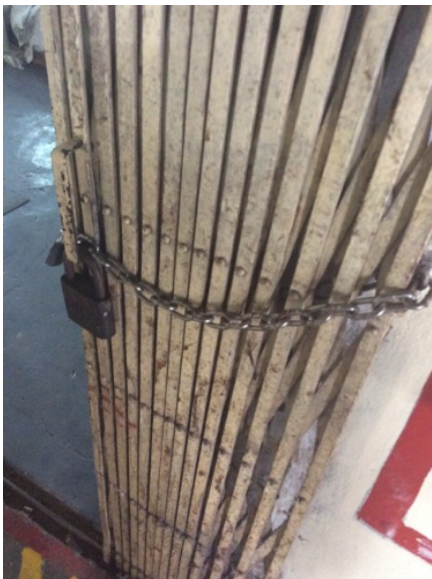
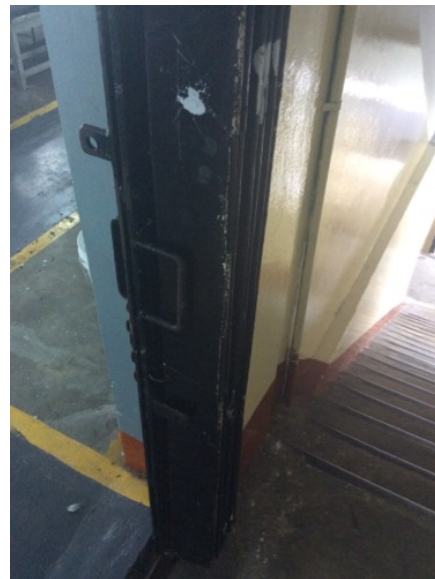
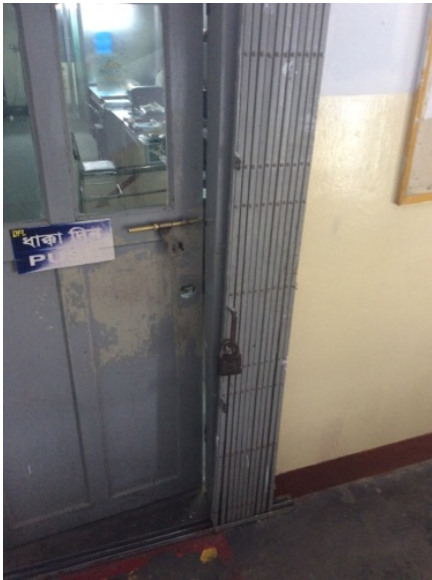
| F-8 | Egress | Collapsible gates / sliding doors are provided at all building exits, exit stairs, along egress routes, exit discharge throughout the factory. | Replace all gates / sliding doors along the means of egress with side-hinged, swinging egress doors.<br><br>If locks are required for security reasons, utilize special door locking features complying with NFPA 101. | Within 1 month |

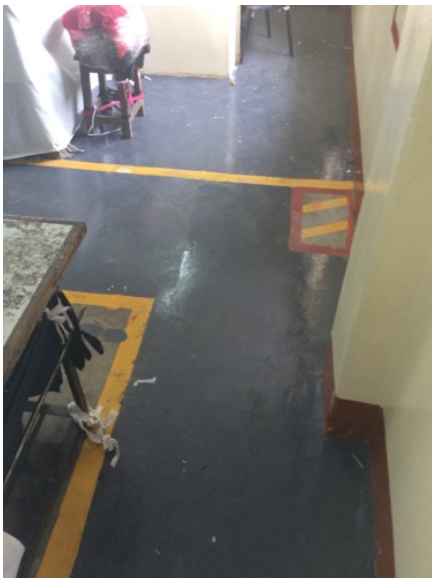
| F-9 | Egress | The width of egress aisles is less than 36-in on the fourth floor located at the North facing wall, between the structural columns and cutting table. | Provide minimum aisle widths of 36-in. | Within 3 months |

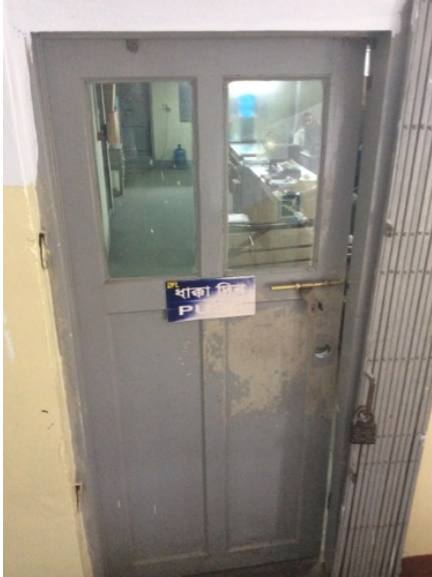
| F-10 | Egress | The office exit door on the second floor to the stairwell does not swing in the direction of egress travel. | Modify the egress door to swing in the direction of egress travel. | Within 3 months |

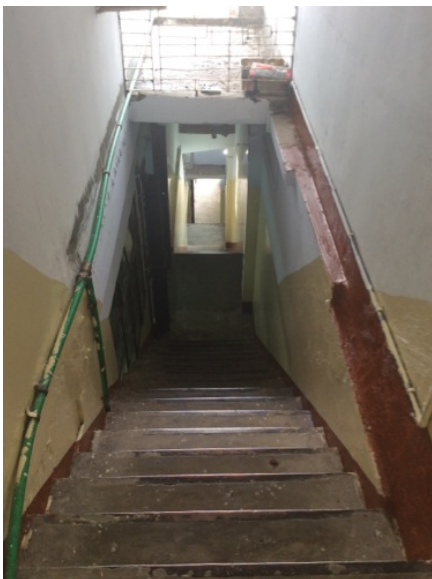
| F-11 | Egress | Handrails are not provided in the exit stair on the West facing exit stair. | Provide handrails on at least one side of exit stair. | Within 3 months |

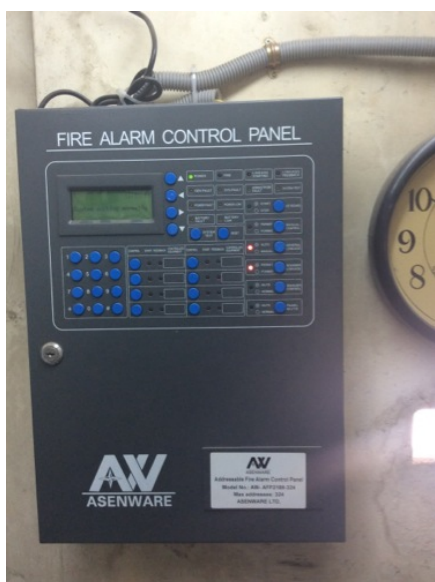
| F-13 | Fire Protection | The fire alarm system does not provide alarm and notification features consistent with acceptable standards required under the NFPA 72 requirement. | Alter the fire alarm system to comply with the requirements of the NFPA 72 standard. | Design within 4 months, install within 9 months |

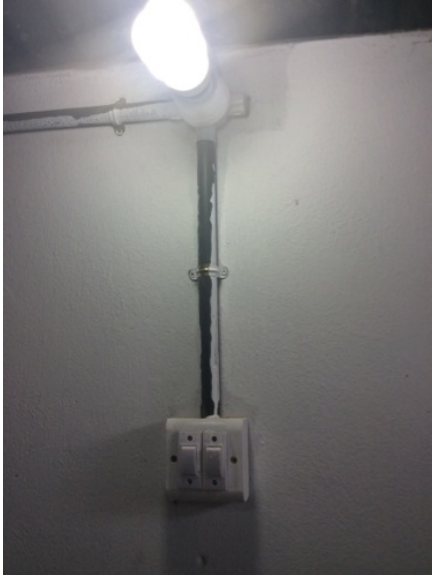
| F-15 | Egress Lighting | Manual on-off switch is provided for emergency lighting throughout the factory. | Remove manual on/off switches from emergency lighting units to prevent them from being switched off. | Within 1 month |
