# INITIAL FIRE ASSESSMENT REPORT (FAR)

Factory Name: **Knit & Knitex (PVT) Ltd**  
Address: **Soydana, Dagerchala Road, National University,  
Joydebpur, Gazipur Joydebpur, Gazipur Dhaka  
Bangladesh**  
Assessor: **Bureau Veritas**  
Date: **14 May 2014**

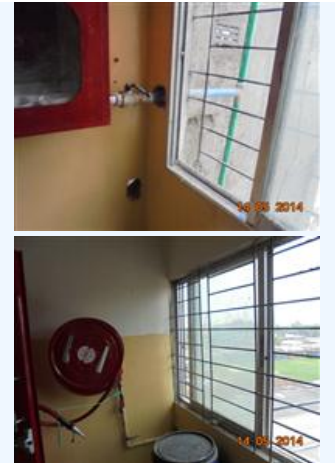
Question:	Are inspection, maintenance, and testing procedures of the standpipe and hose system documented and up to date? Including inspection and testing of hoses if provided.
Priority Level:	Low
Non-Compliance Level:	1
Description:	Complete standpipe system was not installed. There is no test and maintenance plan or record for testing and no maintaining of the existing standpipe system as per NFPA.
Source of Findings:	Document Review: No document regarding inspection, maintenance and testing procedures for available standpipe and hose system was found among the documents shown by the factory personnel.
Suggested Plan of Action:	Install a class III standpipe system at required locations designed by a qualified fire protection engineer. The system is to be compliant with the requirements of NFPA 14. Then establish an inspection, maintenance, and testing program for the standpipe and hose system. Program must comply with NFPA 25 requirements.

Suggested Deadline	14 Dec 2014
