# ELECTRICAL SAFETY INSPECTION REPORT

## MARMA COMPOSITE LTD. (EXTENSION 2)

Tongabari, Ashulia, Savar, Dhaka

**Inspected on:** November 3, 2020

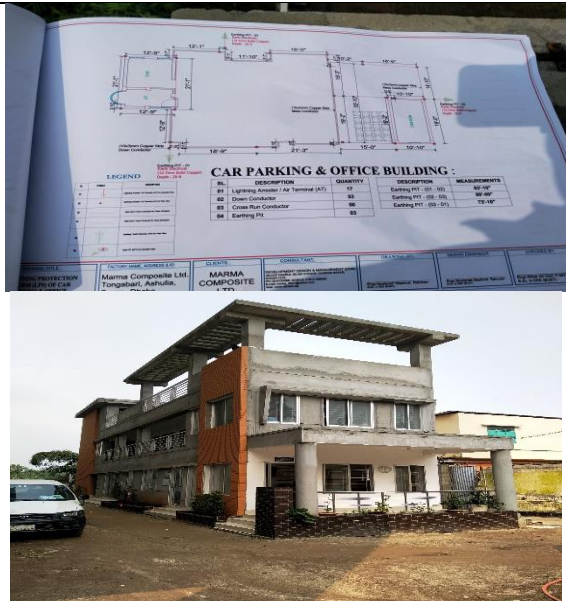
| <b>FINDING NO:</b> | <b>E - 2</b> | |

| <b>FINDING:</b> | <div><div><div>i. LPS drawing is not as built</div><div>ii. Air Terminals are missing few area</div><div>iii. Security building (With Childcare) not under protection zone of LPS.</div></div></div> | |

| <b>RECOMMENDATION:</b> | <div>Factory has to design Lightning Protection System (LPS) for the whole factory (where the Risk index is equal or greater than 40). Once a LPS is designed properly, installation must be done accordingly.</div> | |

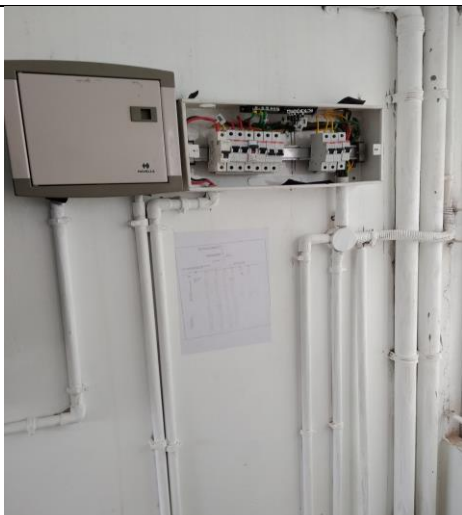
| <b>FINDING NO:</b> | <b>E - 3</b> | | |

| <b>FINDING:</b> | Instruction for CPR (Cardiopulmonary Resuscitation) or Electrical shock restoration is not present. | | |

| <b>RECOMMENDATION:</b> | CPR instruction shall be hanged near all electrical installations (LT panel, MDB, FDB, DB, SDB) at visible location. | | |
