# **FIRE SAFETY INSPECTION REPORT**

**MAGPIE COMPOSITE TEXTILE LTD.**

**832/833, DEWAN IDRIS ROAD, AMTOLI, ASHULIA,  
SAVAR, DHAKA**

May 17, 2014

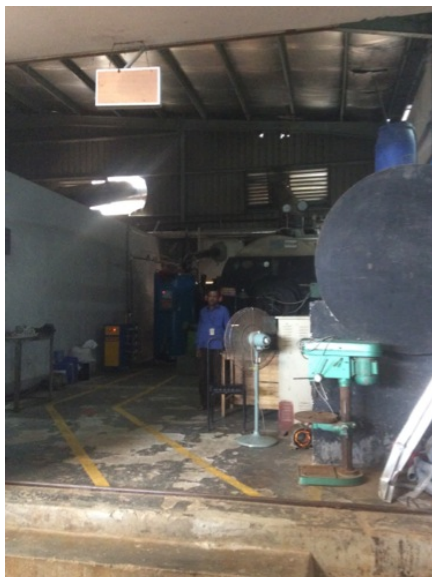
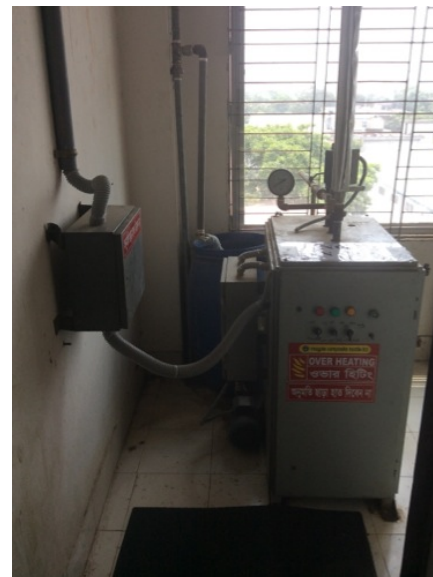
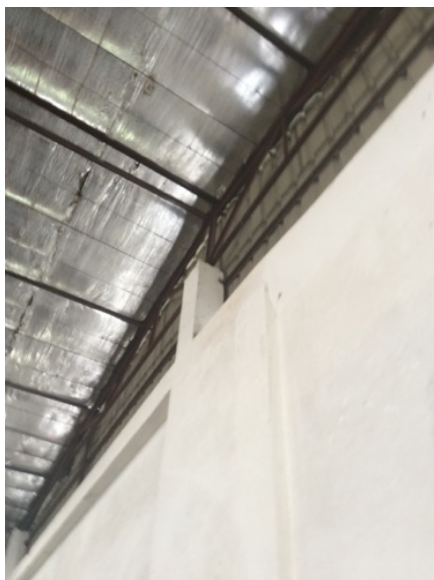
| No. | Category | Finding | Recommendation | Remediation Timeframe |
|---|---|---|---|---|
| F-1 | Fire Rated Construction | <p>The boiler and generator room is not separated by fire-rated construction (openings, non-rated doors, penetrations).</p> <p>Main Boilers on ground floor are not separated from a path of egress.</p> <p>The mini boiler is open to the factory on floors on the 1st and 4th floors.</p> <p>The Generator is not separated from a path of egress and the dyeing and finishing area.</p> | <p>Separate the boiler and generator room by a minimum 2-hr fire-rated construction. Seal and/or protected all openings to maintain the required fire separations</p> | Within 3 months |

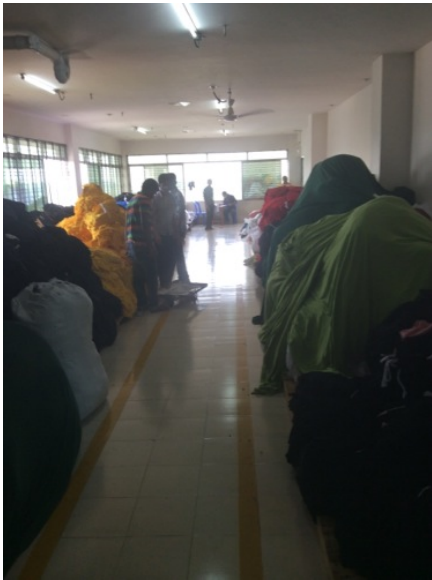
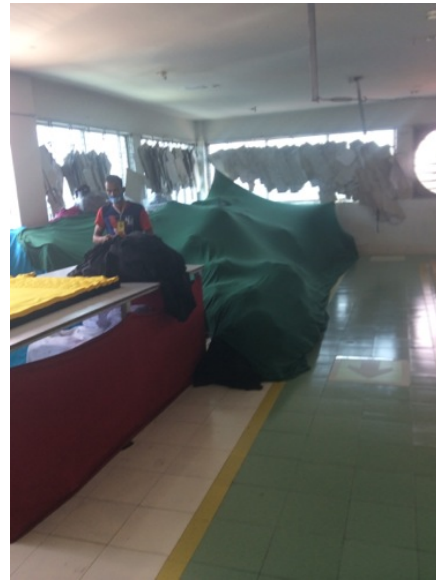
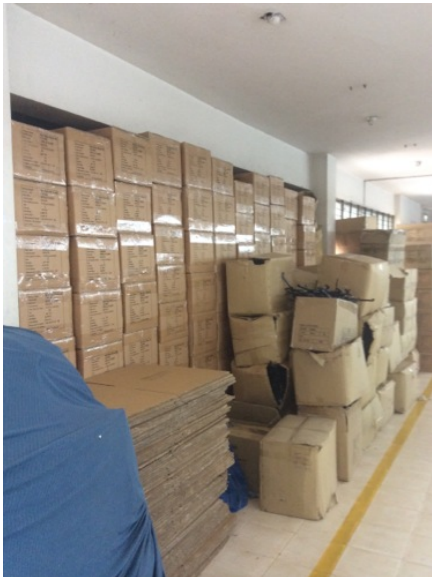
| F-2 | Fire Rated Construction | <p>Areas used for combustible storage are not separated by fire-rated construction.</p> <p>Location:<br/>All Floors</p> | <p>Provide dedicated storage rooms separated by minimum 1-hr fire-rated construction.</p> <p>Where separate storage rooms are not feasible, provide defined storage areas and limit the storage arrangement as follows:</p> <ul style="list-style-type: none"> <li>- Maximum height of 2.4m and maximum area of 23m<sup>2</sup></li> <li>- If sprinkler protected: maximum height of 3.66m and maximum area of 93m<sup>2</sup></li> </ul> <p>Separate areas of unenclosed combustible storage by a minimum clear distance of 3m.</p> | Within 3 months |

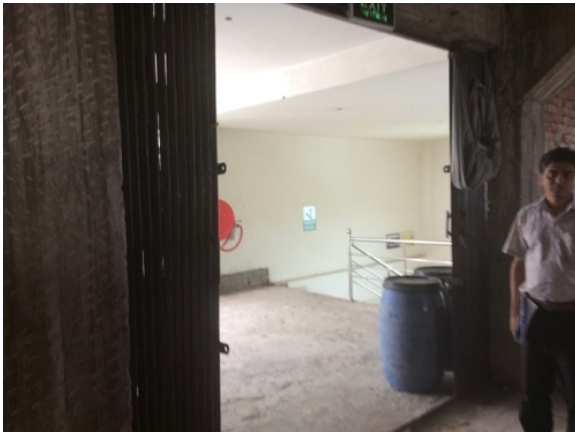
| F-3 | Fire Rated Construction | The exit stairs are not separated from work areas and other spaces on each floor by fire-rated construction. | <p>Provide minimum 1.5-hr fire rated doors and seal all unprotected openings to separate the exit stairs from work areas and other building spaces on all floor levels. Ensure that the fire doors are self-closing and positive latching and that they are provided with fire exit (panic) hardware where serving production floors.</p> <p>If fire doors are required to be held open for functional reasons, provide automatic-closing devices tied to the fire alarm system.</p> | Within 3 months |

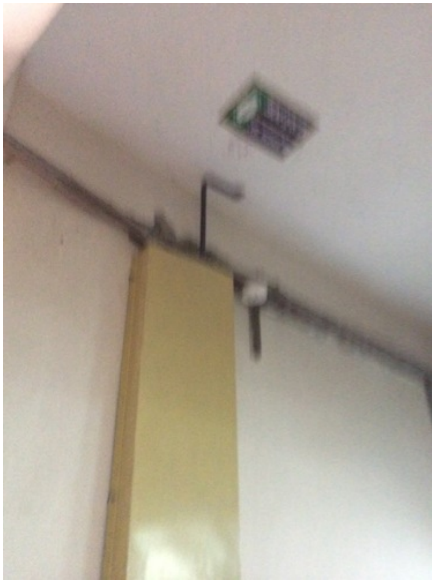
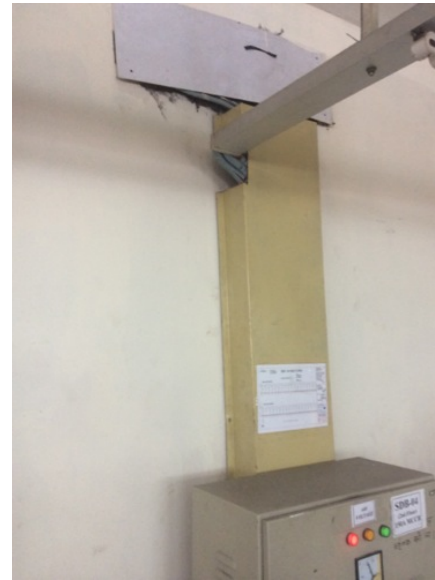
| F-4 | Fire Rated Construction | Unsealed penetrations and openings are located in the fire-rated floor/ceiling assemblies. | Provide a minimum 2-hr fire-rated shaft to separate the utility risers from each floor level. | Within 3 months |

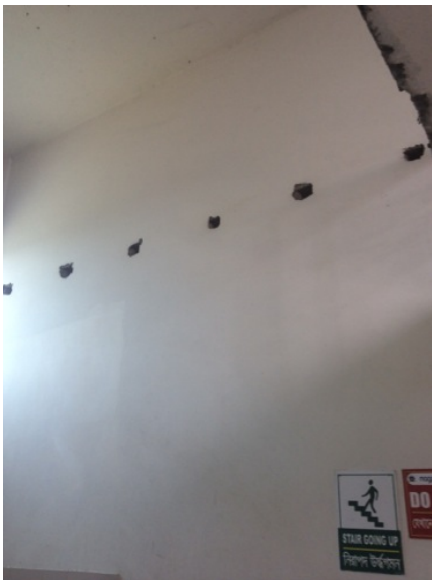
| F-5 | Fire Rated Construction | Unsealed penetrations and openings are located in exit stair enclosures. | Seal all penetrations and openings in exit stair enclosure walls to maintain the fire separation. | Within 3 months |

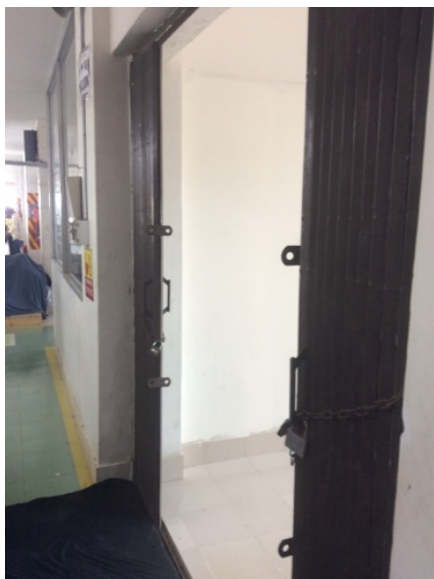
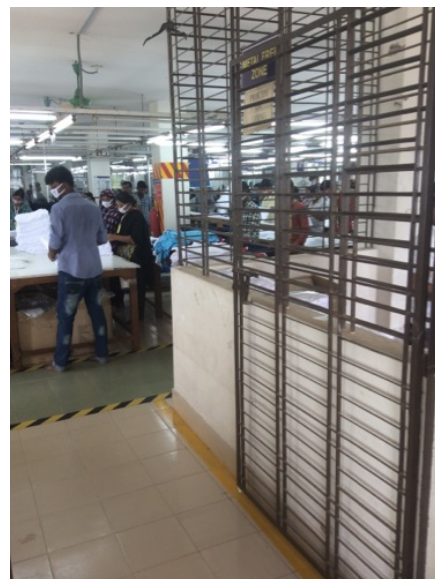
| F-7 | Egress | <p>Egress doors / gates with locking features are provided at building exits, exit stairs, along egress routes, and exit discharge.</p> <p>All gates/doors were open and unlocked during the inspection.</p> | <p>Remove locking features from all egress doors / gates.</p> <p>If locks are required for security reasons, utilize special door locking features complying with NFPA 101.</p> | Immediate |

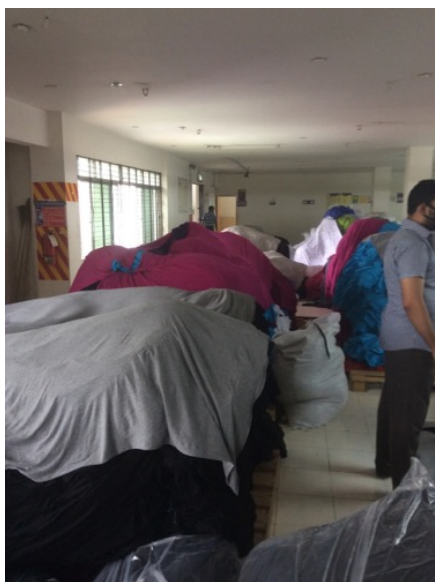
| F-8 | Egress | Storage was located in the egress path on the 5th floor.<br><br>Storage was also located in the exit discharge on the south side of the building in between the main building and shed 1. | Keep egress paths and stairs clear of storage. | Immediate |

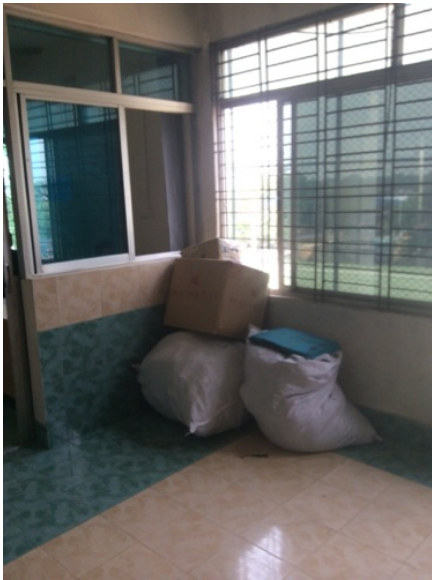
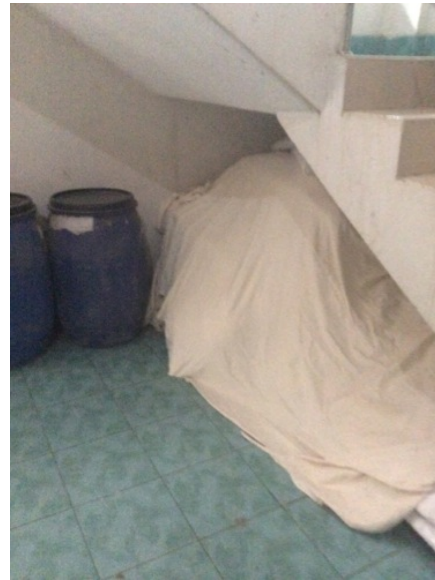
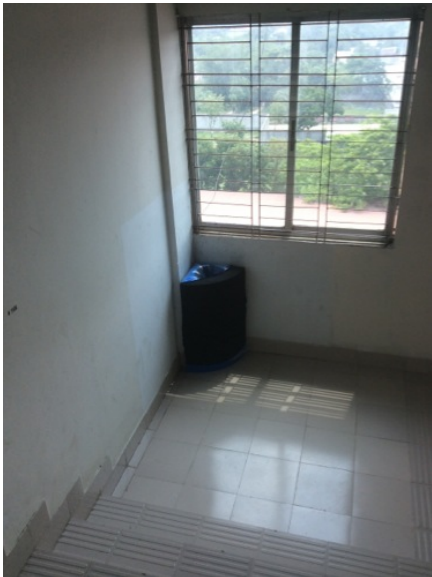
| F-9 | Egress | Storage was located in the all exit stairs.<br><br>It was located on the landings and the base of the stairs. | Remove all storage from exit stairs and egress paths. | Immediate |

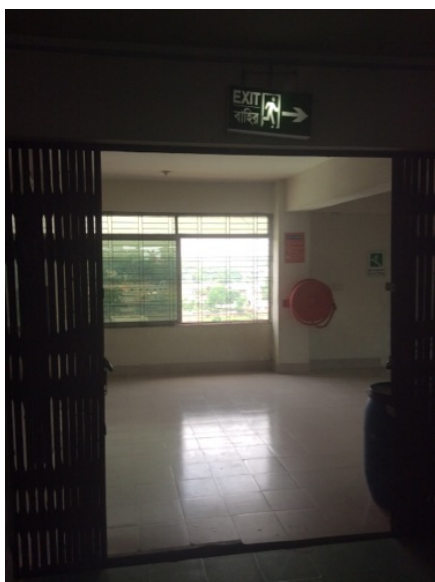
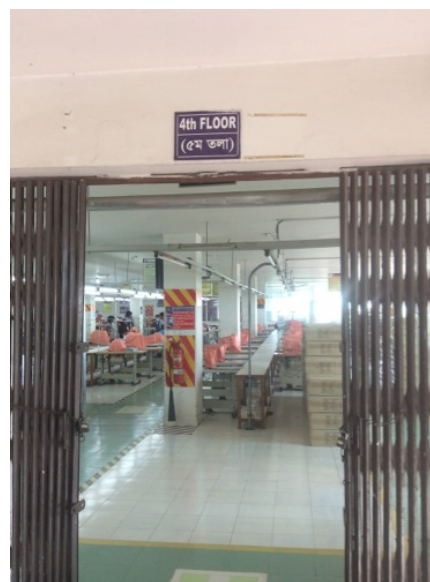
| F-10 | Egress | Collapsible gates / sliding doors are provided at building exits, exit stairs, and exit discharge. | Replace all gates / sliding doors along the means of egress with side-hinged, swinging egress doors.<br><br>If locks are required for security reasons, utilize special door locking features complying with NFPA 101. | Within 1 month |

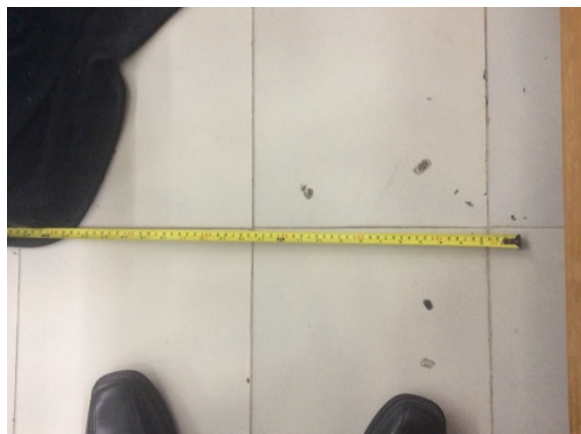
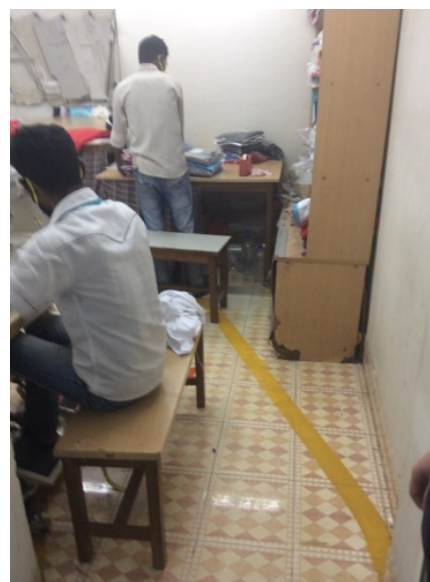
| F-11 | Egress | The width of egress aisles is less than 36-in. | Provide minimum aisle widths of 36-in. | Within 3 months |
| | | Locations:<br>2nd floor<br>5th floor | | |

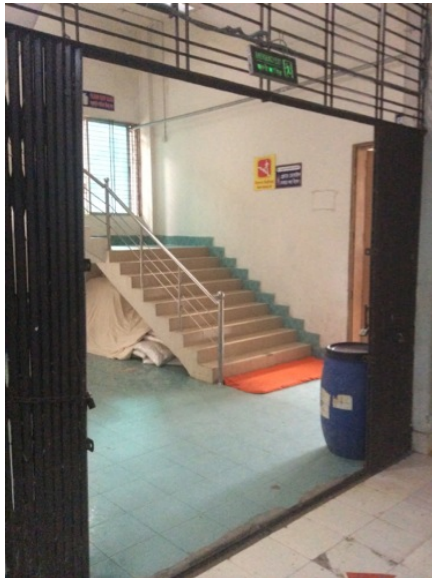
| F-12 | Egress | The South exit stairs discharges inside the building. | Provide 2-hr fire-rated exit passageway leading directly outside (vestibules to separate any storage areas). | Within 6 months |

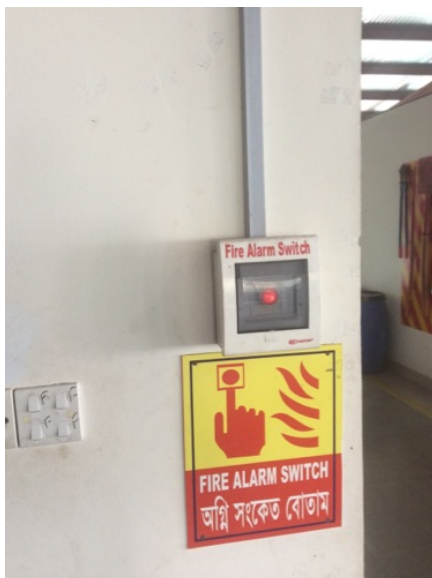
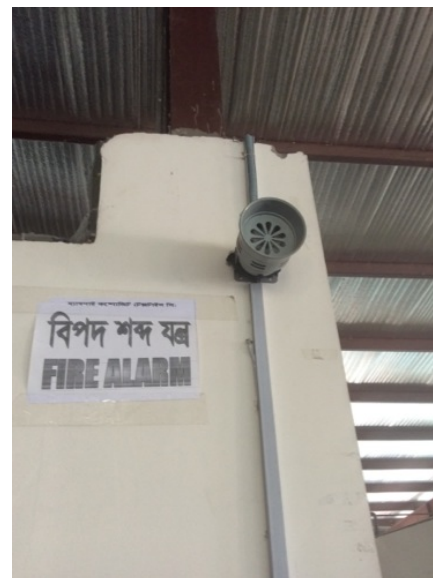
| F-13 | Fire Protection | The fire alarm system is antiquated, not a listed system, and does not provide alarm and notification features consistent with acceptable standards. | Replace the fire alarm system with a new, listed addressable fire alarm system in accordance with NFPA 72. | Design within 4 months, install within 9 months |

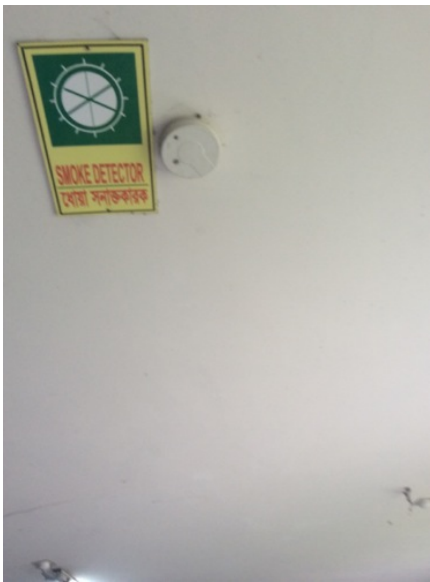
| F-15 | Fire Protection | The building is equipped with single-station smoke alarms. Smoke alarm activation sounds only a local alarm and does not provide automatic fire alarm notification of occupants. | Replace the single-station smoke alarms. Provide automatic smoke detection throughout the building in accordance with NFPA 72. | Within 6 months |

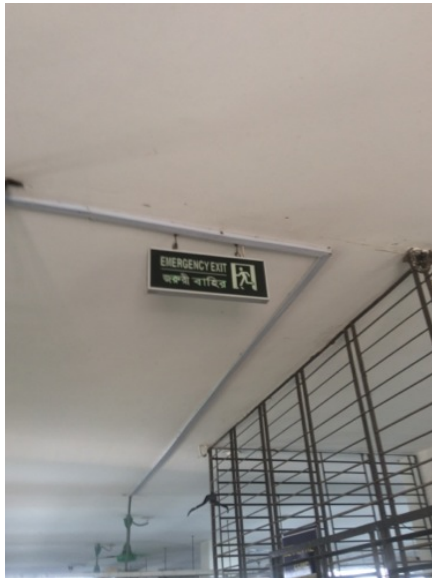
| F-16 | Egress Lighting | Exit signage not illuminated (burned out, broken, etc.).<br><br>Location:<br>On multiple floors | Regularly inspect all exit signage and replace/install lights as needed to illuminate signs. | Within 1 month |
