# **FIRE SAFETY INSPECTION REPORT**

**HABITUS FASHION LTD.**

**ACCORD ID: 11866**

February 27, 2015

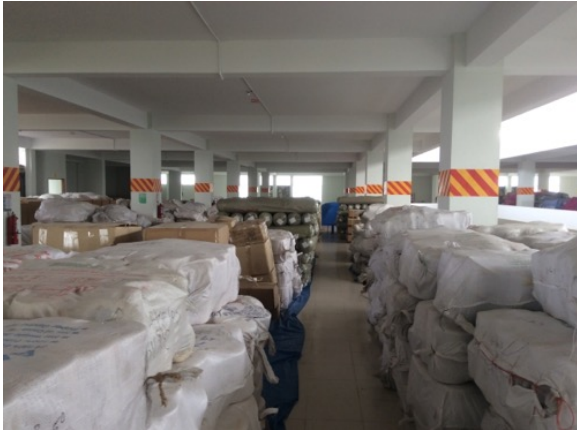
No.	Category	Finding	Recommendation	Remediation Timeframe
F-1	Fire Rated Construction	Rooms on the ground, second, third, fourth and fifth floors used for combustible storage are not separated by fire-rated construction.	<p>Provide dedicated storage rooms separated by minimum 1-hr fire-rated construction.</p> <p>Where separate storage rooms are not feasible, provide defined storage areas and limit the storage arrangement as follows:</p> <ul style="list-style-type: none"> <li>- Maximum height of 2.45m (8ft.) and maximum area of 23m<sup>2</sup> (250 ft<sup>2</sup>)</li> <li>- If sprinkler protected: maximum height of 3.66m (12ft.) and maximum area of 93m<sup>2</sup> (305ft<sup>2</sup>)</li> </ul> <p>Separate areas of unenclosed combustible storage by a minimum clear distance of 3m (10ft.).</p>	Within 3 months

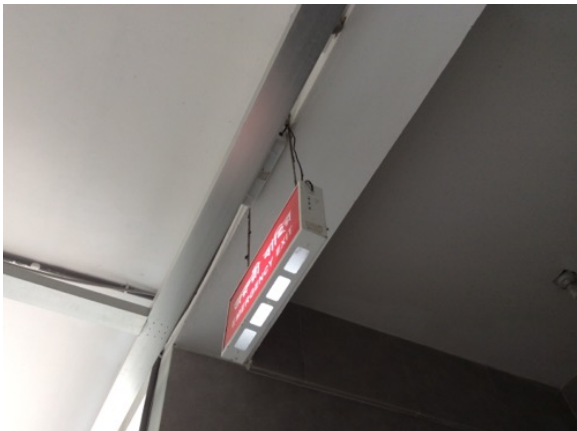
F-10	Fire Protection	The required standpipe system is not installed in accordance with the ACCORD standard.	Install a new standpipe system in accordance with ACCORD standard 5.4 and NFPA 14.  A class III system shall be installed in buildings with the highest occupiable floor 10 m (33 ft.) above grade or more. A class I system shall be permitted in buildings protected throughout by an approved automatic sprinkler system.	Within 6 months
F-11	Egress Lighting	Manual on-off switch is provided for emergency lighting and exit signage units throughout the building.	Remove manual on/off switches from emergency lighting and exit signage units to prevent them from being switched off.	Within 1 month
