FIRE SAFETY INSPECTION REPORT

ALIZA FASHION LTD.

ACCORD ID: 12187

April 11, 2015

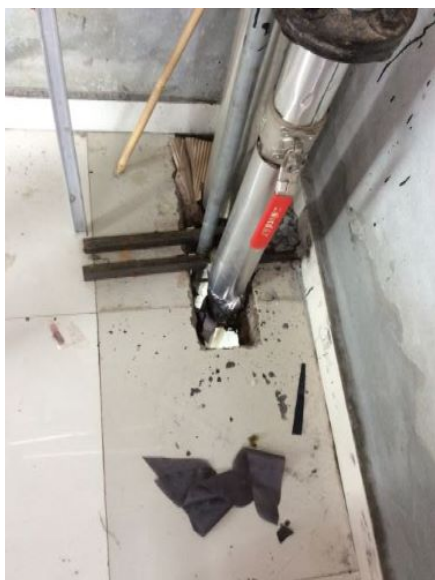
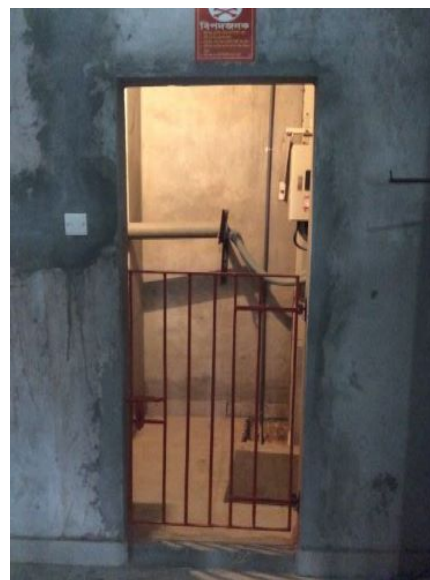
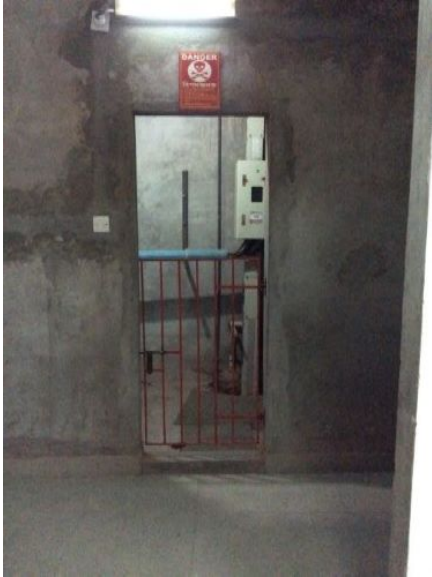
F-1	Fire Rated Construction	Unsealed electrical and mechanical shafts are located in the fire-rated floor/ceiling assemblies.	Provide a minimum 2-hr fire-rated shaft to separate the utility risers from each floor level and seal all penetrations in floor/ceiling assemblies to maintain the fire separation.	Within 3 months
-----	-------------------------	---	---	-----------------

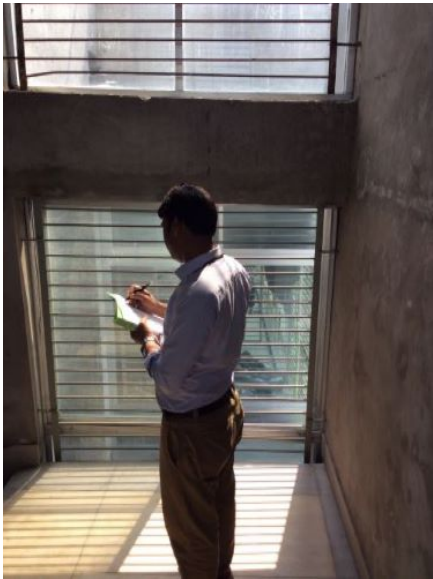
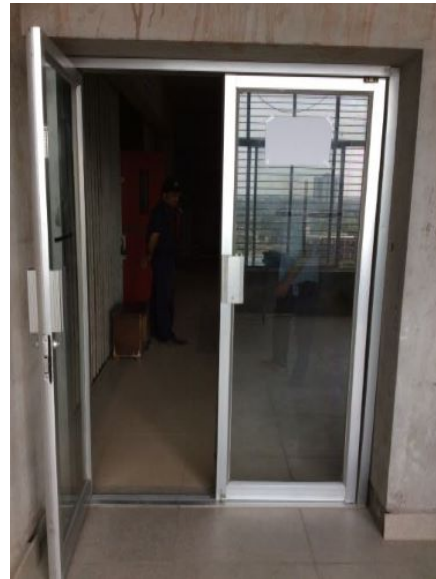
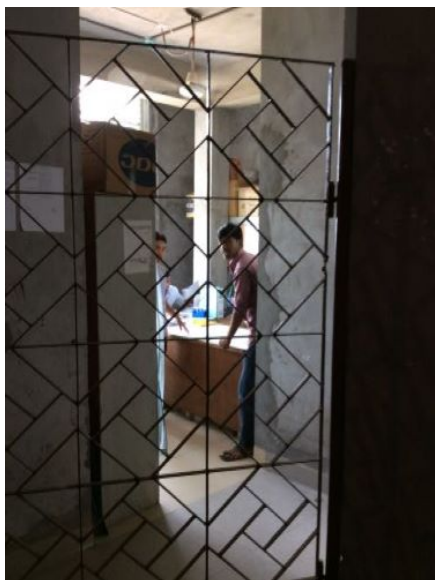
F-2	Fire Rated Construction	The exit stairs are not separated from work areas and other spaces on each floor by fire-rated construction.	Provide minimum 1.5-hr fire rated doors for buildings that are 4 or more stories. Seal all unprotected openings to separate the exit stairs from work areas and other building spaces on all floor levels. Ensure that the fire doors are self-closing and positive latching and that they are provided with fire exit (panic) hardware where serving production floors. If fire doors are required to be held open for functional reasons, provide automatic-closing devices tied to the fire alarm system. Once fire doors are installed, every door in a stair enclosure serving more than 5 stories shall be provided with re-entry unless it meets ACCORD standard 6.8.3.1.	Within 3 months
-----	-------------------------	--	--	-----------------

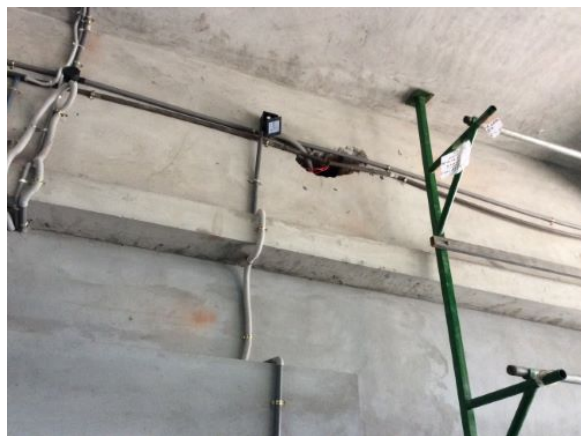
F-3	Fire Rated Construction	Unsealed penetrations and openings are located in east exit stair enclosure.	Seal all penetrations and openings in exit stair enclosure walls to maintain the fire separation.	Within 3 months
-----	-------------------------	--	---	-----------------

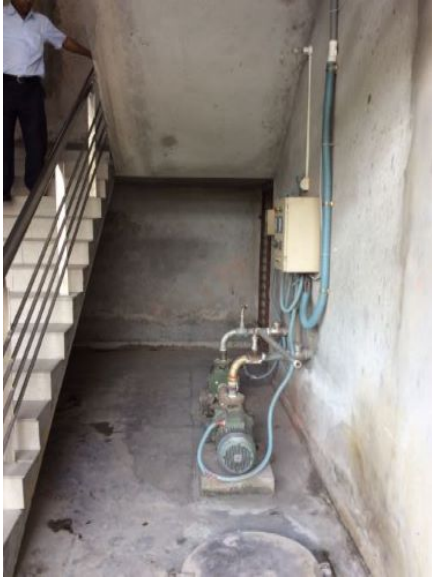
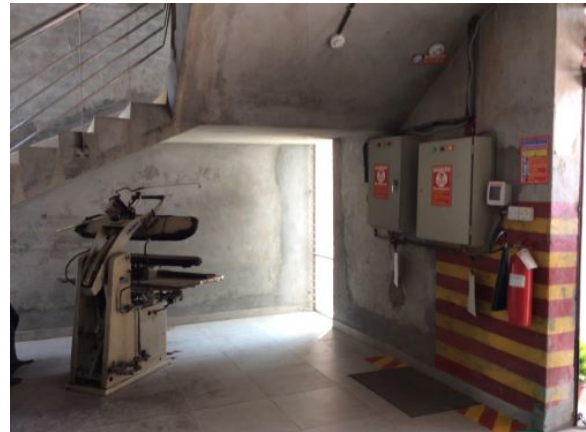
F-4	Fire Rated Construction	Electrical panels were located at the east and north west exit stair enclosures.	Remove and re-locate all electrical panels from exit stair enclosures.	Within 3 months
-----	-------------------------	--	--	-----------------

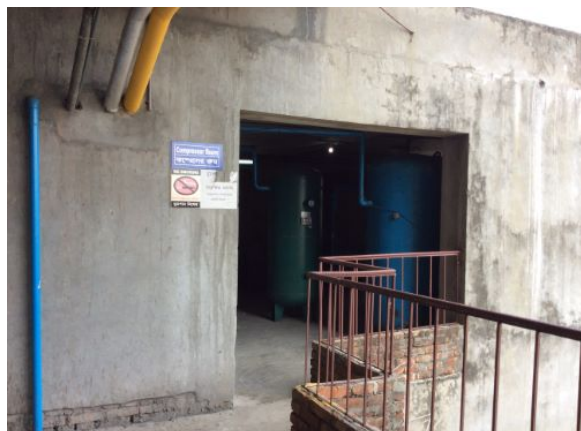
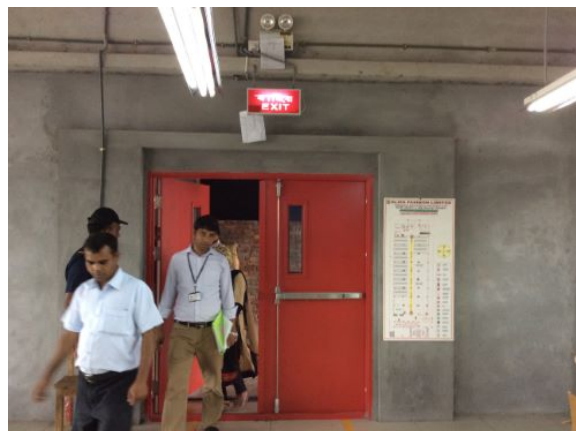
F-5	Fire Rated Construction	Storage boiler rooms discharges directly into east and west exit stair enclosures. Compressor room discharges directly into west exit stair enclosure.	Openings from exit enclosure to storage and utility spaces shall be provided with a vestibule with fire rated construction and openings. Provide a 1.5 hr. fire rated door on the exit stair side and a 1-hr. fire rated door on the storage and compressor room side. Ensure that the fire rating of the vestibule construction matches that of the exit stair enclosure.	Within 3 months
-----	-------------------------	--	---	-----------------

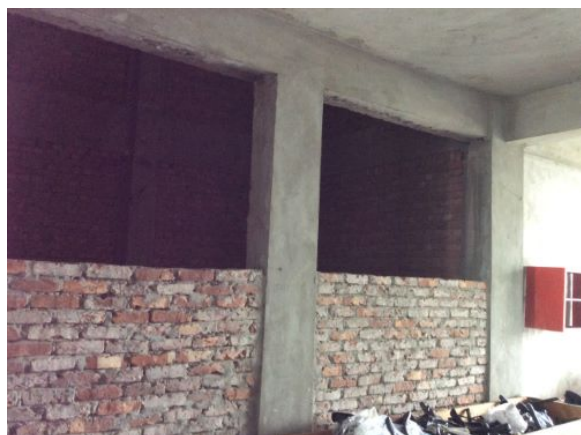
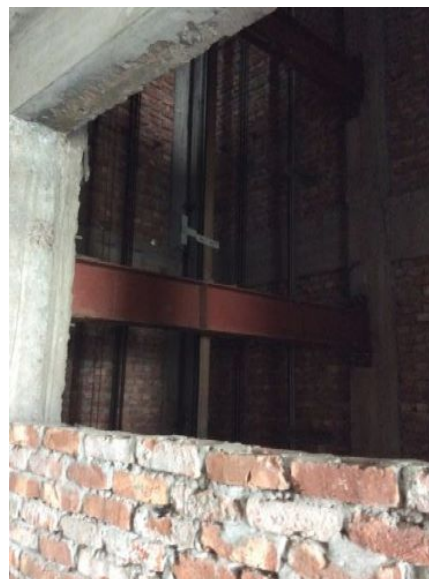
F-6 Fire Rated Construction

The elevator does not have the proper fire rating for the shaft.

Provide the proper 2 hr. fire rating for the shaft.

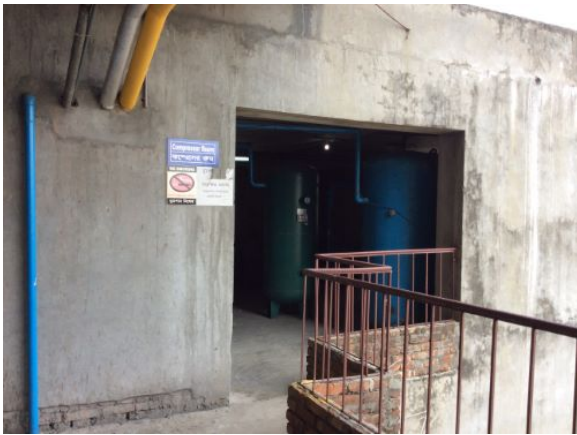
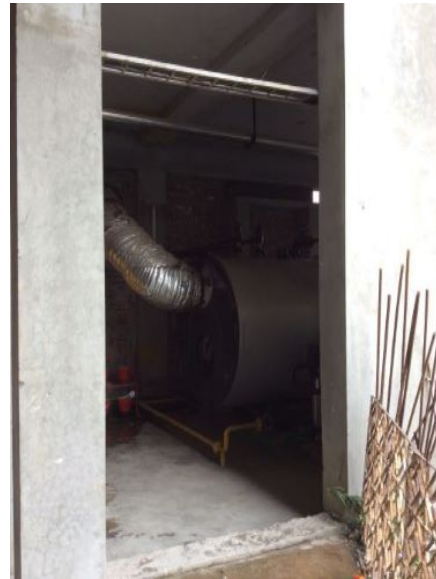
F-7	Fire Rated Construction	<p>The boiler room is not separated by fire-rated construction due to openings on the ground floor. The EMR is not separated by fire-rated construction due to openings in the west exit stair enclosure. The compressor room is not separated by fire-rated construction due to openings on the second floor.</p>	<p>Separate the boiler, EMR and compressor room by a minimum 2-hr fire rated construction for high rise. Seal and protect all openings to maintain the required fire separations. When located to the exterior of a building, 3m (10 ft.) separation is required. Provide proper ventilation and consult a qualified engineer.</p>	Within 3 months
-----	-------------------------	--	--	-----------------

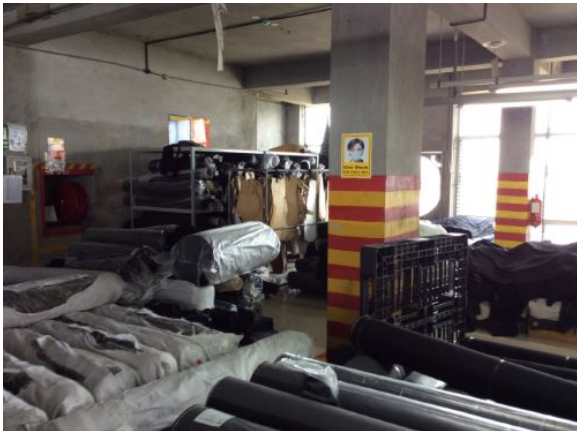
F-8	Fire Rated Construction	Areas used for combustible storage open to the factory are not separated by fire-rated construction on fifth floor.	Provide defined storage areas and limit the storage arrangement as follows: - Maximum height of 2.45m (8ft.) and maximum area of 23m ² (250 ft ²) - If sprinkler protected: maximum height of 3.66m (12ft.) and maximum area of 93m ² (305ft ²) Separate areas of unenclosed combustible storage by a minimum clear distance of 3m (10ft.).	Within 3 months
-----	-------------------------	---	--	-----------------

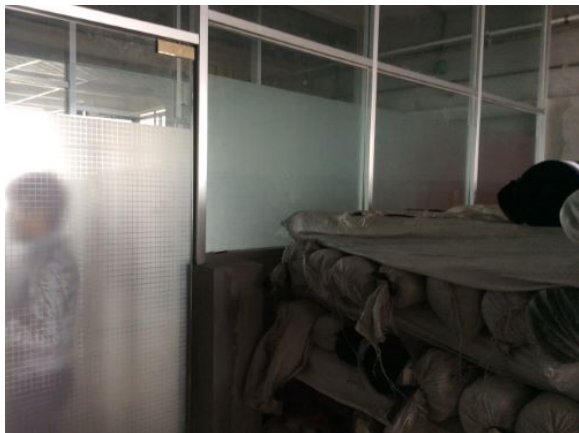
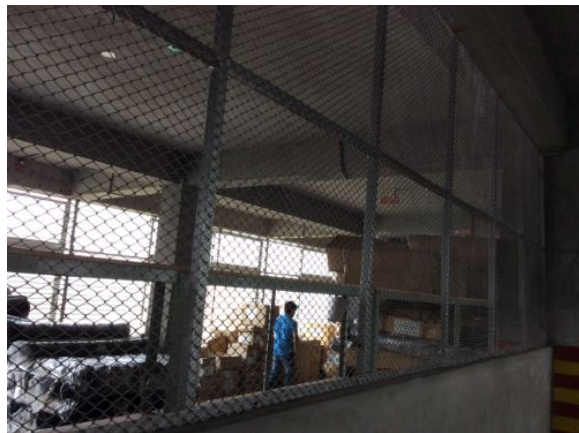
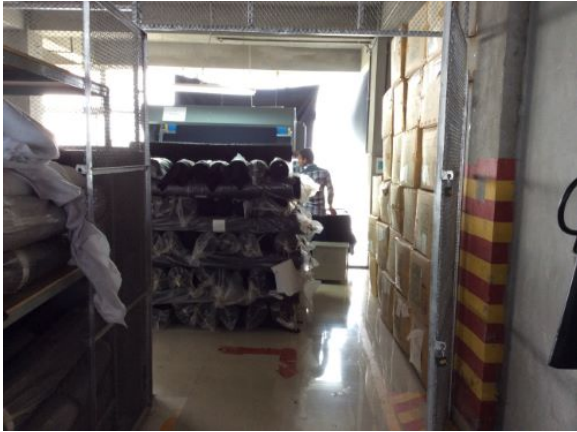
F-9	Fire Rated Construction	Rooms used for combustible storage are not separated by fire-rated construction on ground, fifth and sixth floors.	<p>Provide dedicated storage rooms separated by minimum 1-hr fire-rated construction.</p> <p>Where separate storage rooms are not feasible, provide defined storage areas and limit the storage arrangement as follows:</p> <ul style="list-style-type: none"> - Maximum height of 2.45m (8ft.) and maximum area of 23m² (250 ft²) - If sprinkler protected: maximum height of 3.66m (12ft.) and maximum area of 93m² (305ft²) <p>Separate areas of unenclosed combustible storage by a minimum clear distance of 3m (10ft.).</p>	Within 3 months
-----	-------------------------	--	---	-----------------

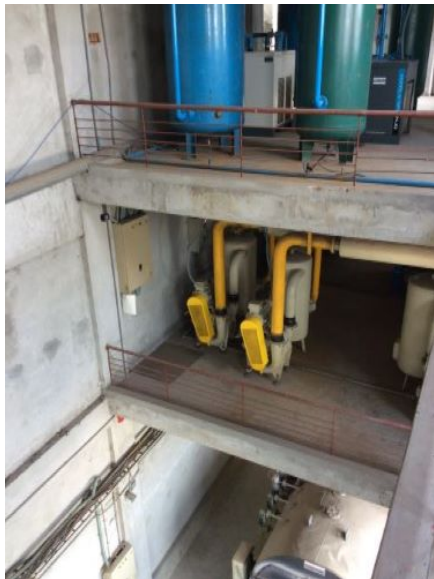
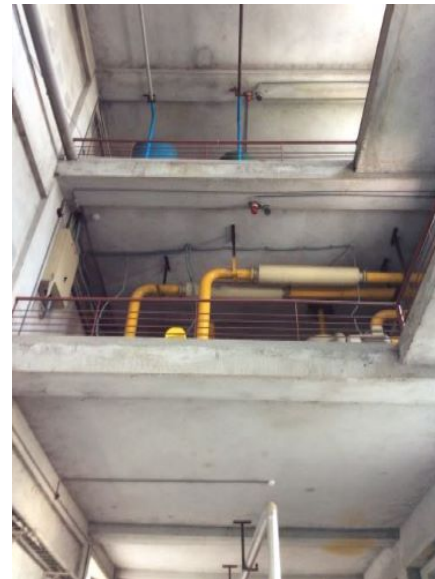
F-10	Fire Rated Construction	Existing atrium in factory connecting ground floor, second and third stories is not properly protected.	Provide proper fire protection in accordance with ACCORD standard 3.7.	Within 6 months
------	-------------------------	---	--	-----------------

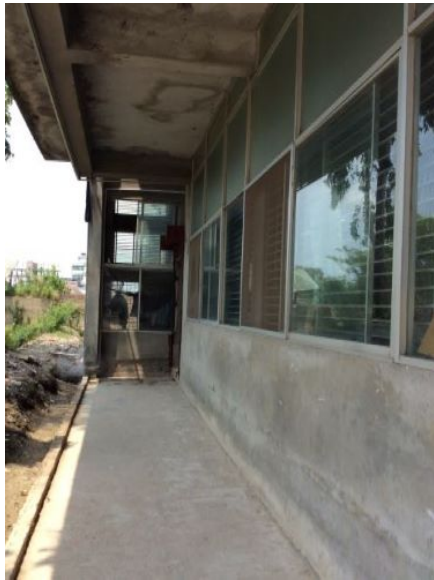
F-11	Fire Rated Construction	The exit discharge path serving the south west exit is less than 3 m wide and is not separated from the building interior.	Seal all penetrations and openings to the interior of the building along the discharge path, up to a height of 10 ft., to provide a minimum 1-hr fire separation.	Within 6 months
------	-------------------------	--	---	-----------------

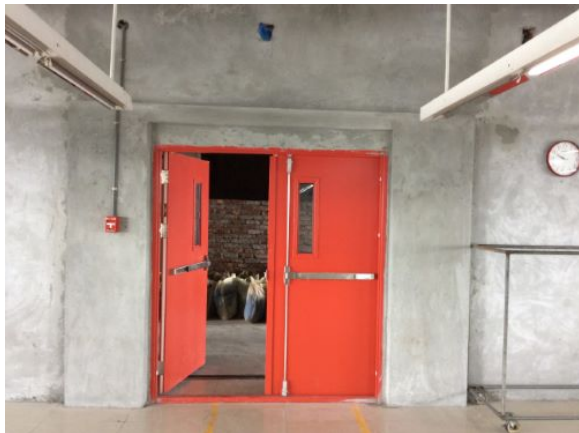
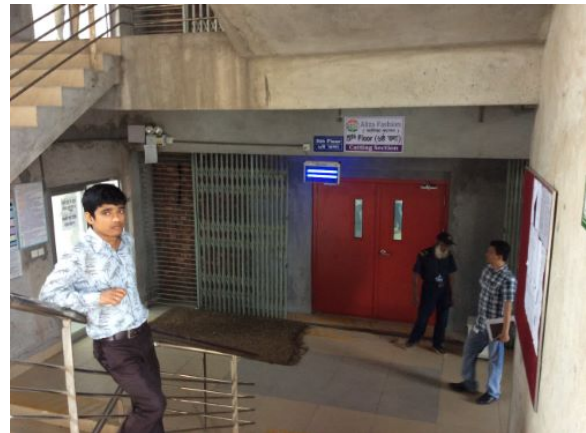
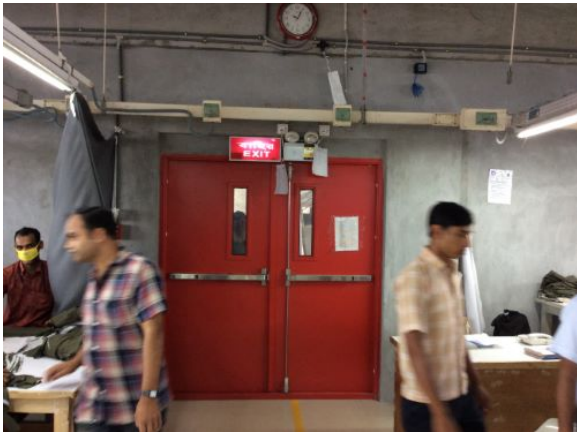
F-12	Egress	<p>Building did not have stair designation signs at the exit stairs. Building did not have occupant load signs and emergency evacuation plans at teh factory floors.</p>	<p>Provide stair designation signs, occupant load signs and emergency evacuation plans at required locations.</p>	Immediately
------	--------	---	---	-------------

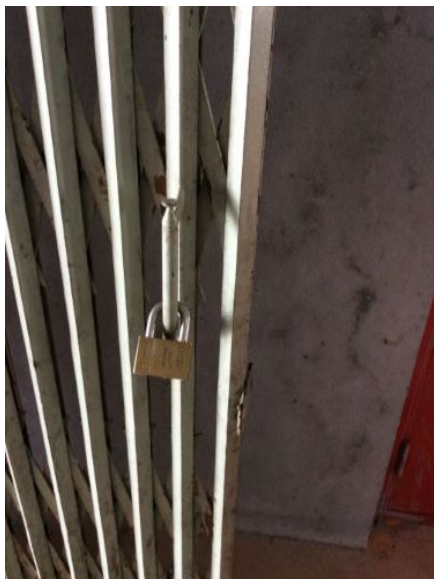
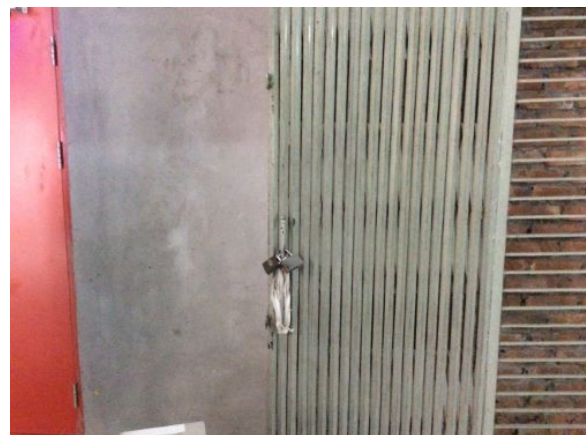
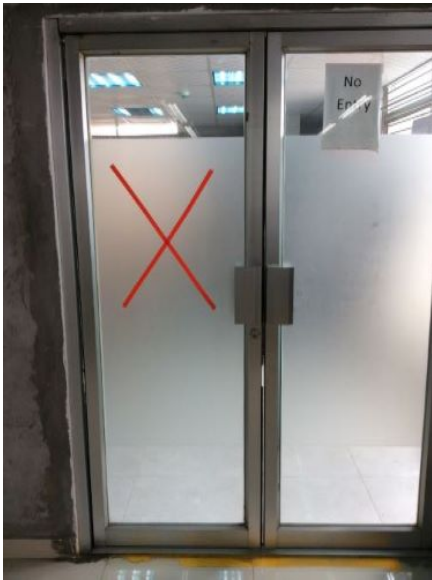
F-13 Egress

Egress doors with locking features were provided along egress routes. Egress gates with locking features are provided at building exits, exit stairs and along egress routes. All doors were not open and unlocked during the inspection.

Remove locking features from all egress doors and gates.

If locks are required for security reasons, utilize special door locking features complying with NFPA 101 and ACCORD standard 6.8.2.

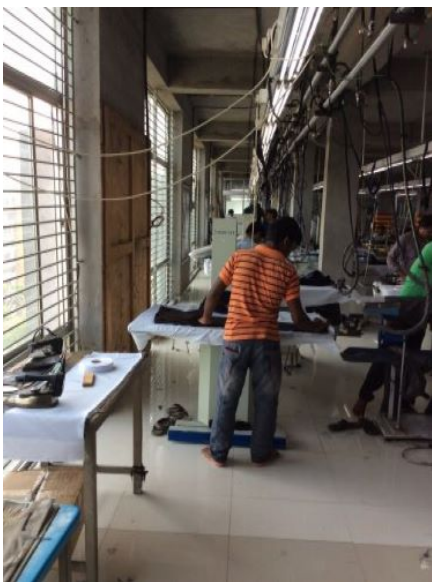
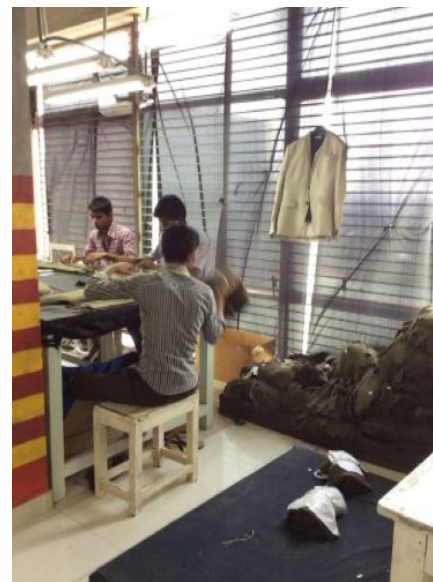
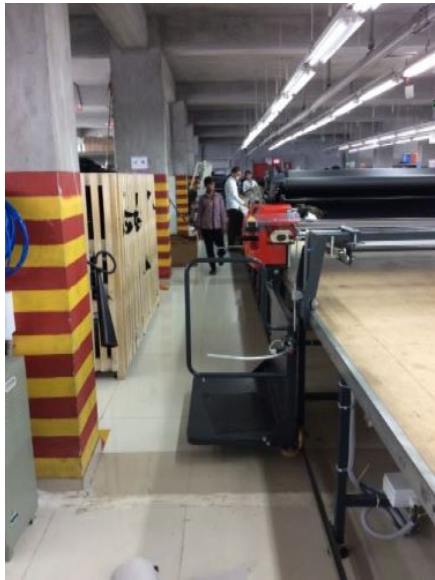
F-14	Egress	Obstructions were located in the egress paths on all the floors and egress court except ground and seventh floors.	Keep egress paths and stairs immediately clear of storage.
------	--------	--	--

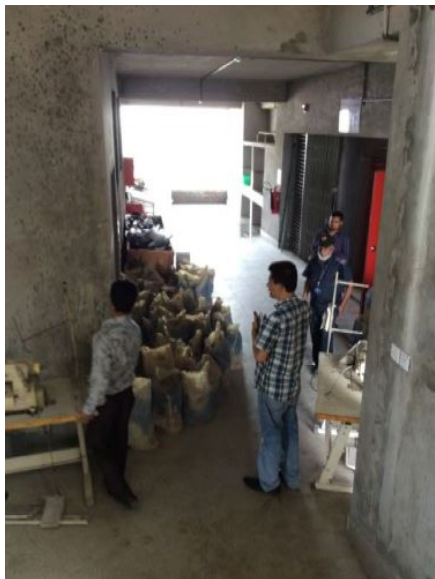
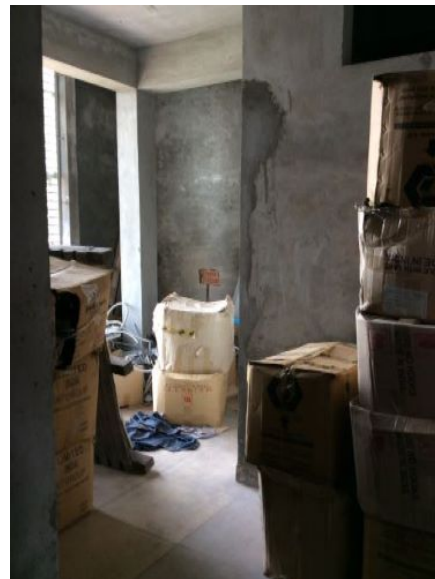
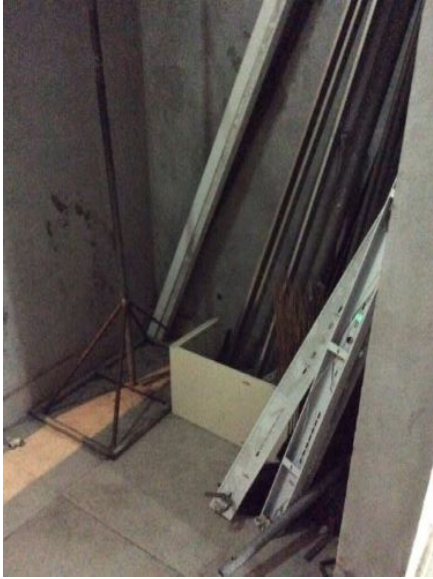
F-15	Egress	Storage was located at all exit stairs.	Remove all storage from exit stairs and egress paths. Immediately
------	--------	---	---

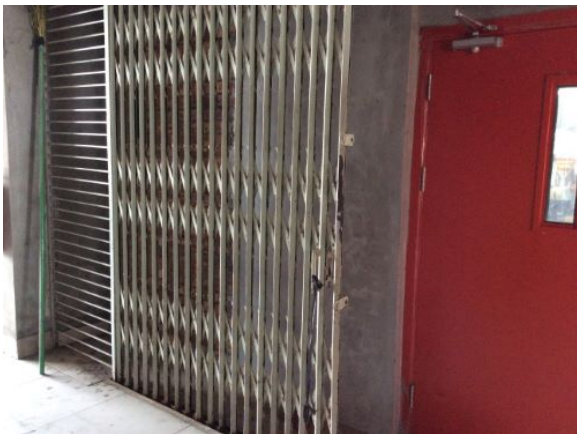
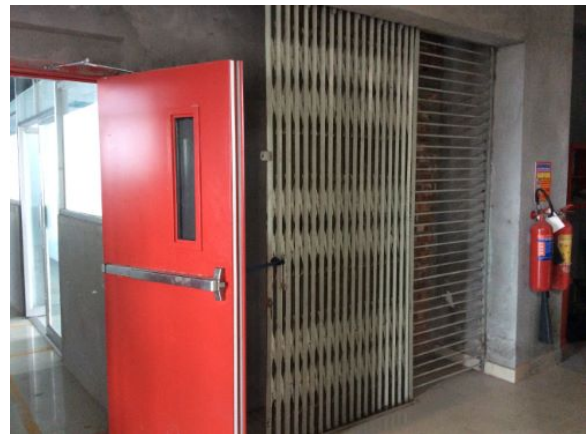
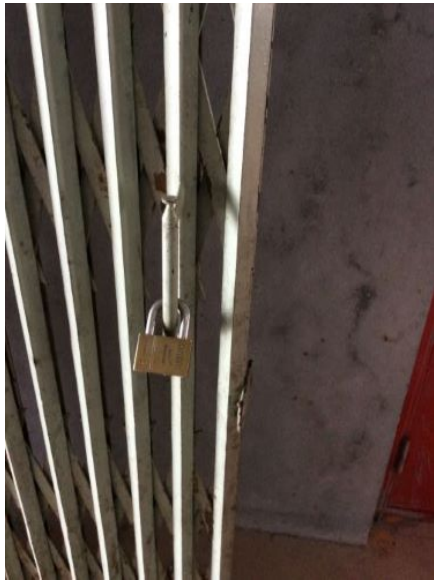
F-16	Egress	Collapsible gates are provided at exit stairs. Sliding doors are provided at exit stairs and along egress routes.	Replace all gates and sliding doors along the means of egress with side-hinged, swinging egress doors in accordance with ACCORD standard 6.8.1.	Within 1 month
------	--------	---	---	----------------

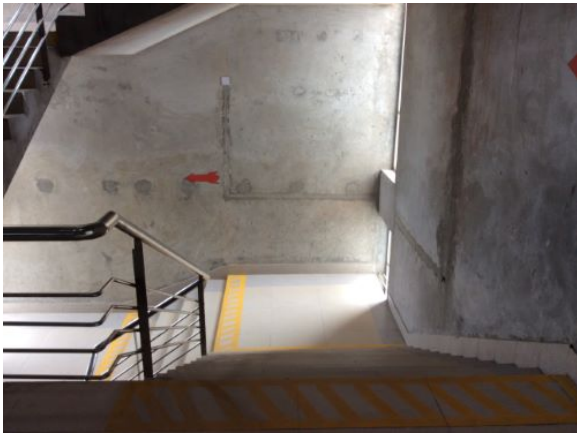
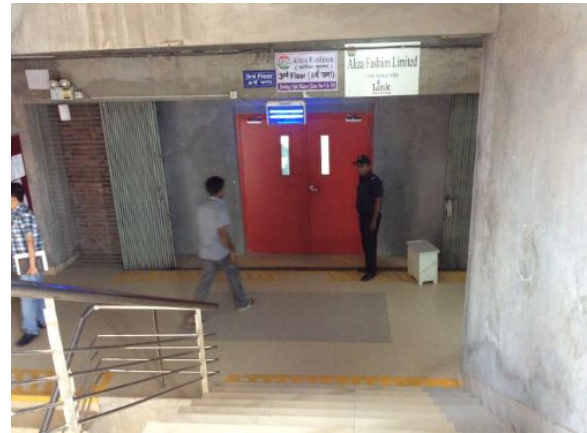
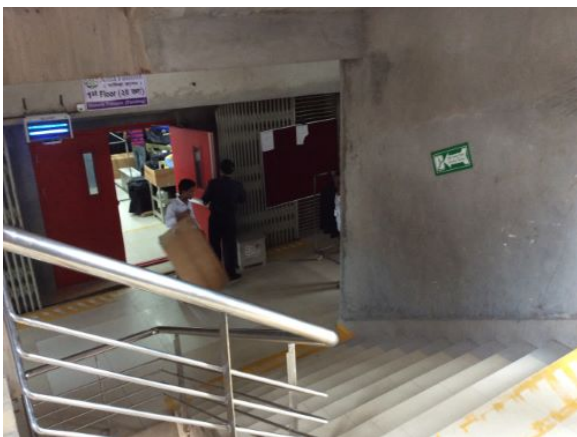
F-19 Egress

Handrails are not provided on both sides of the exit stairs and ramp.

Provide handrails on both sides of the exit stairs and ramp. New handrails shall have a minimum height of 865 mm (34 in.) and a maximum height of 965 mm (38 in.) as measured from the leading edge of the tread. Intermediate handrails shall be provided when the stair width exceeds 2.2 m (87 in.)

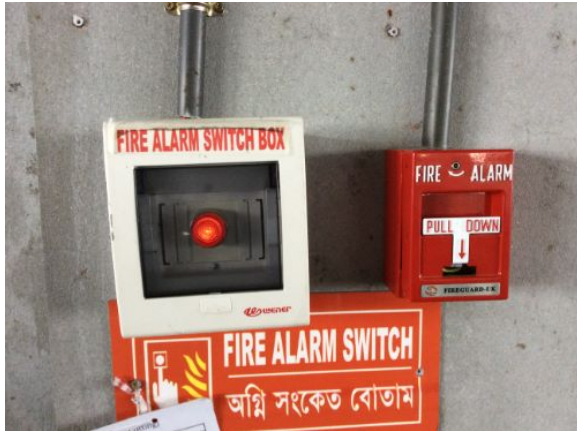
F-20	Fire Protection	The fire alarm system is antiquated, not a listed system and does not provide alarm and notification features consistent with acceptable standards.	Replace the fire alarm system with a new, listed addressable fire alarm system in accordance with NFPA 72.	Design within 4 months, install within 9 months
------	-----------------	---	--	---

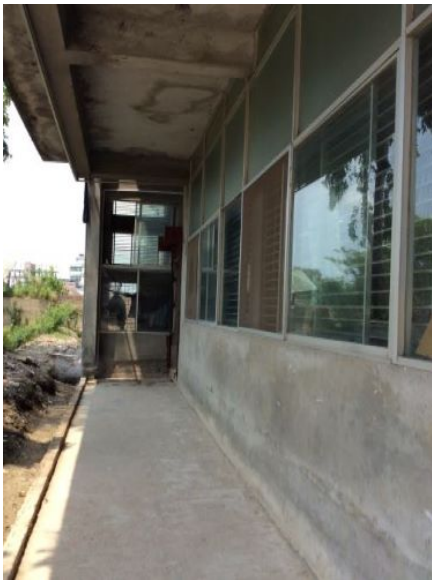
F-22	Fire Protection	The required no smoking signs are not present in the factory.	Smoking is prohibited in any garment factory building or separate storage building. Signs shall be posted in Bengali and English at all building entrances. If the factory creates a designated smoking area outside the building, information of these areas will be posted on the signs.	Within 1 months
------	-----------------	---	--	-----------------

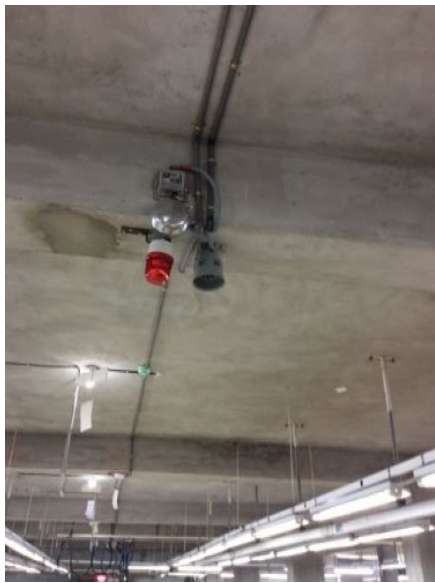
F-26	Fire Protection	Inspection, testing and maintenance of the standpipe system is not in accordance with NFPA 14.	Inspect, test and maintain the standpipe system and keep written records on-site, in accordance with NFPA 14.	Within 3 months
F-27	Fire Protection	Visible notification was not provided for the building in accordance with NFPA 72.	Provide visible notification for the building in accordance with NFPA 72.	Within 3 months

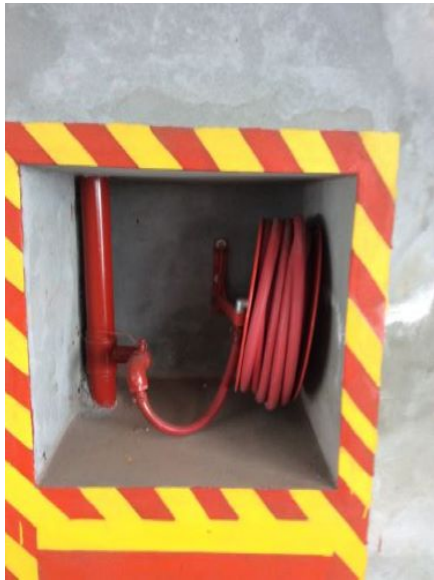
F-28	Fire Protection	The required standpipe system is not installed in accordance with the ACCORD standard.	Install a new standpipe system in accordance with ACCORD standard 5.4 and NFPA 14.	Within 6 months
			<p>A class III system shall be installed in buildings with the highest occupiable floor 10 m (33 ft.) above grade or more. A class I system shall be permitted in buildings protected throughout by an approved automatic sprinkler system.</p>

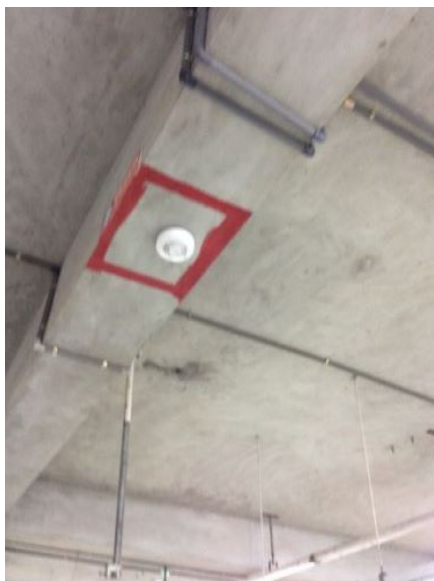
F-29	Fire Protection	The building is equipped with single-station smoke alarms. Smoke alarm activation sounds only a local alarm and does not provide automatic fire alarm notification of occupants.	Remove single-station smoke alarms. Provide automatic smoke detection throughout the building, tied into the fire alarm system, in accordance with NFPA 72.	Within 9 months
------	-----------------	--	---	-----------------

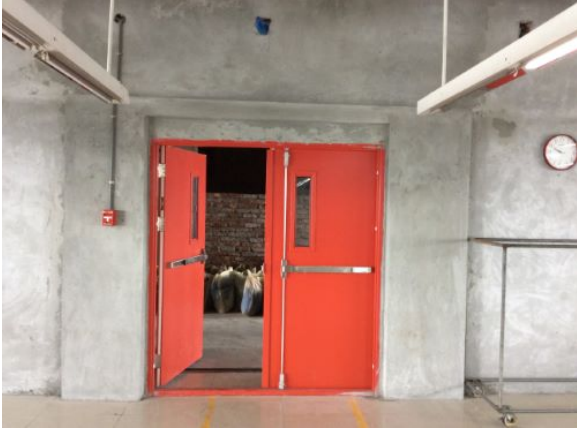
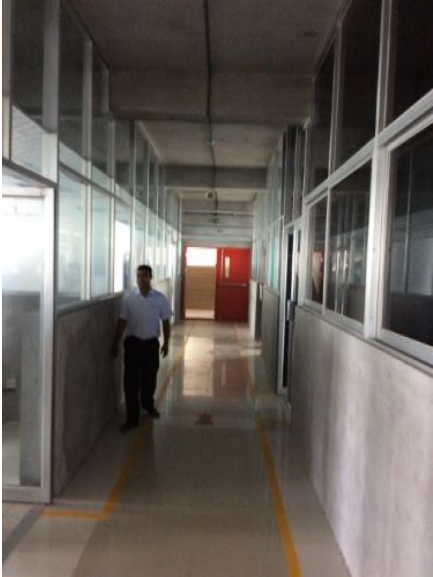
F-30	Egress Lighting	Exit signage was not provided above doors to the exit stairs.	Provide exit signs above all building exits to the exterior, all doors to the exit stairs and along all paths of travel where a change of direction is not obvious.	Within 1 month

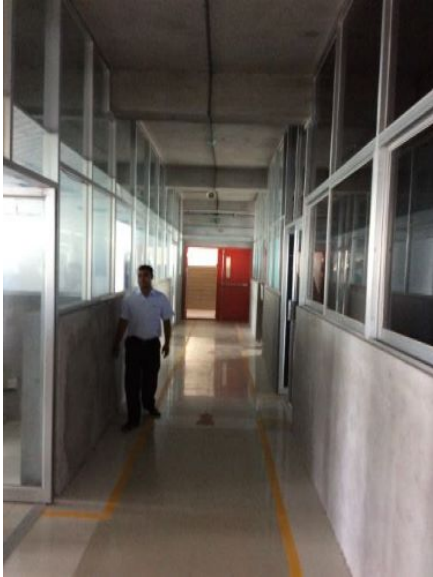
F-31	Egress Lighting	Inspection, testing and maintenance for the emergency lighting system was not in accordance with The ACCORD standard.	Inspect, test and maintain the emergency lighting system in the accordance with The ACCORD standard. Keep written records on-site.	Within 3 months
F-32	Egress Lighting	Based on the number and location of emergency lights observed, adequate illumination levels are not anticipated along egress routes on the factory floors and exit stairs.	Test the emergency lighting system on each floor and provide additional emergency fixtures to supply adequate illumination along the means of egress. Provide a minimum illumination of 10 lux at the floor level within exit stairs and along exit discharge paths and a minimum 2.5 lux along exit access aisles.	Within 3 months
