# INITIAL FIRE SAFETY INSPECTION REPORT

**Entrust Fashions Ltd.(Extended Building)**

**RSC ID: 24038**

**Date: 12-Jan-2021**

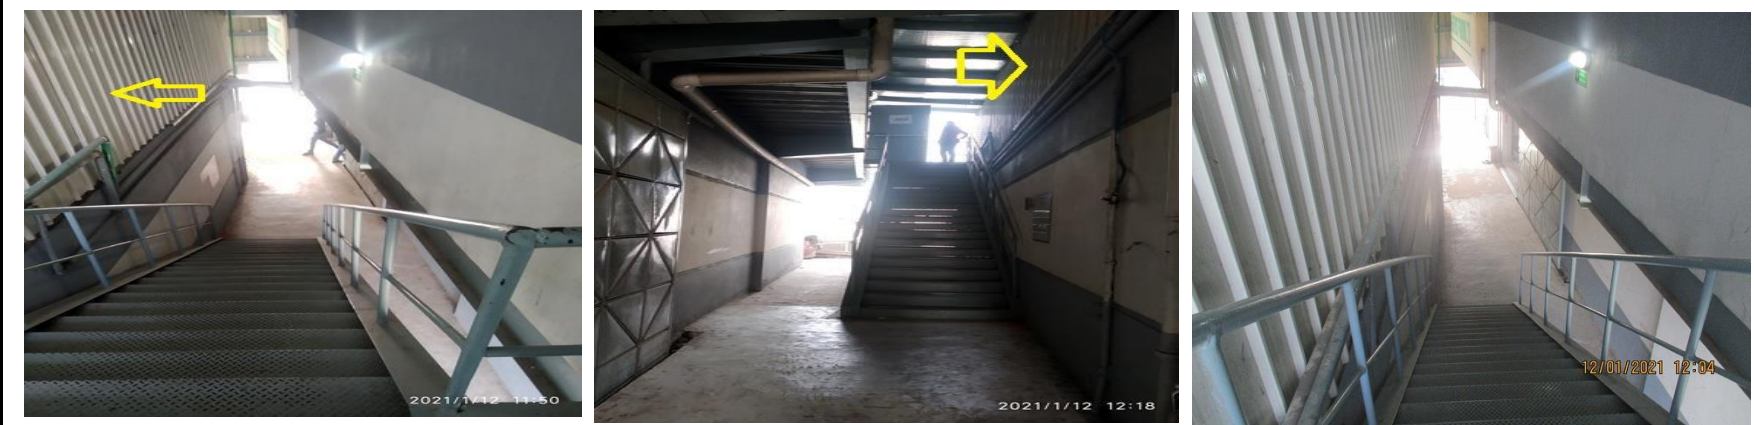
| SI No. | Category | Findings | Required Action | Remediation Time Frame |
|---|---|---|---|---|
| F-1 | Fire Rated Construction | The exit stair -1 (East side) is not separated from Shed-3 and Shed -1 on each floor by fire rated construction.<br>Location: East side exit stair -1 | The exterior wall opening within 10 ft beyond the end of the exterior stair have to be sealed by minimum 1.0 hr 3rd party certified materials in accordance with Accord Standard 6.3.1.2 and 6.3.1.3. | Within 3 months |

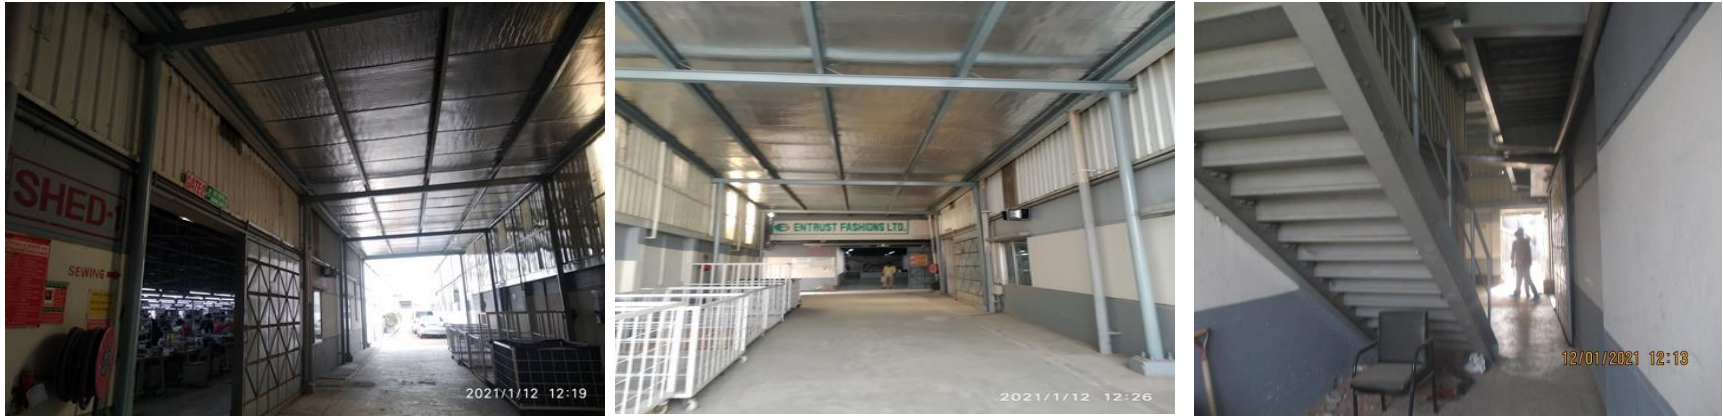
| F-2 | Fire Rated Construction | The exit discharge path (Passageway) is not fire-rated separated as the non-rated roof is continuous. | Provide minimum 1 hr. fire rated exit discharge path which will lead directly outside. | Within 3 months |

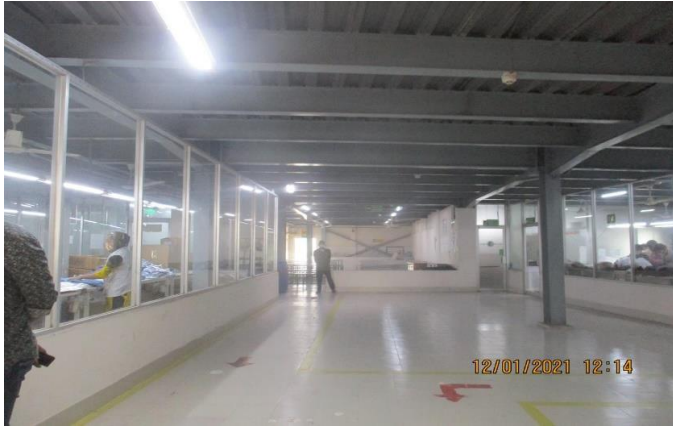
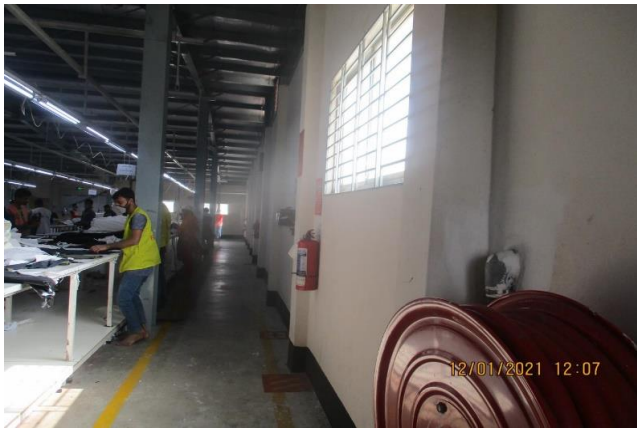
| F-3 | Fire Rated Construction | The main structural element of the building is constructed by steel which is non-rated and were found in exposed condition without any fire protection. | Construction of new non-high-rise factories containing G and/or H2 occupancies (factories) shall be Type 1 or Type 2 construction as required in BNBC Part 3 Table 3.2.4.<br>Provide/ensure required fire rating on the structural elements by following Section 4.4 and Table 4.4.1 of the Accord Standard or Table 3.3.1 and Table 4.1.1 from BNBC. Consult a qualified fire protection engineer to design the rated construction barriers in between two floors and in structural members. | Within 6 months |

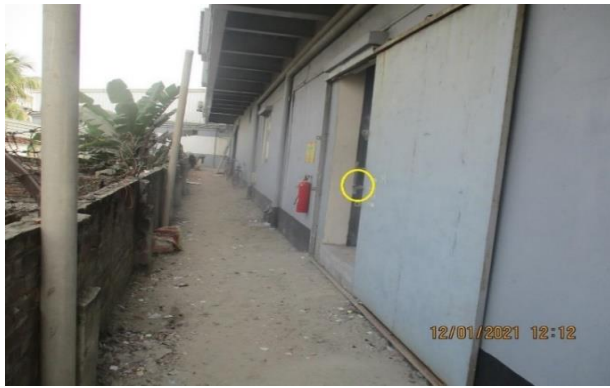
| F-4 | Means of Egress | Egress gates with locking features are provided at ground floor shed-3. | Remove locking features from all egress gates. If locks are required for security reasons, utilize special door locking features complying with NFPA 101. | Immediately |

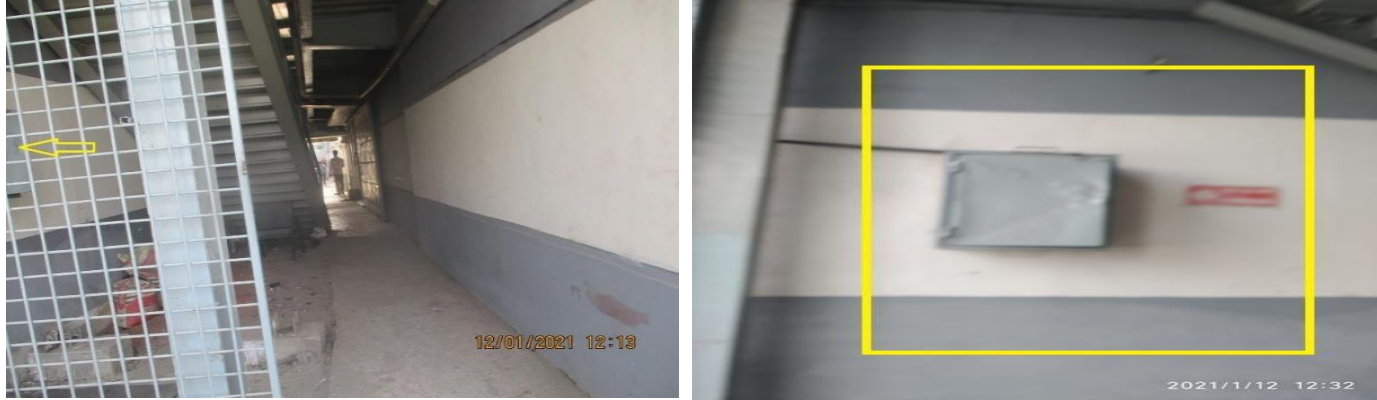
| F-5 | Egress | Electrical panel boards located inside of exit stair-1 east side. | Remove electrical panel boards from exit stairs. | Within 3 months |

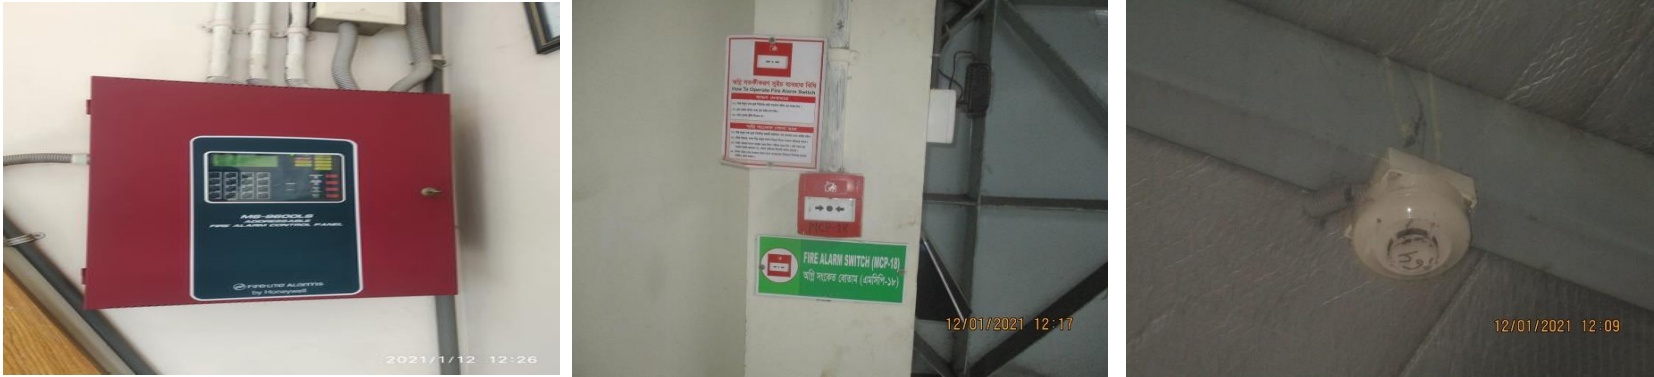
| F-8 | Fire Alarm & Detection System | The Required Fire Alarm system is not installed in accordance with the ACCORD standard and NFPA-72. | Submit design to RSC for review and modify installation if required. Installation of Fire Alarm system should be in accordance with ACCORD standard and NFPA 72. | Design within 2 months, Install within 4 months (If modification required) |
