INITIAL FIRE SAFETY INSPECTION REPORT

Utah Fashions Ltd. (Extension)

RSC ID: 24156

Date: 10 February 2021

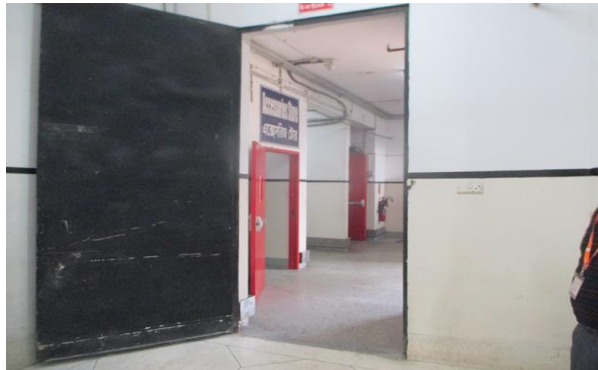
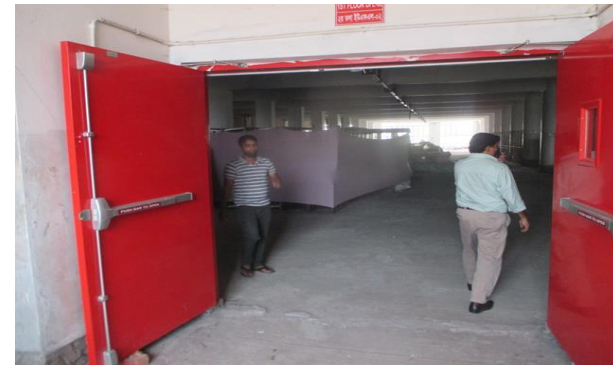
SI No.	Category	Findings	Required Action	Remediation Time Frame
1	Fire Rated Construction	Exit stairs are not separated from work areas and other spaces on each floor by fire rated construction due to unprotected openings and penetrations.	Separate the exit stairs from from work areas and other building spaces on all floor levels by minimum 2-hr firerated construction. Provide minimum 1.5-hr fire rated doors and seal all unprotected openings and penetrations to maintain the fire seperation. Ensure that all fire doors are self-closing and positive latching, and are provided with fire exit (panic) hardware where serving production floors or assembly occupancies. If fire doors are required to be held open for functional reasons, provide automatic-closing devices tied to the fire alarm system. Once fire doors are installed, every door in a stair enclosure serving more than 5 stories shall be provided with re-entry unless it meets ACCORD standard 6.8.3.1.	Within 3 months

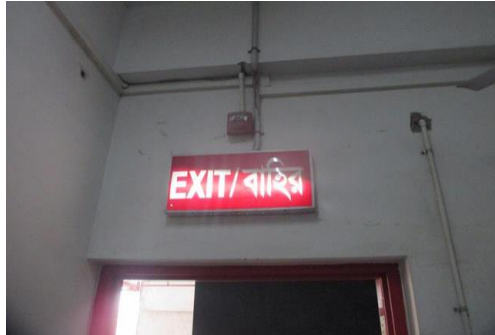
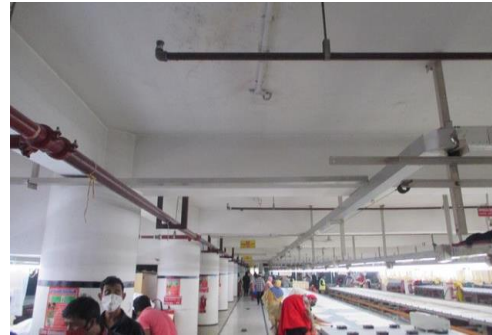
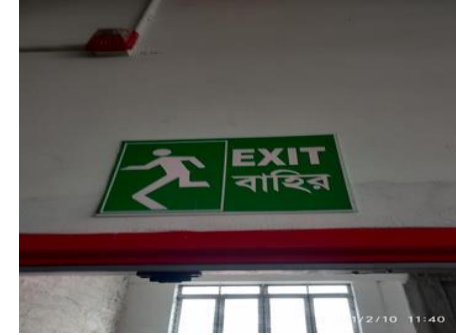
2	Emergency Egress Lighting	<p>Based on the number and location of emergency lights observed, adequate illumination levels are not anticipated along egress routes. Location:-Throughout the building.</p>	<p>Test the emergency lighting system on each floor and provide additional emergency fixtures to provide adequate illumination along the means of egress. Provide a minimum illumination of 10 lux at the floor level within exit stairs and exit discharge paths and minimum 2.5 lux along exit access aisles.</p>	Within 3 months
---	---------------------------	--	---	-----------------

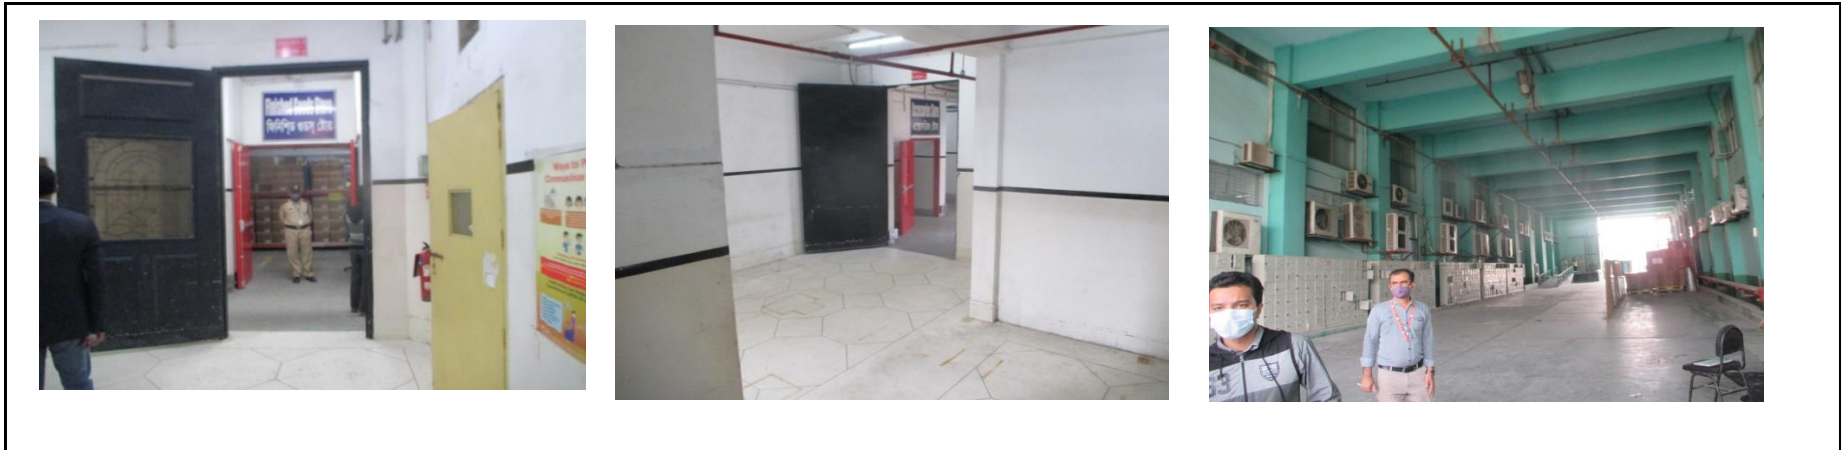
3	Interior Exit Discharge	Exit stair(s) is discharge the occupants inside the building. Exit passageway is not separated by fire rated construction from inside the factory building (both north & south side of the building).	<ol style="list-style-type: none"> 1. Modify stair to discharge directly outside. <li style="text-align: center;">Or 2. Provide 2-hr fire-rated exit passageway leading directly outside (vestibules to separate any storage areas). <li style="text-align: center;">Or 3. Provide sprinkler protection for discharge floor in accordance with NFPA 13. 	within 3 months
---	-------------------------	---	--	-----------------

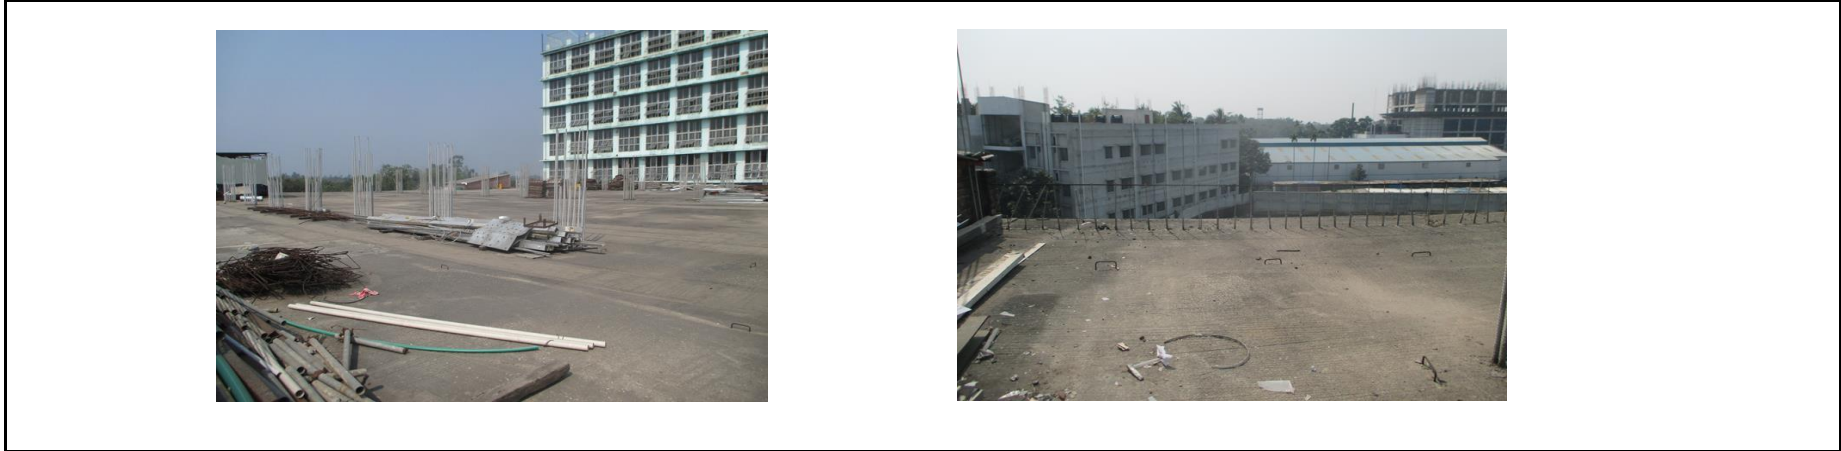
4	Parapets or Guards	Parapets or guards are not provided in occupiable roof.	Provide parapets or guards with a minimum height of 1067mm (42 inch.).	within 3 months
---	--------------------	---	--	-----------------

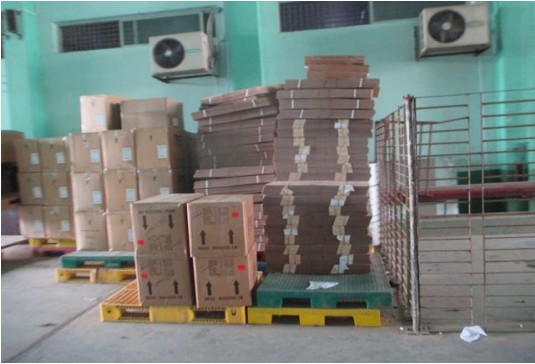
5	Storage in Egress Path	Storage was located in the egress path. (Location: North side of the building in exit discharge path)	Keep egress path and stair clear of storage.	Immediate
<div style="display: flex; justify-content: space-around;">

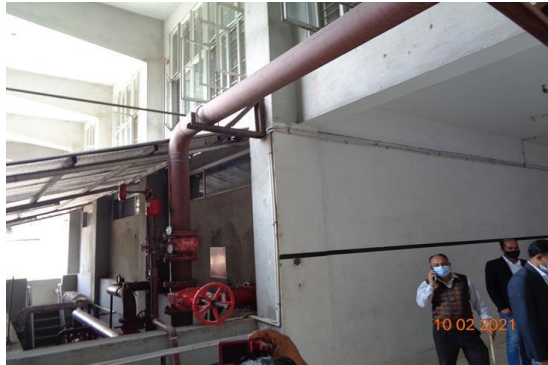
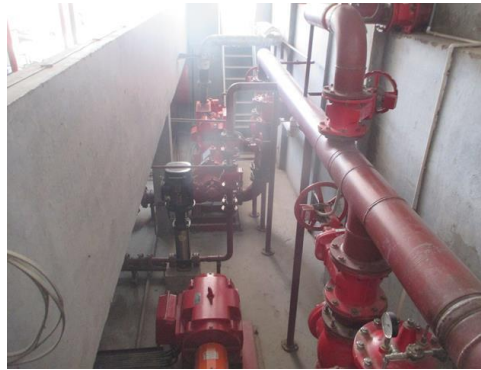
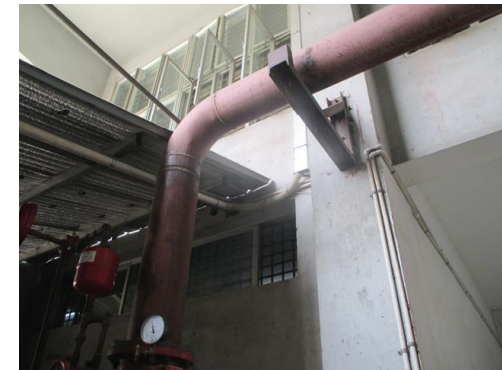
</div>				
6	Unprotected Fire Pump Room	The fire pump room is not provided with adequate fire separation from building interior and exit discharge path (north side of the ground floor).	Provide fire pump room with 2 hr rated fire separation when not sprinklered and 1 hr rated fire separation when provided with automatic sprinklers in accordance with NFPA 20 Or, Physically separate the pump room from the protected building by a minimum of 50 ft (15.3 m) in accordance with NFPA 20	within 3 months

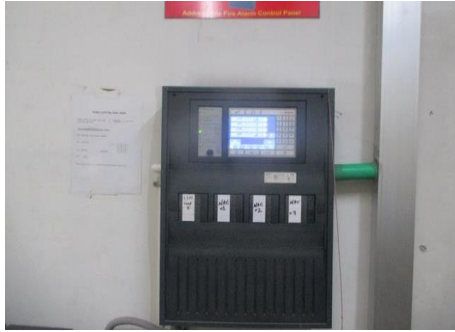
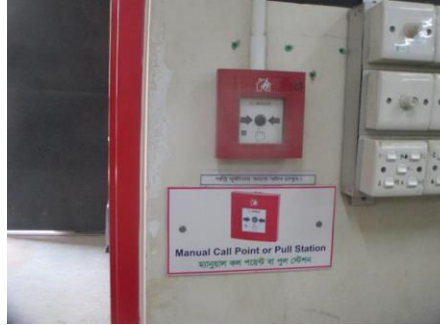
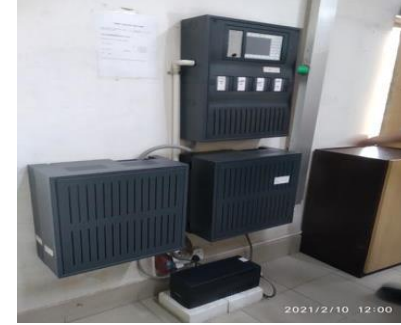
7	Fire Alarm & Detection system	Provide automatic alarm and notification features consistet with acceptable standards throughout the building. Fire detection system installation requires detailed review to confirm compliance with NFPA 72 and ACCORD standards.	Configure the fire alarm system to initiate automatic occupant notification on all floor levels to facilitate whole-building evacuation upon any manual fire alarm station activation. Submit as-built drawings, testing records, equipment certification and other relevant documentation to the RSC for review and approval.	Within 6 months
---	-------------------------------	---	--	-----------------

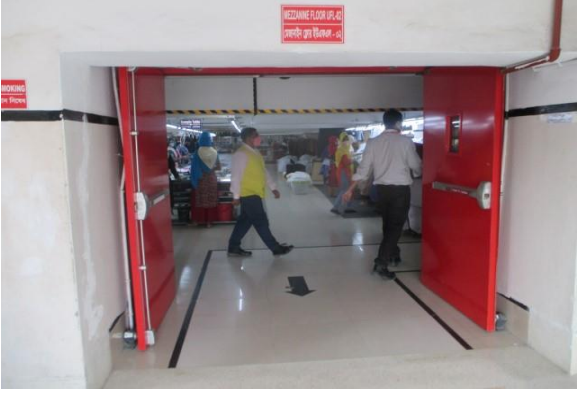
11	Headroom	Headroom is found less than 6 feet 8 inches in mezzanine floors.	All means of egress shall have a minimum ceiling height of 2.3 m (7 ft 6 in.) with projections from the ceiling not less than 2.03 m (6 ft 8 in.). The minimum ceiling height shall be maintained for at least 2/3 of the space or room as long as the remaining area shall be not less than 2.03m (6 ft 8 in.). Headroom on stairs shall not be less than 2.03 m (6 ft 8 in.).	within 3 months
