# FIRE SAFETY INSPECTION REPORT

## Apparel Gallery Ltd. (Extended Building)

Factory ID: 24149

Date: 24 May 2021

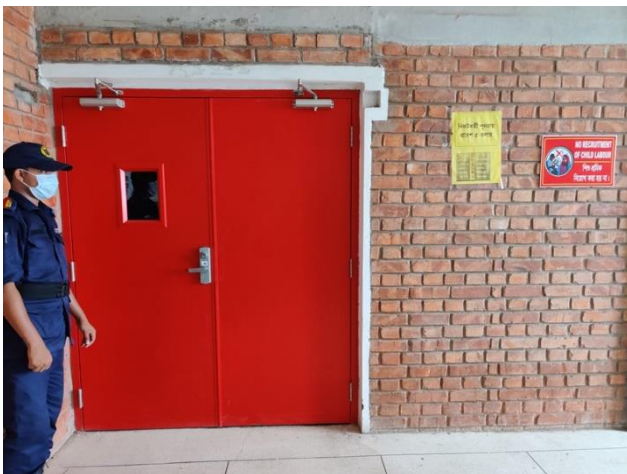
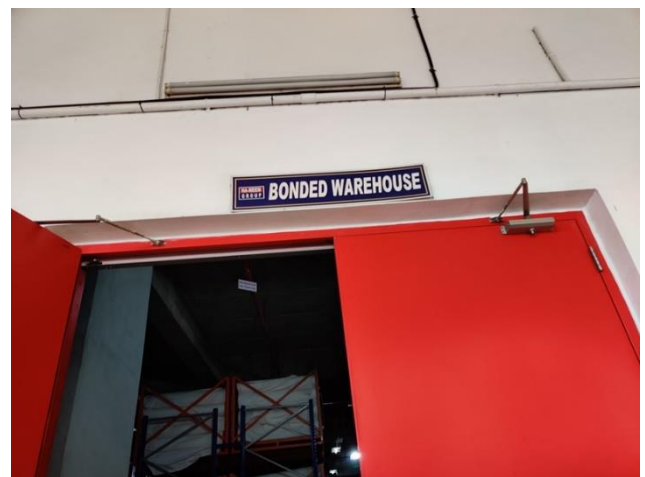
| F-1 | Fire Rated Construction | Storage from all floor discharges directly into the exit stair discharge. | <p>Openings from exit enclosure to storage room, generator and transformer spaces shall be provided with a vestibule with fire rated construction and openings.</p> <p>Provide a 1.5 hr. fire rated door on the exit stair side and a 1-hr. fire rated door on the Store, generator, sub-station room side. Ensure that the fire rating of the vestibule construction matches that of the exit stair enclosure.</p> | Within 3 months |

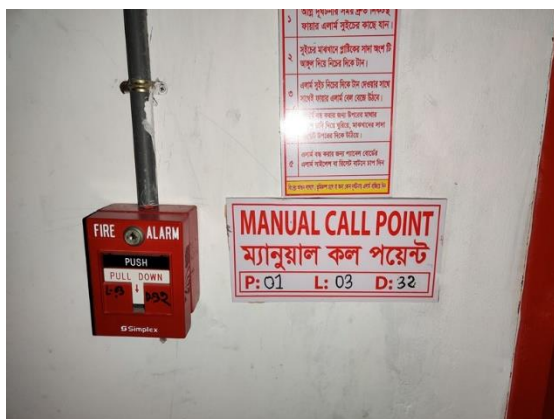
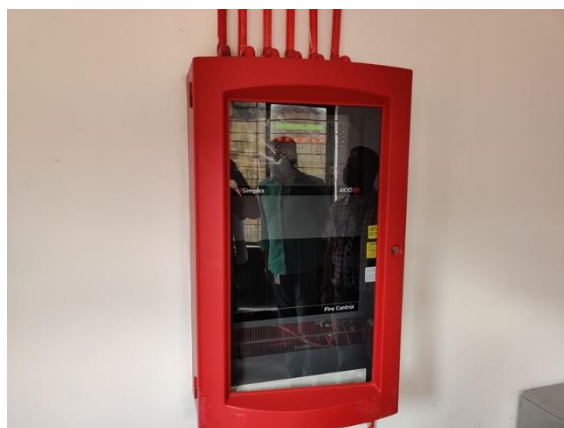
| F-2 | Fire Protection | The fire alarm system installation requires detailed review to confirm compliance with NFPA 72 and ACCORD standard. | Submit as-built drawings, testing records, equipment certification and other relevant documentation to the RSC for review and approval/acceptance test. | Within 3 months |

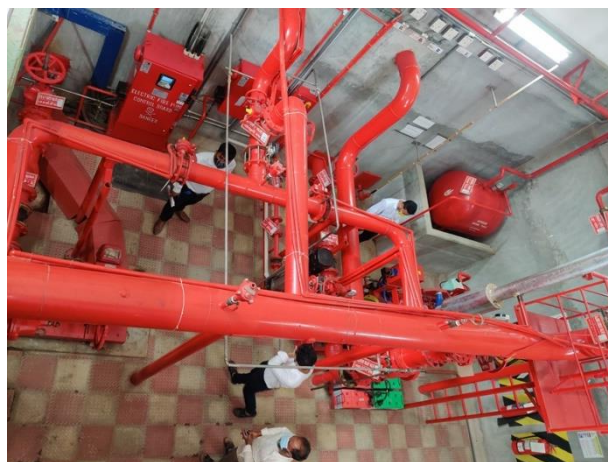
| F-3 | Fire Protection | The fire pump set installation requires detailed review to confirm compliance with NFPA 20 and ACCORD standard. | Submit as-built drawings, testing records, equipment certification and other relevant documentation to the RSC for review and approval/acceptance test. | Within 3 months |

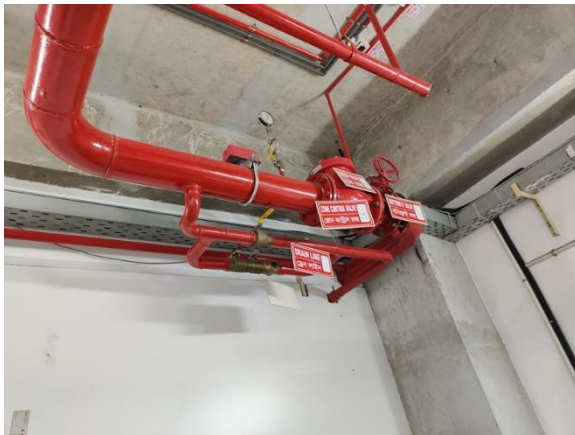
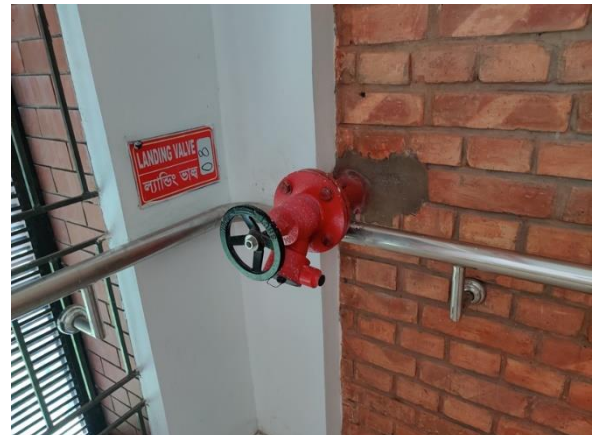
| F-4 | Fire Protection | The firefighting system (sprinkler & standpipe) installation requires detailed review to conform compliance with NFPA 13, NFPA 14. | Submit as built drawing, testing records, equipment certification and all relevant documents to the RSC for review, approval and acceptance test. | Within 3 months |

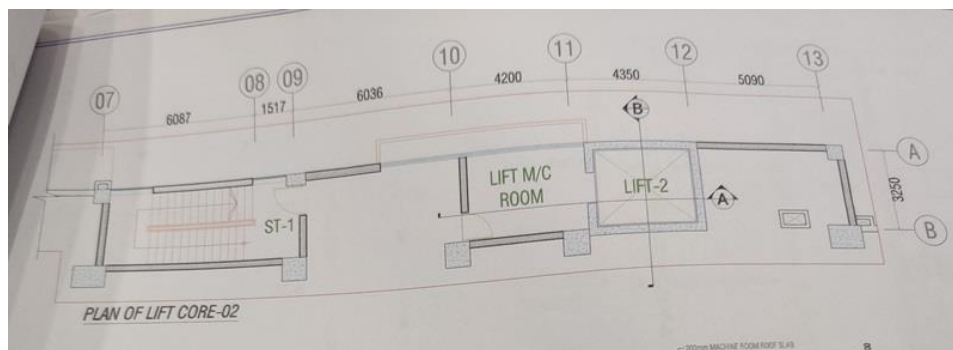
| F-5 | Egress | Width of exit stairs is less than 1.5 m (60 in.) (S-W and S-E stairs). | Provide exit stair minimum clear and unobstructed width of 1.5 m (60 in.) in accordance with Accord standard 6.5.6.2.1. | Within 4 months |

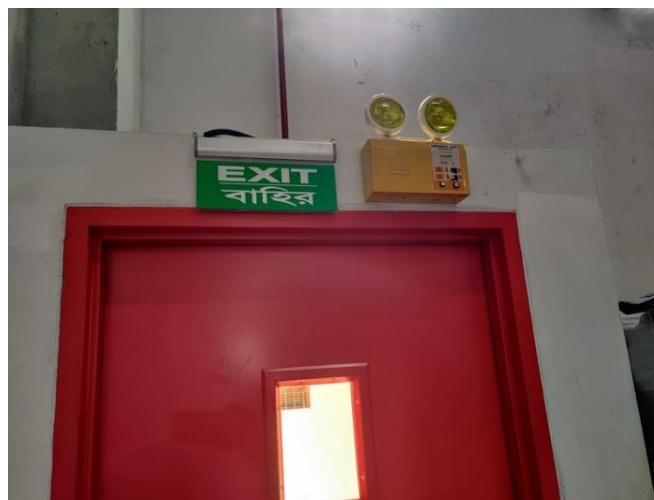
| F-6 | Egress Lighting | Exit signage not illuminated (burned out, broken, etc.).<br>(Ground floor S-E exit) | Regularly inspect all exit signage and replace/install lights as needed to illuminate signs. The source of illumination shall provide not less than 50 lux at the illuminated surface with a contrast of not less than 0.5. Approved self-luminous signs which provide evenly illuminated letters having a minimum luminance of 0.2 cd/m <sup>2</sup> may also be used. | Within 1 month |

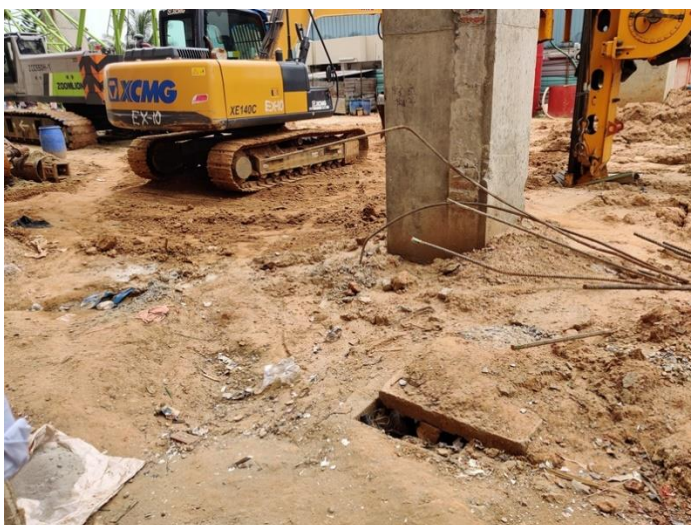
| F-10 | Egress | S-W exit discharge path is not even and smooth. | Level the exit discharge path to ensure smooth and safe evacuation from the S-W exit. | Within 1 month |
