**Shafi Processing Industries Ltd (9239)**  
**Giant Knit Ltd (9242)**  
**Giant Apparels Ltd (9241)**  
**Mavis Garments Ltd (9240)**

Mouza-Chandana, Joydebpur, Gazipur, Dhaka.(+ 23.5922N, 90.2315E)  
11 March 20.14235922N, 90.2315E

## Priority 1 Concerns – Buildings A& B

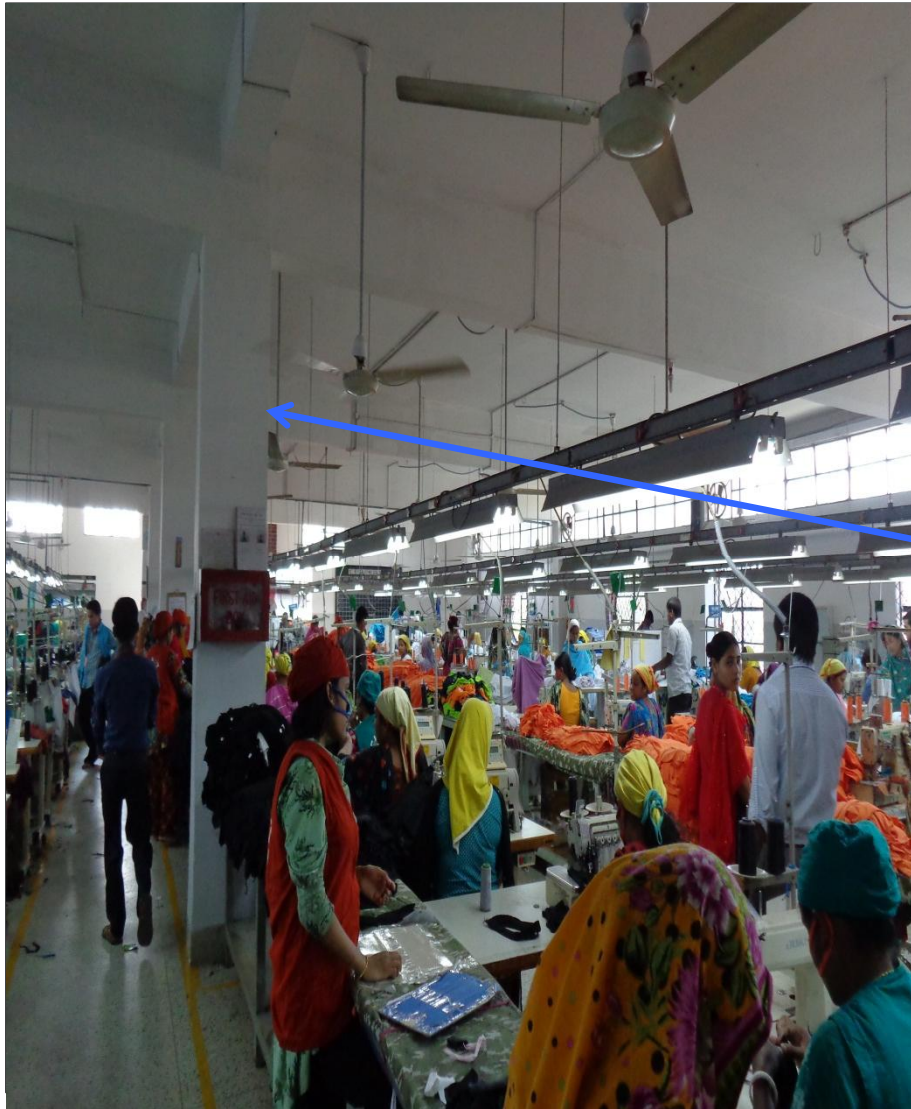
## 1st Priority 1 Concern - Building B

Based on the load run-down analysis following the agreed minimum design live load assignment, the columns' factor of safety falls between 1.5 and 1.86, giving a AMBER warning. Factory Engineer to review design, loads and columns stresses.

Preliminary load take-down calculations indicates that the columns factor of safety is between 1.5 and 1.86.

- Factory Engineer to review design, loads and columns stresses.
- Verify insitu concrete stresses by cores from 4 columns.

- Produce and actively manage a loading plan for all floor plates within the factory giving consideration to floor capacity and column capacity.
- Detail Engineering Assessment to be completed

- Continue to implement load plan.

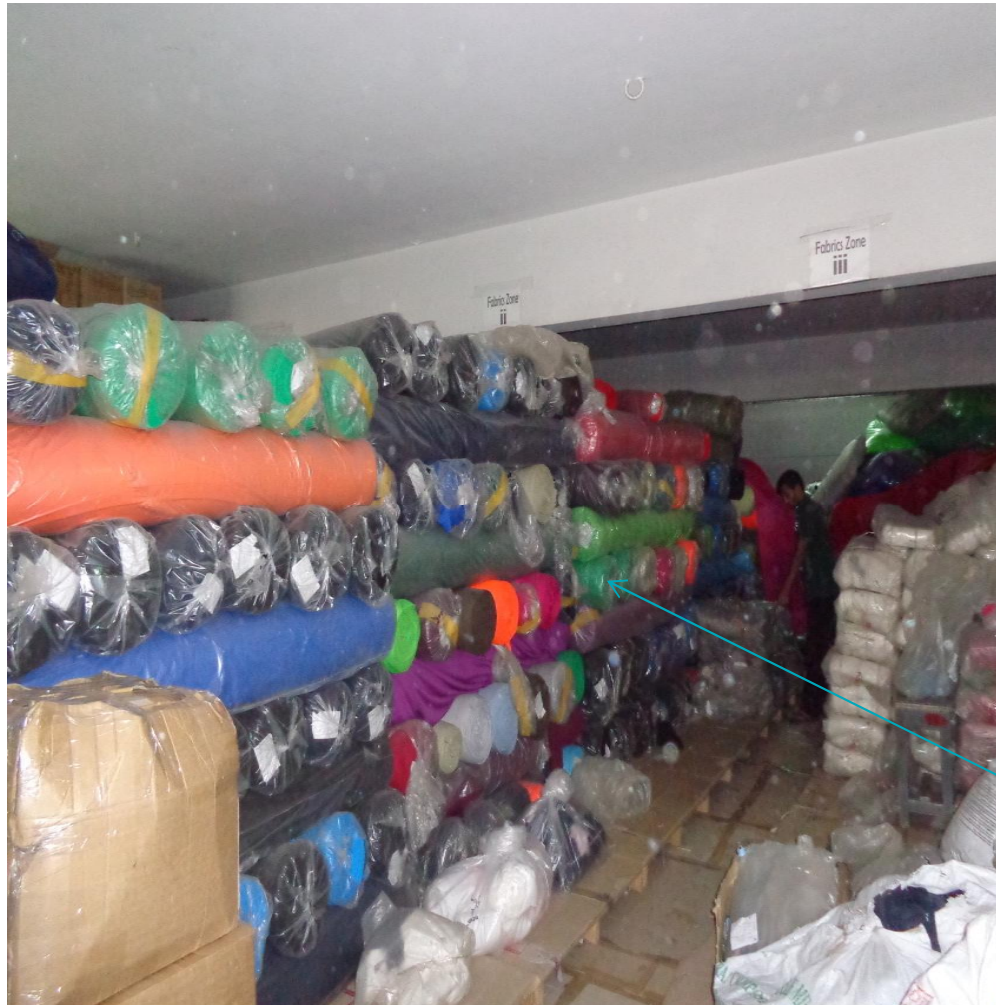
2<sup>nd</sup> Priority 1  
Concern - Building A

Due to a high  
stacking of fabric  
rolls, the columns  
are overstress.

Stacking at every floor.

- At the warehousing of the 3rd floor , the stacking is too high. You must limit the height of the stacking.

- Produce and actively manage a loading plan for all floor plates within the factory giving consideration to floor capacity and column capacity.

- Continue to implement load plan.

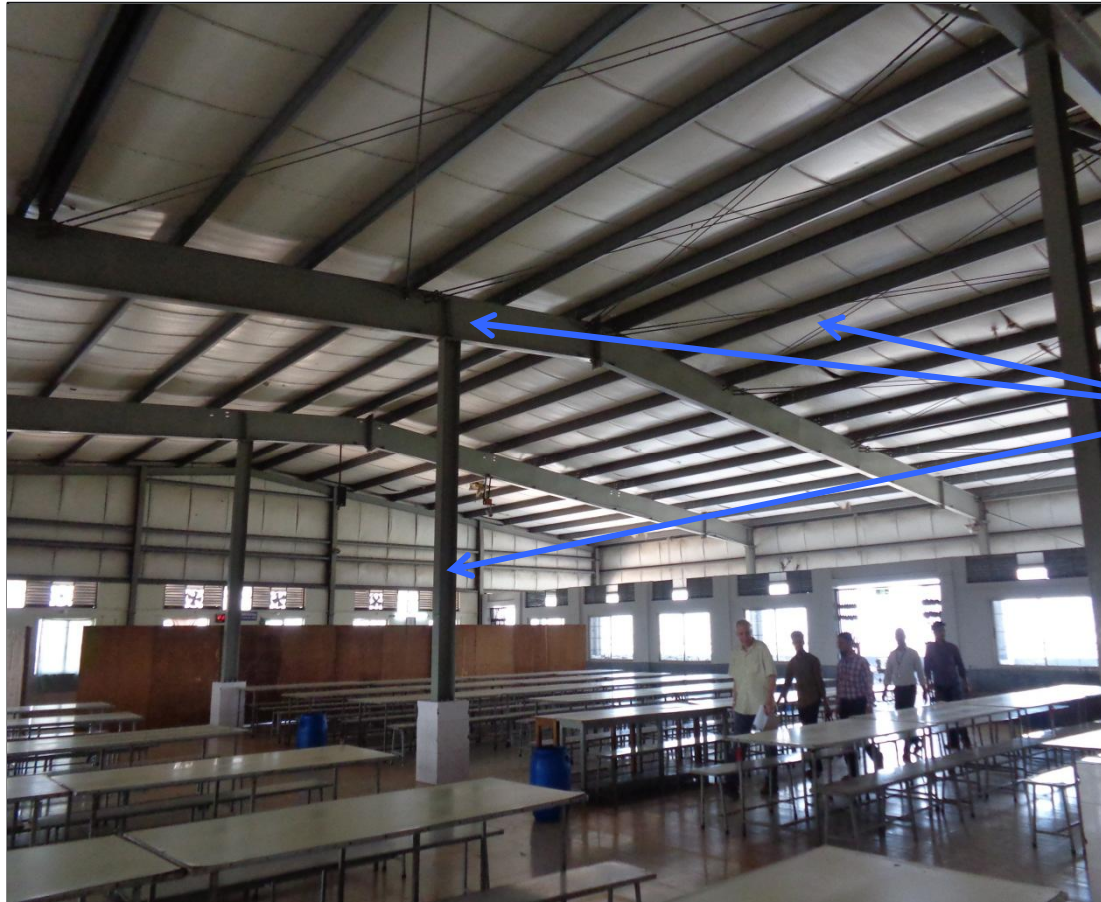
1st Priority 3 Concern -  
Building A

Roof made of steel  
columns, beams,  
purlins and bracings.

Roof made of structural steel.

- Factory engineer to check, collect information and produce accurate and complete as-built documentation

- Factory engineer to review design, loads and columns stresses.

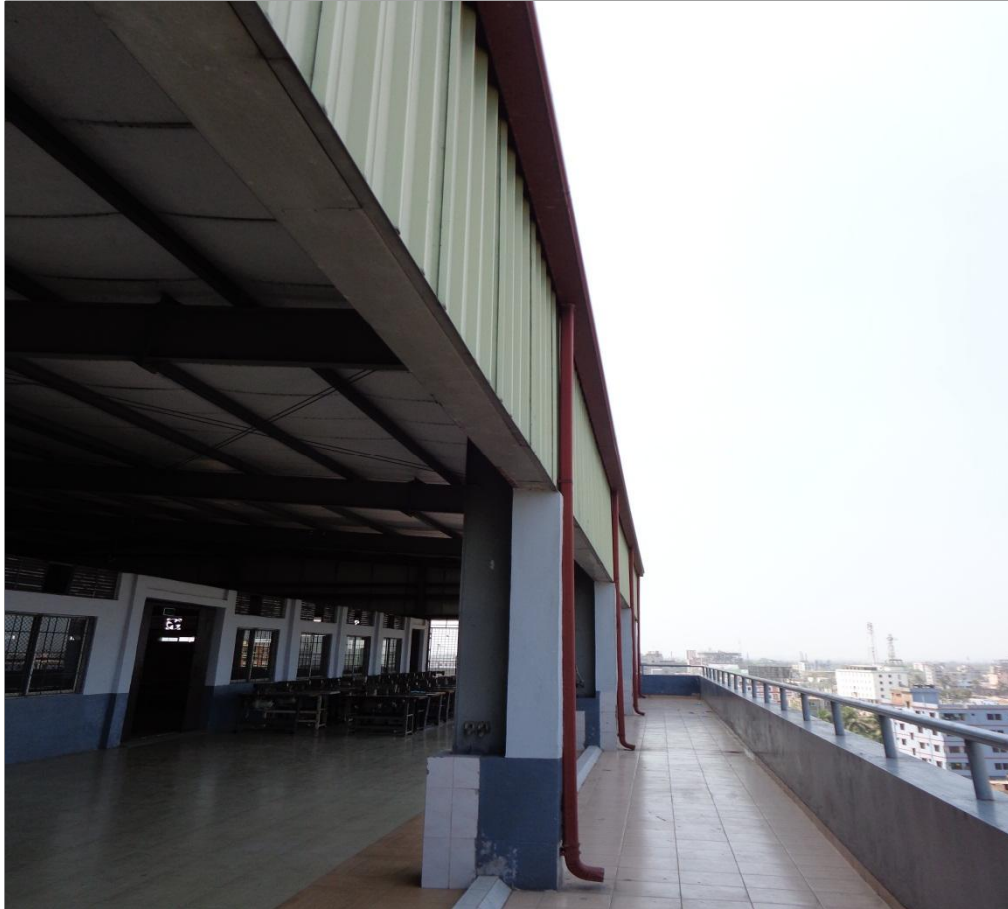
## 2<sup>st</sup> Priority 3 Concern – Building A

No waterproofing membrane was visible on the roof of the building. This means that any cracks in the surface finishes on the roof will allow water to seep into the concrete slab beneath the finishes, and cause long-term soaking of the slab.

Roof appears not to have any waterproofing system applied.

- Consider applying a new waterproofing membrane.
- Manage drainage from above levels and water tanks to downpipes to avoid structural corrosion due to continuous moisture.
