INITIAL FIRE SAFETY INSPECTION REPORT

P.A Knit Composite (Extension)

RSC ID: 24202

Hobirbari, Jamirdia, Valuka, Mymensingh

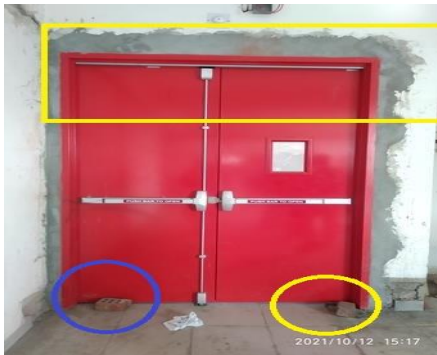
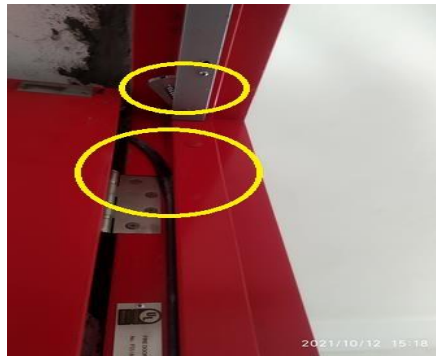
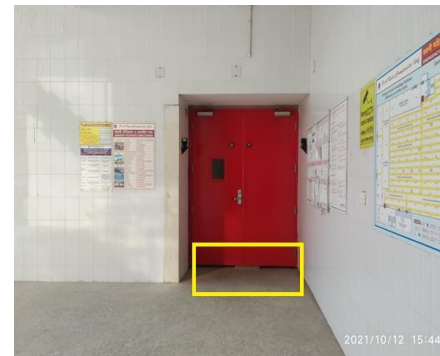
SI No.	Category	Findings	Required Action	Remediation Time Frame
F-1	Fire Rated Construction	<p>Fire doors has been installed in the openings of required fire rated assemblies (Exit stairs, Storage rooms, and other occupancy separations), However, fire door were found with following issues-</p> <ol style="list-style-type: none"> 1. Doors were kept open by means of door wedges. 2. Doors were not provided with adequate/required hardware. 3. Doors were found with excessive clearance. 4. Doors were not provided with required positive latching. 5. Fire doors smoke seal were found with damaged that could impact the fire protection. <p>Location: Exit stairs, Storage rooms of Garments building -2</p>	<p>Install the fire door as per NFPA 80.</p> <p>Ensure that the fire doors are self-closing and positive latching and that they are provided with fire exit (panic) hardware where serving production floors. If fire doors are required to be held open for functional reasons, provide automatic closing devices tied to the fire alarm system.</p> <p>The clearance under the bottom of a fire door shall be a maximum of 19mm. From edges and top shall be limited to a maximum 4.8 mm. All measurement shall be taken from the "pull side" of the door.</p> <p>Any modification of fire doors beyond the job site preparation shall be approved by the door manufacturer.</p>	Within 3 months

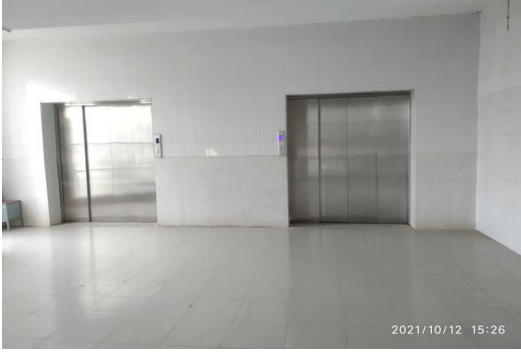
F-2	Fire Rated Construction	Elevator shafts are directly open into the inside of S-W side Stair. Located: Garments building -2	For new construction, elevators shall not open into an exit enclosure as per ACCORD-6.14.3. So, separate the stair enclosure from elevator shaft throughout the building.	Within 3 month

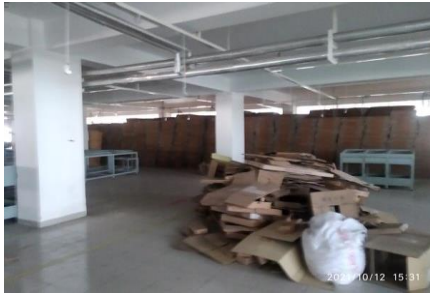
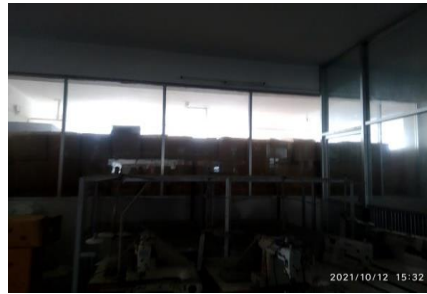
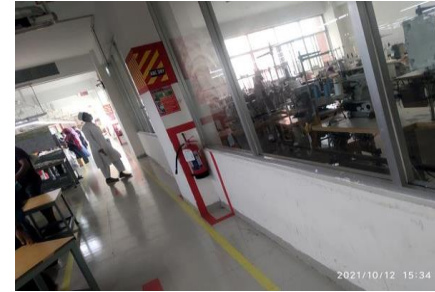
F-3	Fire Rated Construction	Rooms used for storage of combustible materials are not separated from the surrounding occupancy/areas . Location: Several floor of garments building -2	Rooms used for storage of combustible materials shall be separated from the surrounding occupancy with a minimum 1 hour construction.	Within 3 months

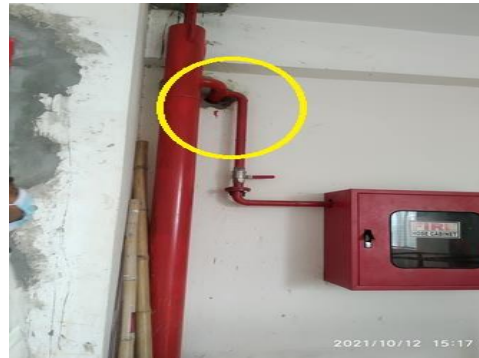
F-4	Fire Rated Construction	<p>Unsealed penetrations and openings are located in exit stair enclosures and separation walls. Location: Garments building -2</p>	<p>Seal all penetrations and openings in exit stair enclosure and separation walls to maintain the required fire separation.</p>	<p>Within 2 months</p>
-----	-------------------------	---	--	------------------------

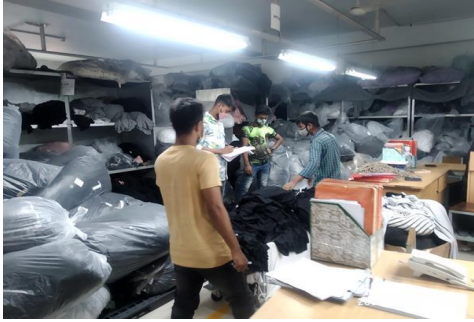
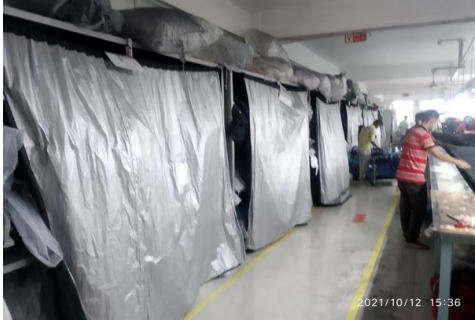
F-5	Fire rated construction	<p>Areas used for in-process storage of combustible materials are open to the surrounding occupancy. Location: Several floor of Garments building -2</p>	<p>Provide defined storage areas and limit the storage arrangement as follows: Maximum height of 2.45 m and maximum area of 23 m² and is separated by a minimum 3.0 m (10ft) from other storage areas and they do not exceed 10 percent of the building area of the story in which they occur. If sprinkler protected, Maximum height 12 ft (3.66 m) and maximum area of 1000 ft² (93 m²) and separated by a at least 25 ft (7.62 m) from other storage areas and does not constitute more than 10 percent of the building area or 4000 ft² (372 m²) of the sprinklered area, whichever is greater. or, Enclose the storage area from the surrounding occupancy with a minimum 1 hour construction.</p>	Within 3 months
<div style="display: flex; justify-content: space-around;">

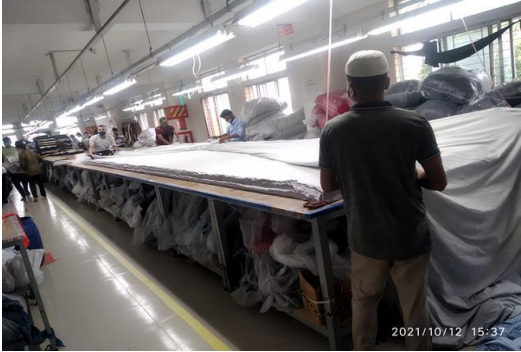
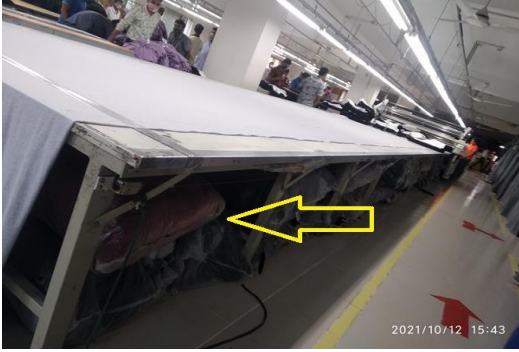
F-6	Fire rated construction	Storage were observed underneath the cutting tables. Location: 1st floor, 2nd floor of garments building 2	Storage underneath the cutting tables shall be kept clear of combustibles at all time, except as provided for miscellaneous storage in accordance with Accord building standard section 3.4.2.1.6 or where automatic sprinkler protection is installed. Where an automatic sprinkler system is installed sprinklers are required to be installed beneath cutting tables greater than 4 ft in width that are used for storage of combustibles.	Within 2 months
<div style="display: flex; justify-content: space-around;">

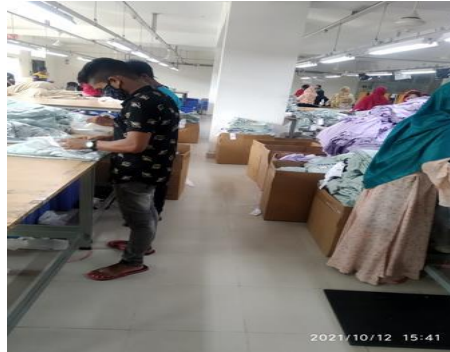
</div>				
F-7	Means of Egress	The egress path along the means of egress has been interrupted by obstruction/storage and aisles are not marked at several floor of Garments building-2	Means of egress shall be maintained continuously free and clear of all obstructions/storage. Or Aisles shall be provided with a minimum unobstructed clear- with of 0.9m (36 in).	Within 1 month

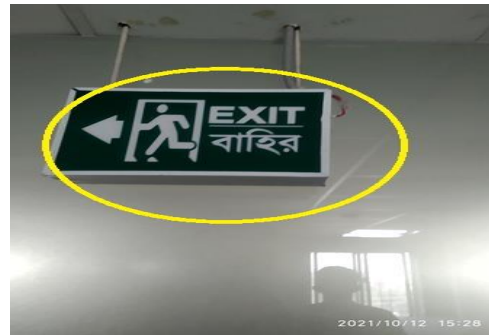
F-11	Egress lighting	Directional signs are not provided where direction of the path of travel to an exit has changed. Location: all floor of garments building-2	Illuminated directional signs shall be provided where there is a change in the direction for the path of travel and the direction to an exit is not obvious.	Within 1 months
F-12	Egress lighting	Based on the number and location of emergency lights observed, adequate illumination levels are not anticipated along egress routes. Location: all floor of garments building-2	Test the emergency lighting system on each floor and provide additional emergency fixtures to provide adequate illumination along the means of egress. Provide a minimum illumination of 10 lux at the floor level within exit stairs and exit discharge paths and minimum 2.5 lux along exit access aisles.	Within 3 months
F-13	Egress lighting	Emergency lights not illuminated during testing (burned out, broken, etc.). Location : Several location several floor of garments building-2	Regularly inspect all emergency lighting system as per Accord standard and replace/install lights as needed to illuminate signs.	Within 1 month

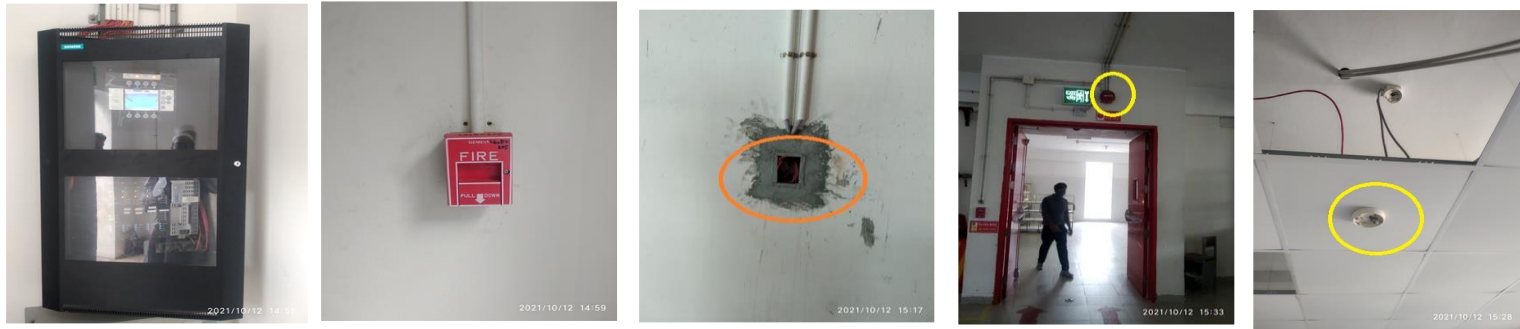
F-16	Fire Alarm & Detection System (FADS)	<p>An addressable fire alarm & detection system installation was ongoing during inspection day. The fire alarm and detection system installation requires detailed review to confirm compliance with NFPA 72.</p> <p>Location: Garments building-2</p>	<p>Design & Installation of Fire Alarm & Detection system shall be in accordance with ACCORD standard and NFPA 72. Submit design, documents and calculations to RSC for review prior installation/modification.</p> <p>After installation the owner shall contact the RSC for witness of conducting the final acceptance testing of the fire detection & alarm system installation.</p> <p>Also inspect, test and maintain the fire alarm system, and keep written records on-site, in accordance with NFPA 72.</p>	Design within 2 months, Install within 6 months.
------	--------------------------------------	--	---	--

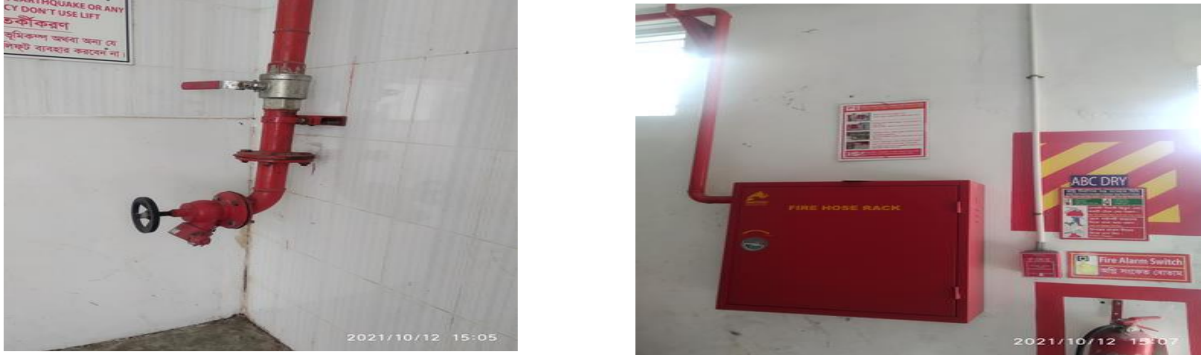
F-18	Fire Protection System(Standpipe)	<p>Standpipe system installation requires detailed review to confirm compliance with ACCORD standard and NFPA-14.</p> <p>Location: Garments building-2</p>	<p>Submit the standpipe system drawing to RSC for review. Once reviewed, install or modify the standpipe system throughout the building in accordance with Accord standard and NFPA 14. After installation the owner shall contact the RSC for witness of conducting the final acceptance testing of the fire protection System(Standpipe) installation.</p>	<p>Design within 2 months, Install within 6months.</p>

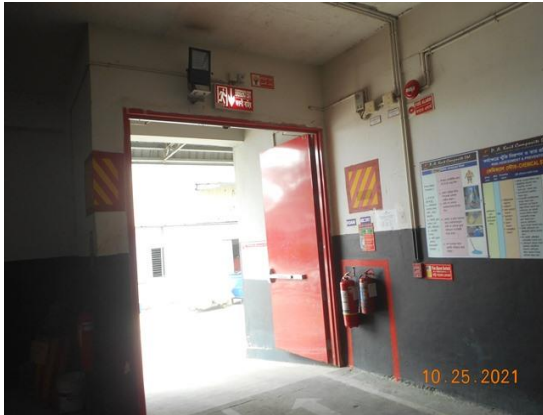
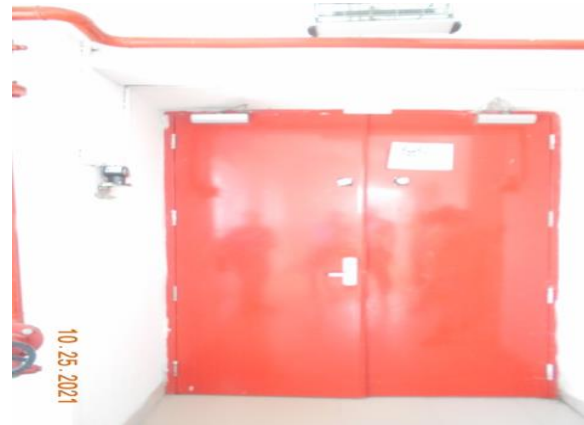
SI No.	Category	Findings	Required Action	Remediation Time Frame
F-24	Fire-Rated Construction	Most of the exit stairs and storage rooms are separated by double and single leaf fire rated doors but smoke seal damaged for several doors. For that doors are not closing properly.	Install/repair smoke seal and ensures that all the doors are closing properly. Submit proper certifications for installed fire doors to the RSC for approval.	Within 3 months

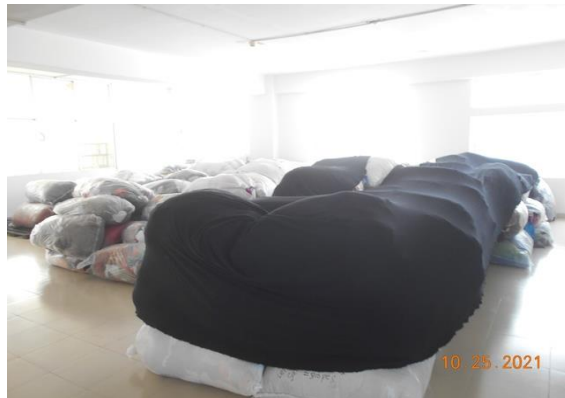
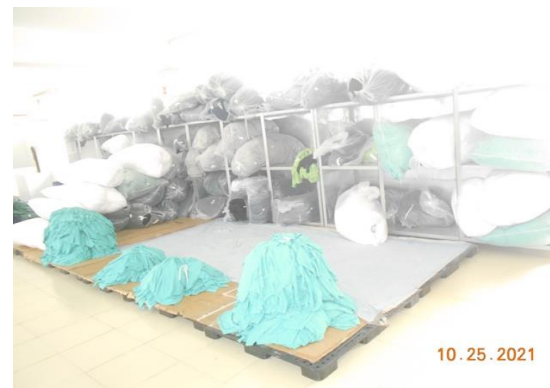
F-25	Fire-Rated Construction	<p>Areas used (in-process storage) for combustible materials are open to the surrounding occupancy. Location: 3rd floor.</p>	<p>Provide defined storage areas and limit the storage arrangement as follows:-</p> <ol style="list-style-type: none"> 1. General Condition: Maximum height of 2.4m and maximum area of 23m². Separate areas of unenclosed combustible storage by a minimum clear distance of 3m. 2. If sprinkler protected: maximum height of 3.66m and maximum area of 93m². Separate areas of unenclosed combustible storage by a minimum clear distance of 3m. <p>or</p> <ol style="list-style-type: none"> 3. Enclose the storage area from the surrounding occupancy with a minimum 1 fire rated hour construction. 	Within 3 months
------	-------------------------	---	--	-----------------

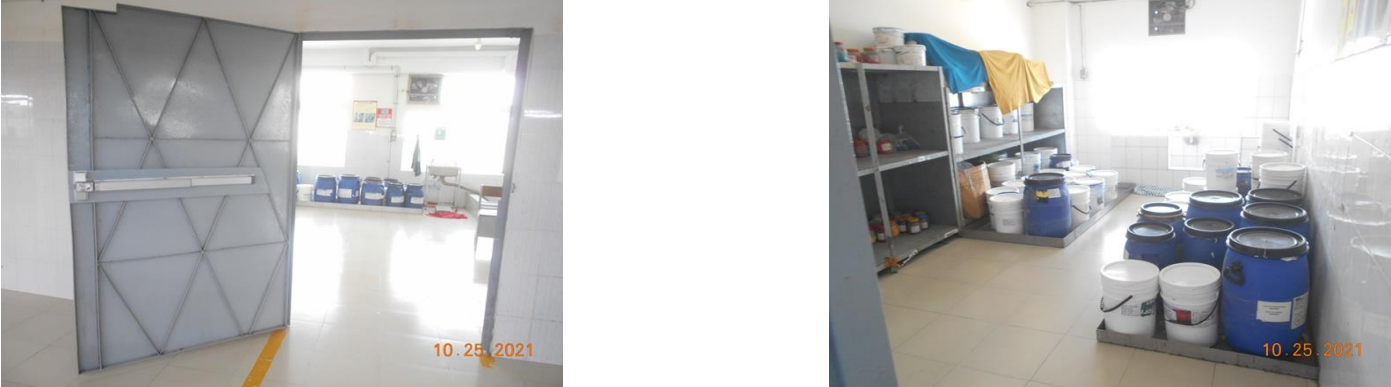
F-26	Fire Rated Construction	[Hazardous materials / flammable liquid storage] area is separated by fire-rated construction (openings, non-rated doors, penetrations) but door is non rated. Location: Chemical storage on 3rd,4th and 5th floors.	Provide a minimum 2-hr fire rated shaft to separate the utility risers from each floor level. Seal all penetrations and openings in floors/ceiling assemblies to maintain the fire separation.	Within 3 months

<p>The first photograph on the left shows a large, grey, diamond-patterned fire-rated door that is slightly ajar, revealing a brightly lit interior space with blue chairs. The second photograph on the right shows a utility room with several blue and white buckets and containers stacked on a metal shelving unit, with a window in the background. Both photos have an orange timestamp '10.25.2021' in the bottom right corner.</p>				
F-27	Egress	Building did not have stair designation signs or occupant load signs at the required locations.	Provide stair designation signs and occupant load signs at the required locations.	Within 1 month

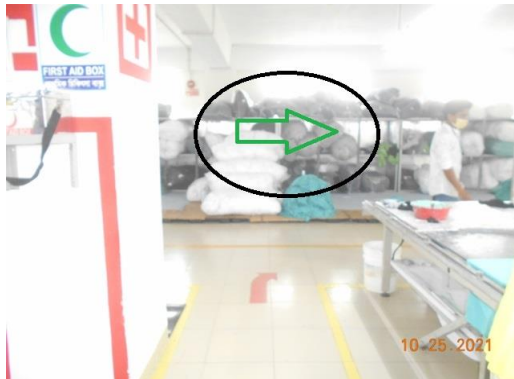
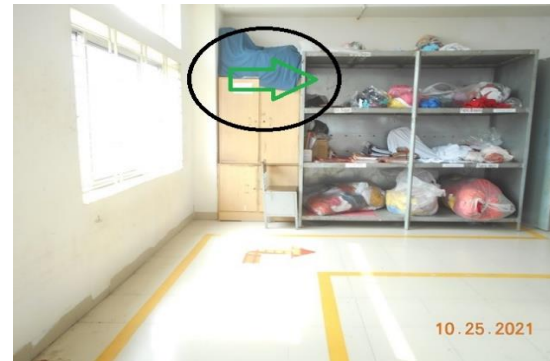
F-34	Egress Lighting	<p>Illuminated directional signs are not provided where direction of the path of travel to an exit has changed.</p> <p>Location: All floor.</p>	<p>Illuminated directional signs shall be provided where there is a change in the direction for the path of travel and the direction to an exit is not obvious.</p>	Within 1 month
------	-----------------	--	---	----------------

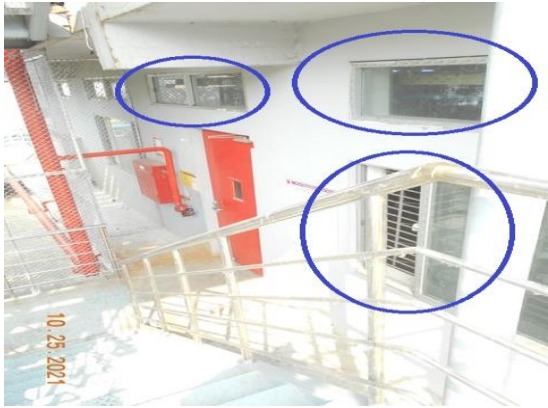
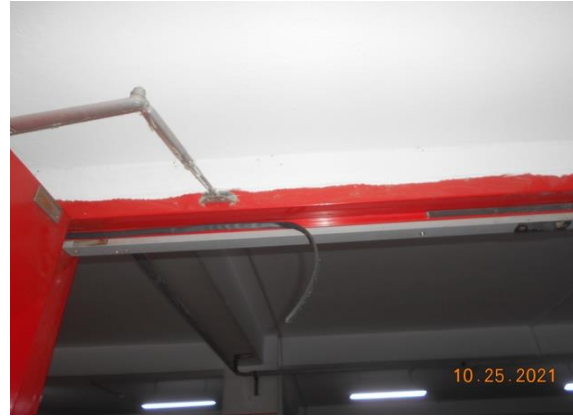
SI No.	Category	Findings	Required Action	Remediation Time Frame
F-36	Fire-Rated Construction	The exit stair-2 is not separated from work areas & other spaces on each floor by fire rated construction and fire door . Also doors are not closing properly.	<p>Stair shall be enclosed with a minimum 2-hr fire-rated construction. Seal all unprotected openings and provide minimum 1.5 -hr. fire rated doors to separate the exit stairs from work areas and other building spaces on all floor levels. Ensure that the fire doors are self-closing, positive latching and that they are provided with fire exit (panic) hardware where serving production floors.</p> <p>If fire doors are required to be held open for functional reasons, provide automatic-closing devices tied to the fire alarm system.</p>	Within 3 months

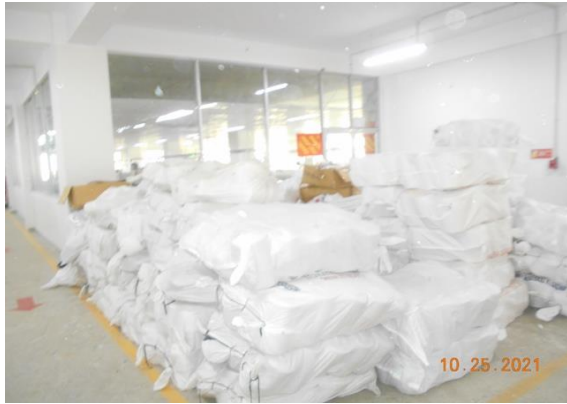
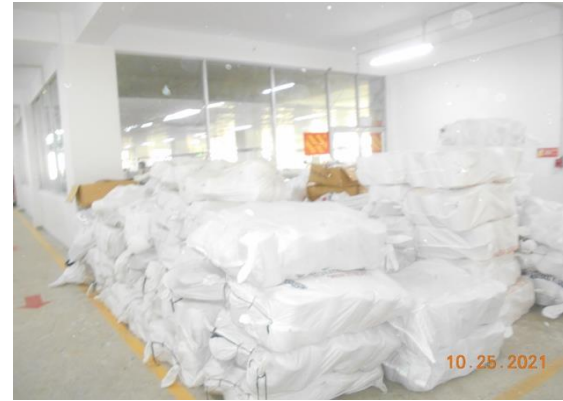
F-37	Fire-Rated Construction	<p>Areas used (in-process storage) for combustible materials are open to the surrounding occupancy. Location: 2nd floor.</p>	<p>Provide defined storage areas and limit the storage arrangement as follows:-</p> <ol style="list-style-type: none"> 1. General Condition: Maximum height of 2.4m and maximum area of 23m². Separate areas of unenclosed combustible storage by a minimum clear distance of 3m. 2. If sprinkler protected: maximum height of 3.66m and maximum area of 93m². Separate areas of unenclosed combustible storage by a minimum clear distance of 3m. <p style="text-align: center;">or</p> <ol style="list-style-type: none"> 3. Enclose the storage area from the surrounding occupancy with a minimum 1 fire rated hour 	Within 3 months
------	-------------------------	---	--	-----------------

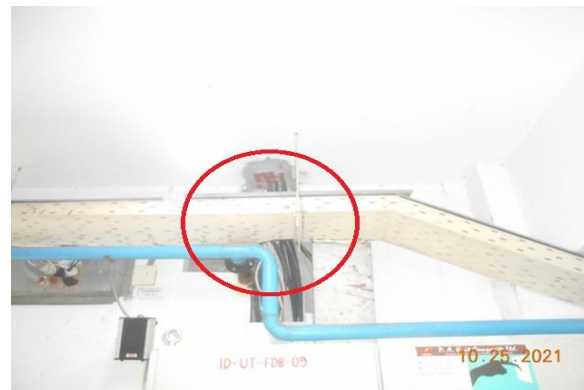
F-38	Fire Rated Construction	Unsealed penetrations and openings are located in the fire rated floor/ceiling assemblies. Location: Electrical riser.	Provide a minimum 2-hr fire rated shaft to separate the utility risers from each floor level. Seal all penetrations and openings in floors/ceiling assemblies to maintain the fire separation.	Within 3 months
------	-------------------------	---	--	-----------------

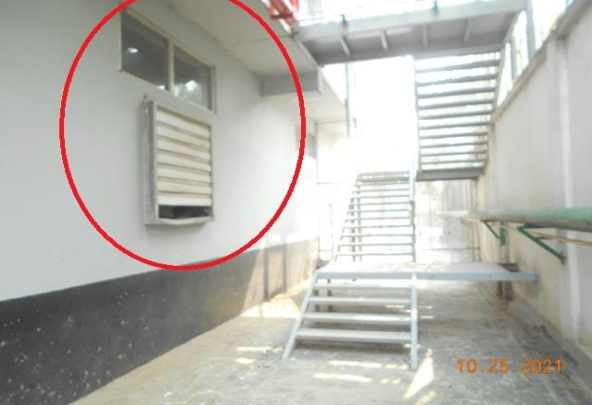
F-39	Fire Rated Construction	Exterior exit stairs are not properly separated from the building and stair exit discharge. Location: Stair-2.	Exterior exit stairs shall be separated from the building with a rating requirement of 2 hr. fire rating for 4 or more stories. The rating of the exterior wall shall extend 3.05 m (10 ft) beyond the ends of the stair structure.	Within 3 months

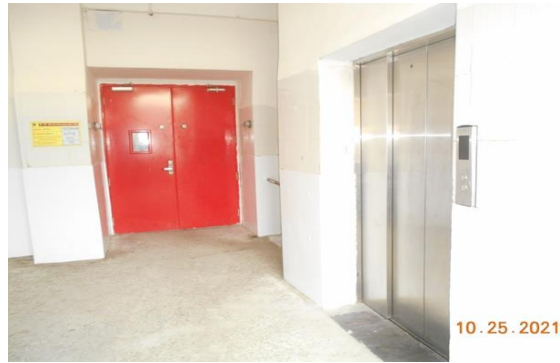
F-40	Egress	Building did not have stair designation signs or occupant load signs at the required locations.	Provide stair designation signs and occupant load signs at the required locations.	Within 1 month

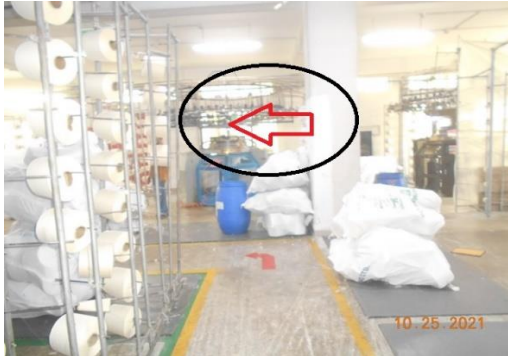
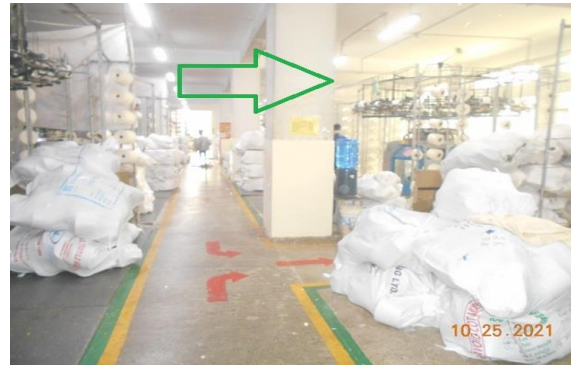
F-48	Egress Lighting	<p>Illuminated directional signs are not provided where direction of the path of travel to an exit has changed.</p> <p>Location: All floor.</p>	<p>Illuminated directional signs shall be provided where there is a change in the direction for the path of travel and the direction to an exit is not obvious.</p>	Within 1 month

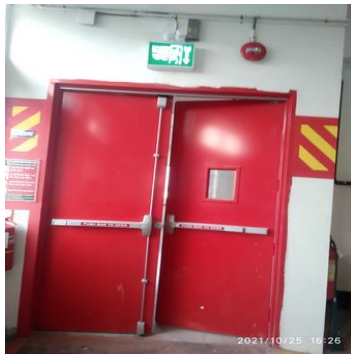
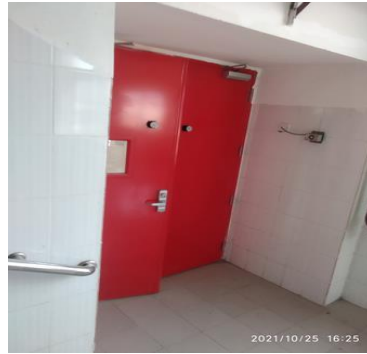
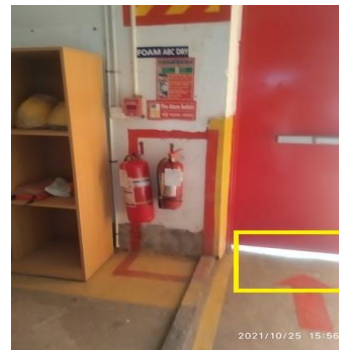
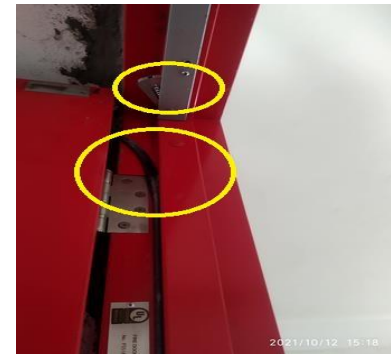
SI No.	Category	Findings	Required Action	Remediation Time Frame
F-50	Fire Rated Construction	<p>Fire doors has been installed in the openings of required fire rated assemblies (Exit stairs, Storage rooms, and other occupancy separations), However, fire door were found with following issues-</p> <ol style="list-style-type: none"> 1. Doors were kept open by means of door wedges. 2. Doors were not provided with adequate/required hardware. 3. Doors were found with excessive clearance. 4. Doors were not provided with required positive latching. 5. Fire doors smoke seal were found with damaged that could impact the fire protection. <p>Location: Exit stairs & Store of the sample building.</p>	<p>Install the fire door as per NFPA 80.</p> <p>Ensure that the fire doors are self-closing and positive latching and that they are provided with fire exit (panic) hardware where serving production floors. If fire doors are required to be held open for functional reasons, provide automatic closing devices tied to the fire alarm system.</p> <p>The clearance under the bottom of a fire door shall be a maximum of 19mm. From edges and top shall be limited to a maximum 4.8 mm. All measurement shall be taken from the "pull side" of the door.</p> <p>Any modification of fire doors beyond the job site preparation shall be approved by the door manufacturer.</p>	Within 3 months

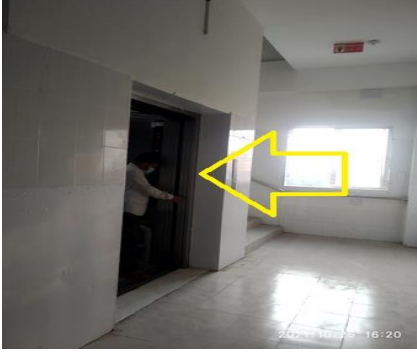
F-51	Fire Rated Construction	Elevator shafts are directly open into the inside of S-W side Stair. Located: Sample building	For new construction, elevators shall not open into an exit enclosure as per ACCORD-6.14.3. So, separate the stair enclosure from elevator shaft throughout the building.	Within 3 month

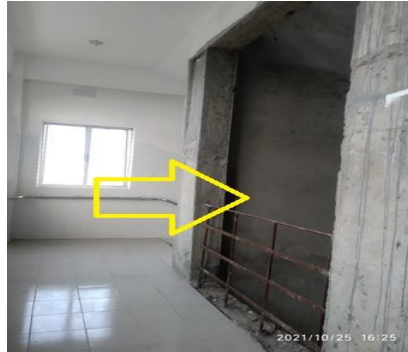
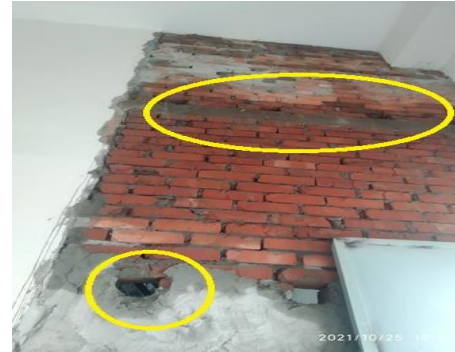
F-52	Fire rated construction.	Unsealed penetrations and openings are located in exit stair enclosures. Location: Both exit stair of sample building.	Seal all penetrations and openings in the wall of exit enclosure walls (full thickness of the wall) by fire rated materials to maintain the fire resistance rating.	Within 3 months

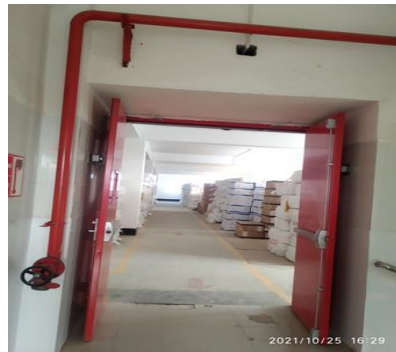
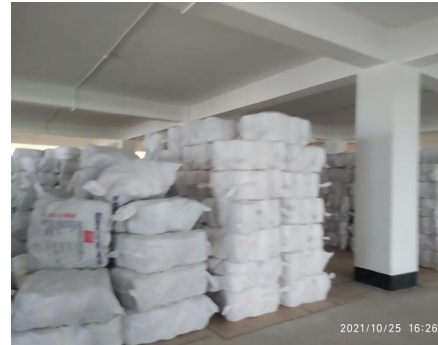
F-53	Fire rated construction.	Storage room discharges directly into exit stair enclosure. Location: 3rd floor of sample building.	Openings from exit enclosure to storage spaces shall be provided with a vestibule with fire rated construction and openings. Provide a 1.5-hr. fire rated door on the exit stair side and a 1-hr. fire rated door on the storage room side. Ensure that the fire rating of the vestibule construction matches that of the exit stair enclosure.	Within 3 months
------	--------------------------	--	--	-----------------

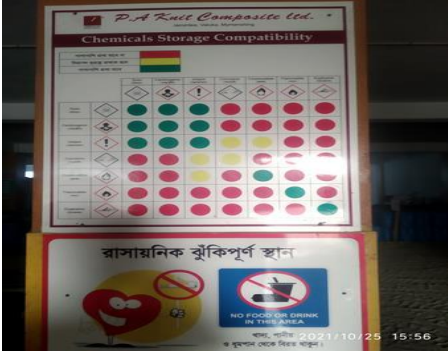
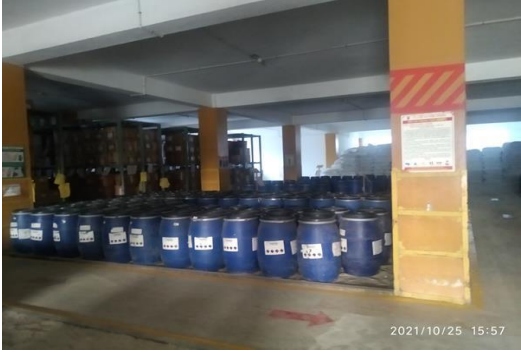
F-54	Fire Rated Construction	<p>Chemical storage area is not separated by fire-rated construction.</p> <p>Location: Ground floor of Sample building</p>	<p>Separate the chemical storage room by 4-hr fire rated construction. Seal all penetrations and protect the openings to maintain the required fire separations. Keep 16-points MSDS of all chemicals in the storage area. The clearance under the bottom of a fire door shall be a maximum of 19mm.</p> <p>** As per BNBC, chemical storage room shall be Type-1 construction (Table-3.2.4 of BNBC-2006). Follow section-2.13 and Table 3.2.1 of BNBC-2006 for the guideline.</p>	Within 3 month
<div style="display: flex; justify-content: space-around;">

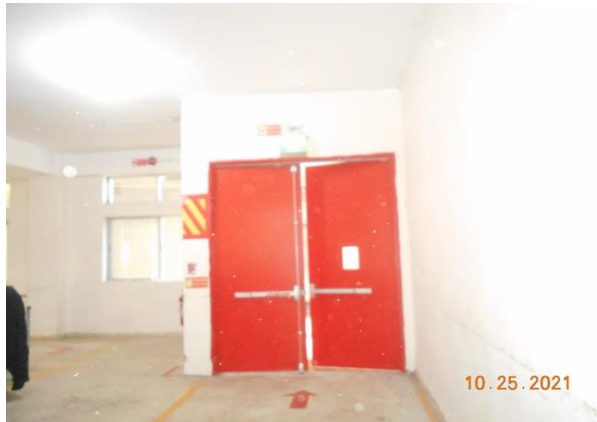
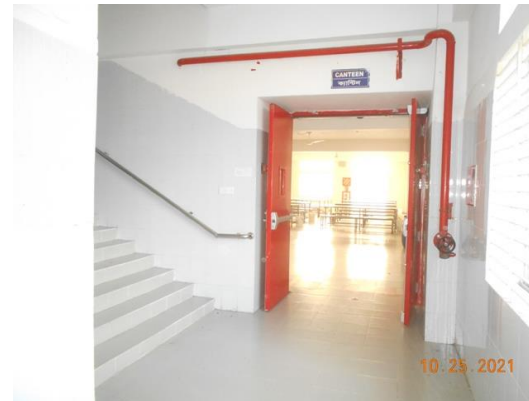
SI No.	Category	Findings	Required Action	Remediation Time Frame
F-69	Fire-Rated Construction	Most of the exit stairs and storage rooms are separated by double and single leaf fire rated doors but smoke seal damaged one door. For that doors are not closing properly and magnetic holder connection is underway for floor 3rd to 5th.	Install/repair smoke seal and ensures that all the doors are closing properly. Submit proper certifications for installed fire doors to the RSC for approval.	Within 3 months

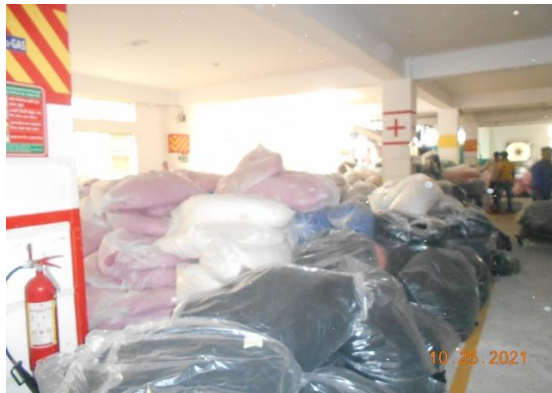
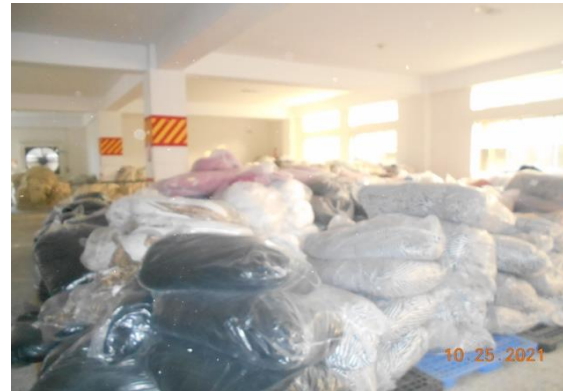
F-70	Fire-Rated Construction	<p>Areas used (in-process storage) for combustible materials are open to the surrounding occupancy. Location: Ground floor.</p>	<p>Provide defined storage areas and limit the storage arrangement as follows:-</p> <ol style="list-style-type: none"> 1. General Condition: Maximum height of 2.4m and maximum area of 23m². Separate areas of unenclosed combustible storage by a minimum clear distance of 3m. 2. If sprinkler protected: maximum height of 3.66m and maximum area of 93m². Separate areas of unenclosed combustible storage by a minimum clear distance of 3m. or 3. Enclose the storage area from the surrounding occupancy with a minimum 1 fire rated hour construction. 	Within 3 months
------	-------------------------	--	--	-----------------

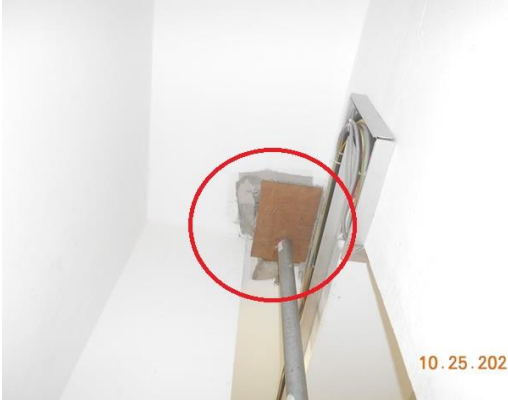
F-71	Fire Rated Construction	Unsealed penetrations and openings are located in the fire rated floor/ceiling assemblies.	Provide a minimum 2-hr fire rated shaft to separate the utility risers from each floor level. Seal all penetrations and openings in floors/ceiling assemblies to maintain the fire separation.	Within 3 months

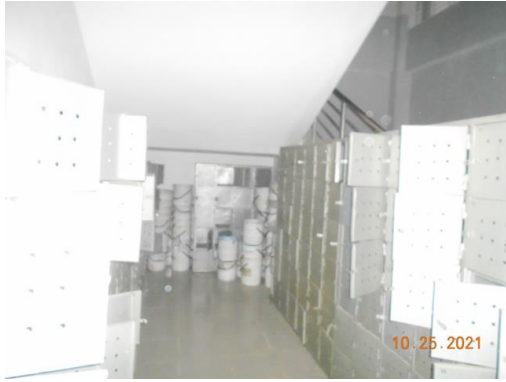
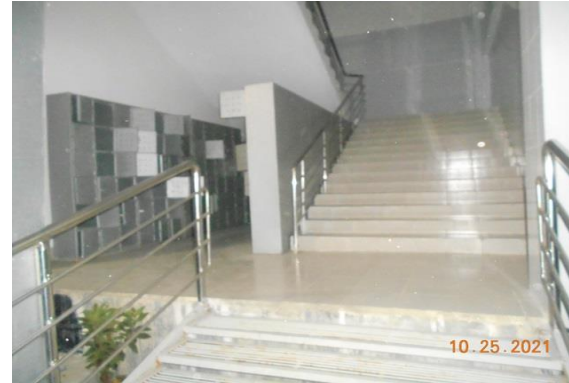
F-72	Mean of Egress	Storage was located in exit stair. Location: Below staircase-2 on ground floor.	Remove all storage from exit stair enclosures.	Within 1 month

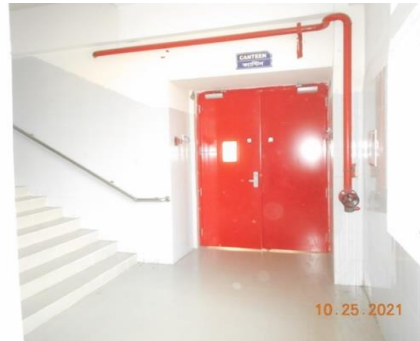
F-73	Egress	Building did not have stair designation signs or occupant load signs at the required locations.	Provide stair designation signs and occupant load signs at the required locations.	Within 1 month
------	--------	---	--	----------------

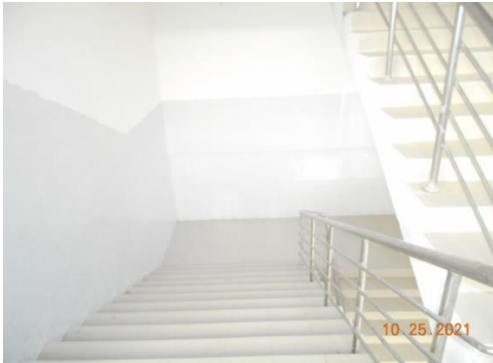
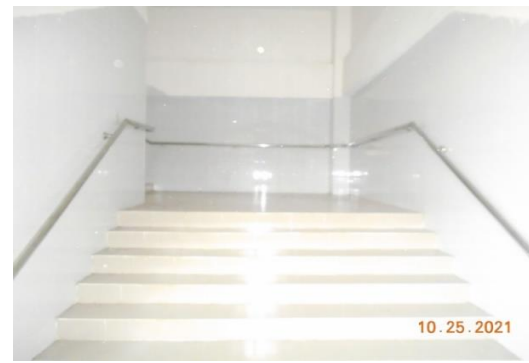
F-74	No Handrails	<p>Handrails are not provided on both sides of each exit stairs on all floors for stair-2. Having handrails on one side of said staircase, may pose as a falling hazard during evacuation. Stair width exceeds 87 in for stair-1. Or, Handrails are not provided at exit stairs.</p>	<p>Provide handrails on both sides of the exit stair. New handrails shall have a minimum height of 865 mm (34 in.) and a maximum height of 965 mm (38 in.) as measured from the leading edge of the tread. Intermediate handrails shall be provided when the stair width exceeds 2.2 m (87 in).</p>	Within 3 months
------	--------------	--	---	-----------------

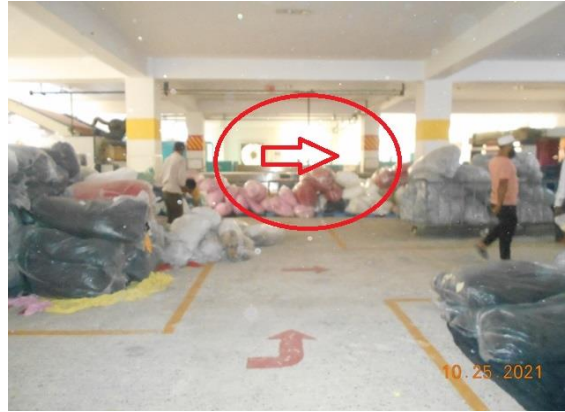
</div>				
F-82	Egress Lighting	<p>Illuminated directional signs are not provided where direction of the path of travel to an exit has changed.</p> <p>Location: All floor.</p>	<p>Illuminated directional signs shall be provided where there is a change in the direction for the path of travel and the direction to an exit is not obvious.</p>	Within 1 month

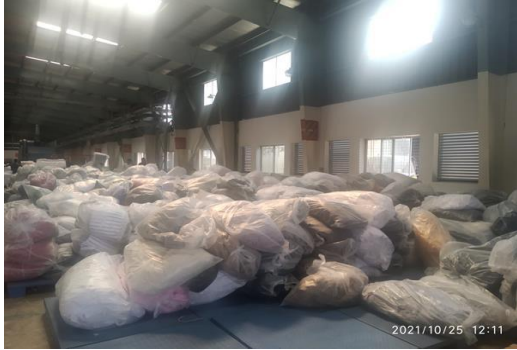
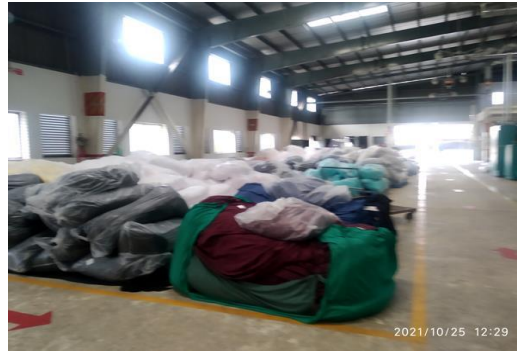
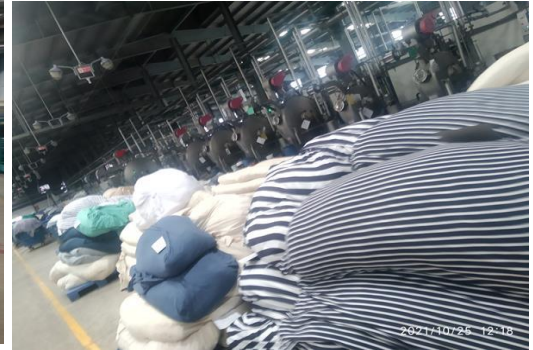
SI No.	Category	Findings	Required Action	Remediation Time Frame
F-84	Fire rated construction	Areas used for in-process storage of combustible materials are open to the surrounding occupancy. Location: Dyeing shed-2	Provide defined storage areas and limit the storage arrangement as follows: Maximum height of 2.45 m and maximum area of 23 m ² and is separated by a minimum 3.0 m (10ft) from other storage areas and they do not exceed 10 percent of the building area of the story in which they occur. If sprinkler protected, Maximum height 12 ft (3.66 m) and maximum area of 1000 ft ² (93 m ²) and separated by a at least 25 ft (7.62 m) from other storage areas and does not constitute more than 10 percent of the building area or 4000 ft ² (372 m ²) of the sprinklered area, whichever is greater. or, Enclose the storage area from the surrounding occupancy with a minimum 1 hour construction.	Within 3 months

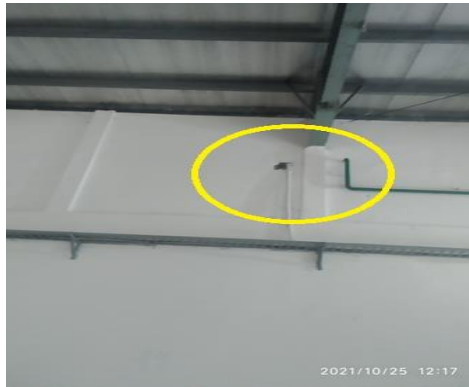
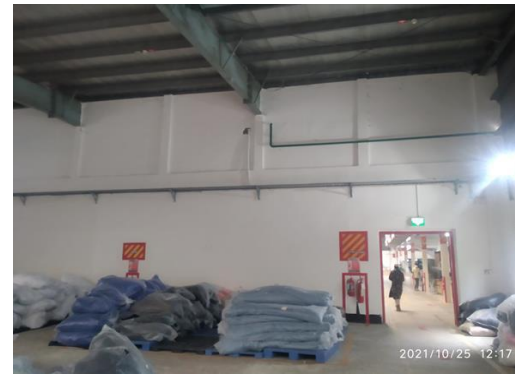
F-85	Fire Rated Construction	Rooms used for storage of combustible materials are not separated from the surrounding occupancy/areas due to unseal penetration. Location: Dyeing shed-2	Rooms used for storage of combustible materials shall be separated from the surrounding occupancy with a minimum 1 hour construction.	Within 3 months
------	-------------------------	--	---	-----------------

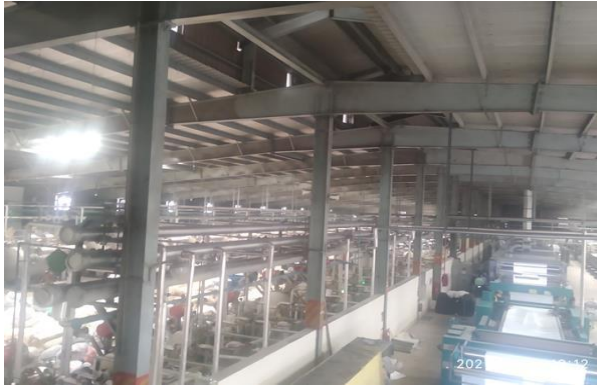
F-86	Fire Rated Construction	<p>The main structural elements of the buildings are constructed by steel which is non-rated and were found in exposed condition without any fire protection. (New Structure).</p> <p>Location: Dyeing shed-2, Godown shed & Dyeing finishing shed-1</p>	<p>The buildings are new steel structure which shall be type-I or II construction. So, provide require rating in the structural elements of the buildings. Consult with a qualified fire protection engineer. Follow BNBC 2006-Table 3.2.4, 3.1.9 and 3.3.1 as reference.</p> <p>Note: J occupancy (Chemical Store) shall be type-I construction.</p>	Within 6 months
------	-------------------------	--	--	-----------------

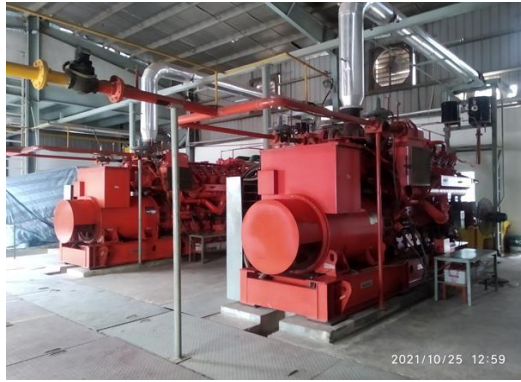
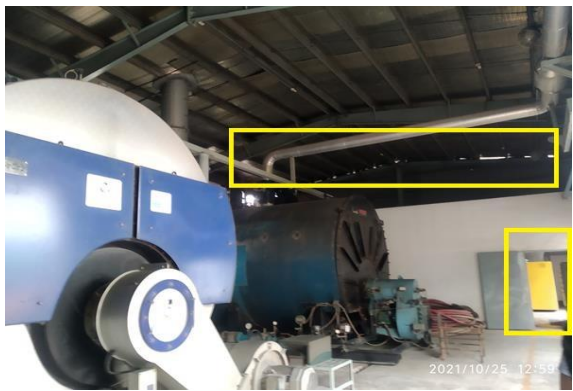
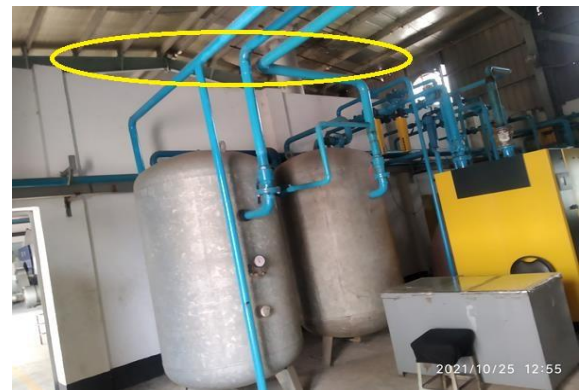
F-87	Fire rated construction	<p>Generator ,Boiler & compressor are not properly separated from each other by fire rated construction.</p> <p>Location :Utility shed</p>	<p>Generator Boiler & Compressor room shall be separated from each other by a minimum 2-hr fire-rated construction (wall, floor, slab, etc.). Seal all penetrations and openings (door, window, etc.) by minimum 1.5-hr fire-rated materials to maintain the fire separation as required. All exhaust systems shall discharge to the exterior of the building in a safe location.</p>	Within 3 months
------	-------------------------	--	---	-----------------

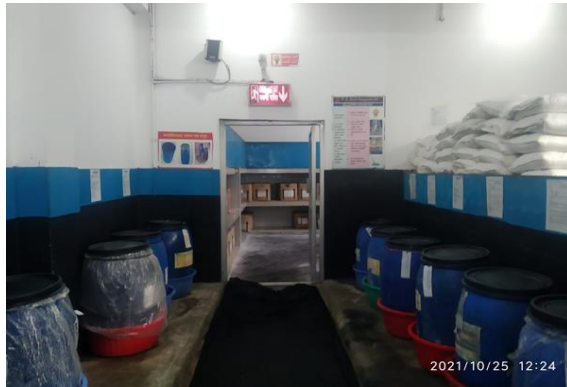
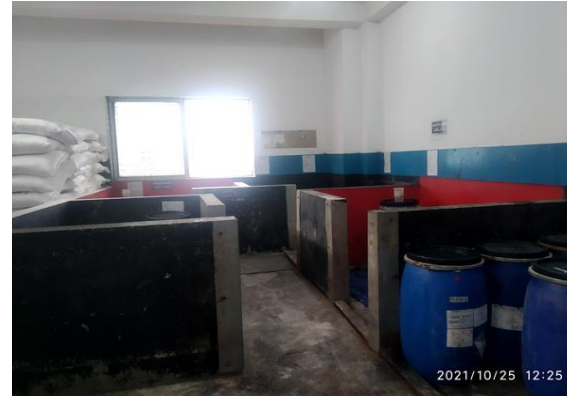
F-88	Fire Rated Construction	<p>Chemical storage area is not properly separated by fire-rated construction.</p> <p>Location: Dyeing shed-2</p>	<p>Separate the chemical storage room by 4-hr fire rated construction. Seal all penetrations and protect the openings to maintain the required fire separations. Keep 16-points MSDS of all chemicals in the storage area.</p> <p>** As per BNBC, chemical storage room will be Type-1 construction. Follow section-2.13 and Table 3.2.1 of BNBC-2006 for the guideline.</p>	Within 3 month
------	-------------------------	---	--	----------------

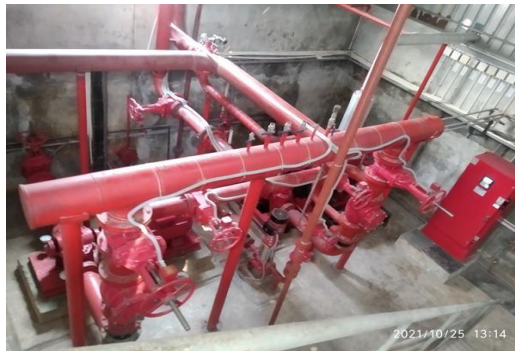
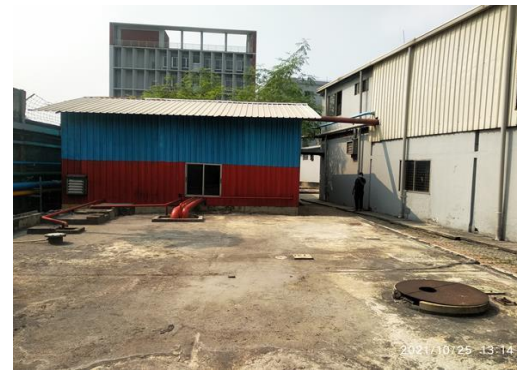
F-89	Fire Rated Construction	The fire pump room was not properly separated from other occupancy by fire rated construction. Location: Pump shed.	Provide fire pump room with 2 hr. rated fire separation by fire rated construction. Seal all unprotected opening & penetrations.. Or, Physically separate the pump room from the protected building by a minimum of 50 ft. (15.3 m) in accordance with NFPA 20.	Within 3 months
------	-------------------------	---	---	-----------------
