# Armour Garments Ltd. Envoy Garments Ltd.

380/31/1 East Rampura, Dhaka-121.  
(23.763602, 90.423651)

3<sup>rd</sup> February 2015

# Observations

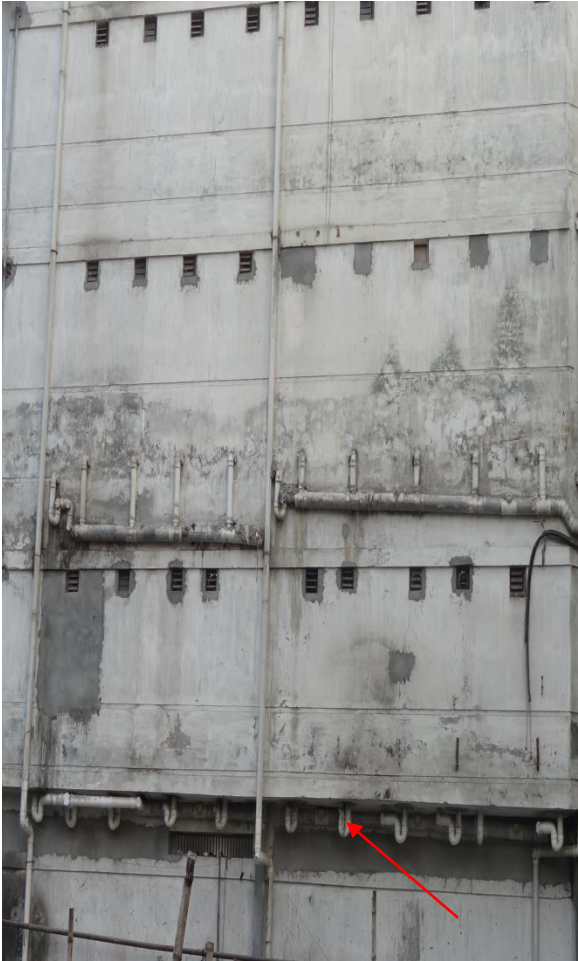
Cantilever at North side

**ITEM 2:** Cantilevers noted on each elevation on each floor plate

| Item No. | Observation | Recommended Action Plan | Recommended Timeline |
|---|--|---|---|
| 2 | Cantilevers noted on each elevation on each floor plate | Engineer to expand current slab structural calculation study to cover the cantilever section of the slab. | 6-months |

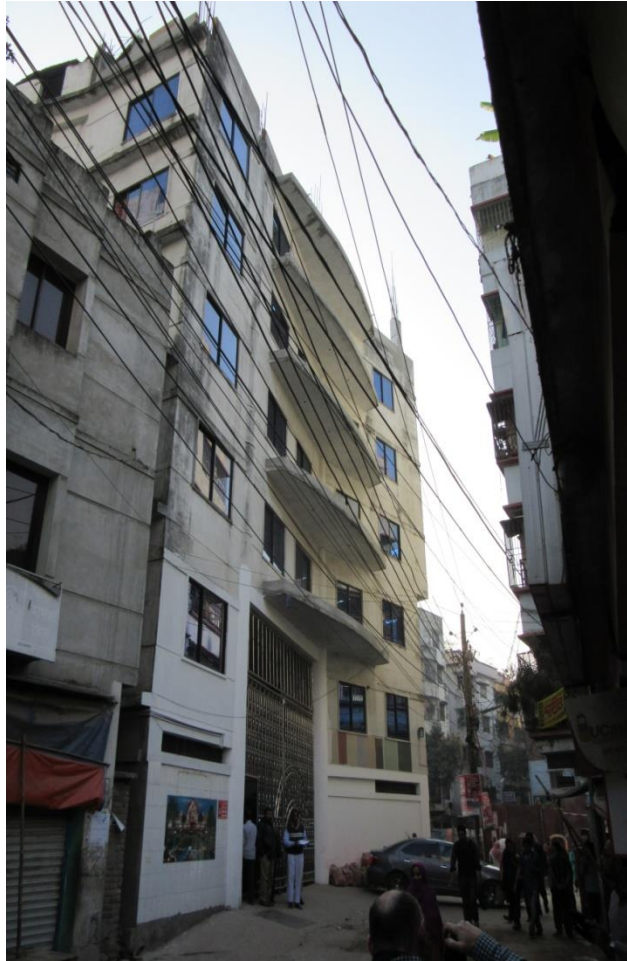
Cantilever at West side

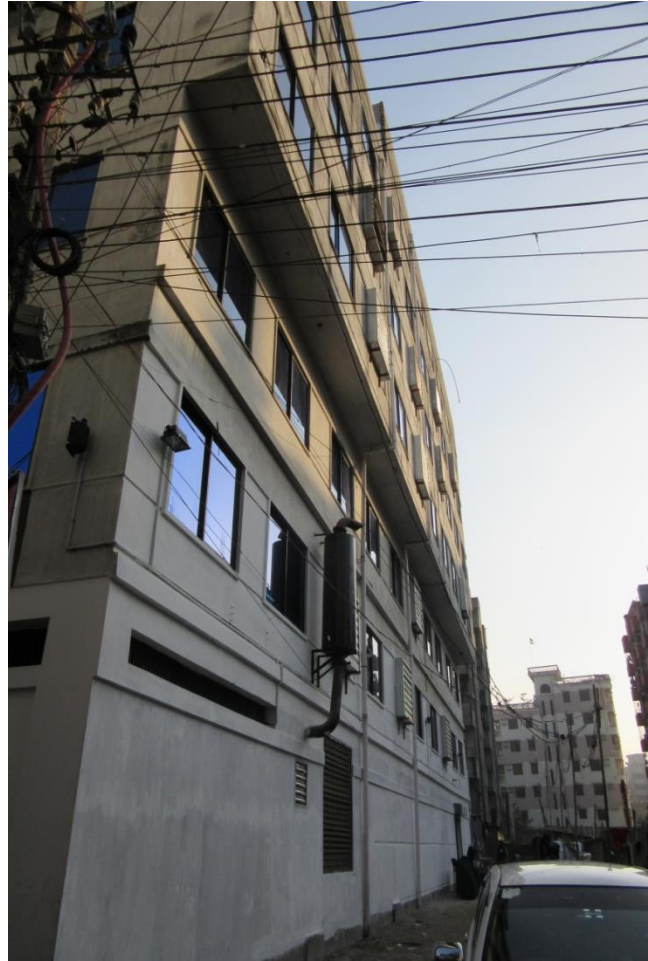
Cantilever at south side

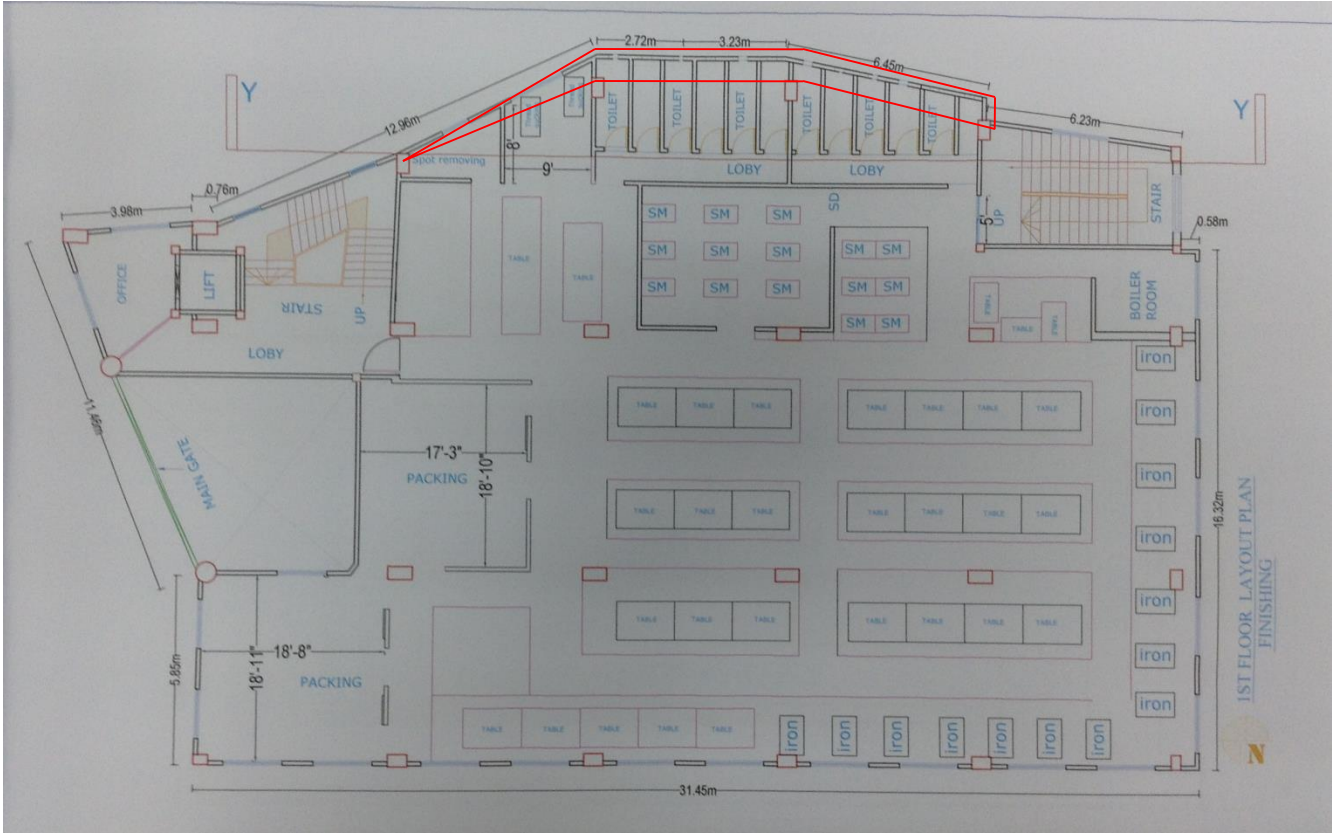
# Toilets Located in North side cantilever portion

**ITEM 3:** Significant build-up in toilets

| Item No. | Observation | Recommended Action Plan | Recommended Timeline |
|---|--|---|---|
| 3 | Significant build-up in toilets | Engineer to expand current slab structural calculation study to cover the toilet loading on the slab. | 6-months |

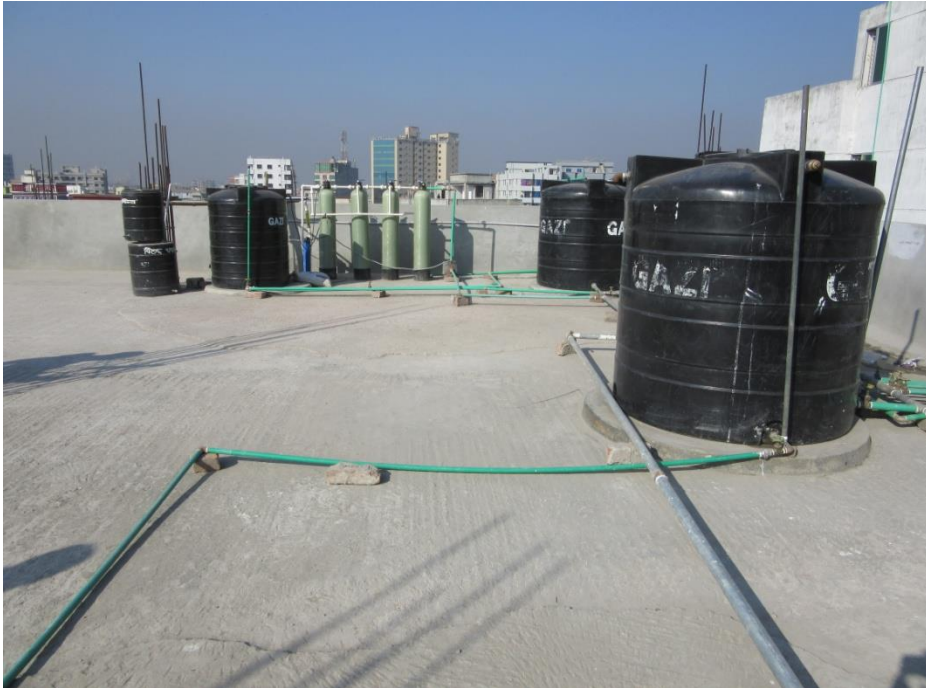
Water tanks on roof

**ITEM 5:** Water tanks on the roof

| Item No. | Observation | Recommended Action Plan | Recommended Timeline |
|---|--|---|---|
| 5 | Water Tanks on the roof | Engineer to confirm the adequacy of the roof slab to carry the water tanks. | 6-months |

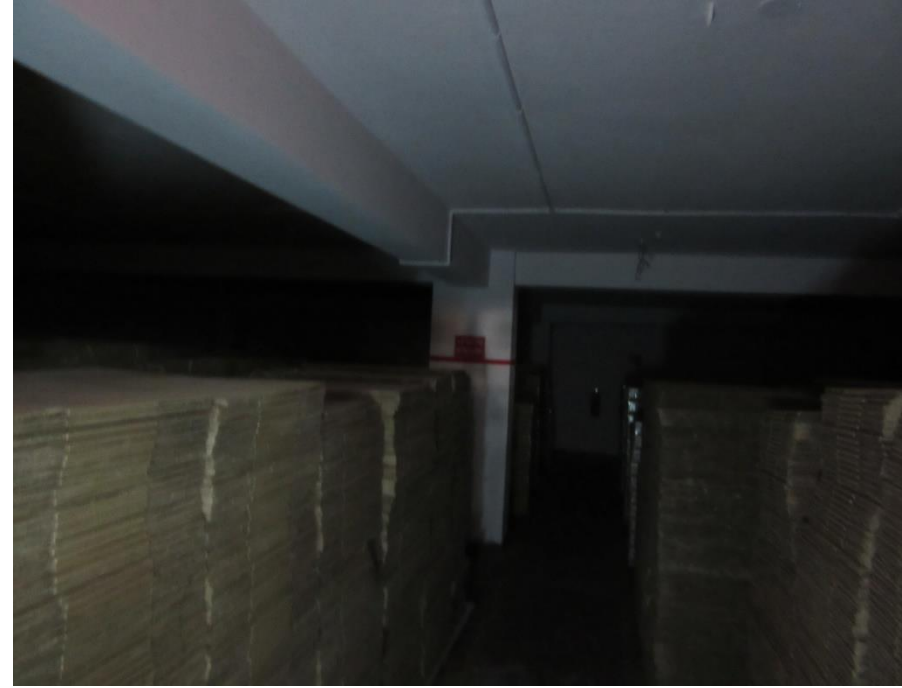
Storage at level 7

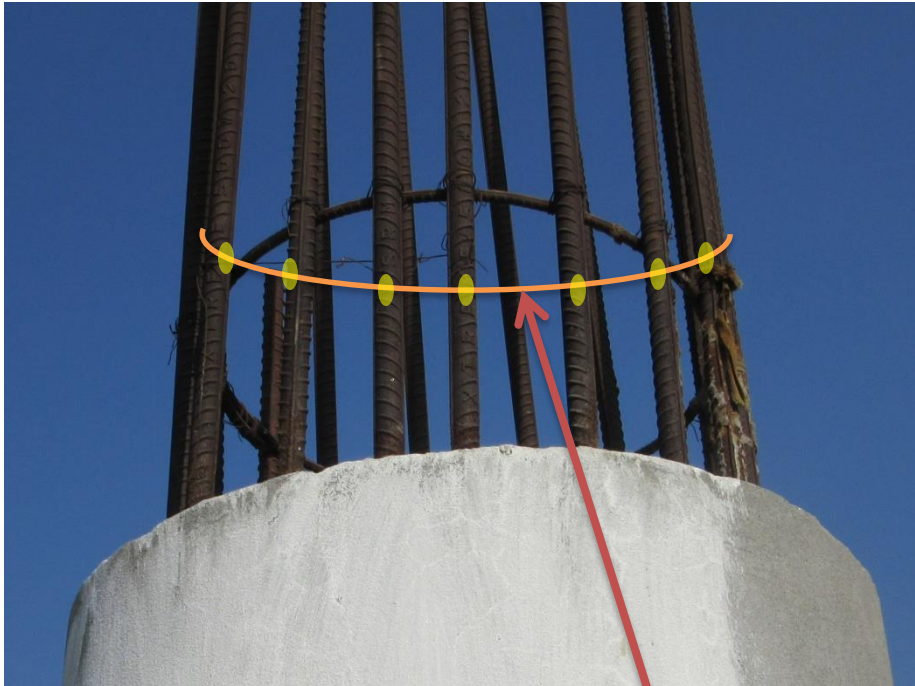
Rebar Fabrication found on site

16-20mm $\emptyset$  rebar found on site

**ITEM 1:** Different rebar noted on-site to the structural rebar drawings

| Item No. | Observation | Recommended Action Plan | Recommended Timeline |
|---|--|---|---|
| 1 | Different rebar noted on-site to the structural rebar drawings | Engineer to revise engineering drawings to reflect correct rebar. | 6-months |

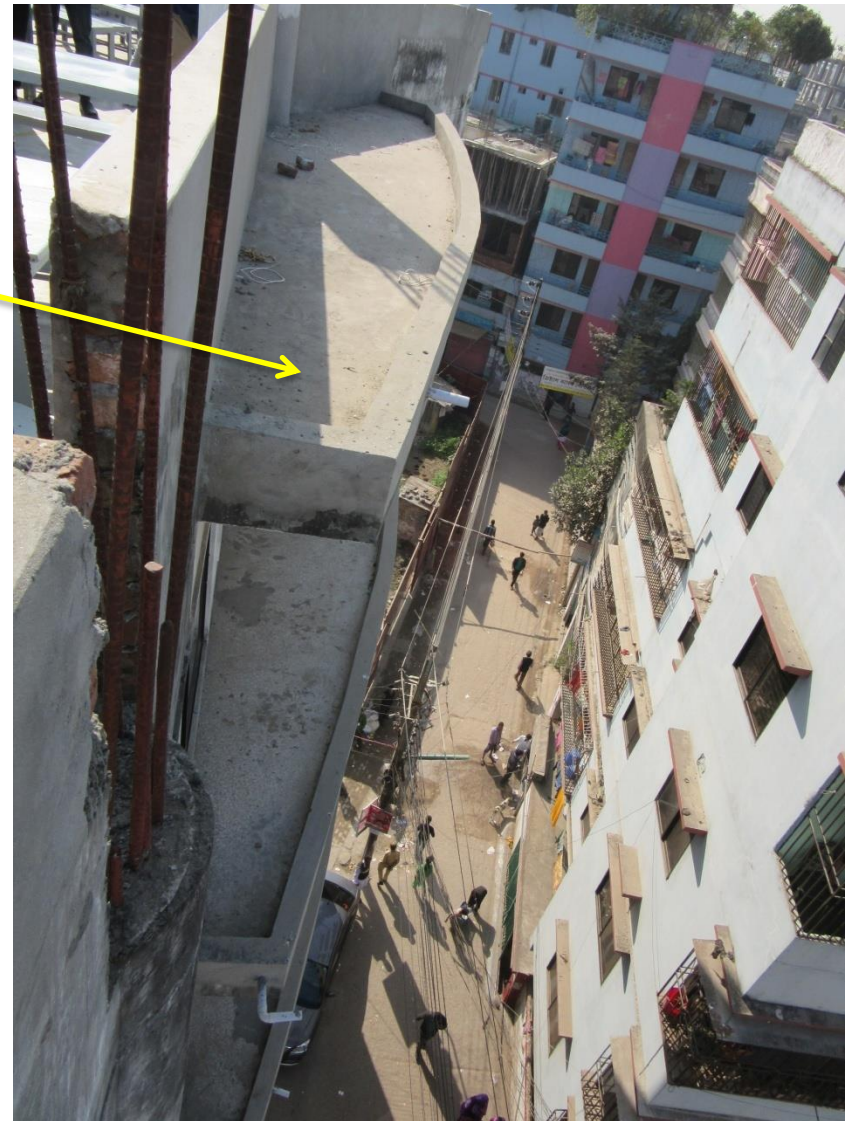
Column layout on Structural drawing

16-25mm $\emptyset$  rebar found on site

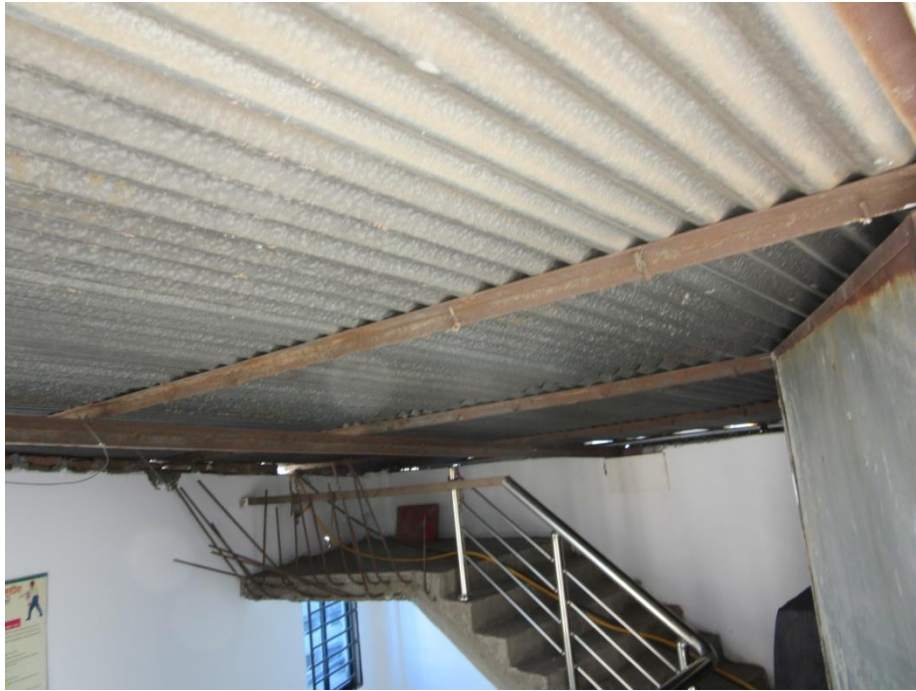
Stair near canteen at level 6

**ITEM 4:** Non- engineered metal roofs to both staircores

| Item No. | Observation | Recommended Action Plan | Recommended Timeline |
|---|--|---|---|
| 4 | Non-engineered metal roofs to both staircores | Engineer to assess the current non-engineered roof structures to both cores | 6-months |

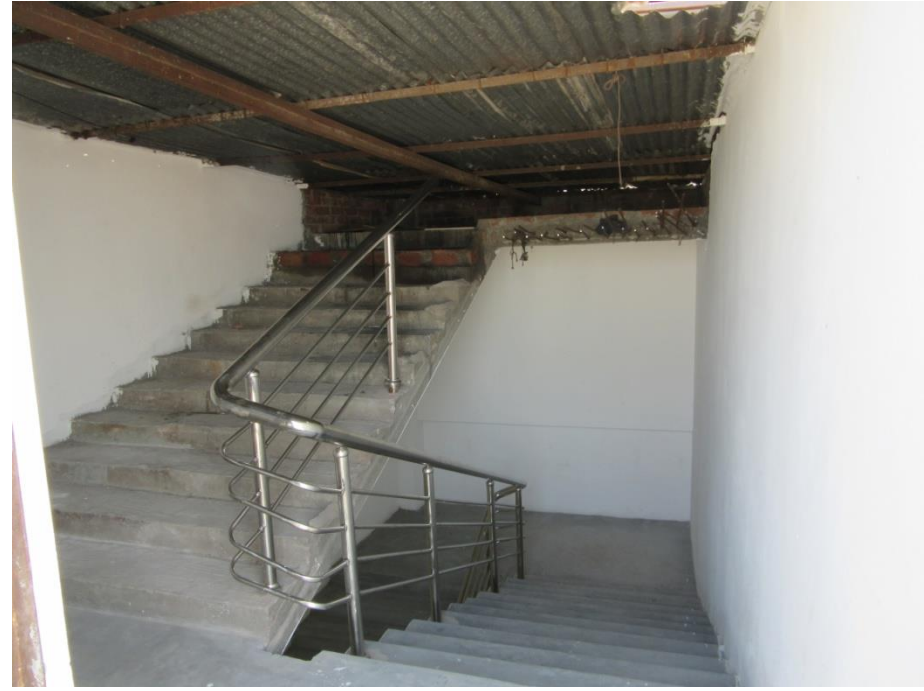
Stair at level 7
