INITIAL FIRE SAFETY INSPECTION REPORT

Pacific Blue (Jeans Wear) Ltd

A-8/1 Jalessar, Savar, Dhaka-1343, Bangladesh

Date: 15 February 2022

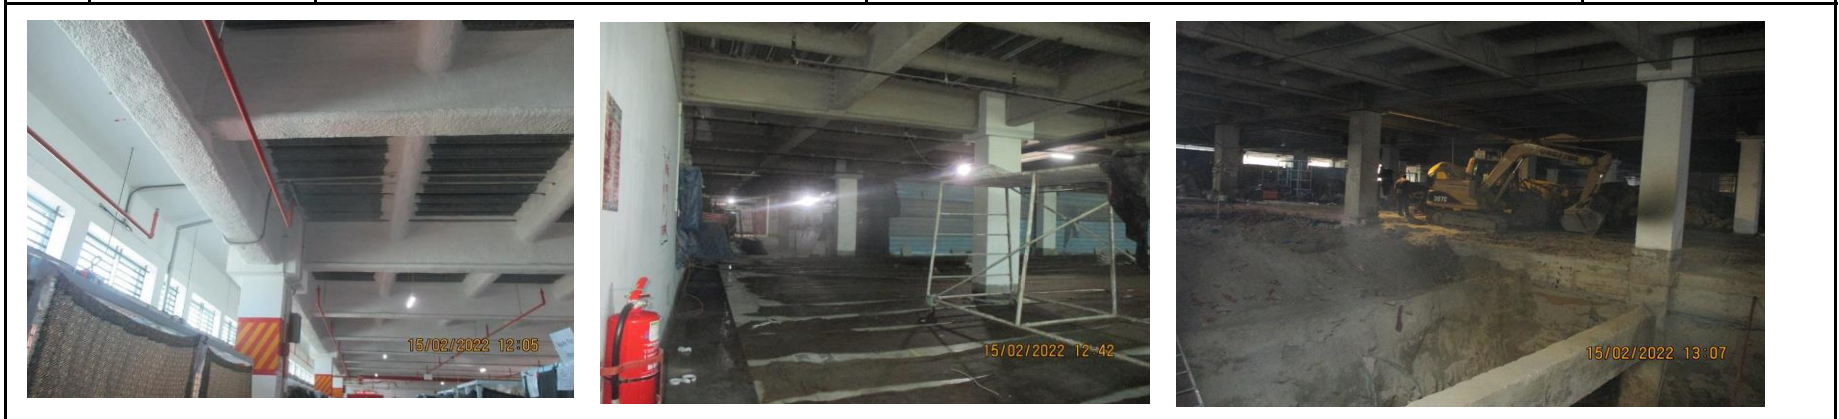
SI No.	Category	Findings	Required Action	Remediation Time Frame
F-1	Fire Rated Construction	The Building is newly constructed where structural members are constructed by steel but fire protection for ensuring type-I construction following table 3.2.4 and 3.3.1 of BNBC-2006 is not properly provided. (Note: The building is in under construction status).	The building shall be type-1 construction as per Table 3.2.4, 3.3.1 and 3.1.9 of BNBC-2006. Provide required fire rating on the structural elements following Table 3.3.1 and 3.19 of BNBC-2006 Part 4. Consult a qualified fire protection engineer to design the rated construction for required rating.	Within 6 months

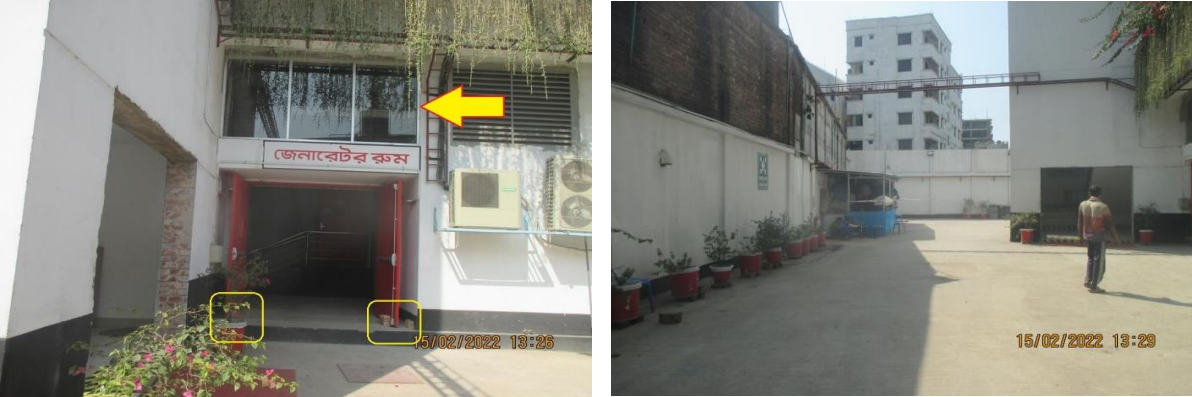
F-2	Fire Rated Construction	<p>Generator room is not properly separated by fire rated construction with exit discharge path.</p> <p>Location: Ground Floor/ Stair No-05/ South West corner.</p>	<p>Generator room shall be separated from other occupancies by a minimum 2-hr fire rated construction (wall, floor, slab etc.). Seal all penetrations and openings (door, window etc.) should be protected by 1.5-hr fire rated materials to maintain the fire separation if required. All exhaust systems shall discharge to the exterior of the building in a safe location.</p> <p>Or</p> <p>Relocate it to exterior of the building and maintain a minimum 3m (10 ft.) spatial separation distance from the building.</p>	Within 3 Months

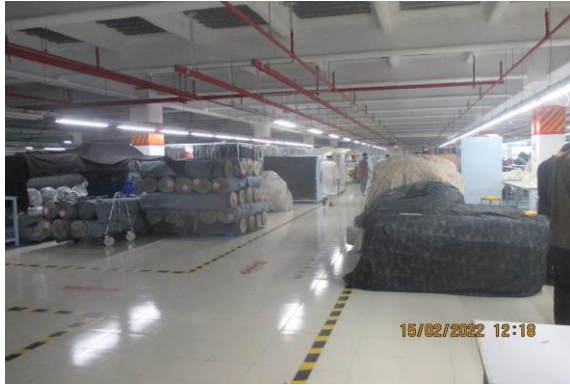
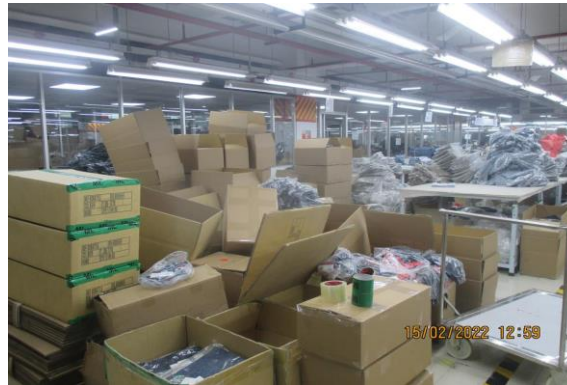
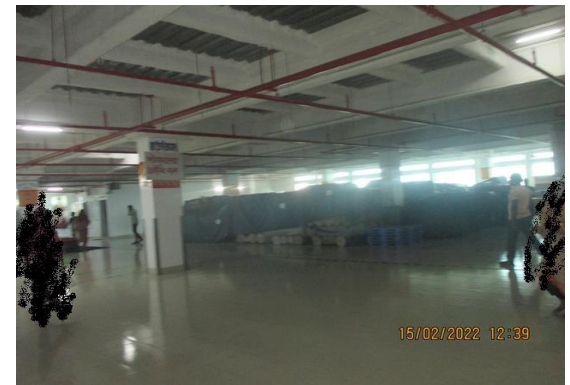
F-4	Fire Rated Construction	<p>Areas used for in-process storage of combustible materials are open to the surrounding occupancy which are not separated by fire rated construction. Location: 1st & 6th floor.</p>	<p>Provide dedicated storage rooms separated by minimum 1-hr fire-rated construction. Or, Where separate storage rooms are not feasible, Provide defined storage areas and limit the storage arrangement as follows:-</p> <ol style="list-style-type: none"> 1. General Condition: Maximum height of 2.4m and maximum area of 23m². Separate areas of unenclosed combustible storage by a minimum clear distance of 3m. 2. If sprinkler protected: maximum height of 3.66m and maximum area of 93m². Separate areas of unenclosed combustible storage by a minimum clear distance of 3m. 	Within 3 Months

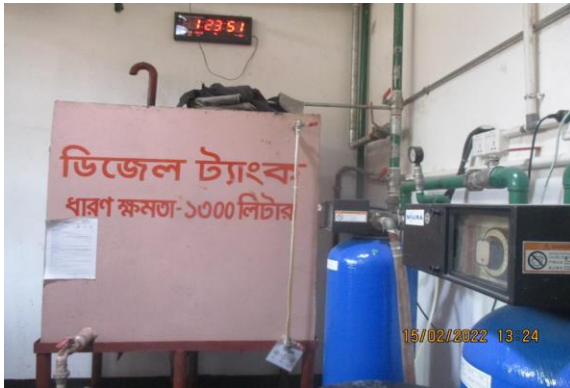
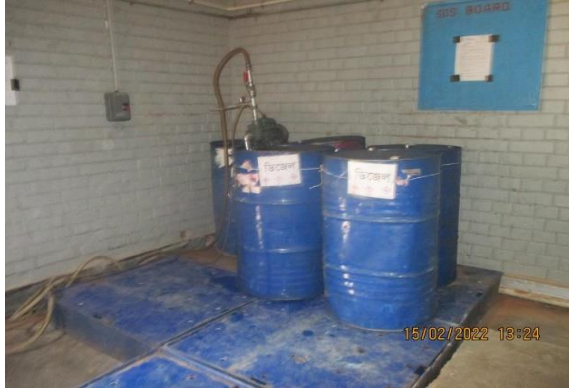
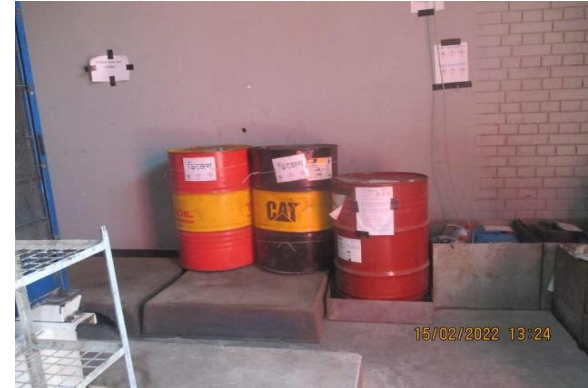
F-5	Fire Rated Construction	2500 liters of diesel (1300 liters inside of boiler room and 1200 liters inside of generator room) were stored without any fire separation.	Separate the Fuel storage by minimum 3-hr fire rated construction. Seal all penetrations and protect the openings to maintain the required fire separation for 3-hrs. As, license issue is applicable so, collect license from Explosive department of Bangladesh and follow storing guideline provided with license.	Within 3 Months
-----	-------------------------	---	---	-----------------

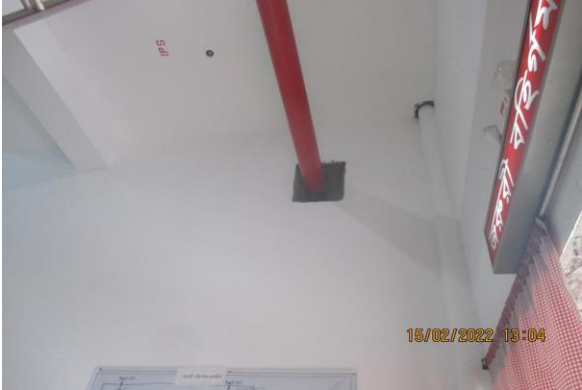
F-6	Fire Rated Construction	<p>Unsealed penetrations and openings were identified in exit stair enclosures.</p> <p>Location: Ground floor/ Stair-2</p>	<p>Seal all penetrations and openings in the wall of exit enclosure walls (full thickness of the wall) by fire rated materials to maintain the fire resistance rating minimum of 1.5-hr.</p>	Within 3 Months

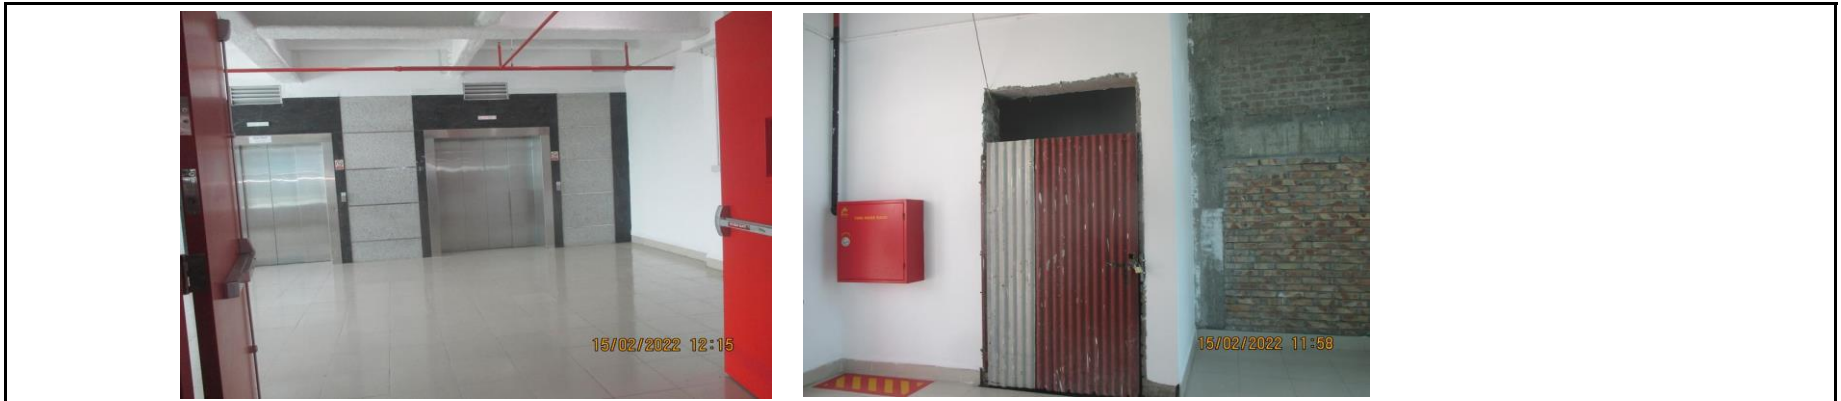
F-7	Fire Rated Construction	<p>Elevator shafts are directly open into exit enclosure which is a violation of ACCORD Standard-6.14.3.</p> <p>Location: Stair enclosure 1 & 4</p>	<p>For new construction, elevators shall not open into an exit enclosure as per ACCORD-6.14.3. So, provide separate enclosures for elevator and stair. The elevator shaft shall be fire separated for 2-hrs at least.</p>	Within 3 months

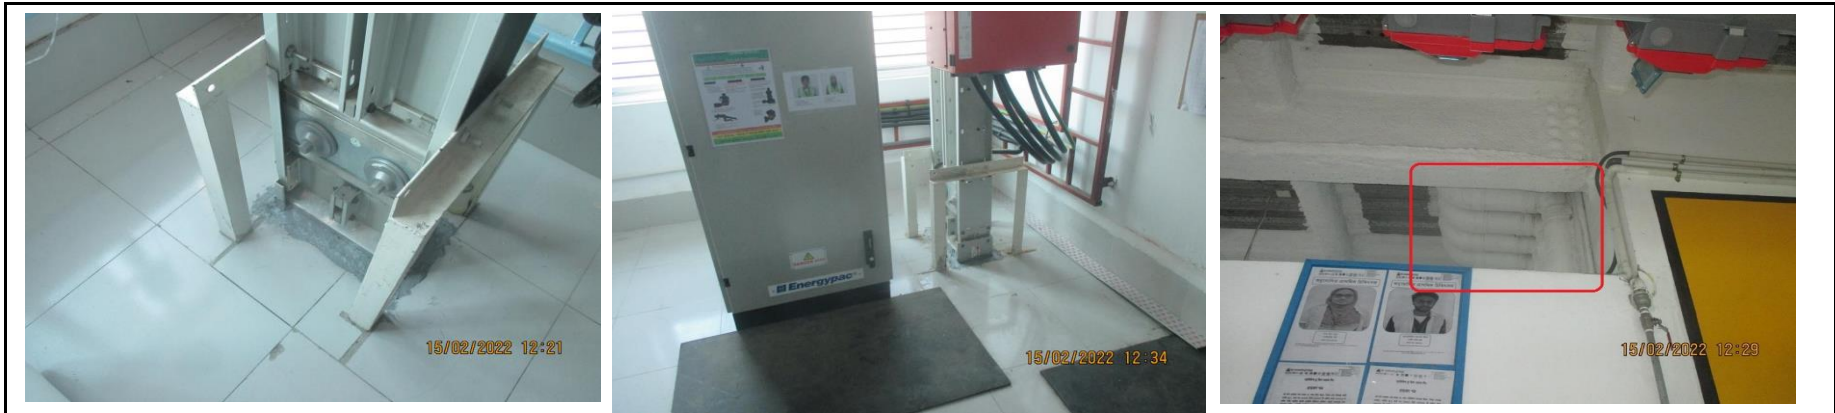
F-8	Fire Rated Construction	<p>Penetrations through floor/ceiling assemblies were not found properly sealed as required.</p> <p>Location: Electric Busbar, Rainwater harvesting pipe, Sewerage pipe for Toilet (All Floor).</p>	<p>Seal all penetrations and openings in floor/ceiling assemblies to maintain the fire separation at least by 3-hr. The used sealer shall be 3rd party certified and installation shall be as per manufacturer's guideline.</p> <p>or,</p> <p>Provide a minimum 2-hr fire rated shaft to separate the utility risers from each floor if required.</p>	Within 3 months
-----	-------------------------	---	---	-----------------

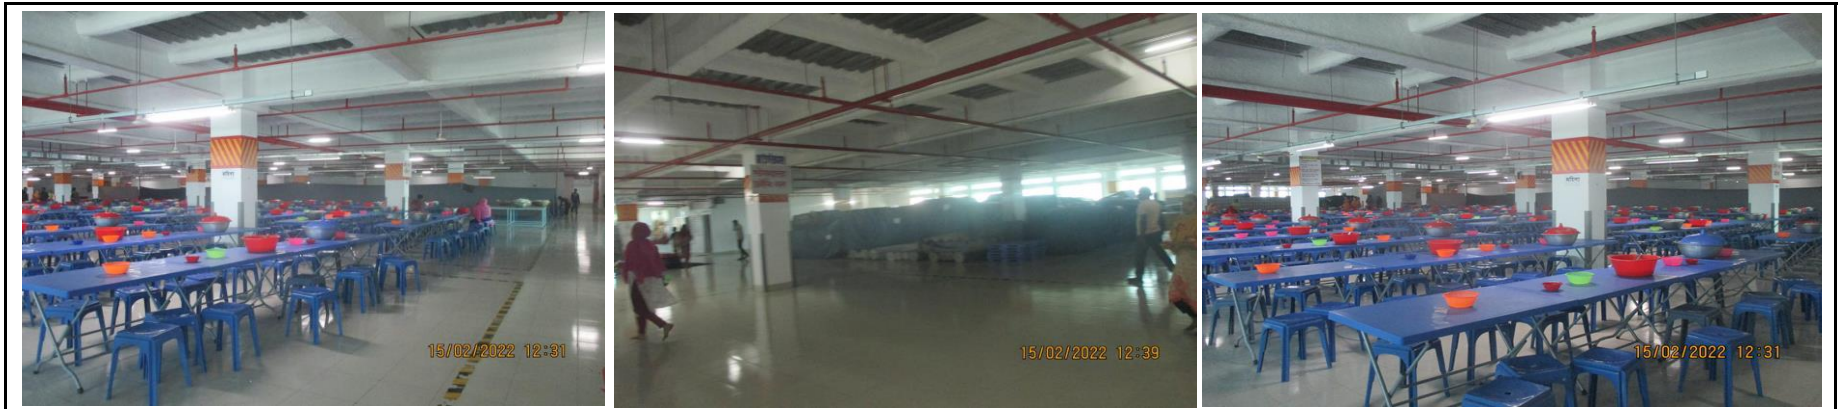
F-9	Fire Rated Construction	<p>Dining area (E-3, capacity-1250) was not separated by fire rated construction with adjacent store room. The above and bottom floor of the dining was occupied for production, which is a moderate hazard occupancy (G2).</p> <p>Location: 5th Floor</p>	<p>The dining shall be fire separated from store room by minimum 3 hr. rated construction with minimum 3-hr opening protection. The dining area (E3) is not permitted with moderate hazard occupancies (G2) following table 3.2.1of BNBC-2006. Required number of exits for entire dining arrangement shall lead directly to safe discharge path without passing through any other occupancies.</p>	Within 3 months
-----	-------------------------	--	---	-----------------

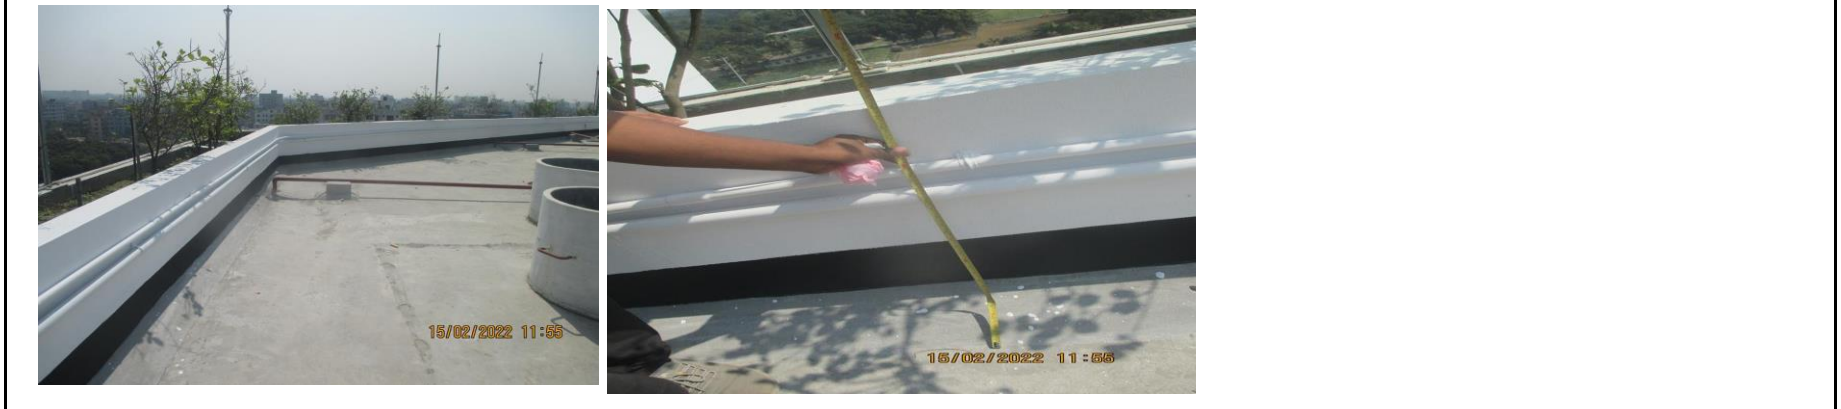
F-10	Fire Rated Construction	<p>Parapets or guards are provided in occupied roof which is less than 1067mm (42 inch).</p> <p>[Note: Existing parapets is 30 inch]</p>	<p>Provide parapets or guards with a minimum height of 1067mm (42 inch.).</p>	<p>Within 3 months</p>
------	-------------------------	--	---	------------------------

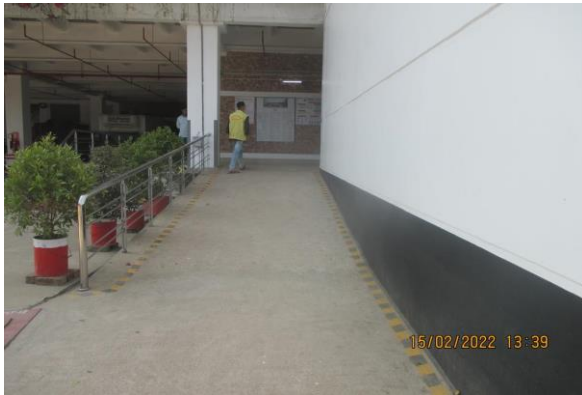
F-11	Means of Egress	Building did not have stair designation signs, floor designation signs and occupant load signs at required locations.	Provide stair designation signs, floor designation signs and occupant load signs at required locations following appropriate guideline.	Within 1 Month
F-12	Means of Egress	Fire evacuation maps was not posted at the entrance of all exit stair.	Fire evacuation maps shall be posted at the entrance to each exit stair.	Within 1 Month
F-13	Means of Egress	Handrails was not provided on both side of the ramp. Location: Main entrance/ east side	Provide handrails on both sides of the ramp. New handrails shall have a minimum height of 865 mm (34 in.) and a maximum height of 965 mm (38 in.) as measured from the leading edge of the tread.	Within 1 Month
