Silken Sewing Ltd (New) (Extension Building)

Baniar Chala (Member Bari), Vobanipur, Gazipur, Bangladesh

14th March 2022

1. Woven Building (Partially eight storied) (reinforced concrete structure)

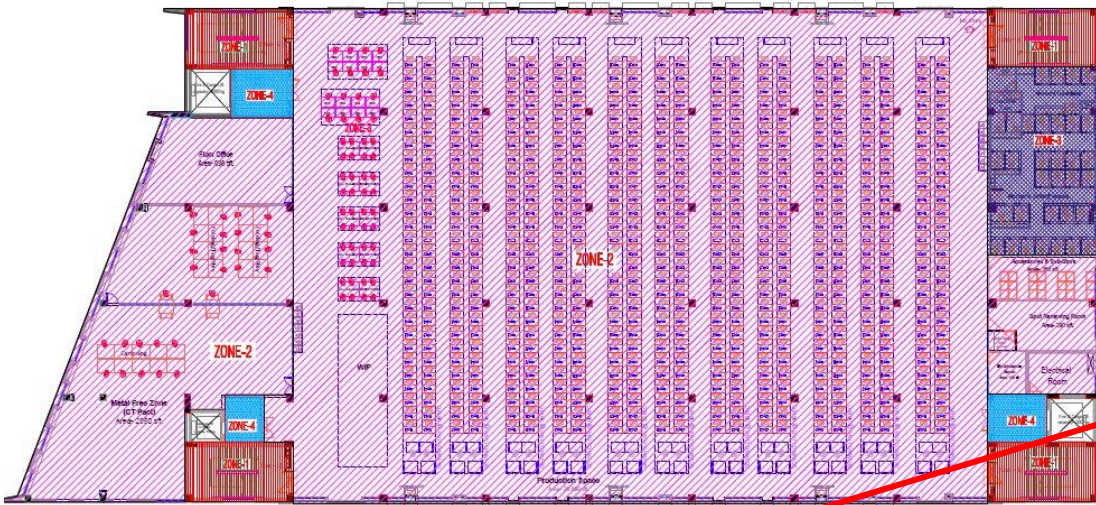
Live load plan- 3rd to 6th floor 4.8 kPa (100 psf)

Prepared load plan to be revised

Live load on typical floor (3rd to top floor) is considered as 4.8 kPa in prepared load plan. As per BNBC-2020, live load for light storage areas is required to be considered minimum 6 kPa. However, the factory engineer is required to revise the load plan as per BNBC requirement and check the design accordingly.

Item-2: Prepared load plan to be revised.

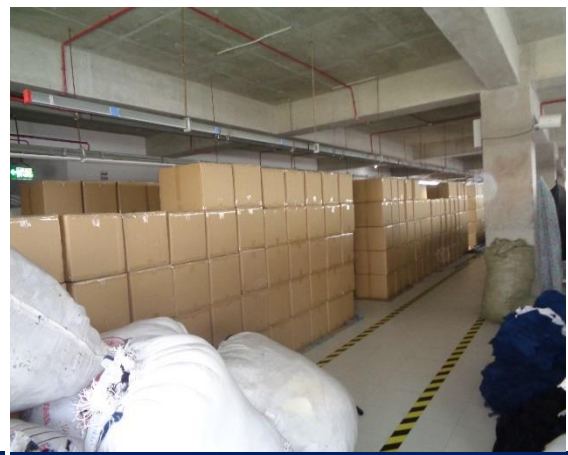
Storage on 3th floor

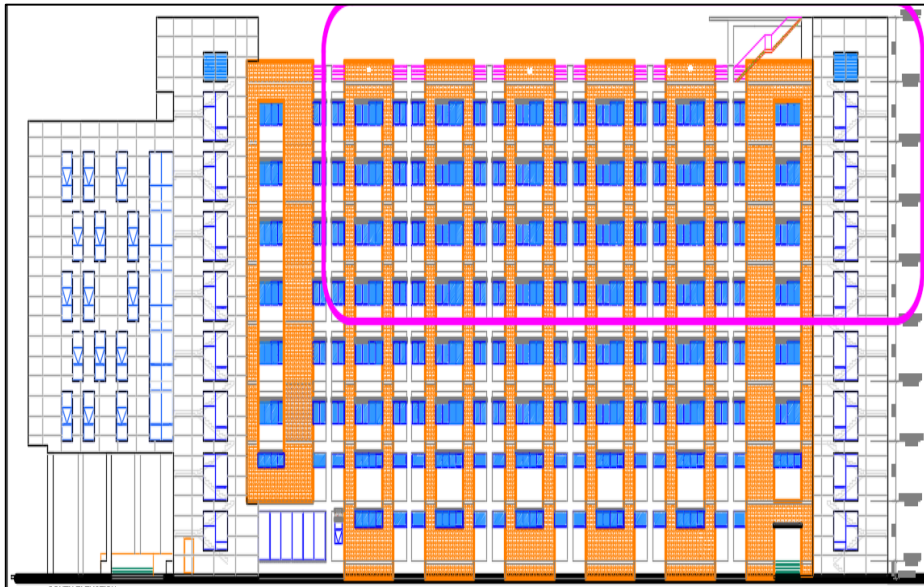
Building is designed as 8 storied

The building has permit drawing for 8 storied and factory is conducting vertical extension on five storied part.

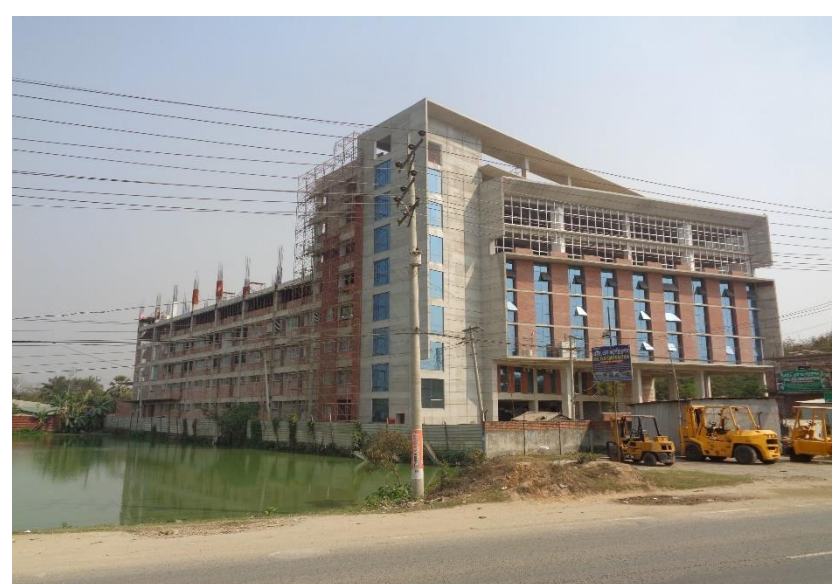
Building is currently partially 8 storied

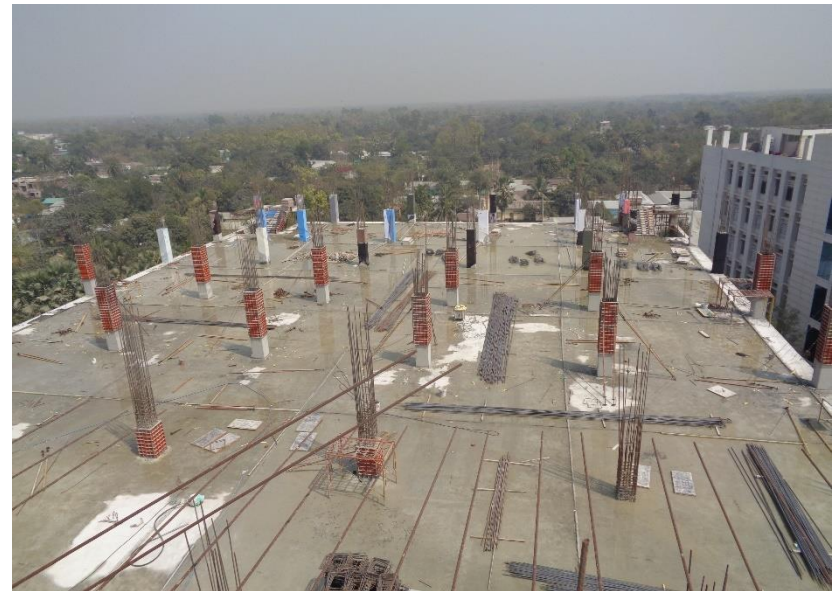
Ongoing construction on 5th floor

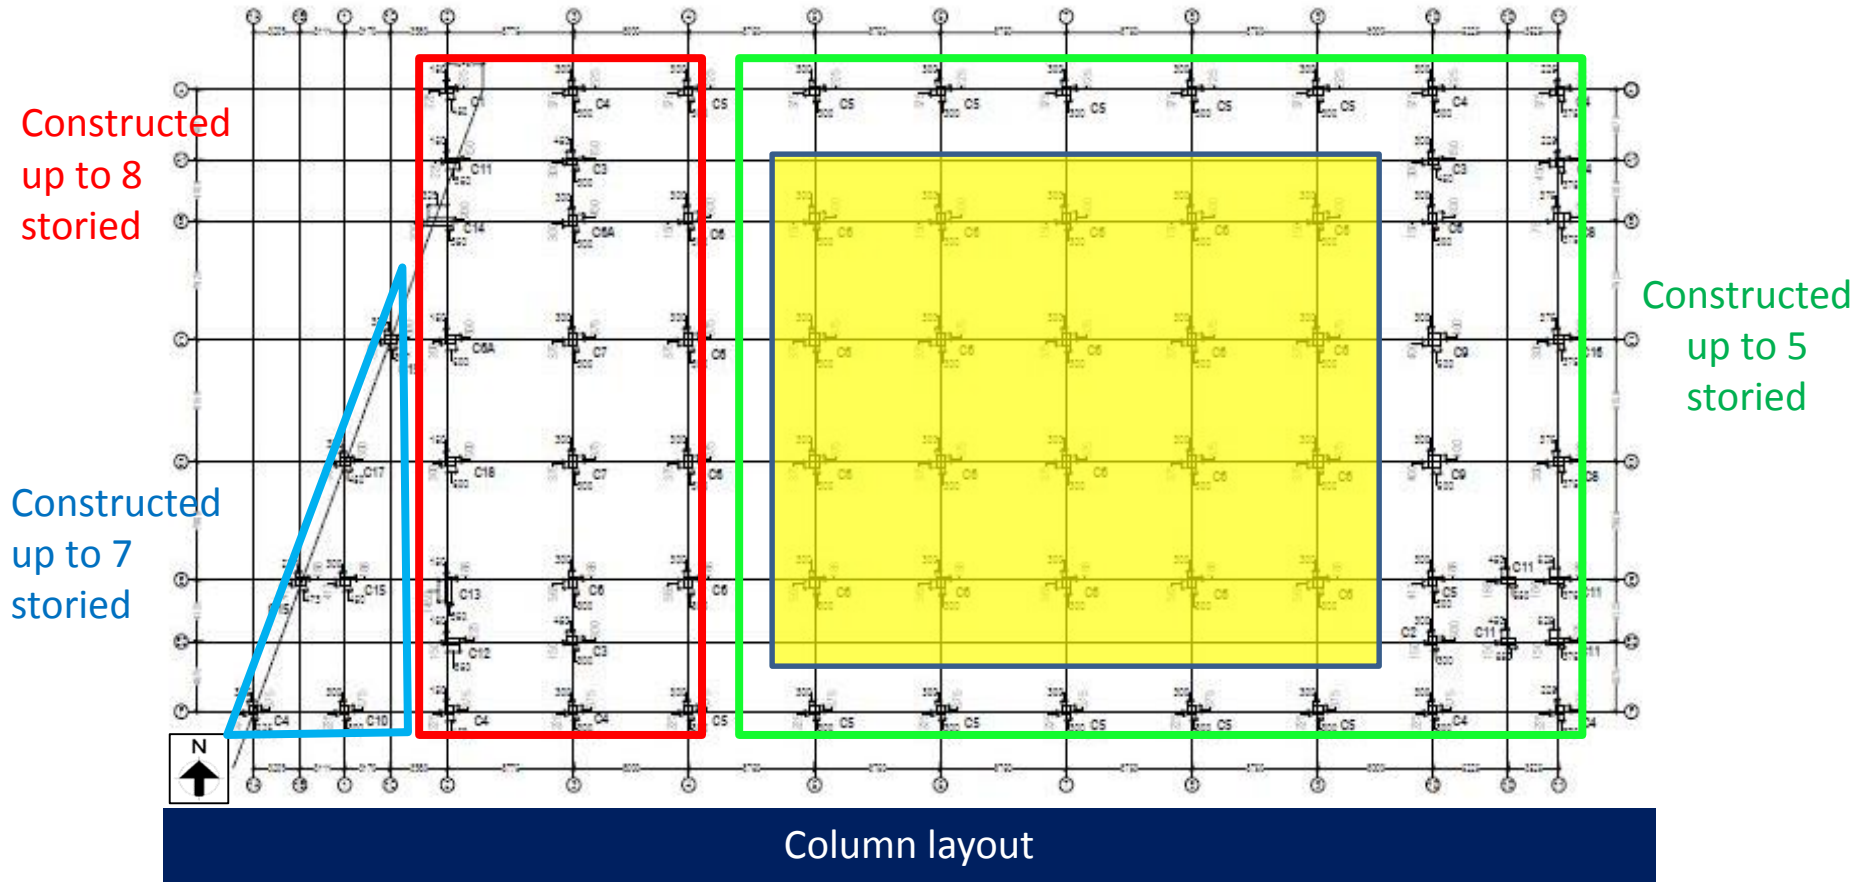
Cursory calculation indicates the stress in highlighted column in layout (yellow marked) will be exceeded normal design limit for above of 7 storied. Factory engineer is required to review, design of column stress and prepare a Detail Engineering Assessment (DEA) report prior conducting any vertical extension.

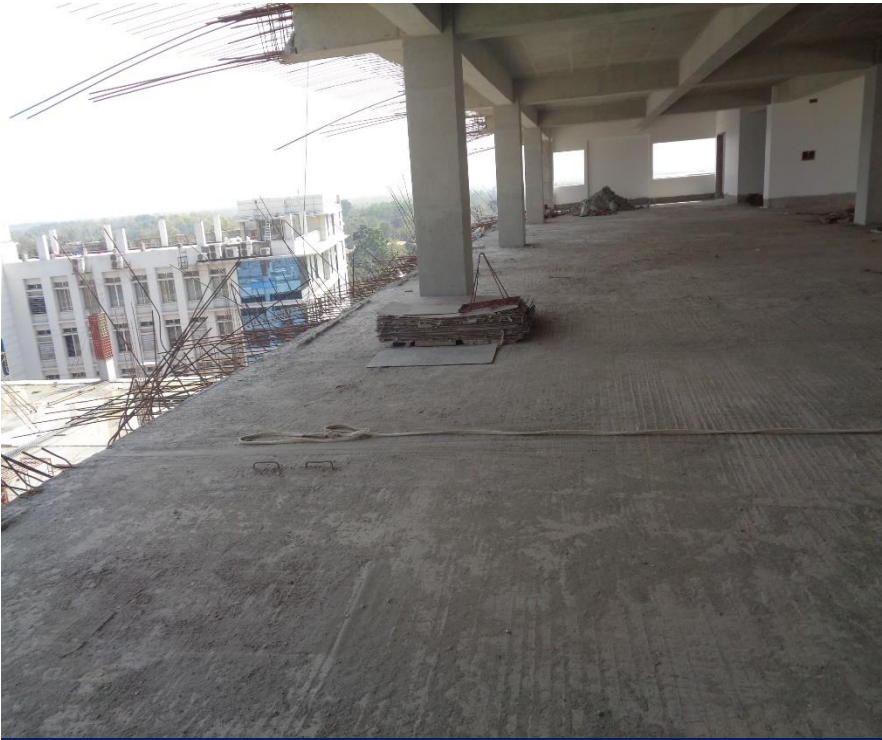
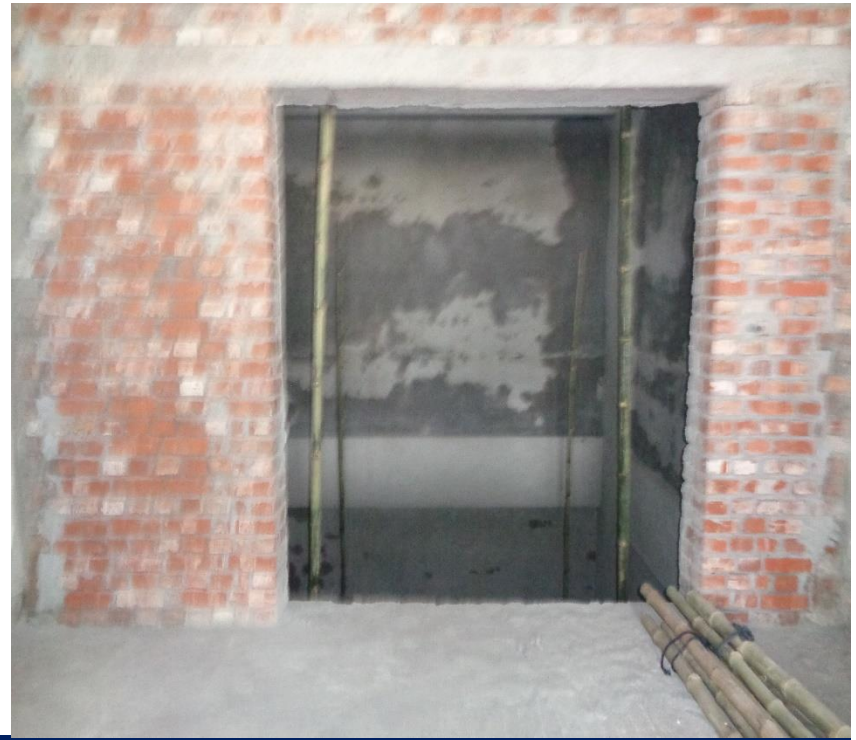
Falling hazard at existing eight storied part

No edge protection provided at existing 6th, 7th floor and roof

No edge protection provided at existing 6th, 7th floor and roof. Factory is required to provide edge protection at all areas to prevent possible falling hazard.

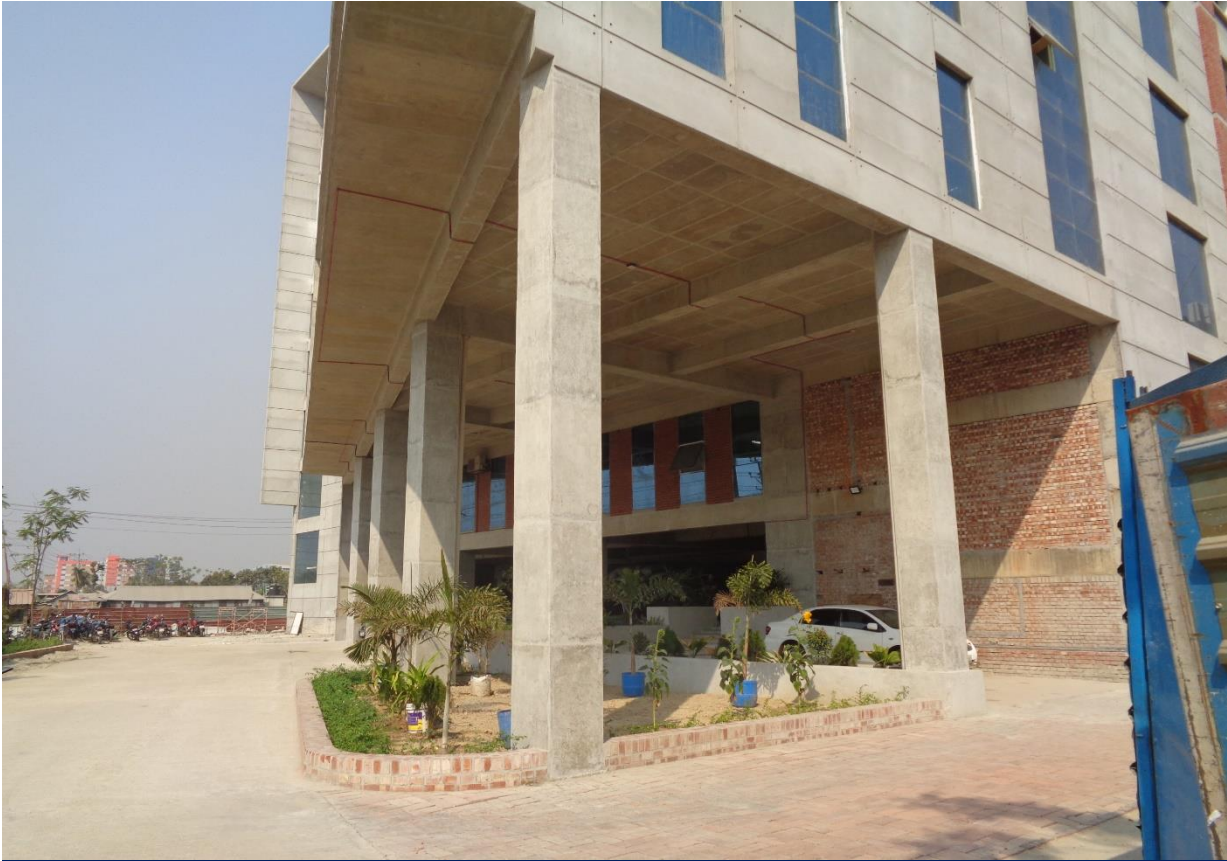
Possible vehicle impact for column

No barrier provided for the exposed columns at ground floor

Columns at ground floor are prone to possible vehicle impact. Factory is required to provide barrier for all exposed column at ground floor to prevent from possible vehicle impact.

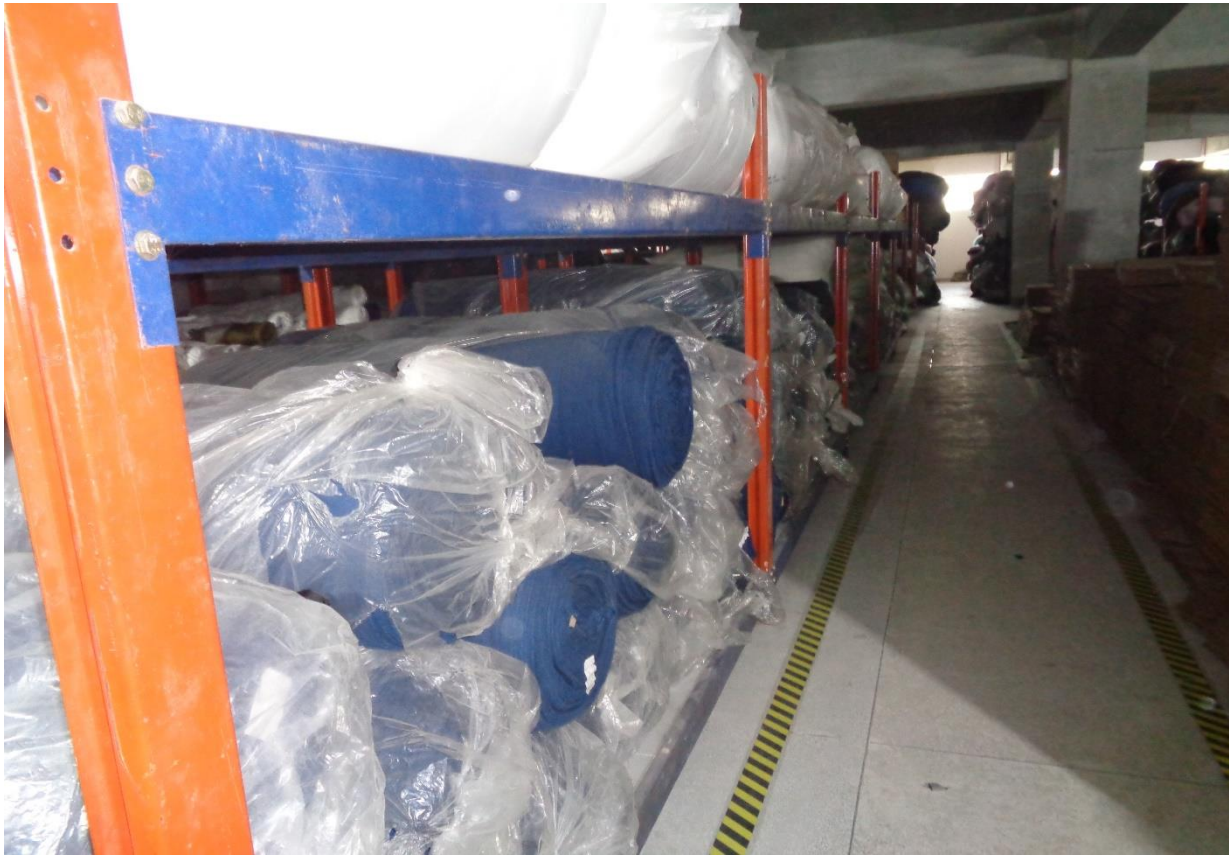
Non-structural elements found unbraced/not anchored

Storage rack found within the building without braced/anchored

Factory is required to brace/anchor all non structural elements.
