# KNIT BAZAR (PVT.) LTD (9933)

40/41 Vadam, Tongi, Gazipur, Bangladesh

2 April 2014

# Site Observations

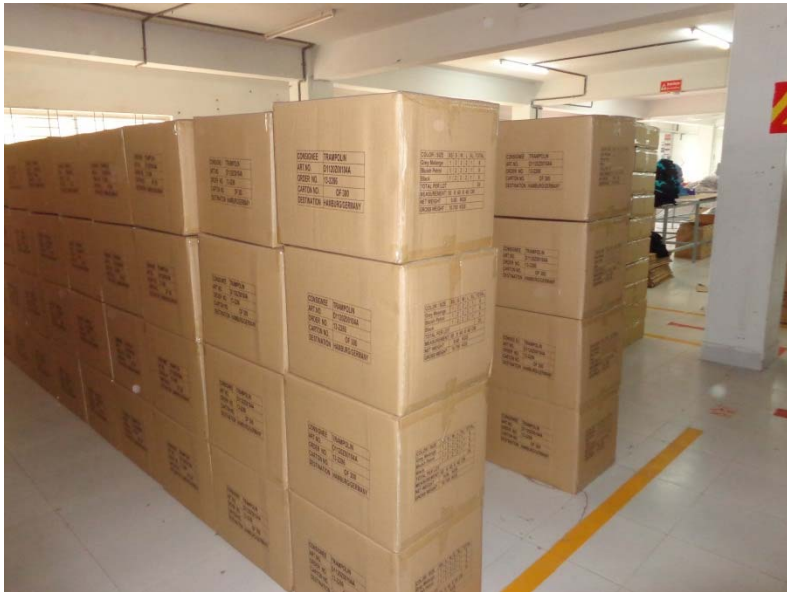
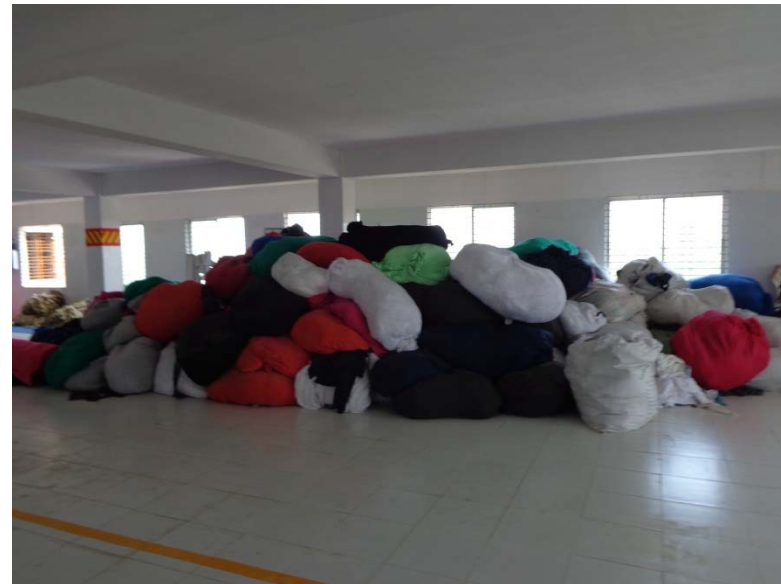
**Excessive Storage**

**High loads on floors 2 and 3**

Excessive and uncontrolled storage of boxes and fabric on the second and third floor.

High storage loads.

- Immediately reduce stacking height of boxes and fabric to ensure total load does not exceed 3.0kPa.

- Mark the maximum allowable height of fabric and box stacking to ensure full compliance with specified design loads.

- Produce and actively manage a loading plan, ensuring maximum height of storage is adhered to in the long-term.

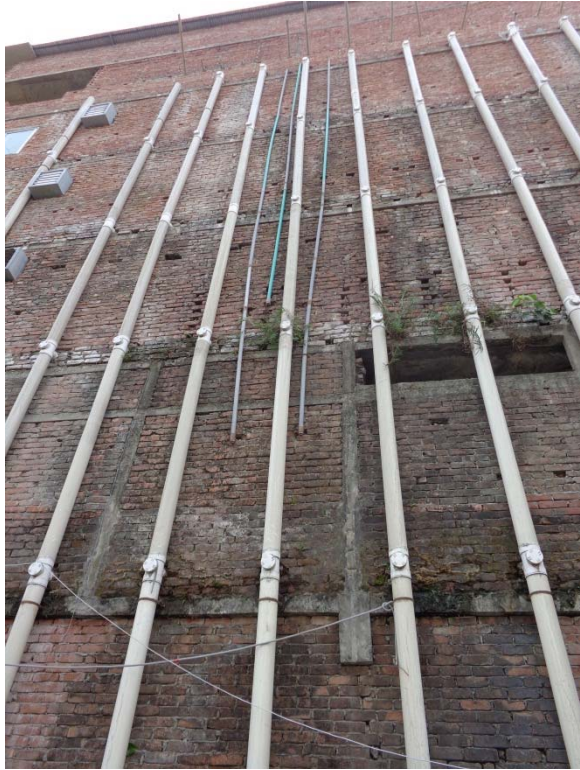
# **Water causing damage and corrosion**

Presence of water damage and plant growth on the façade.

- Consider applying a new waterproofing membrane.
- Manage drainage from above levels and water tanks to downpipes to avoid structural corrosion due to continuous moisture.

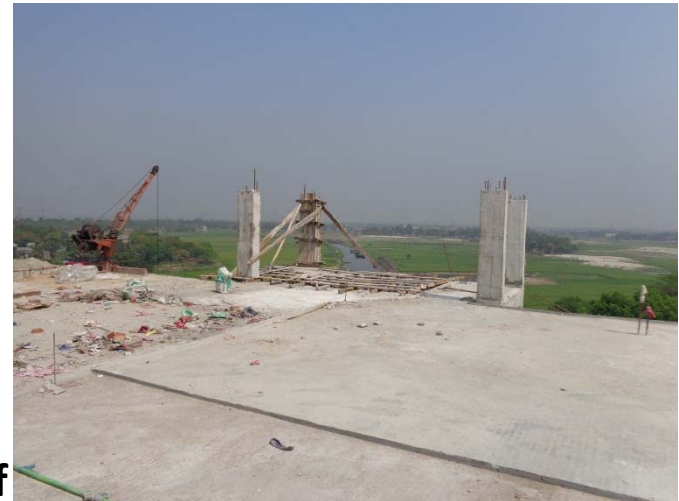
**Roof Floor does not appear to have any waterproof membrane to protect lower floor from water damage**

No waterproofing membrane was visible on the roof of the building. This means that any cracks in the surface finishes on the roof will allow water to seep into the concrete slab beneath the finishes, and cause long-term soaking of the slab.

Roof appears not to have any waterproofing system applied.
