# INITIAL FIRE SAFETY INSPECTION REPORT

## KDS Washing Plant

RSC ID: 24482

# Fire Safety Inspection Report

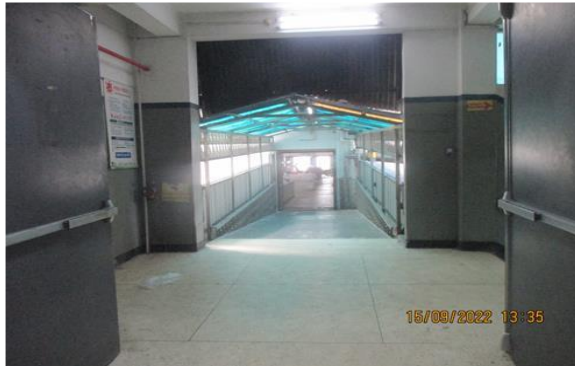
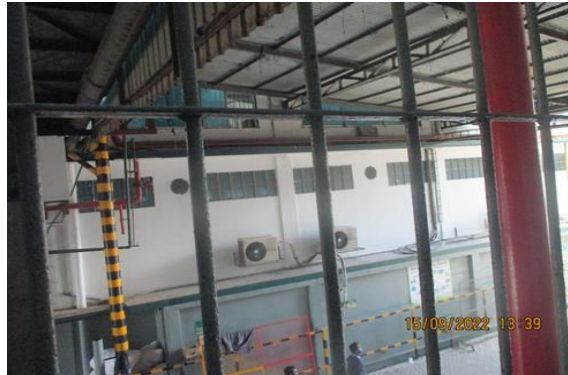
| SI No. | Category | Findings | Required Action | Remediation Time Frame |
|---|---|---|---|---|
| F-1 | Fire Rated Construction | The exit stair-1 enclosures (Block B) are not separated from work areas and other spaces by fire-rated construction due to unprotected opening with building-A and C (Under common roof) and non-functionality of installed fire rated doors. | <p>The exit stair enclosure shall be provided with a minimum of 2- hr. fire resistance rating . Provide 1.5 hr. fire rated door and seal all penetrations and openings by 2 hr. fire rated fire rated barrier construction.</p> <p>Provide a fire-resistive rated assembly between the exterior exit stairs and the building up to 10 ft. beyond the end of the stair to achieve the required separation. The rated assembly shall be approved and/or designed by a qualified fire protection engineer.</p> <p>Ensure that the fire doors are self-closing and positive latching and that they are provided with fire exit (panic) hardware where serving production floors. If fire doors are required to be held open for functional reasons, provide automatic closing devices tied to the fire alarm system.</p> | Within 3 months |

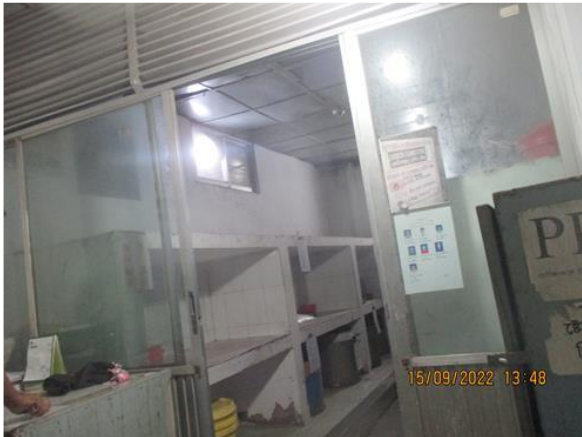
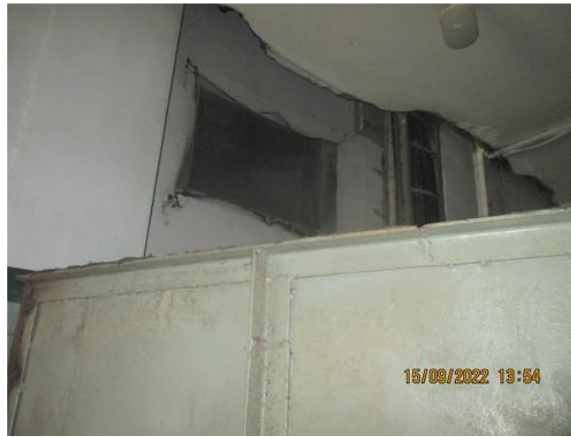
| F-3 | Fire Rated Construction | <p>Main chemical storage area is not separated by fire-rated construction having unsealed penetrations and openings from washing section, powerhouse and general store. Chemical Sub-store is not separated from WTP having unprotected penetrations. Location: Ground floor of Block B.</p> | <p>Ensure the chemical store fire separated by minimum 4-hr fire rated construction barrier with only occupancies with G and H following table 3.2.1 of BNBC-2006. No opening is permitted in the 4-hr rated wall towards any other occupancy. Follow section 2.13 of BNBC-2006 as a guideline chemical store while rearranging.</p> | Within 3 months |

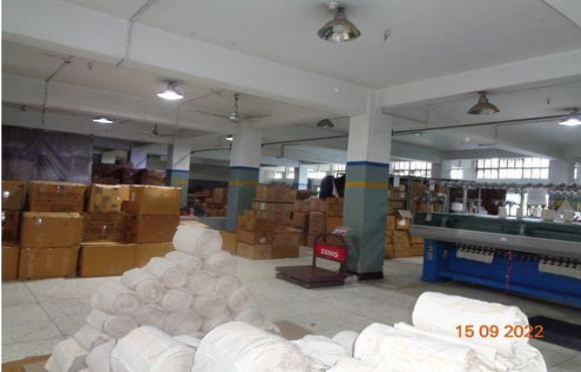
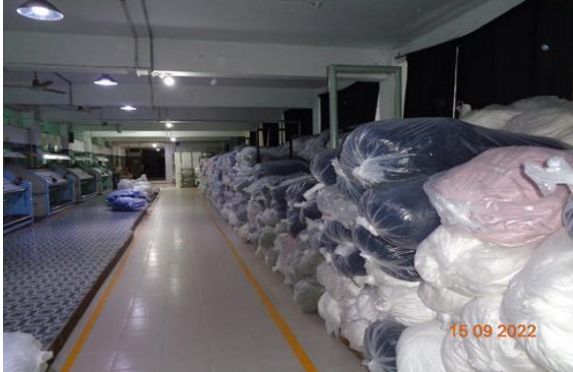
| F-4 | Fire Rated Construction | Areas used for in-process storage of combustible materials are open to the surrounding occupancy. Location: at 3rd floor and 2nd floor Block B. | <p>Provide defined storage areas and limit the storage arrangement as follows:</p> <p>Maximum height of 2.45 m and maximum area of 23 m<sup>2</sup> and is separated by a minimum 3.0 m (10ft) from other storage areas and they do not exceed 10 percent of the building area of the story in which they occur.</p> <p>or,</p> <p>Enclose the storage area from the surrounding occupancy with a minimum 1 hour construction.</p> | Within 3 months |

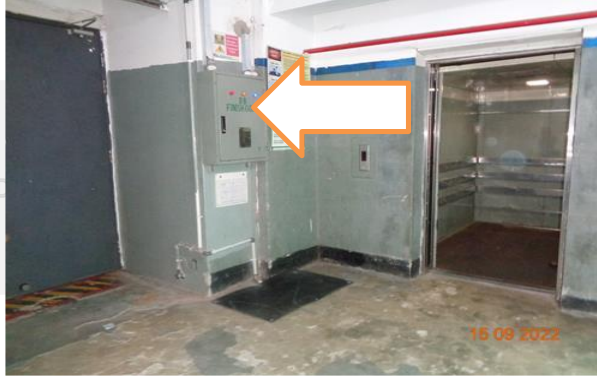
| F-05 | Fire Rated Construction | Electrical distribution board is located inside of both exit stairs. Location: Stair 1, Block B. | Relocate all electrical panel box from exit stairs. | Within 1 month |

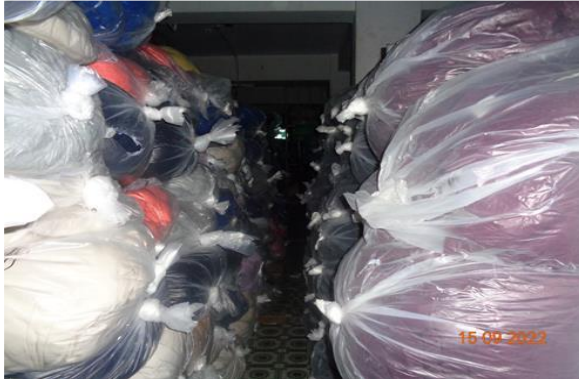
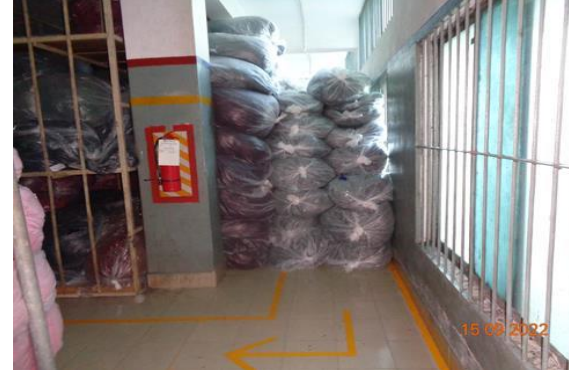
| F-6 | Means of Egress | The egress path along means of egress has interrupted by obstruction/storage on the fabric store in 3rd floor. Location: Block B. | Aisles shall be provided with a minimum unobstructed clear-width of 0.9 m (36 in.). Means of egress shall be maintained continuously free and clear of all obstructions/storage. | Immediately |

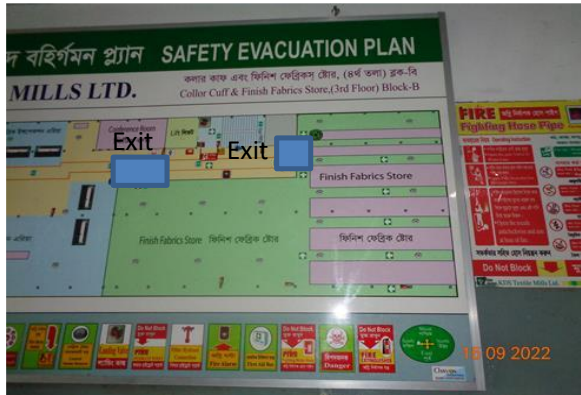
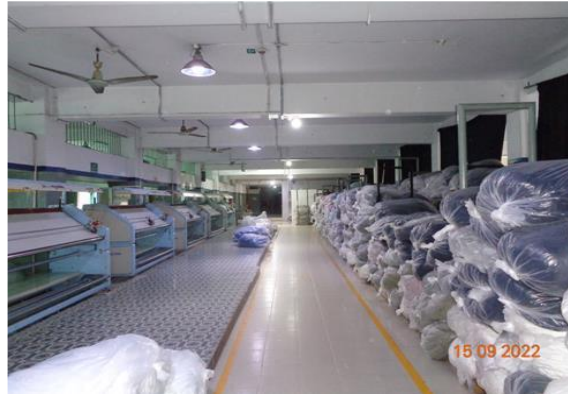
| F-7 | Means of Egress | The exit are not remotely located from each other such that a single fire event could compromise both exits. Location: finished fabric store, 3rd floor of block C. | <p>Modify the exits arrangement or Provide additional exit to ensure that the exit doors or means of egress openings are located a distance apart equal to not less than one-half of the length of the maximum overall diagonal dimension of the building or area to be served measured in a straight line between exits or egress openings (Where the building is provided with a complete automatic sprinkler system, the separation of the exits or means of egress openings shall be not less than one-third of the maximum overall diagonal dimension).</p> <p>In addition, ensure that the common path of egress travel for Group H (storage) occupancies with not more than 30 occupants does not exceed 30 m (100 ft).</p> | Within 4 months |

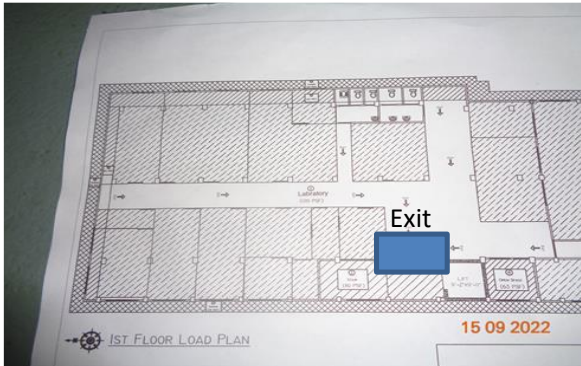
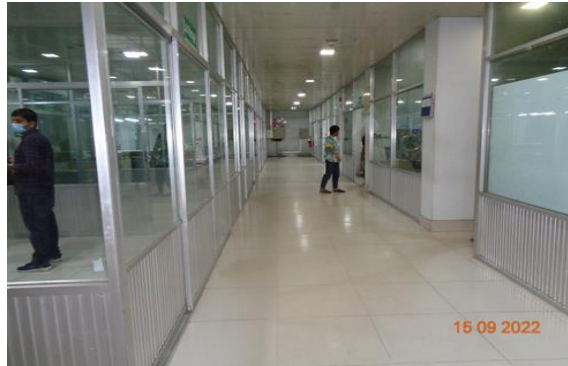
| F-8 | Means of Egress | Only one exit has been provided and the travel distance exceeds 100 ft. at R&D Lab, 1st floor. Location: Block B | Maintain maximum 30 occupants having a travel distance of 23m (75 ft).<br>Or<br>Provide additional exit. | Within 5 months |

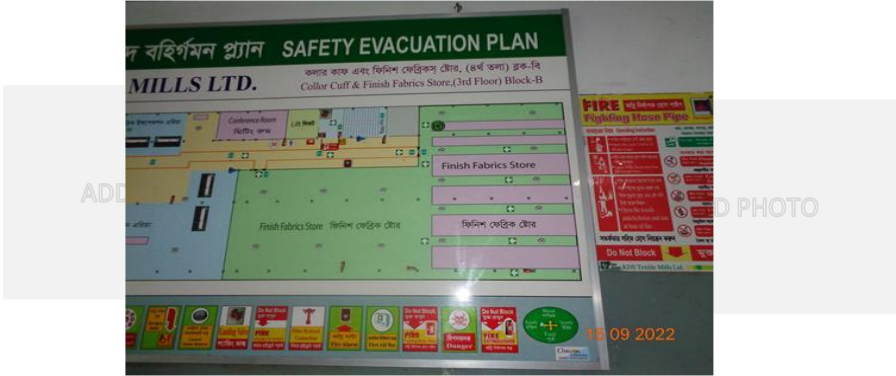
| F-9 | Means of Egress | The common path of egress travel exceeds 100 ft at finished fabric store (3rd Floor) and exceeds 25 ft at chemical store (Ground Floor). Location: Block B. | The common path of egress travel for Group H (storage) occupancies with not more than 30 occupants shall not exceed 30 m (100 ft). The common path of egress travel for Group J (high hazard) occupancies shall not exceed 8 m (25 ft). | Within 5 months |

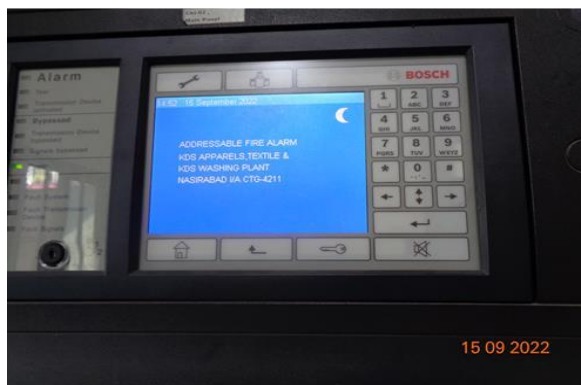
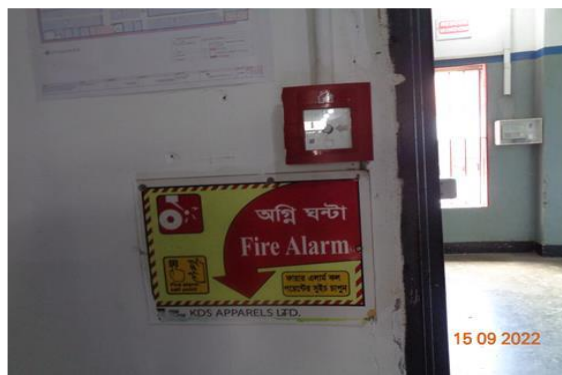
| F-14 | Fire Alarm & Detection System | Fire alarm and detection system installation complete which requires detailed review to confirm compliance with NFPA 72 and RSC Technical Guidelines (Standard). | <p>Submit the fire alarm system design to RSC for review. Once the design is reviewed, install and modify the fire detection and alarm system throughout the building in accordance with review comment, RSC Technical Guidelines (Standard) and NFPA 72.</p> <p>After installation the owner shall conduct internal testing and commissioning and then contact the RSC for witness of final acceptance testing.</p> | Design within 1 month and modification/ installation with 3 months |

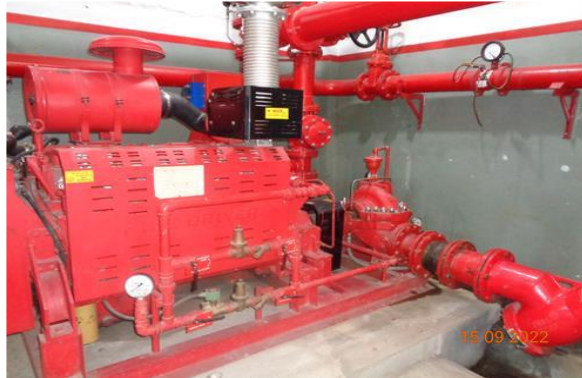
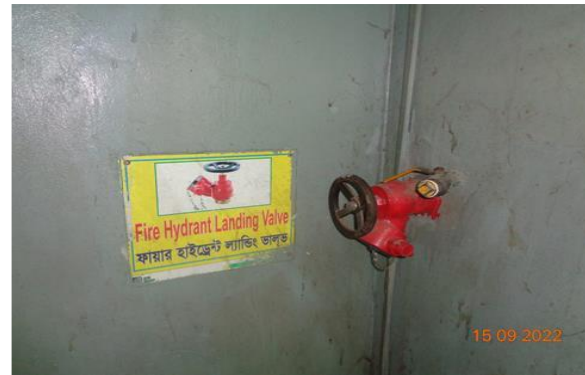
| F-15 | Fire Suppression System | <p>The highest occupied floor of existing building (Block A, Block C and Cextension) is more than 10 m (33 ft.) above grade where class III standpipe system is mandatory, and the factory has installed Class-III standpipe which is required to be reviewed and verified.</p> | <p>Submit the fire suppression system (fire pump &amp; standpipe) design and documents to RSC for review. Once the design is reviewed, install and modify the fire suppression system throughout the building in accordance with review comment, RSC Technical Guidelines (Standard) and NFPA 14, 20, 22 and 24.</p> <p>After installation the owner shall conduct internal testing and commissioning and then contact the RSC for witness of final acceptance testing.</p> | <p>Design within 1 month and modification/ installation with 3 months</p> |
