# INITIAL FIRE ASSESSMENT REPORT (FAR)

Factory Name: **Zaber & Zubair Fabrics Ltd**  
Address: **Pagar, Tongi, Gazipur Tongi, Gazipur Dhaka  
Bangladesh**  
Assessor: **Bureau Veritas**  
Date: **19 May 2014**

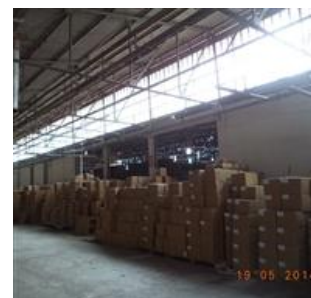
| Description: | All the existing doors, openings, penetrations and ducts along the required fire rated barriers or assemblies in the buildings were found non-rated. Some of the findings are as follows: 1) Openings of fabric store on ground floor of stitch-2 building. 2) Openings of chemical mixing area of Home Dyeing sheds and Fashion Dyeing sheds. 3) Openings of Dyeing Lab and Chemical Sub-store in Home Dyeing-1 and 2 and at Fashion Dyeing-2 were either open or non-rated. |
| Source of Findings: | Photograph: Openings and penetrations were found without required fire protection at all the assessed buildings in the factory premises. |

| Suggested Plan of Action: | Provide fire rated doors and protections at all the required non-rated doors or openings in all the assessed buildings. If possible, close all these openings with fire rated barriers. Protect all the penetrations along the fire restrictive rated assemblies with a listed through penetration fire-stop system tested in accordance with ASTM E81. Consult a qualified fire protection engineer for required solutions. |
