# INITIAL FIRE SAFETY INSPECTION REPORT

**Brandix Apparel Bangladesh Ltd**

**RSC ID: 24452**

**Date: 17-July-2022**

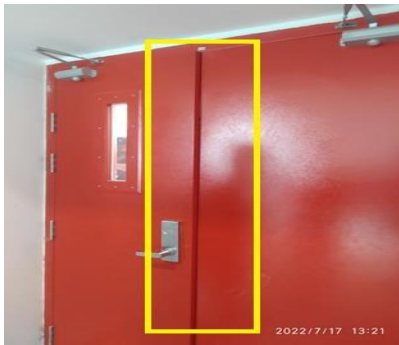
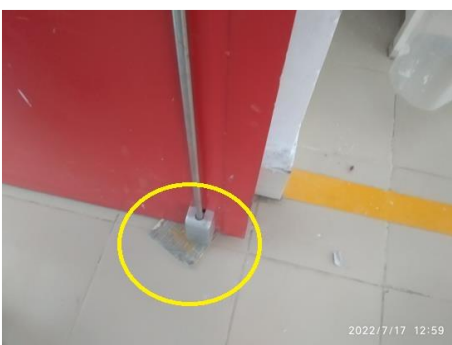
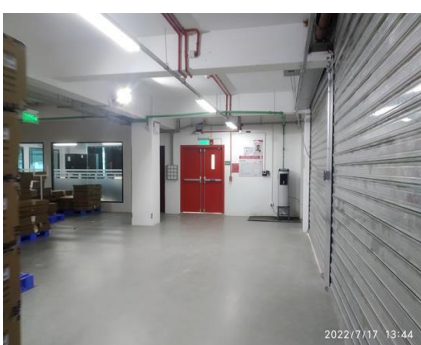
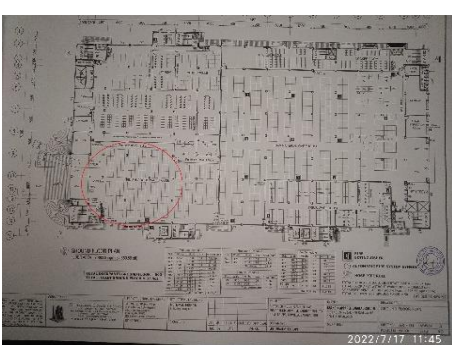
| Sly No. | Category | | Required Action | Remediation Time Frame |
|---|---|---|---|---|
| F-1 | Fire Rated Construction | <p>The exit stairs are not separated from [work areas, other spaces] on each floor by fire rated construction as the installed fire door was not functional.</p> <p>Location: 3 storied industrial building</p> | <p>The exit stair enclosure shall be provided with a minimum 1-hr fire resistance rating with 1- hr. fire rated door and seal all penetrations and openings by 1 hr. fire rated materials for buildings with 3 or fewer stories and a minimum of 2- hr. fire resistance rating exit stair enclosure for buildings 4 or more stories.</p> <p>Ensure that the fire doors are self-closing and positive latching and that they are provided with fire exit (panic) hardware where serving production floors. If fire doors are required to be held open for functional reasons, provide automatic closing devices tied to the fire alarm system.</p> <p>Openings from exit enclosure to storage spaces shall be provided with a vestibule with fire rated construction as per RSC Technical Guideline (Standard) V1-6.14.3 ..</p> | Within 3 months |

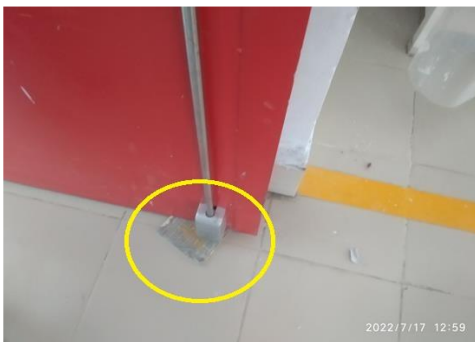
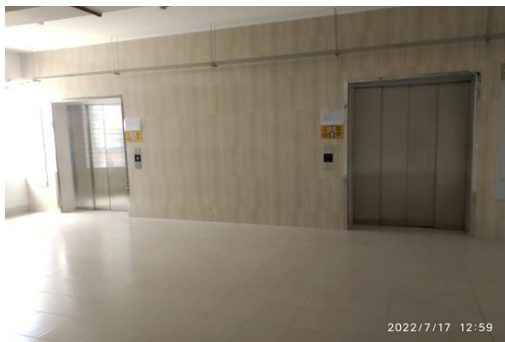
| F-2 | Fire Rated Construction | Elevator shafts are directly open into the production floor without proper fire separation as installed fire rated door was not functional.<br>Located: 3 storied industrial building | Ensure minimum 1-hr listed/3rd part certified fire rated lift landing doors for elevator shafts otherwise close the area of the shaft with a 1-hr fire-rated construction barrier.<br>If fire rated doors are required to be held open for functional reasons, provide automatic closing devices tied to the fire alarm system. | Within 3months |

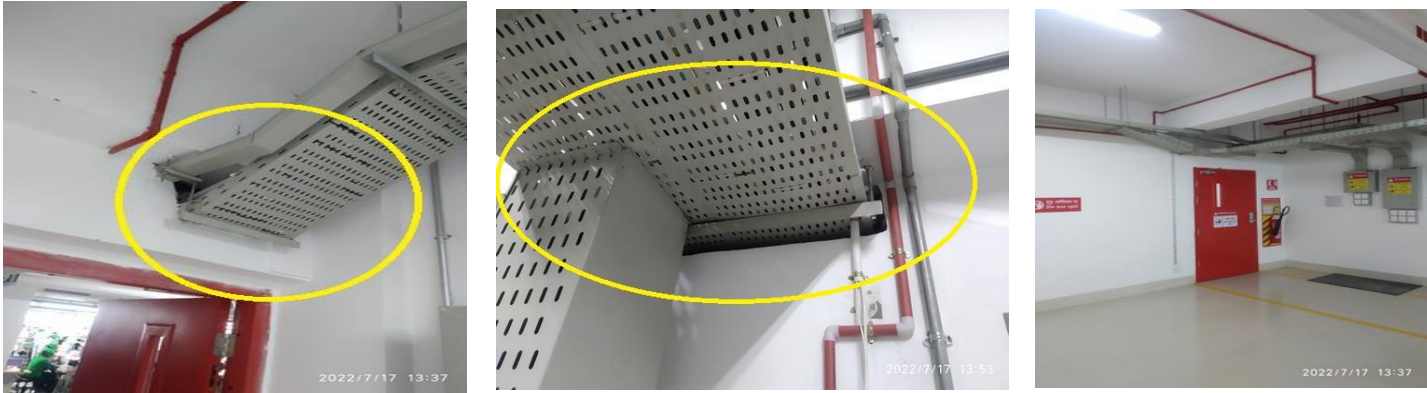
| F-3 | Fire rated construction | <p>Unsealed penetrations and openings are located in the fire-rated floor/ceiling assemblies.</p> <p>Location: Electrical riser of 3 storied industrial building</p> | <p>Seal all penetrations and openings in floor/ceiling assemblies to maintain the fire separation at least by 2-hr. The used sealer shall be 3rd party certified and installation shall be as per manufacturer's datasheet.</p> <p>Or</p> <p>Provide a minimum 2-hr fire rated shaft to separate the utility risers from each floor if required. If fire doors are required to be held open for functional reasons, provide automatic closing devices tied to the fire alarm system.</p> | Within 3 months |

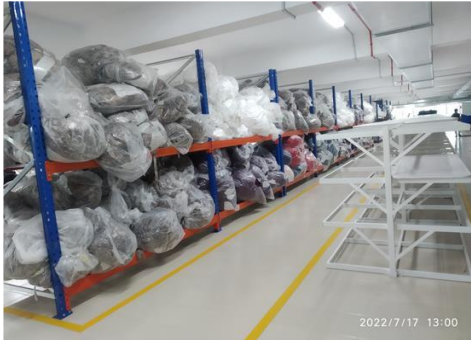
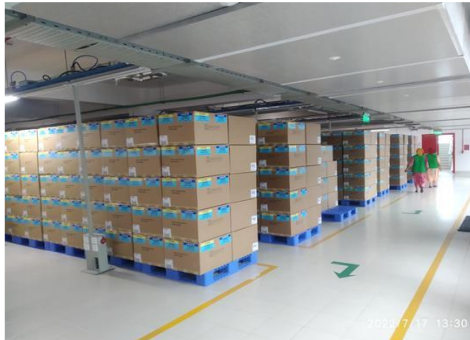
| F-4 | Fire rated construction | <p>Areas used for in-process storage of combustible materials are open to the surrounding occupancy.</p> <p>Location: Ground, first &amp; 2nd floor of industrial building.</p> | <p>Provide defined storage areas and limit the storage arrangement as follows:</p> <p>Maximum height of 2.45 m and maximum area of 23 m<sup>2</sup> and is separated by a minimum 3.0 m (10ft) from other storage areas and they do not exceed 10 percent of the building area of the story in which they occur. If sprinkler protected, Maximum height 12 ft (3.66 m) and maximum area of 1000 ft<sup>2</sup> (93 m<sup>2</sup>) and separated by a at least 25 ft (7.62 m) from other storage areas and does not constitute more than 10 percent of the building area or 4000 ft<sup>2</sup> (372 m<sup>2</sup>) of the sprinklered area, whichever is greater.</p> <p>or,</p> <p>Enclose the storage area from the surrounding occupancy with a minimum 1 hour fire rated construction.</p> | Within 3 months |

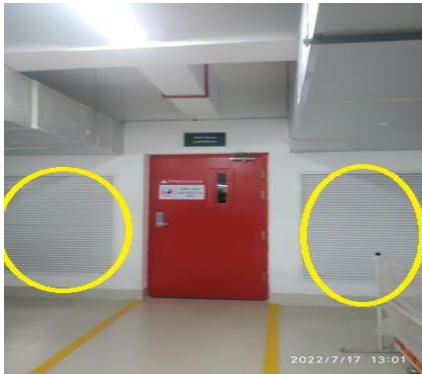
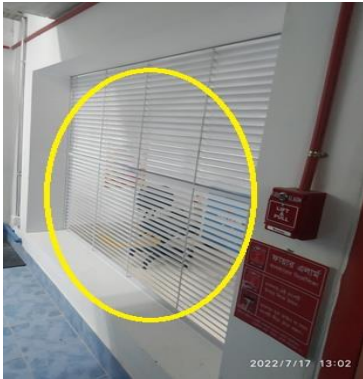
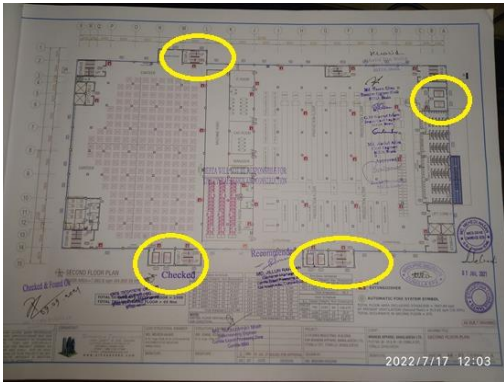
| F-5 | Fire rated construction | <p>AHU are not properly fire separated by fire rated construction due to unprotected opening .</p> <p>Location: W-E-N side of ground, first &amp; 2nd floor of 3 storied industrial building</p> | <p>Separate the Air handling unit/machine by 2-hr fire rated construction. Seal all unprotected openings and penetration.</p> | Within 3 months |

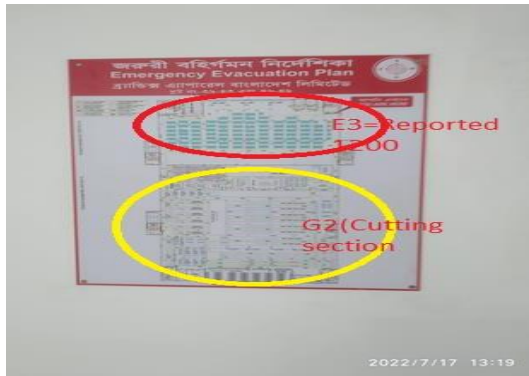
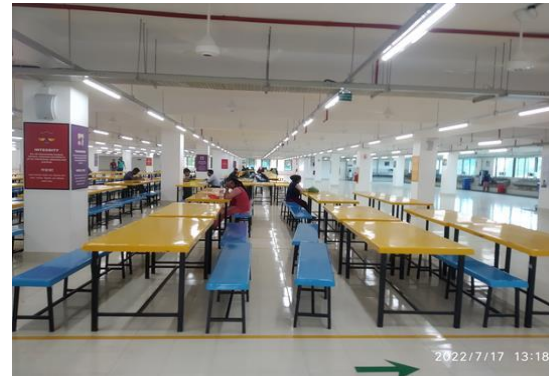
| F-6 | Fire Rated Construction | <p>The Dining area E3 (Reported capacity 1200) are not properly separated from cutting section (G2) by fire rated construction.</p> <p>Location: 2nd floor of Industrial building</p> | <p>The dining area (E3) is not permitted with moderate hazard occupancies (G2) following part 3, table 3.2.1 of BNBC-2006.</p> <p>Relocate the dining to or from this building to meet the requirement as per BNBC 2006, part 4 chapter 3 section 3.21.3 and part 3 of table 3.2.1.</p> | Within 3 months |

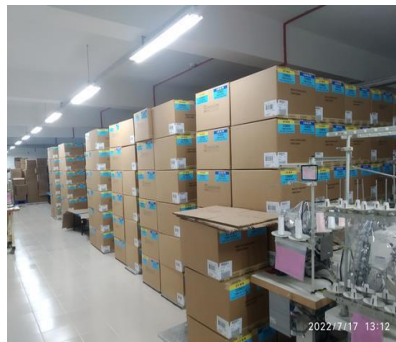
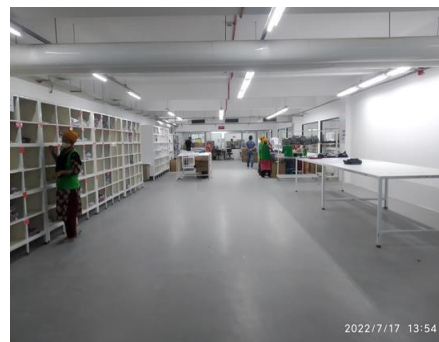
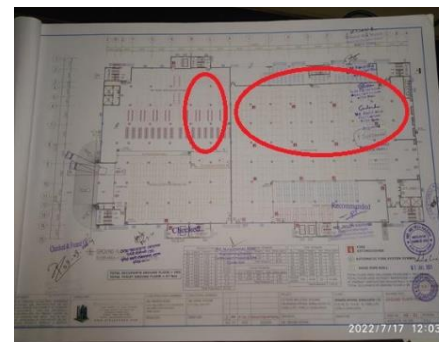
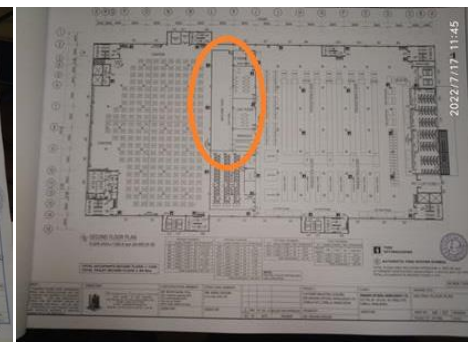
| F-7 | Means of Egress | Common path of egress travel was more than 23 m in the ground floor & 2nd floor of 3 storied industrial building | Reconfigure the egress arrangement to reduce the maximum common path of travel to not more than 23m. | Within 3 months |
