# INITIAL FIRE SAFETY INSPECTION REPORT

**Famkam Fashion Ltd**

**RSC ID: 24426**

# **Fire Safety Inspection Report**

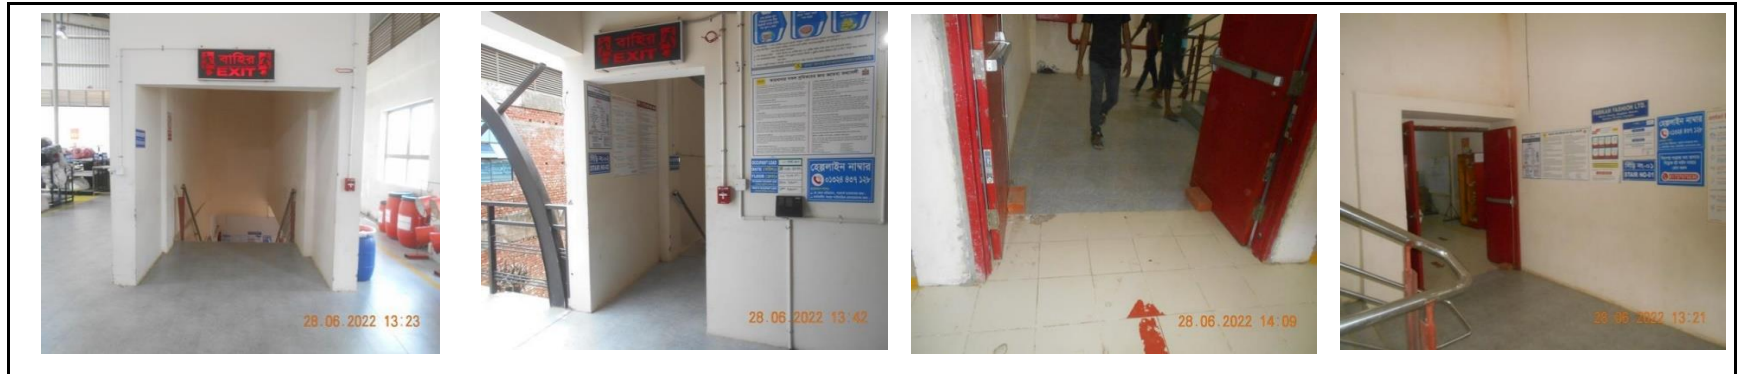
| SI No. | Category | Findings | Required Action | Remediation Time Frame |
|---|---|---|---|---|
| F-01 | Fire Rated Construction | <b>Famkam Fashion Building:</b><br>The exit stairs are not separated from [work areas, other spaces] on each floor by fire-rated construction. | <p>Provide minimum 2-hr fire rated construction for buildings 4 storied or more and 1-hr for upto 3 storied. Seal all unprotected openings to separate the exit stairs from work areas and other spaces on all floor levels by 90 minutes for 2 hr construction and 60 minutes for 1-hr construction. Ensure that the fire rated doors are self-closing and positive latching and that they are provided with fire exit (panic) hardware where serving production floors and provide vestibules to avoid direct discharge from storage to exit stair enclosure.</p> <p>If fire rated doors are required to be held open for functional reasons, provide automatic closing devices tied to the fire alarm system.</p> <p>Once fire doors are installed, every door in a stair enclosure serving more than 5 stories shall be provided with re-entry unless it meets RSC Technical Guidelines (Standard) 6.8.3.1</p> <p>If fire doors are required to be held open for functional reasons, provide automatic-closing devices tied to the fire alarm system.</p> | Within 3 months |

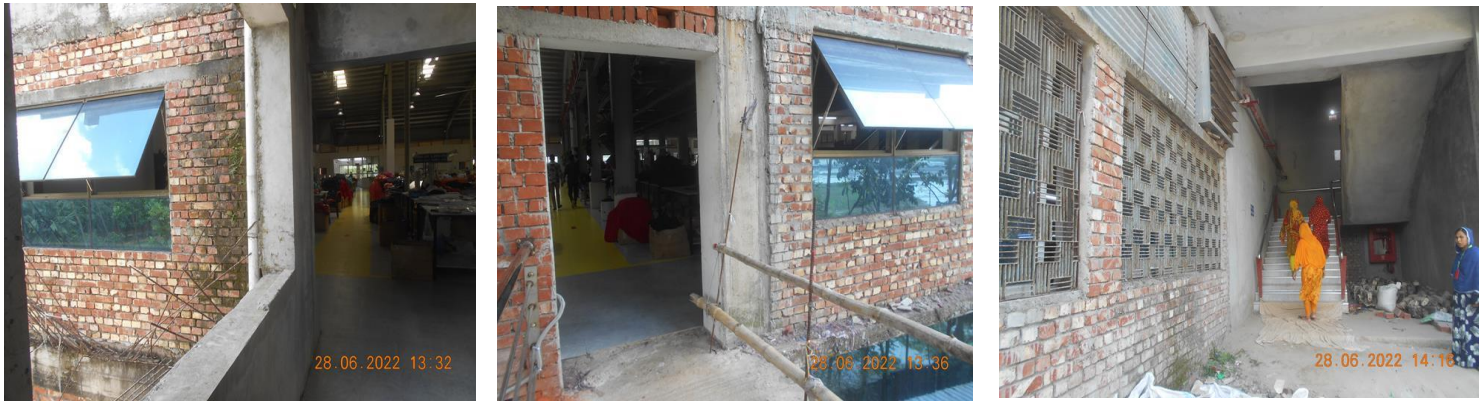
| F-02 | Fire Rated Construction | <p>Unsealed penetrations and openings (non-rated exterior walls within 3050 mm (10 ft) horizontally and an angle of less than 180 degrees of stair-5) are located in the exit stair enclosures.</p> <p><b>Location:</b> Stair-3 and stair-4 of Famkam Fashion Building.</p> | Seal all penetrations and openings in exit stair enclosure walls to maintain the fire separations. | Within 3 months |

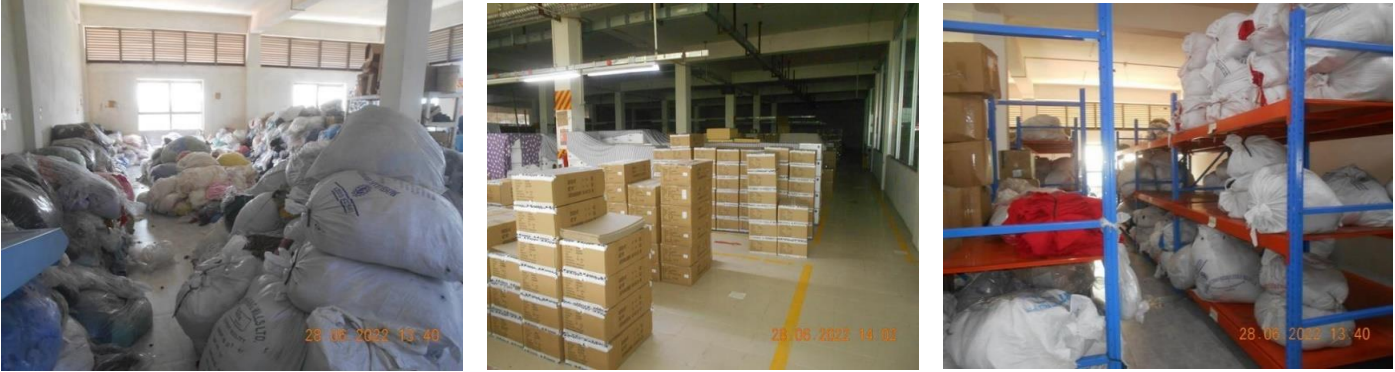
| F-03 | Fire Rated Construction | <p>Areas used for in-process storage of combustible materials are open to the surrounding occupancy.<br/>Location: On ground, 1st and 2nd floor of Famkam Fashion Building.</p> | <p>Provide defined storage areas and limit the storage arrangement as follows: -</p> <ol style="list-style-type: none"> <li>1. General Condition: Maximum height of 2.4m and maximum area of 23m<sup>2</sup>. Separate areas of unenclosed combustible storage by a minimum clear distance of 3m.</li> <li>2. If sprinkler protected: maximum height of 3.66m and maximum area of 93m<sup>2</sup>. Separate areas of unenclosed combustible storage by a minimum clear distance of 3m.or</li> <li>3. Enclose the storage area from the surrounding occupancy with a minimum 1-hour construction.</li> </ol> | Within 3 months |

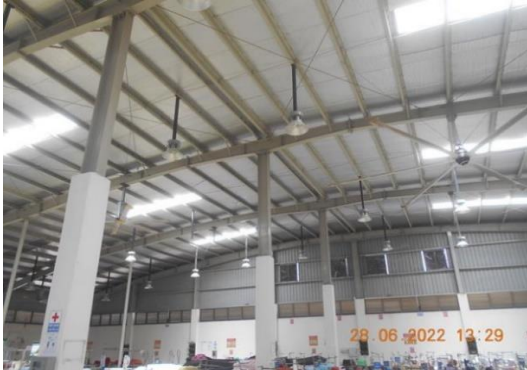
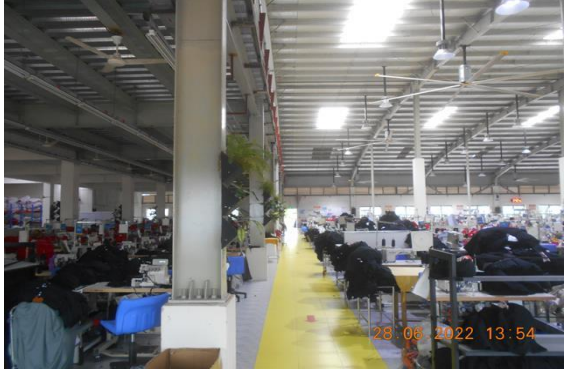
| F-04 | Fire Rated Construction | <p>Structural Fire Protection: The building is newly constructed where structural members are constructed by RCC except Mezzanine (Mezzanine is constructed by steel) and have been found in exposed condition without any fire protection.</p> <p>Location: Mezzanine floor of Famkam Fashion Building</p> | <p>Provide fire-resistive rated construction barriers between floors following Section 4.4 and Table 4.4.1 of the RSC Technical Guidelines (Standard) or Table 3.3.1 and Table 4.1.1 from BNBC Part 4. Consult a qualified fire protection engineer to design the rated construction barriers.</p> | Within 4 months |

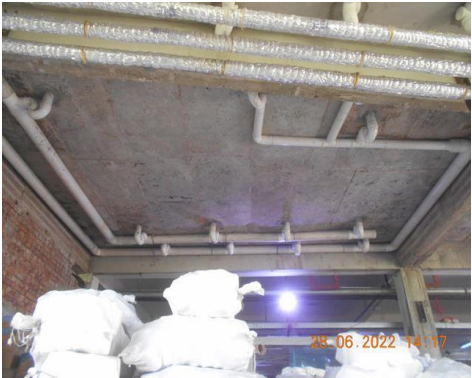
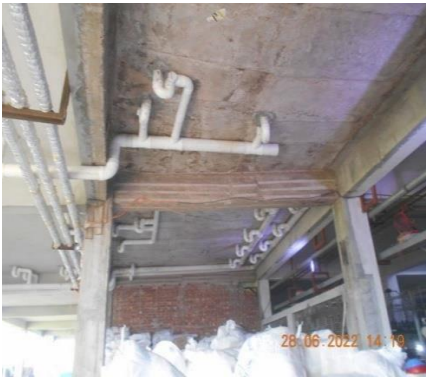
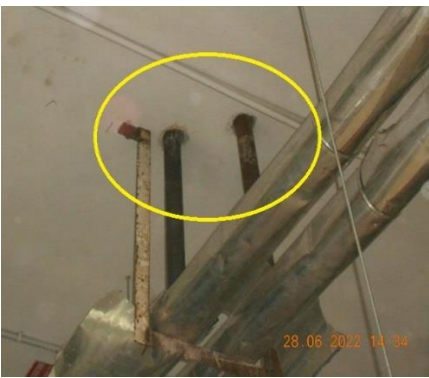
| F-05 | Fire Rated Construction | <p>Unsealed penetrations and openings are located in the fire rated floor/ceiling assemblies. Followings are the description of openings or penetrations indicating specific locations:</p> <ol style="list-style-type: none"> <li>1. PVC pipes penetrate the floor slabs in toilet block of production building.</li> <li>2. Air compressor pipes penetrate the floor slabs of production building.</li> </ol> | <p>Seal all penetrations and openings in floor/ceiling (full thickness of the floor/ceiling) assemblies by fire rated materials to maintain the fire resistance rating.</p> <p>Provide a minimum 2-hr fire rated shaft to separate the utility risers from each floor if required.</p> | Within 3 months |

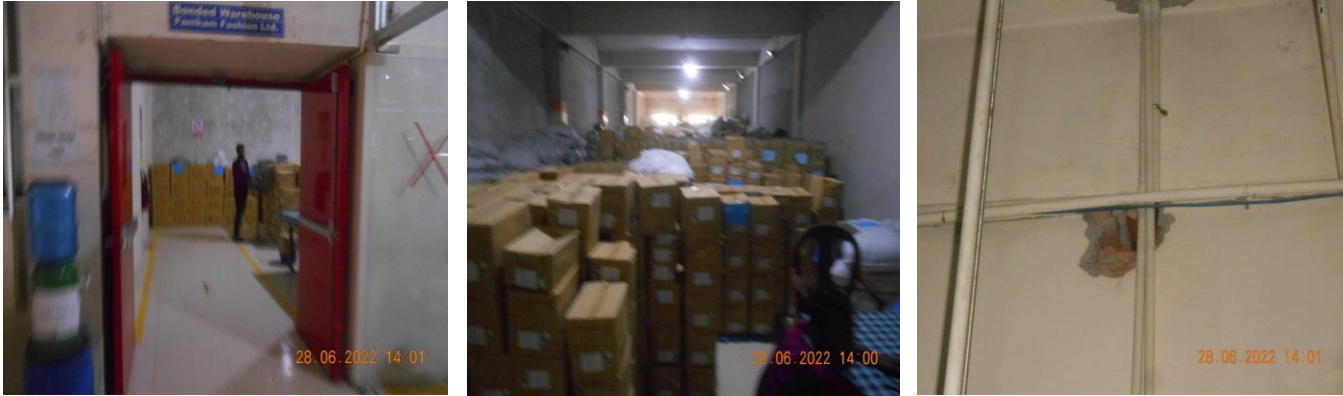
| F-06 | Fire Rated Construction | Rooms used for combustible storage are not separated by fire rated construction.<br>Location: On 1st floor of Famkam Fashion Building. | Separate the dedicated storage rooms by minimum 1-hr fire-rated construction. Provide 0.75 hr. fire rated door and seal all penetrations and openings by 1 hr. fire rated fire rated barrier construction. | Within 3 months |

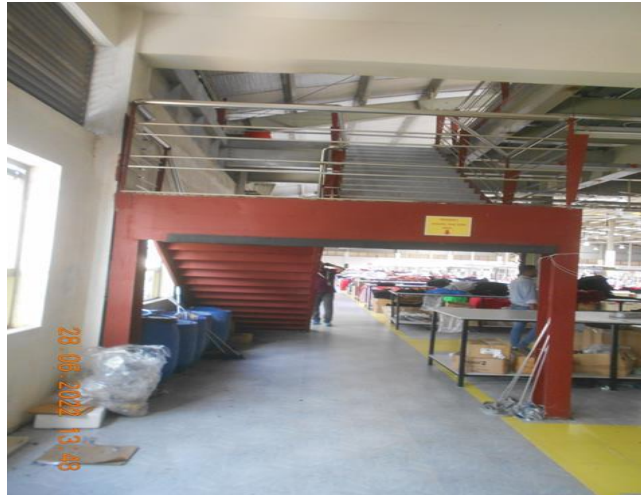
| F-08 | Means of Egress | Means of egress have a ceiling height less than 2.03 m (6 ft 8 in.).<br>Location: Steel stair with the mezzane floor of Famkam Fashion Building. | All means of egress shall have a minimum ceiling height of 2.3 m (7 ft 6 in.) with projections from the ceiling not less than 2.03 m (6 ft 8 in.). The minimum ceiling height shall be maintained for at least 2/3 of the space or room as long as the remaining area shall be not less than 2.03 m (6 ft 8 in.). Headroom on stairs shall not be less than 2.03 m (6 ft 8 in.). | Within 3 months |

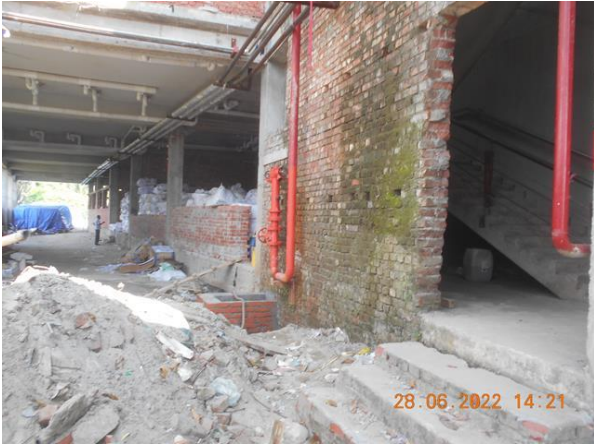
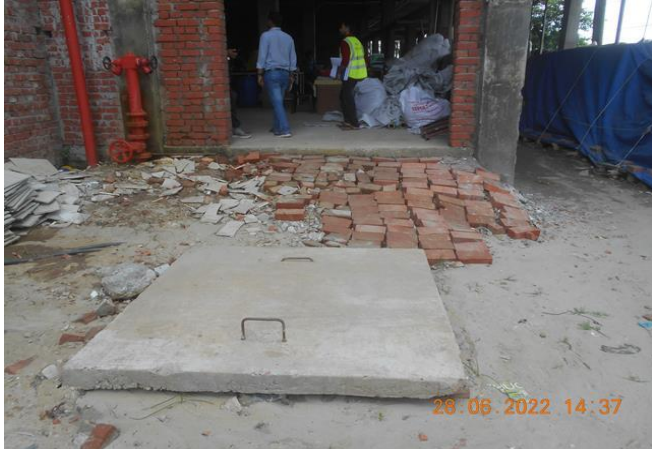
| F-09 | Means of Egress | The exit discharge path of the Northeast an North-west stairwell poses an immediate tripping/drop off hazard. Location: North-east and North-west stair discharge on ground floor of Famkam Fashion Building. | Provide an unobstructed even walking surface for all egress routes. | Within 1 month |

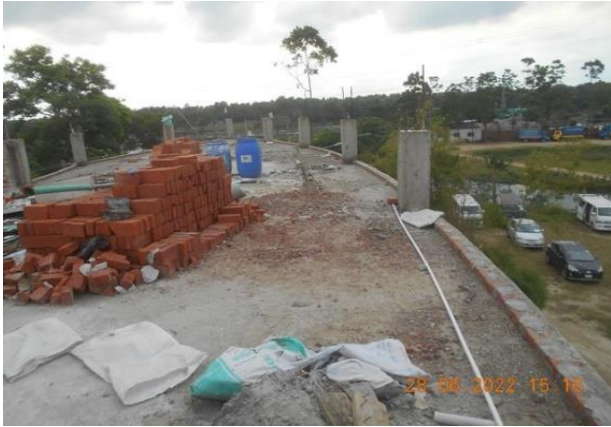
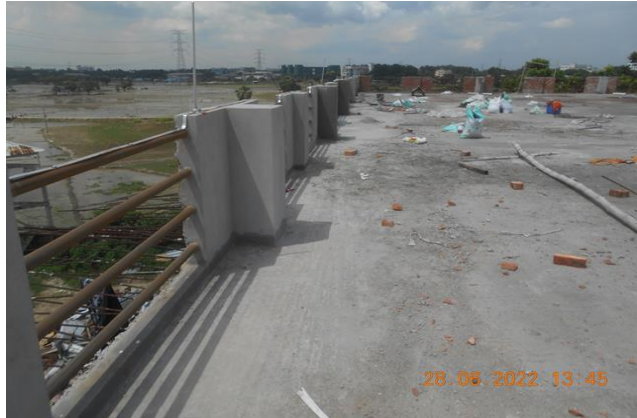
| F-10 | Means of Egress | <p>Parapets or guards are provided in occupied roof which is less than 1067mm (42 inch.).</p> <p>Location: Famkam Fashion Building, Admin Building and Medical Building.</p> | <p>Provide parapets or guards with a minimum height of 1067mm (42 inch.).</p> | <p>Within 3 months</p> |

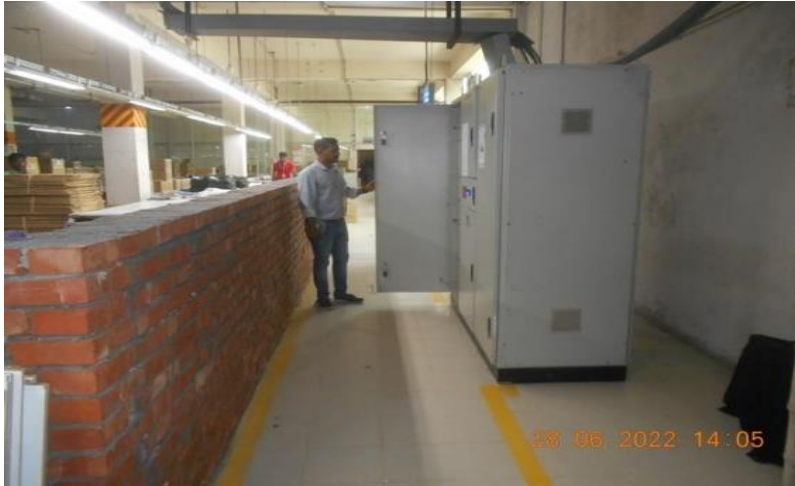
| F-12 | Means of Egress | Electrical DB panel has been found in the aisles on production floor.<br>Location: On 1st floor (North side) of Famkam Fashion Building. | Remove the electrical DB panel from the aisles or exit stair to a safe location. | Within 1 month |

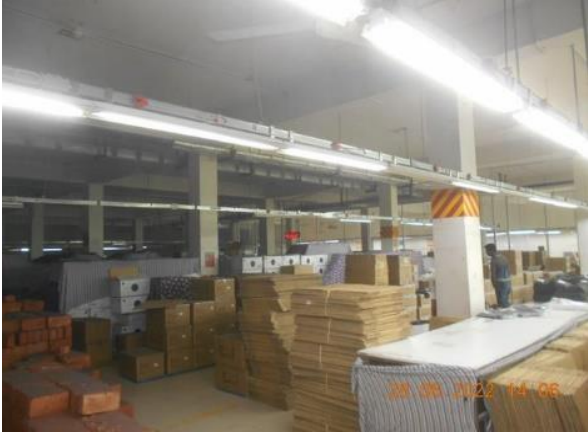
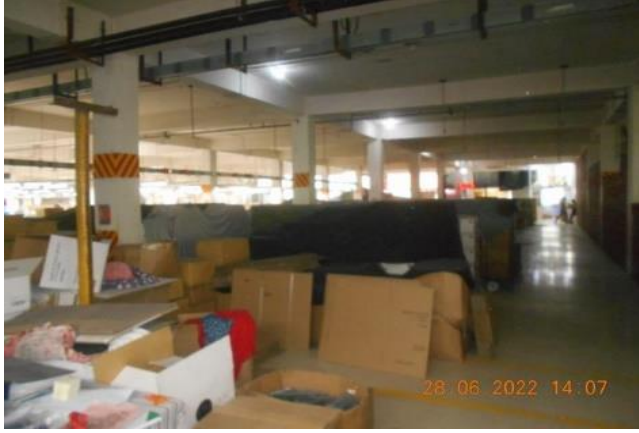
| F-15 | Means of Egress | Aisles mark was not provided on several locations on ground floor of Famkam Fashion Building. | Aisles shall be provided with a minimum unobstructed clear-width of 0.9 m (36 in.). | Within 1 month |

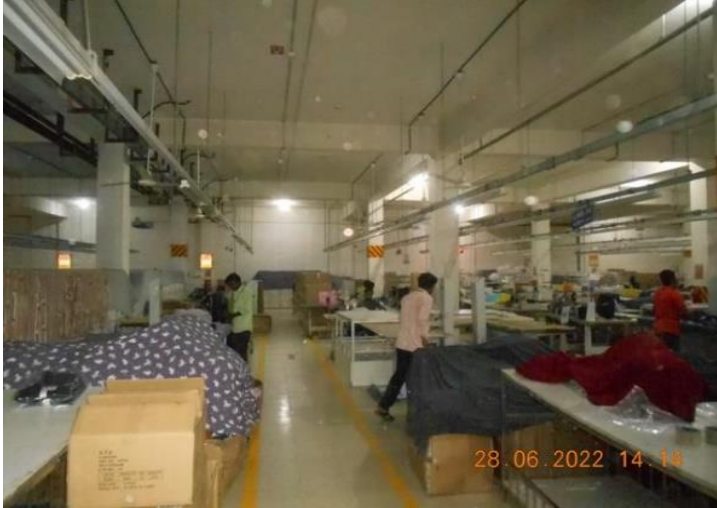
| F-16 | Egress Lighting | <p>Based on the number and location of emergency lights observed, adequate illumination levels are not anticipated along egress routes.</p> <p>Location: On several floors of Famkam Fashion Building.</p> | <p>Test the emergency lighting system on each floor and provide additional emergency fixtures to provide adequate illumination along the means of egress. Provide a minimum illumination of 10 lux at the floor level within exit stairs and exit discharge paths and minimum 2.5 lux along exit access aisles.</p> | Within 3 months |

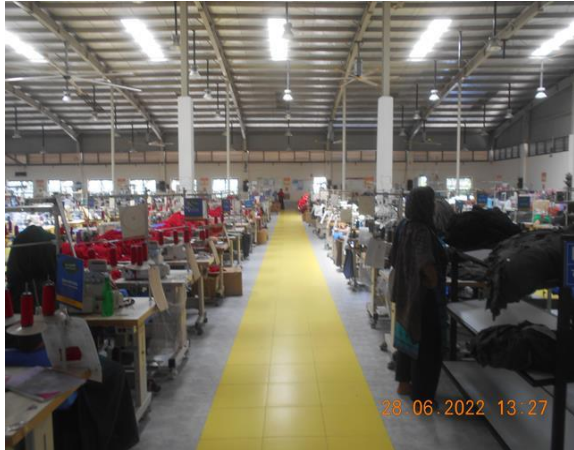
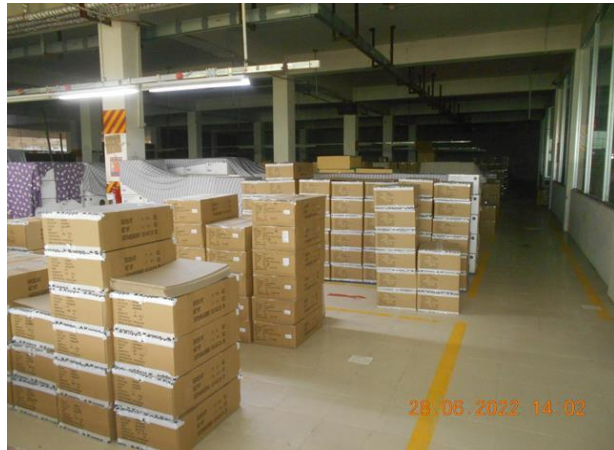
| F-17 | Egress Lighting | <p>The directional signs are not provided where there is a change in direction and where the continuation of the egress path is not obvious.</p> <p>Location: On all floors of Famkam Fashion Building.</p> | <p>Install illuminated directional signs shall be provided where there is a change in the direction for the path of travel and the direction to an exit is not obvious.</p> | Within 1 month |

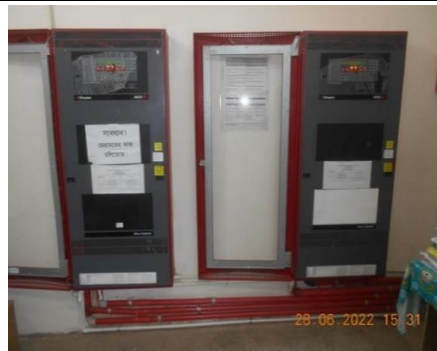
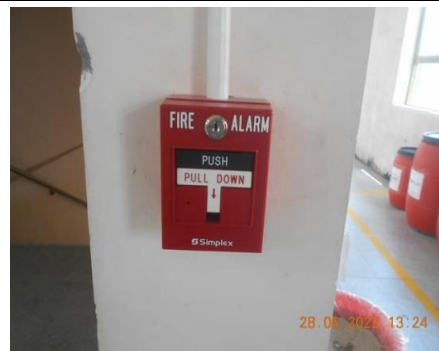
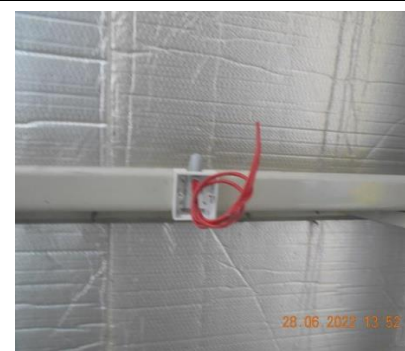
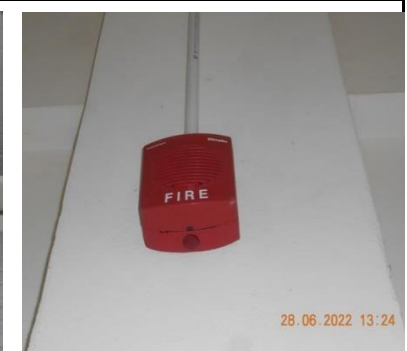
| F-19 | Fire Alarm & Detection system | Fire alarm and detection system installation was going on which requires detailed review to confirm compliance with NFPA 72 and RSC Technical Guidelines (Standard). | Submit the fire alarm system design to RSC for review. Once the design is reviewed, install and modify the fire detection and alarm system throughout the buildings in accordance with review comment, RSC Technical Guidelines (Standard) and NFPA 72. After installation the owner shall conduct internal testing and commissioning and then contact the RSC for witness of final acceptance testing. Also inspect, test and maintain the fire alarm system, and keep written records on-site, in accordance with Table-14.3.1 of NFPA 72. | Design within 2 months, Install within 4 months |

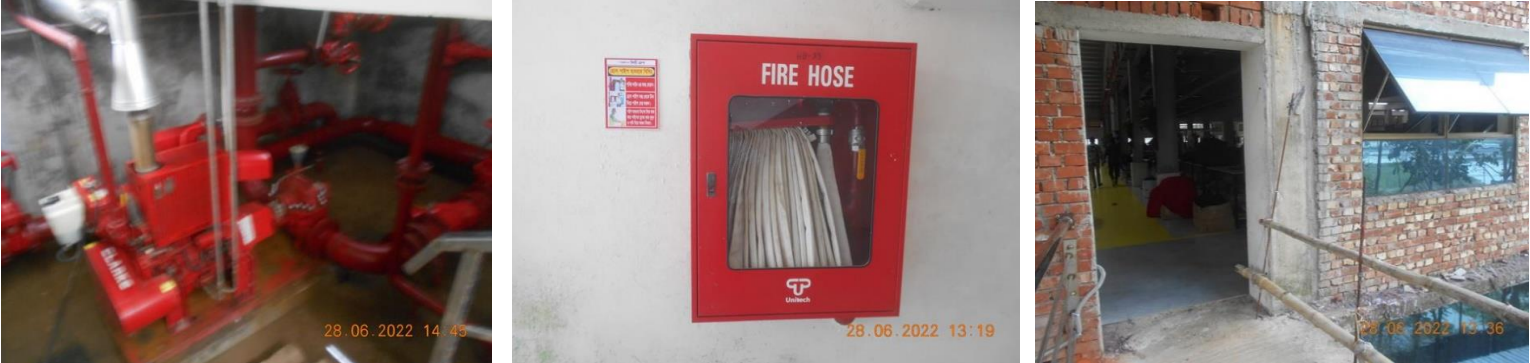
| F-21 | Fire Protection System | The existing building has an occupied floor greater than 10 meter (33 feet) and is not provided (installation is ongoing) with standpipe protection. | Install a new class III standpipe system, fire department connection and fire pump system in accordance with NFPA 13, 14, 20, 22 and RSC Technical Guideline (Standard). | Design within 3 months, Install within 6 months |
| <p>The bottom row of the table contains three photographs. The first photo on the left shows a red fire pump assembly with various pipes and valves, with a timestamp of 28.06.2022 14:45. The middle photo shows a red fire hose cabinet mounted on a wall, with a fire hose visible inside, and a timestamp of 28.06.2022 13:19. The third photo on the right shows a brick building under construction with a fire hose connection and a timestamp of 28.06.2022 15:36.</p> | | | | |

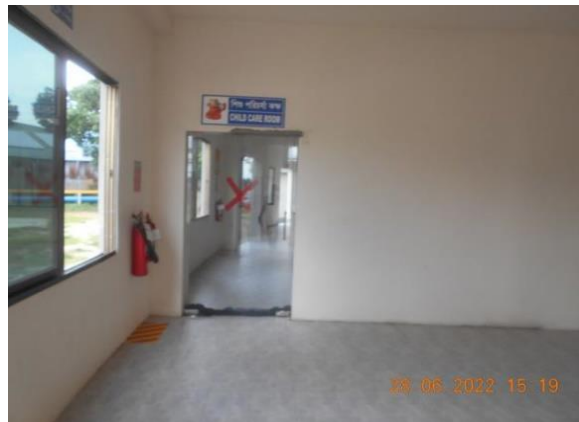
| F-25 | Egress Lighting | Exit signs are not provided at exit.<br>Location: Admin Building and Medical Building. | Provide exit signs above all exits to the exterior and all doors to the exit stair. | Within 1 month |
