# INITIAL FIRE SAFETY INSPECTION REPORT

## Russel Apparels & Ekram Sweater Ltd (New Building)

**RSC ID: 24262**

# **Fire Safety Inspection Report**

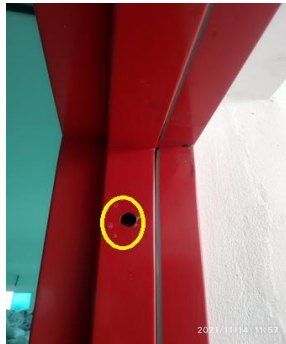
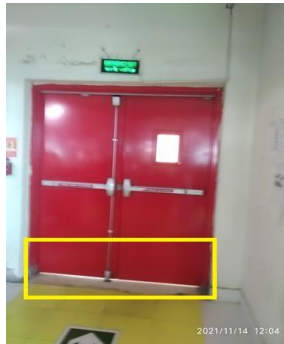
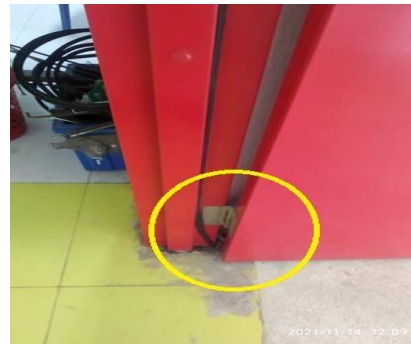
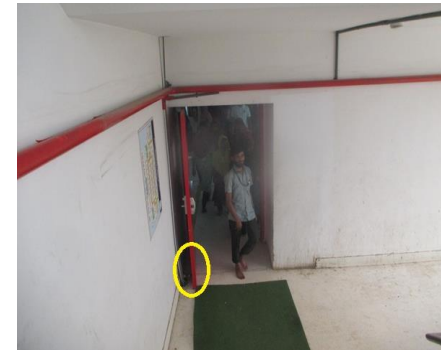
| SI No. | Category | Findings | Required Action | Remediation Time Frame |
|---|---|---|---|---|
| F-1 | Fire Rated Construction | <p>Fire doors has been installed in the openings of required fire rated assemblies ( Exit stairs, Storage rooms, and other occupancy separations), However, fire door were found with following issues-</p> <ol style="list-style-type: none"> <li>1. Doors were kept open by means of door wedges.</li> <li>2. Fire door smoke seal are damaged</li> <li>3. Doors were found with excessive clearance.</li> <li>4. Fire doors frames were found with holes that could impact the fire protection rating.</li> </ol> <p>Location: Exit stairs, Storage rooms of Factory building-2(New) &amp; Dining building</p> | <p>Install the fire door as per NFPA 80.</p> <p>Ensure that the fire doors are self-closing and positive latching and that they are provided with fire exit (panic) hardware where serving production floors. If fire doors are required to be held open for functional reasons, provide automatic closing devices tied to the fire alarm system.</p> <p>The clearance under the bottom of a fire door shall be a maximum of 19mm. From edges and top shall be limited to a maximum 4.8 mm. All measurement shall be taken from the "pull side" of the door.</p> <p><b>Any modification of fire doors beyond the job site preparation shall be approved by the door manufacturer.</b></p> | Within 3 months |

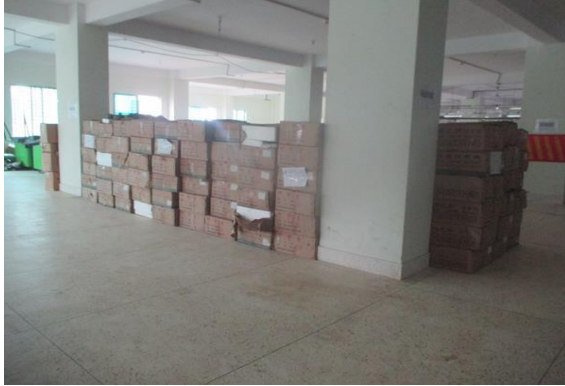
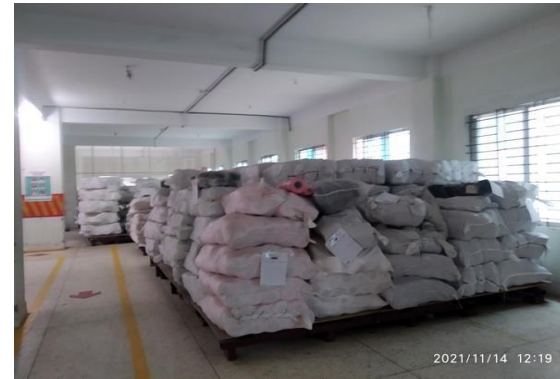
| F-4 | Fire rated construction | Areas used for in-process storage of combustible materials are open to the surrounding occupancy.<br>Location: Ground floor of factory building-2. | Provide defined storage areas and limit the storage arrangement as follows:<br>Maximum height of 2.45 m and maximum area of 23 m <sup>2</sup> and is separated by a minimum 3.0 m (10ft) from other storage areas and they do not exceed 10 percent of the building area of the story in which they occur. If sprinkler protected, Maximum height 12 ft (3.66 m) and maximum area of 1000 ft <sup>2</sup> (93 m <sup>2</sup> ) and separated by a at least 25 ft (7.62 m) from other storage areas and does not constitute more than 10 percent of the building area or 4000 ft <sup>2</sup> (372 m <sup>2</sup> ) of the sprinklered area, whichever is greater.<br>or,<br>Enclose the storage area from the surrounding occupancy with a minimum 1 hour construction. | Within 3 months |

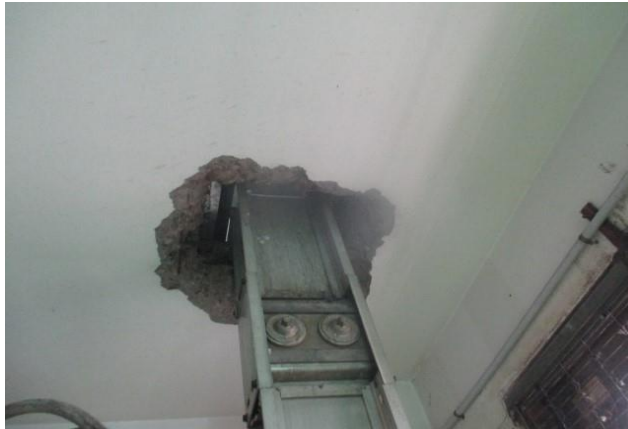
| F-5 | Fire Rated Construction | <p>Penetrations through fire rated floor/ceiling/wall assemblies are not properly sealed all floor of each level.</p> <p>Locations: Electrical riser ,Shaft enclosures</p> | <p>Seal all penetrations and openings in floor/ceiling (full thickness of the floor/ceiling) assemblies by minimum 3-hr fire-rated materials to maintain the required fire-resistance rating.</p> <p>If fire stopping materials with proprietary design are used for seal, then it shall be classified for the purpose it is used for. Also the installation shall be as per the proprietary design it has been tested with.</p> | Within 3 months |

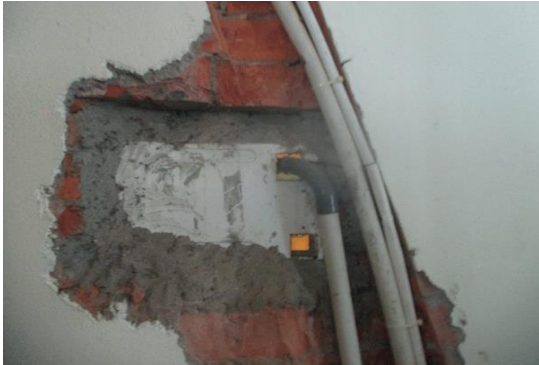
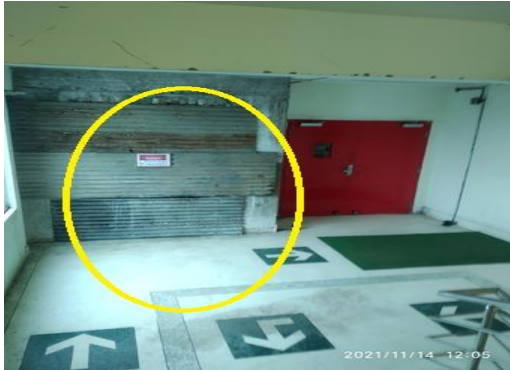
| F-6 | Fire rated construction. | Unsealed penetrations and openings are located in exit stair enclosures.<br>Location: Dining building & Factory building -2 | Seal all penetrations and openings in the wall of exit enclosure walls (full thickness of the wall) by fire rated materials to maintain the fire resistance rating. | Within 3 months |

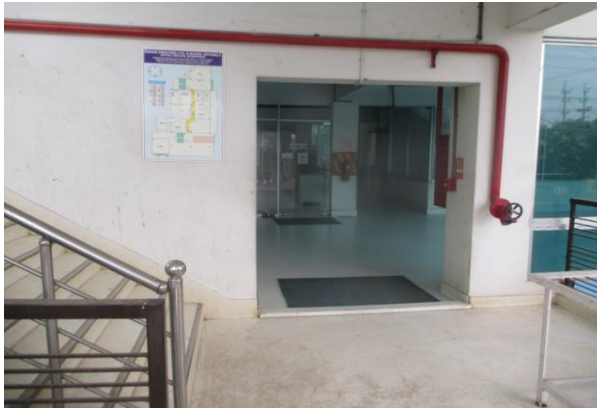
| F-7 | Means of Egress | Exit stairs do not discharge directly to the outside.<br>Location: Dining Building | <p>Modify stair to discharge directly outside.</p> <p>Or</p> <p>Provide 2-hr fire-rated exit passageway leading directly outside (vestibules to separate any storage areas).</p> <p>Or</p> <p>Provide sprinkler protection for discharge floor in accordance with NFPA 13 meeting Accord 6.17.3..</p> | Within 3months |

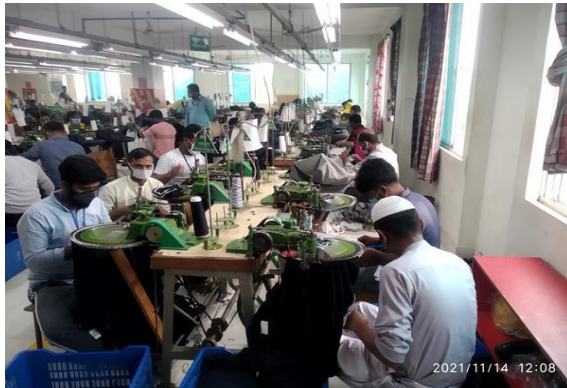
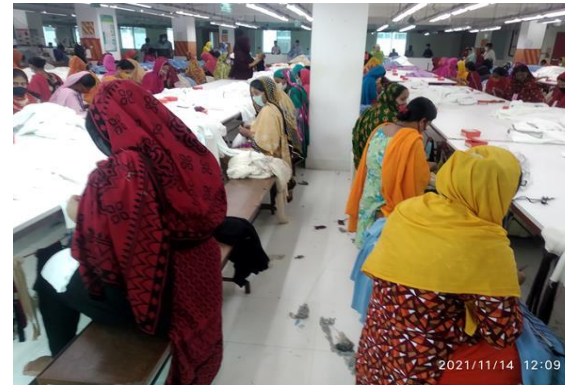
| F-8 | Means of Egress | Aisles are not marked at 2nd floor of Factory building-2(new). | Aisles shall be provided with a minimum unobstructed clear- with of 0.9m (36 in). Means of egress shall be maintained continuously free and clear of all obstructions/storage. | within 3 month |

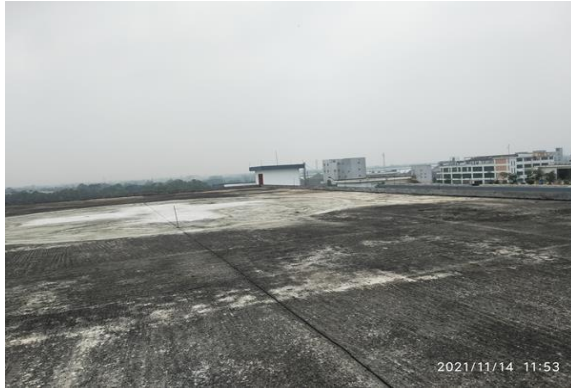
| F-9 | Means of Egress | Parapets or guards are provided in occupied roof which is less than 1067mm (42 inch)<br>Location: Factory building -2 new. | Provide parapets or guards with a minimum height of 1067mm (42 inch.). | Within 3 months |

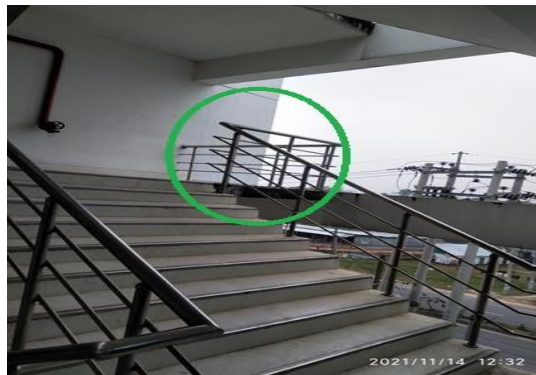
| F-12 | Means of Egress | Guards are not provided at falling hazards located at stair-2 of the dining building . | Provide all guards with a minimum height of 1067mm (42 inch.). | Within 1 month |

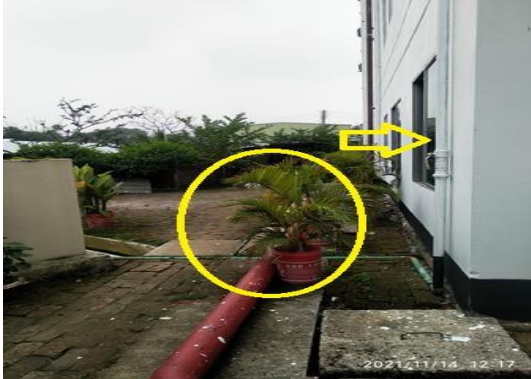
| F-13 | Fire Rated Construction | <p>The exit discharge path (Egress Court) was less than 10 ft wide and was not separated from the building interior.</p> <p>Location: North side of Factory building-2</p> | <p>Seal all penetrations and openings to the interior of the building along the discharge path, up to a height of 10 ft. to provide a minimum 2-hr fire separation.</p> <p>Means of egress shall be maintained continuously free and clear of all obstructions</p> | Within 3 months |
