# GMS Trims Ltd.

Sardaganj, Kashimpur, Gazipur-1346, Bangladesh  
(23.96674, 90.29609)

25<sup>th</sup> October 2021

# Observations

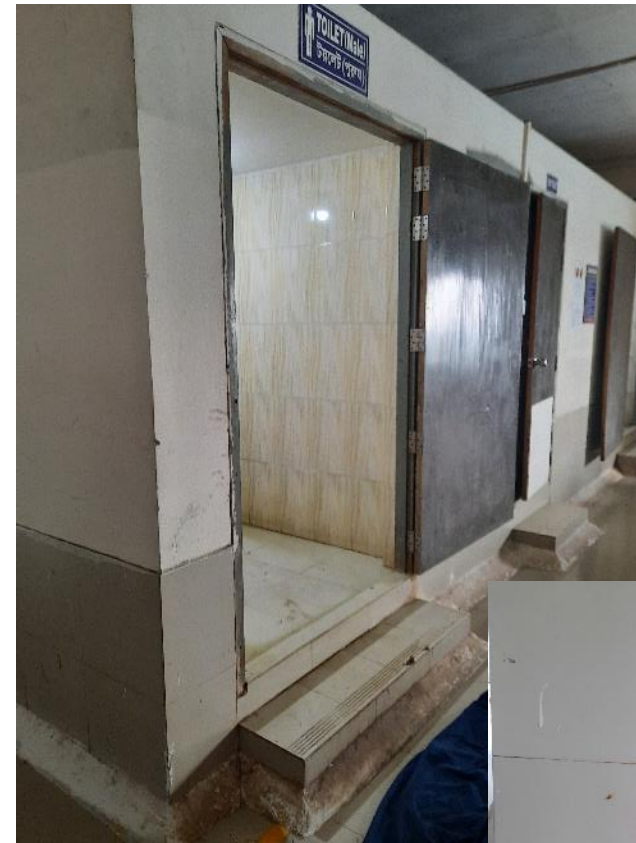
Additional super imposed loading. 350 mm toilet buildup and 120 mm false slab

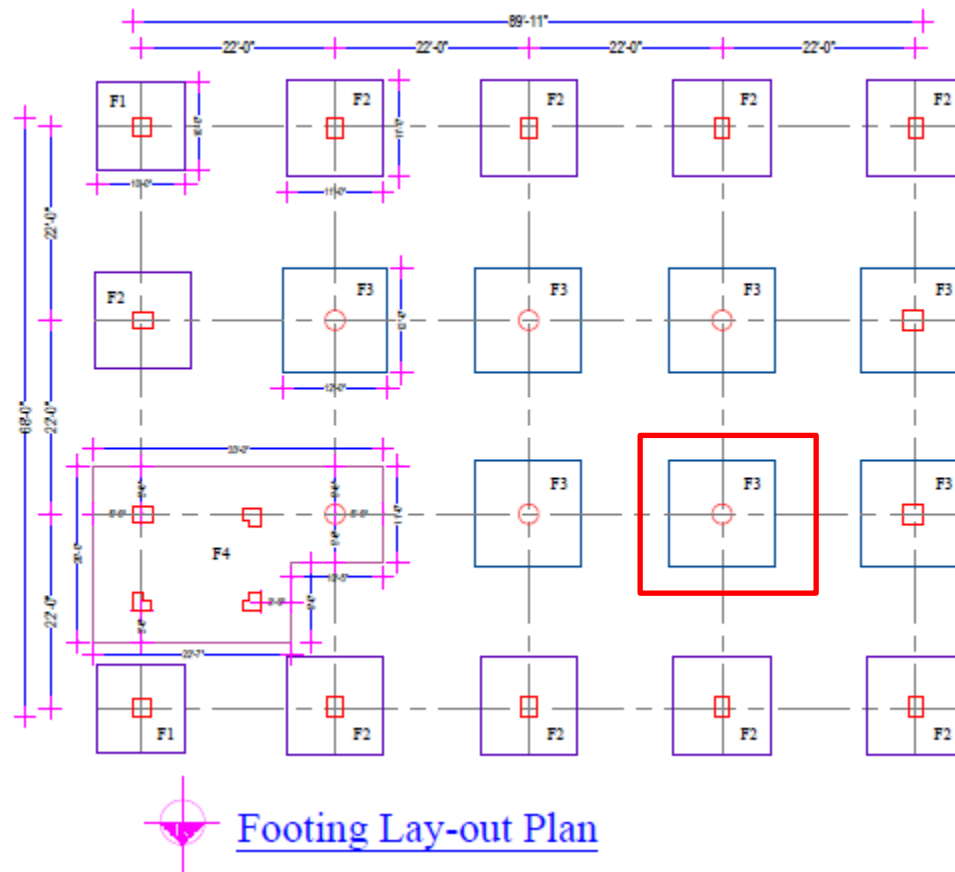
Footing Lay-out Plan

**Footings are stressed above normal design limit  
considering full construction**

The cursory calculation indicates that footings are stressed above the normal design limit for punching shear force considering the equivalent concrete strength from the core test data. Building engineer is required to review the foundation stresses of the area identified above before commencing further construction works.

As per design report some of the footings are overstressed due to punching shear.

| Item No. | Observation | Recommended Action Plan | Recommended Timeline |
|---|---|---|---|
| 07 | Footings are stressed above normal design limit considering full construction. (Building 2) | Before commencing any further construction, building engineer is required to review the design of foundation. | Immediate - Now |
| 08 | Footings are stressed above normal design limit considering full construction. (Building 2) | Building engineer is required to review the foundation stresses of the area identified above. | 6-weeks |
| 09 | Footings are stressed above normal design limit considering full construction. (Building 2) | Building Engineer to prepare design report as per BNBC (part 6; Article 1.9.1) by reviewing design, loads, capacity of structural members & serviceability issues. | 6-weeks |

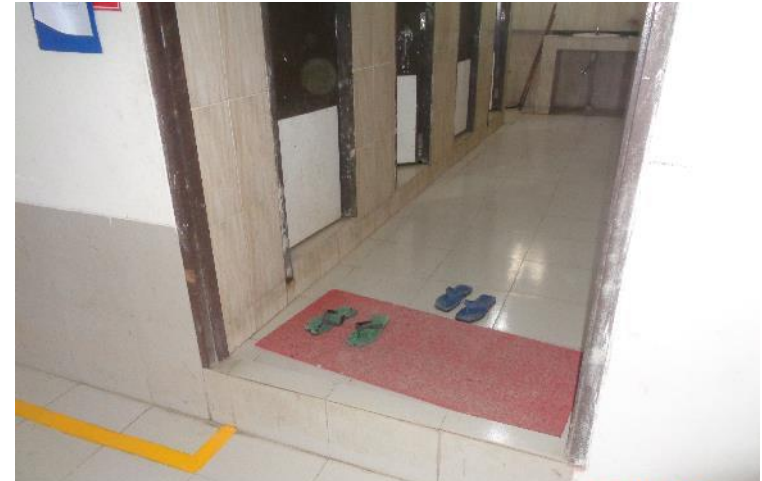
Additional super imposed loading. 300 mm toilet buildup.

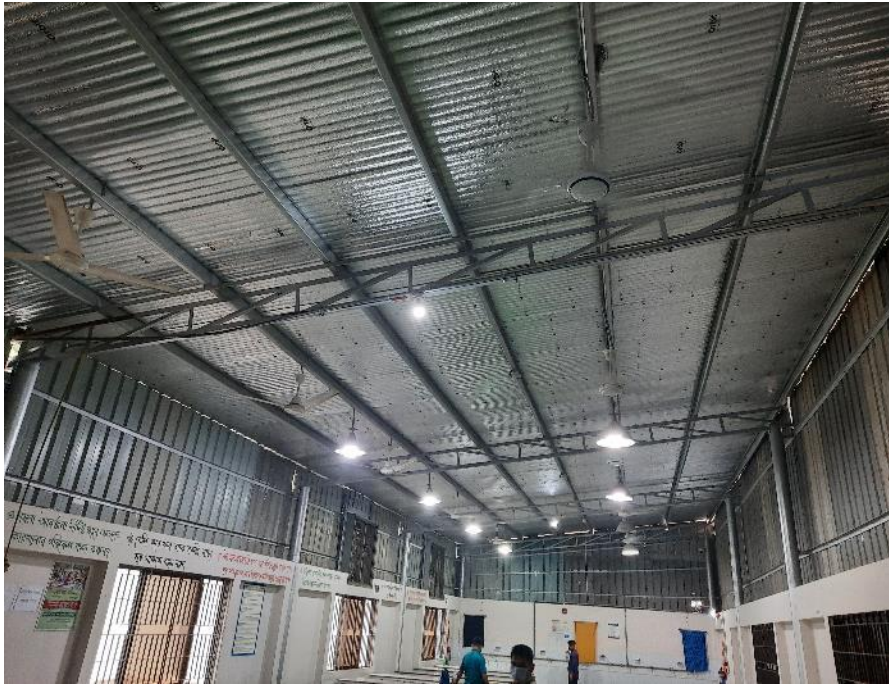
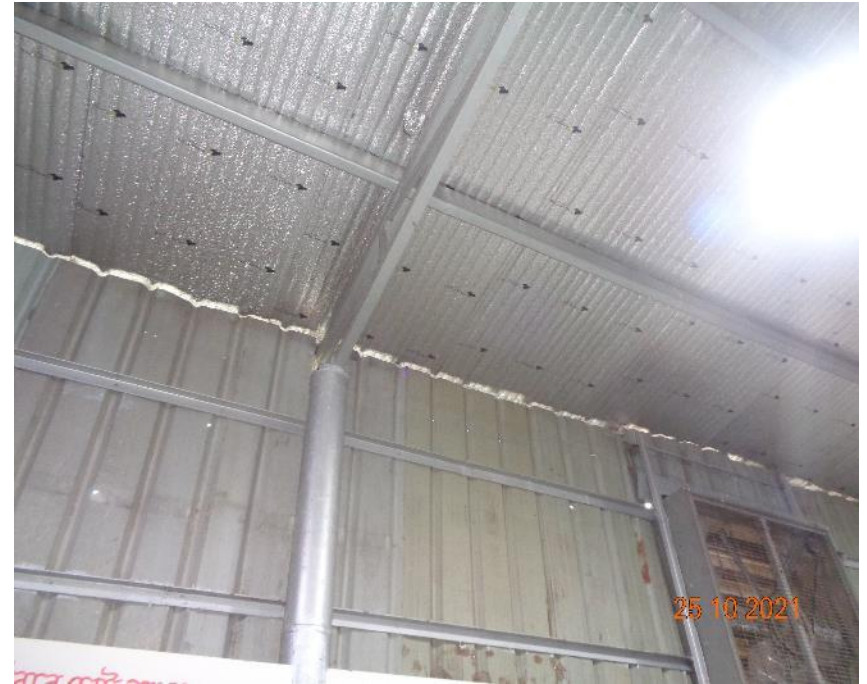
## Observations Shed 1

Apparently lack of lateral load resisting system observed in shed 1. Truss action in the short direction no compression strut and bracing observed in the long direction. Building engineer is required to check the lateral stability of the shed.

| Item No. | Observation | Recommended Action Plan | Recommended Timeline |
|---|---|---|---|
| 13 | Apparently lack of lateral stability system. (Shed 1) | Building engineer is required to check the lateral stability of the structure and suggest proper remedial actions accordingly. | 6-weeks |
| 14 | Apparently lack of lateral stability system. (Shed 1). | Carryout remedial works where required | 6-months |

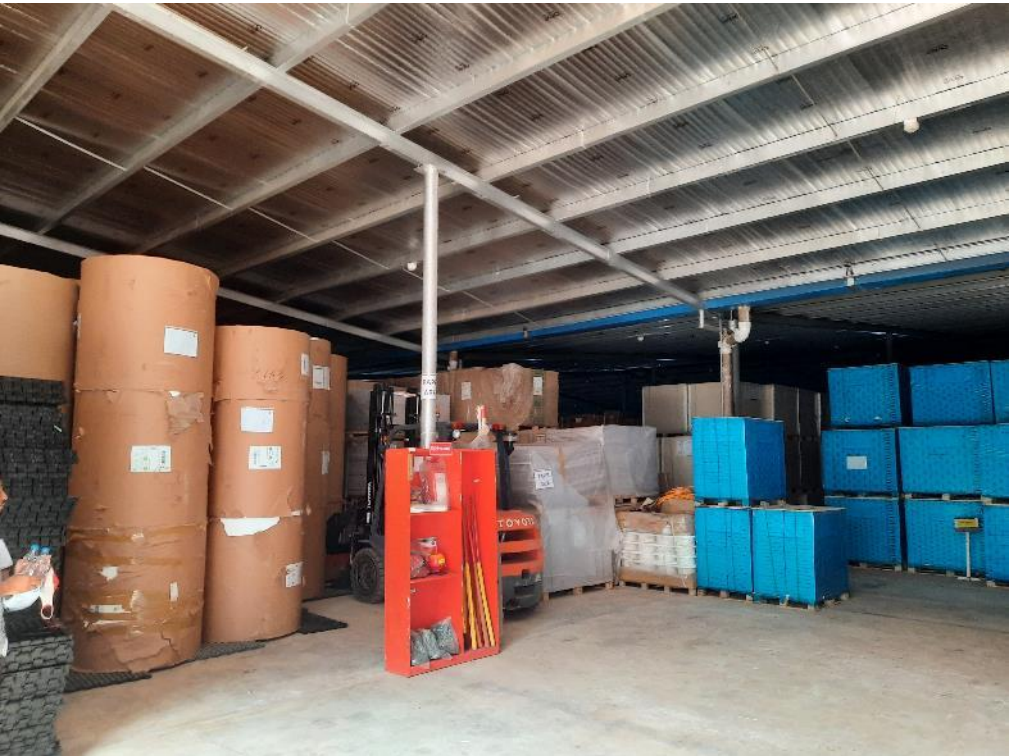
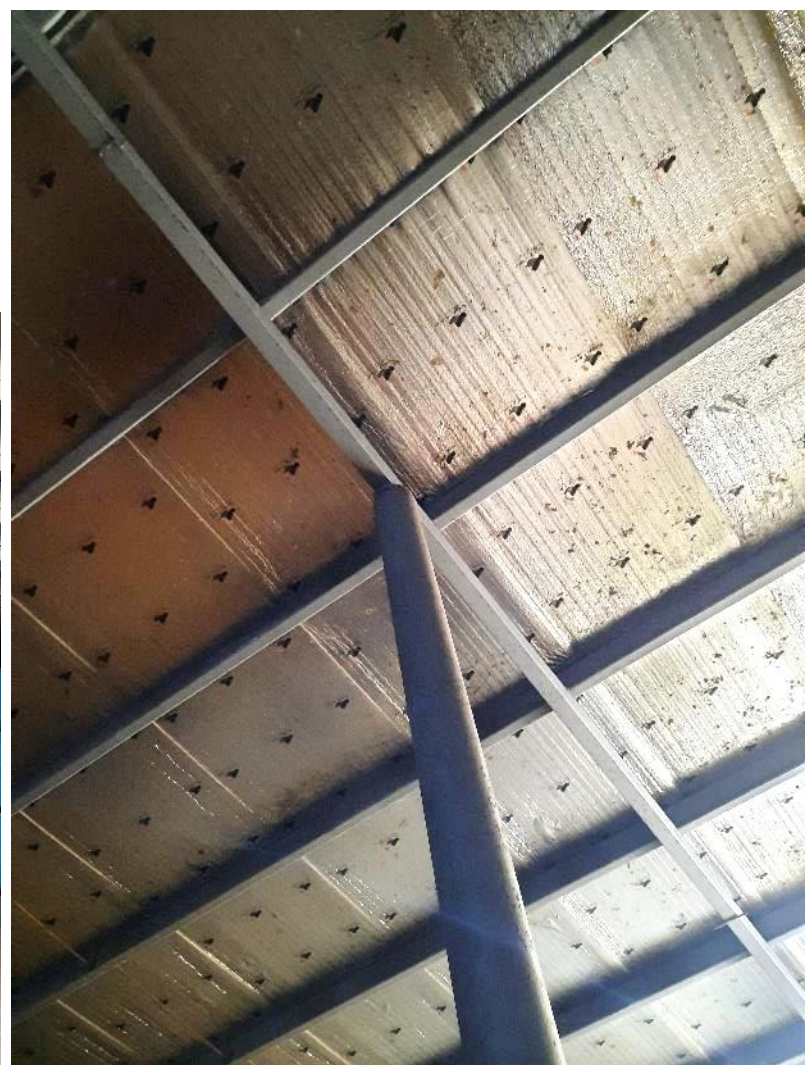
## Observations Shed 2

Apparently lack of lateral load resisting system observed in shed 2. Apparently inadequate member, no compression strut, bracing observed in the long direction & poor connection found. Building engineer is required to check the lateral stability of the shed.

| Item No. | Observation | Recommended Action Plan | Recommended Timeline |
|---|---|---|---|
| 15 | Apparently lack of lateral stability system. (Shed 2) | Building engineer is required to check the lateral stability of the structure and suggest proper remedial actions accordingly. | 6-weeks |
| 16 | Apparently lack of lateral stability system. (Shed 2). | Carryout remedial works where required | 6-months |

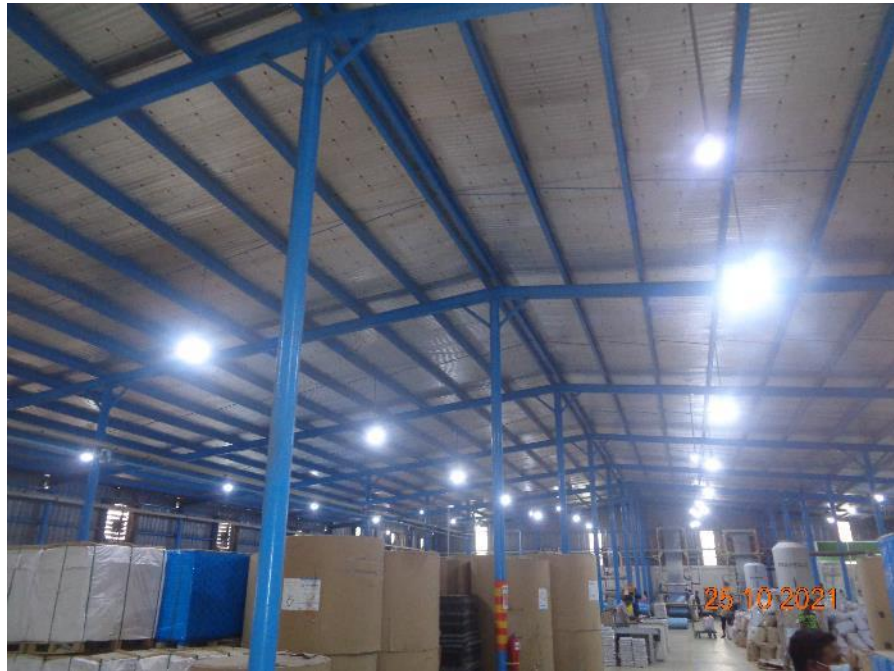
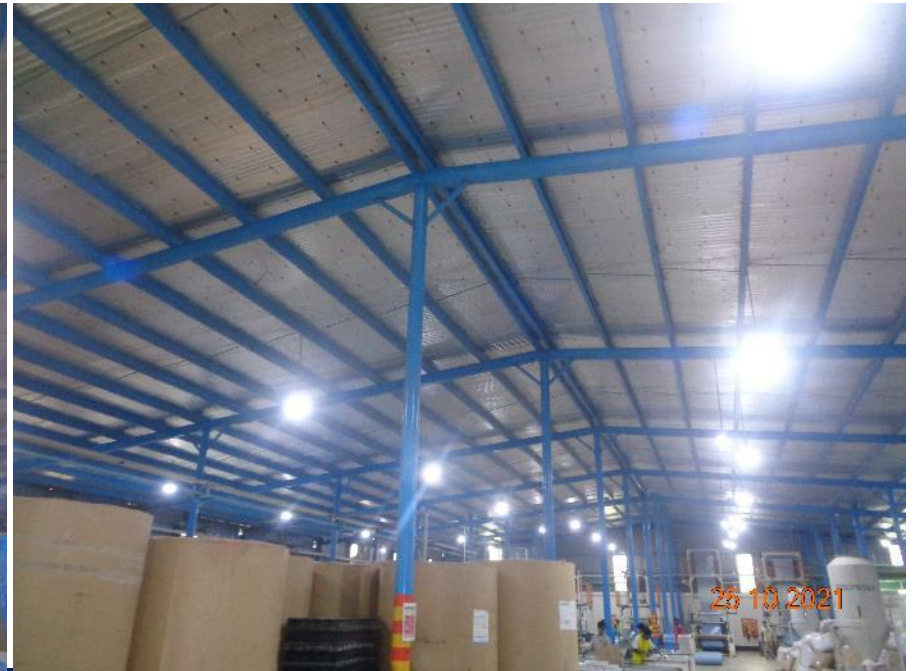
## Observations Shed 4

Apparently lack of lateral load resisting system observed in shed 1. Only frame action in short direction. No compression strut and bracing observed in the long direction. Building engineer is required to check the lateral stability of the shed.

| Item No. | Observation | Recommended Action Plan | Recommended Timeline |
|---|---|---|---|
| 17 | Apparently lack of lateral stability system. (Shed 4) | Building engineer is required to check the lateral stability of the structure and suggest proper remedial actions accordingly. | 6-weeks |
| 18 | Apparently lack of lateral stability system. (Shed 4). | Carryout remedial works where required | 6-months |
