Simba Fashions Ltd (plot#124)

Plot# 124, Adamjee EPZ, Siddhirganj, Narayanganj
(23.67399, 90.52762)
9th November 2021

1. Building 1 (G+5) (Partially 6-Storeyed)

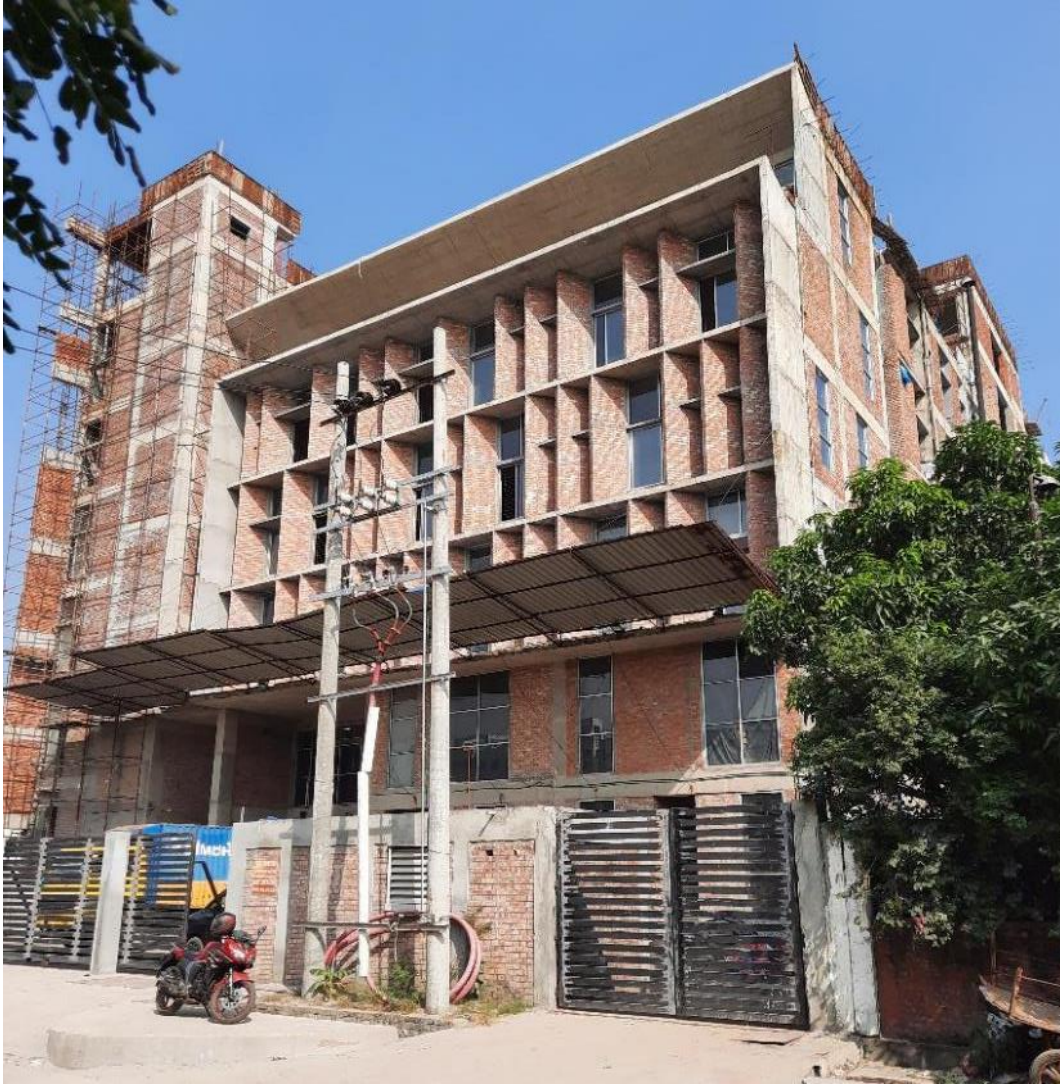
Structural design report not available

As per BNBC, every buildings or structures designed shall have its design documents prepared in accordance with the provision of Section 1.9.1. The design document including a design report, and a set of structural drawings, which shall be prepared in compliance with section 1.9.1.1 and section 1.9.1.2 as per BNBC. At the time of inspection, no design report was available which is required to be prepared in compliance with section 1.9.1.1 (part-6, BNBC).

Item No.	Observation	Recommended Action Plan	Recommended Timeline
01	Structural design report not available. (Building 1)	Building engineer to prepare the Design report in compliance with section 1.9.1.1 and section 1.9.1.2 as per BNBC. The report must include all the structural members (Beam, Column, Slab, Foundation, Retaining wall) adequacy & serviceability checks.	6-weeks
02	Structural design report not available. (Building 1)	Produce and actively manage a loading plan for all floor plates within the factory considering floor, column and foundation capacity.	6-weeks
03	Structural design report not available. (Building 1)	Carryout remedial works where required.	6-months
04	Structural design report not available. (Building 1)	Continue to implement loading plan.	6-months
05	Construction safety practice not maintained properly. (Building 1)	Building engineer is required follow the safety guidelines illustrated in BNBC (Chapter-3).	Immediate - Now

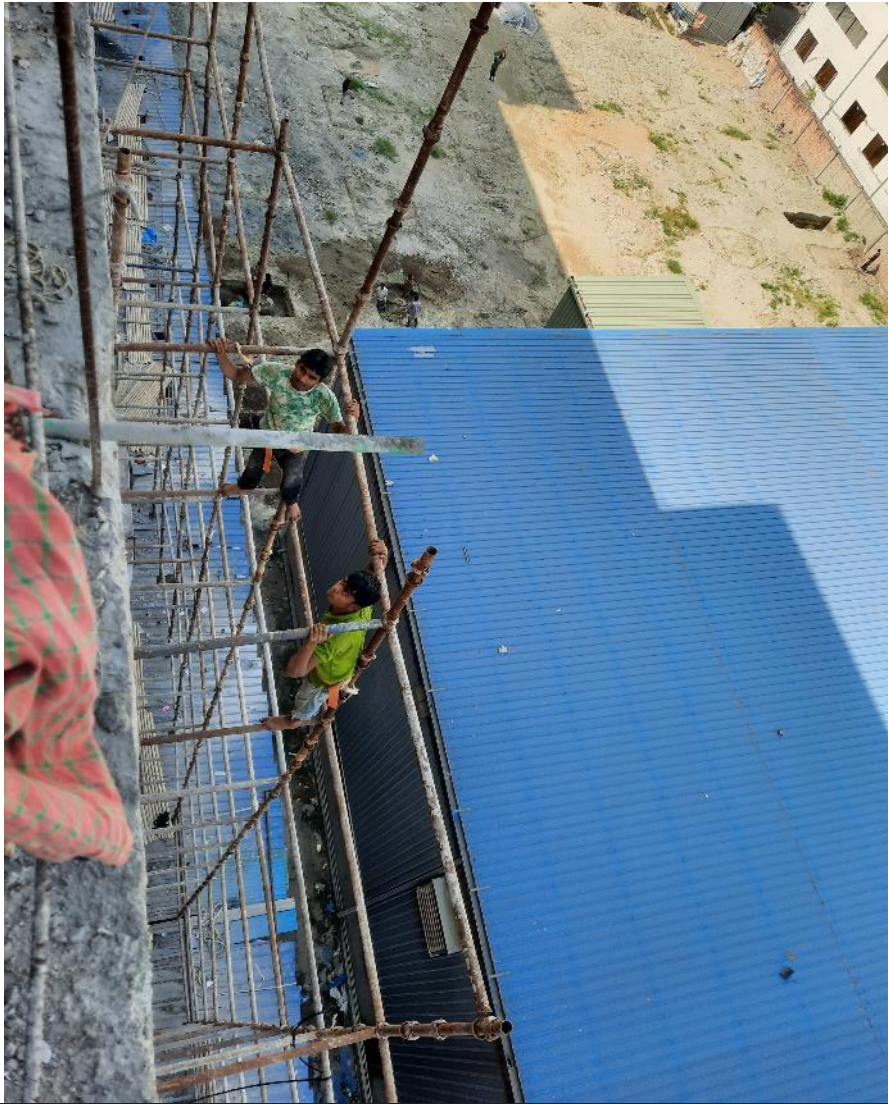
Construction safety practice not maintained properly

Construction worker not using PPE

Item No.	Observation	Recommended Action Plan	Recommended Timeline
06	Construction safety practice not maintained properly. (Building 1)	All personnel related to the construction work, must wear PPE during construction. BDS standard must follow for PPE.	Immediate - Now
07	Construction safety practice not maintained properly. (Building 1)	Safety guarder/ guard rail/ edge protection must be provided around the building.	Immediate - Now

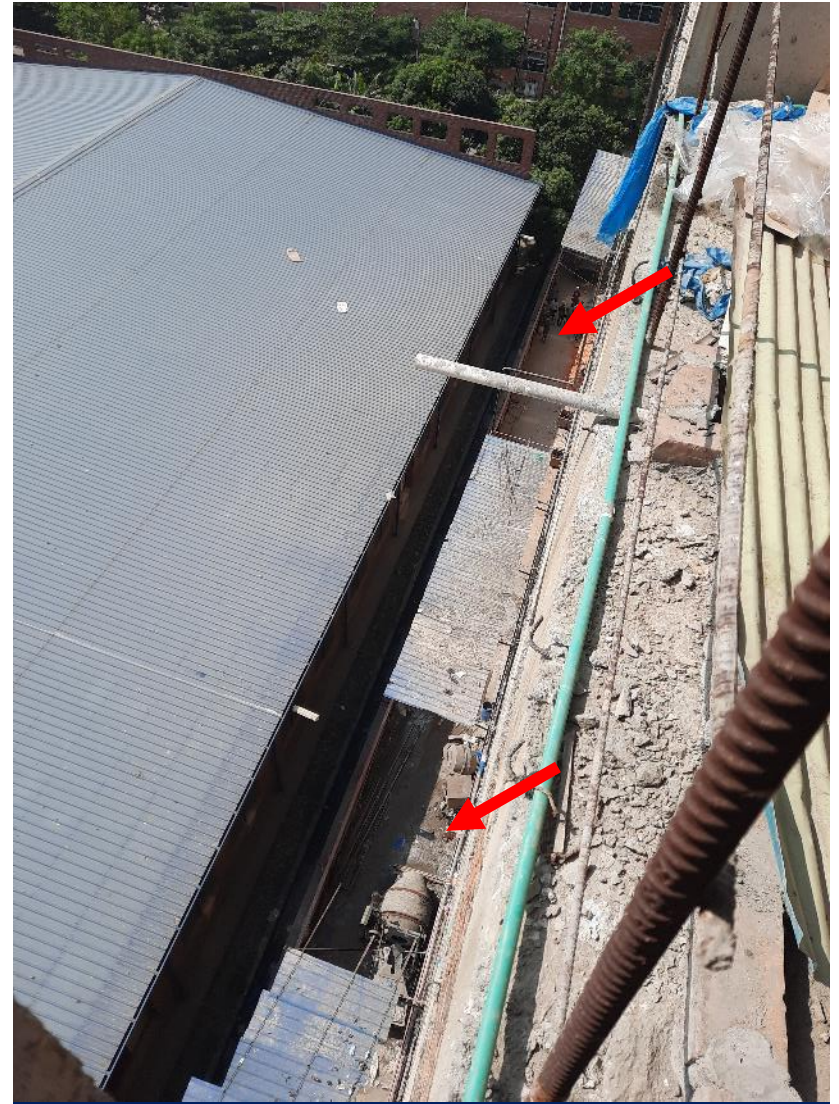
Edge protection/Safety guardrails not provided

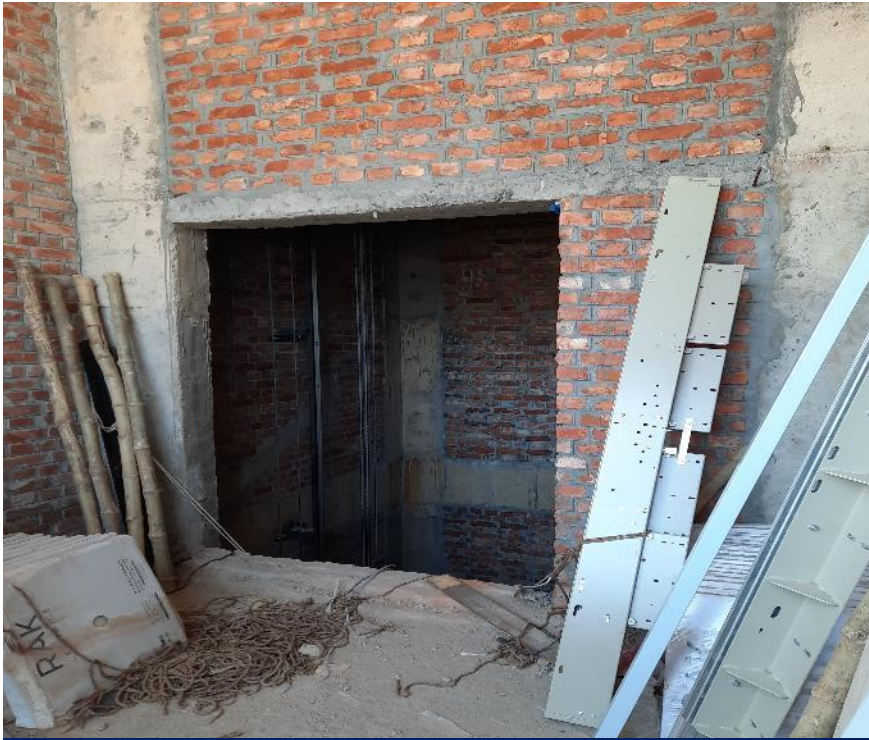
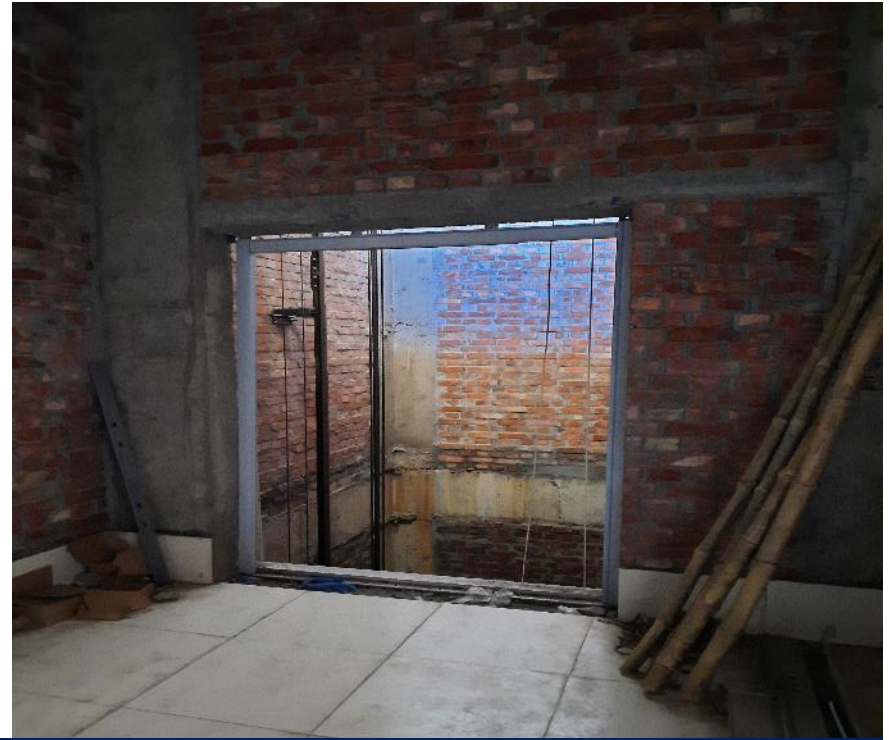
No guardrails around the lift core
