# INITIAL FIRE SAFETY INSPECTION REPORT

**Hamza Clothing Ltd.**

**RSC ID: 24110**

**Date: 26 August 2021**

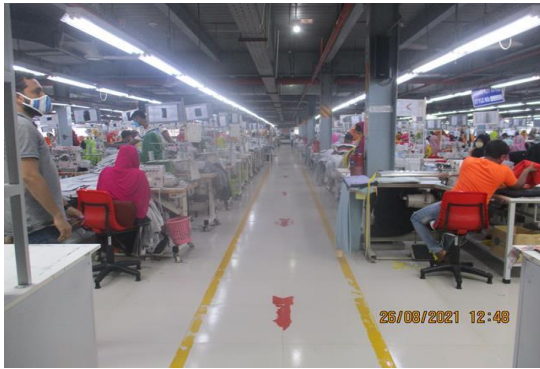
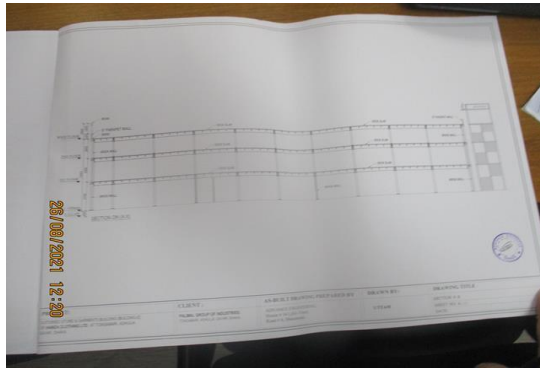
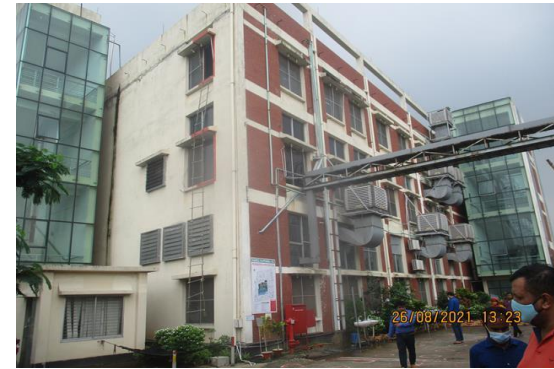
SI No.	Category	Findings	Required Action	Remediation Time Frame
1	Fire Rated Construction	<p>The main structural element of the building is constructed by steel which is non-rated and were found in exposed condition without any fire protection.</p> <p>[Main Building and Building-N (1st floor)]</p>	<p>The building is a new steel structure which shall be type-I or II construction (based on table 3.1.9 of BNBC 2006). So, provide require rating in the structural elements of the building. Consult with a qualified fire protection engineer. Follow BNBC 2006-Table 3.2.4, 3.1.9 and 3.3.1 as reference.</p>	<p>Within 6 months</p>

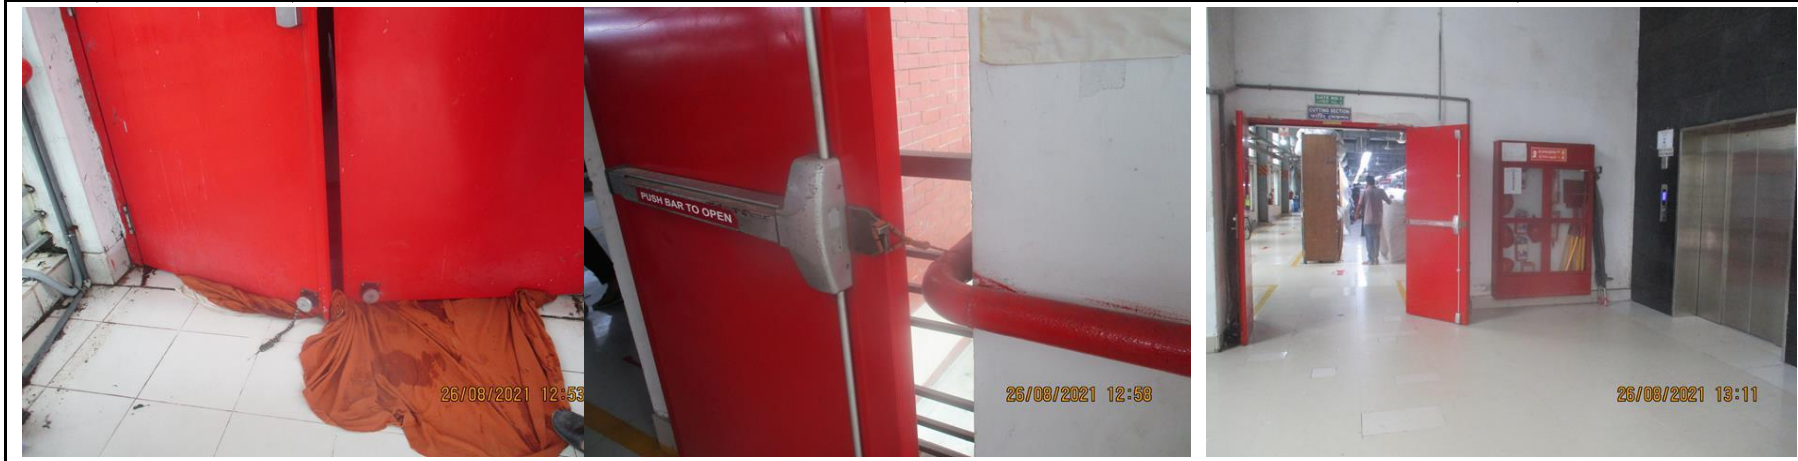
2	Fire Rated Construction	<p>Exit Enclosures are not properly fire separated from other occupancy on each floor due to non-functionality of fire rated doors. The fire rated doors are installed with main building where the stair portion is constructed by RCC. However, most of the doors were found open using external objects.</p> <p>Location : Main Building .</p>	<p>Provide minimum 1-hr fire rated separation in exit enclosures with minimum 1-hr fire rated doors and seal all unprotected openings and penetration to separate the exit stairs from work areas and other building spaces on all floor levels with similar rating of fire door.</p> <p>Ensure that the fire doors are self-closing and positive latching and that they are provided with fire exit (panic) hardware where serving production floors. If fire doors are required to be held open for functional reasons, provide automatic closing devices tied to the fire alarm system.</p>	Within 3 months

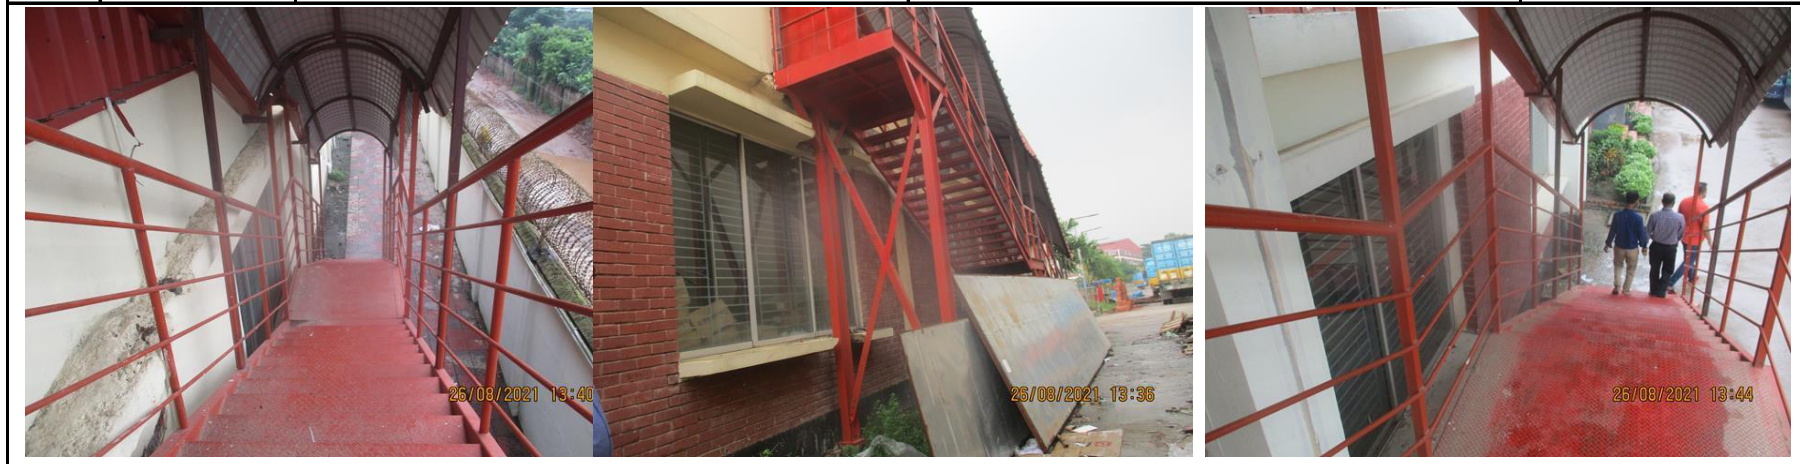
3	Fire Rated Construction	<p>The exterior stairs for building-N is not fire separated properly due to unprotected openings within 10 ft distance.</p> <p>(Building-N)</p>	<p>Exterior exit stairs shall be separated by minimum 1-hr fire-rated construction and the rating of the exterior wall shall extend 3.05 m (10 ft.) beyond the ends of the stair structure. Provide minimum 1-hr fire rated doors to separate the exit stairs from work areas and other building spaces on all floor levels. Ensure that the fire doors are self-closing, positive latching and that they are provided with fire exit (panic) hardware where serving production floors.</p> <p>If fire doors are required to be held open for functional reasons, provide automatic-closing devices tied to the fire alarm system.</p>	Within 3 months
---	-------------------------	---	--	-----------------

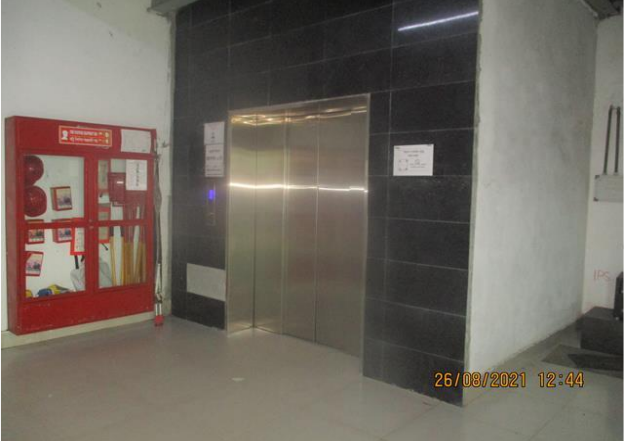
4	Fire Rated Construction	<p>Elevator shafts are directly open inside of stair enclosure which is a violation of ACCORD Standard-6.14.3.</p> <p>Location: Main Building.</p>	<p>In new construction, elevators shall not open into an exit enclosure [Accord Building Standard 6.14.3]. So, rearrange the facility to provide separate enclosure for lifts with 2-hr fire rating.</p>	<p>Within 3 months</p>

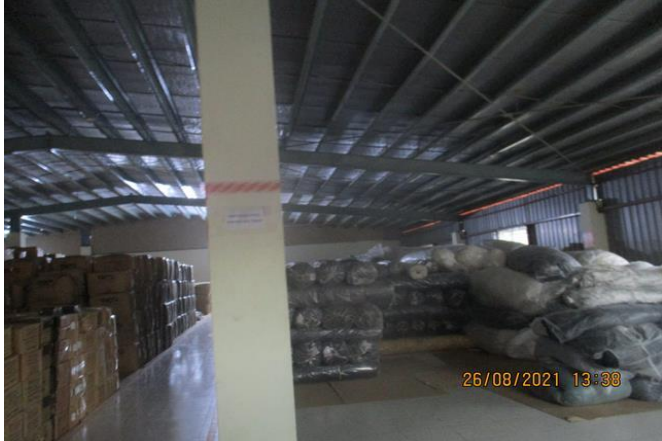
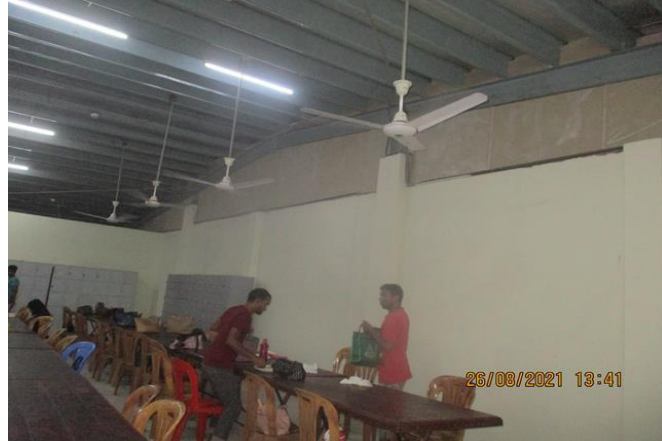
5	Fire Rated Construction	<p>Store room are not properly fire separated with dining area (E4-280 people) on 1st floor of building-N.</p>	<p>Provide 3-hr fire separation in-between store and dining on 1st floor of the dining building.</p>	<p>Within 3 Months</p>

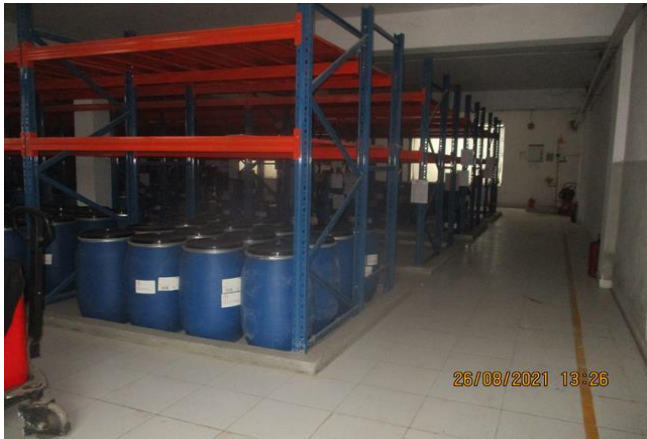
6	Means of Egress	Common path of travel for chemical store was more than 8 m.	Reconfigure the exit arrangement so that the common path of travel does not being more than 8 m on ground floor chemical store of building-N.	1 Month
---	-----------------	---	---	---------

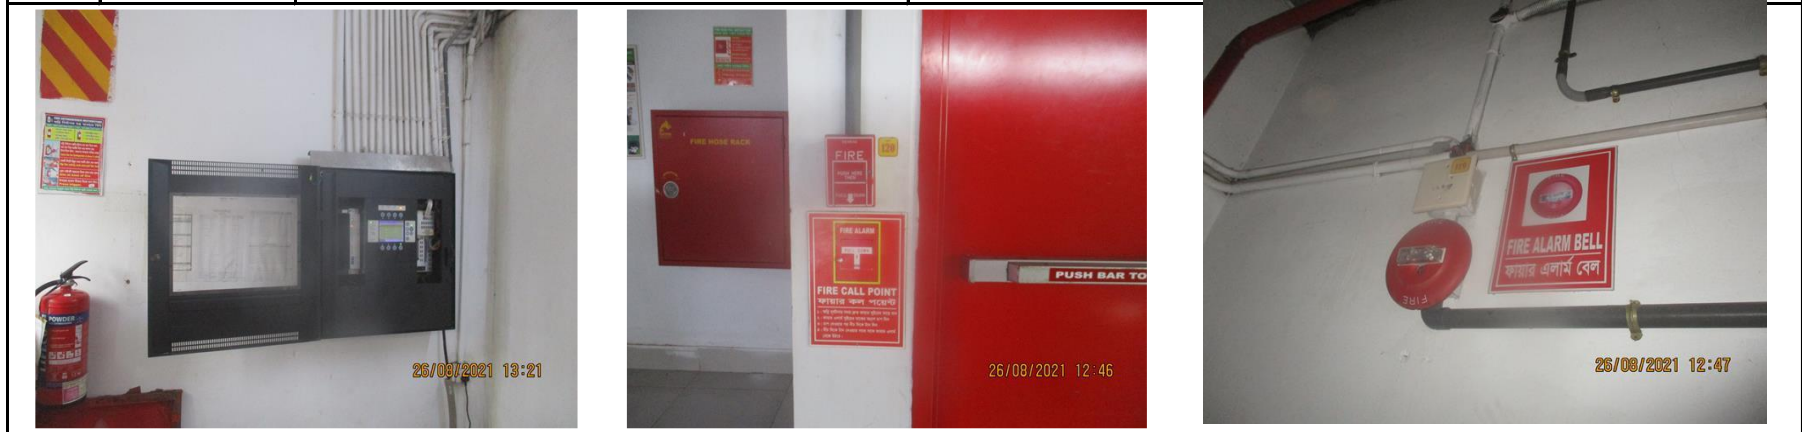
7	Fire Alarm & Detection System (FADS)	Fire alarm system installation requires detailed review to confirm compliance with NFPA 72 and ACCORD standard.	<p>Design &amp; Installation of Fire Alarm system shall be in accordance with ACCORD standard and NFPA 72. Submit design, documents and calculations to RSC for review prior installation/modification.</p> <p>After installation the owner shall contact the RSC for witness of conducting the final acceptance testing of the fire detection &amp; alarm system installation.</p> <p>Also inspect, test and maintain the fire alarm system, and keep written records on-site, in accordance with NFPA 72.</p>	Design within 2 months, Install within 4 months.
---	--------------------------------------	---	---	--

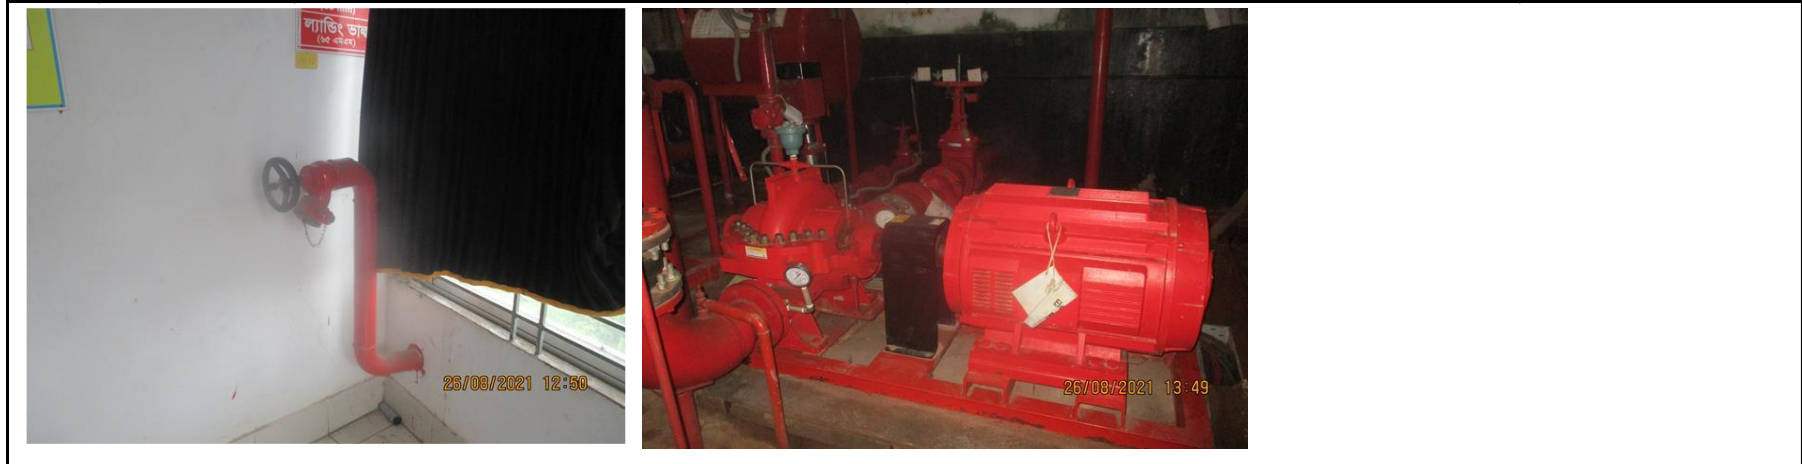
8	Fire Protection System (Standpipe)	<p>Standpipe System installation requires detailed review to confirm compliance with NFPA 14, 20, 22 &amp; 24 and ACCORD standard.</p> <p>Location: Main Building.</p>	<p>Submit the standpipe system drawing to RSC for review. Once reviewed, install or modify the standpipe system throughout the building in accordance with Accord standard and NFPA 14, 20, 22 and 24. After installation the owner shall contact the RSC for witness of conducting the final acceptance testing of the fire detection &amp; alarm system installation.</p>	<p>Design within 2 months, Install within 4 months.</p>
---	------------------------------------	--	---	---
