IMPRESS FASHION LTD.

Dag No. 2224, Matuial, Konapara Katherpool, Jatrabari, Dhaka-1362
(23.713984N, 90.462352E)

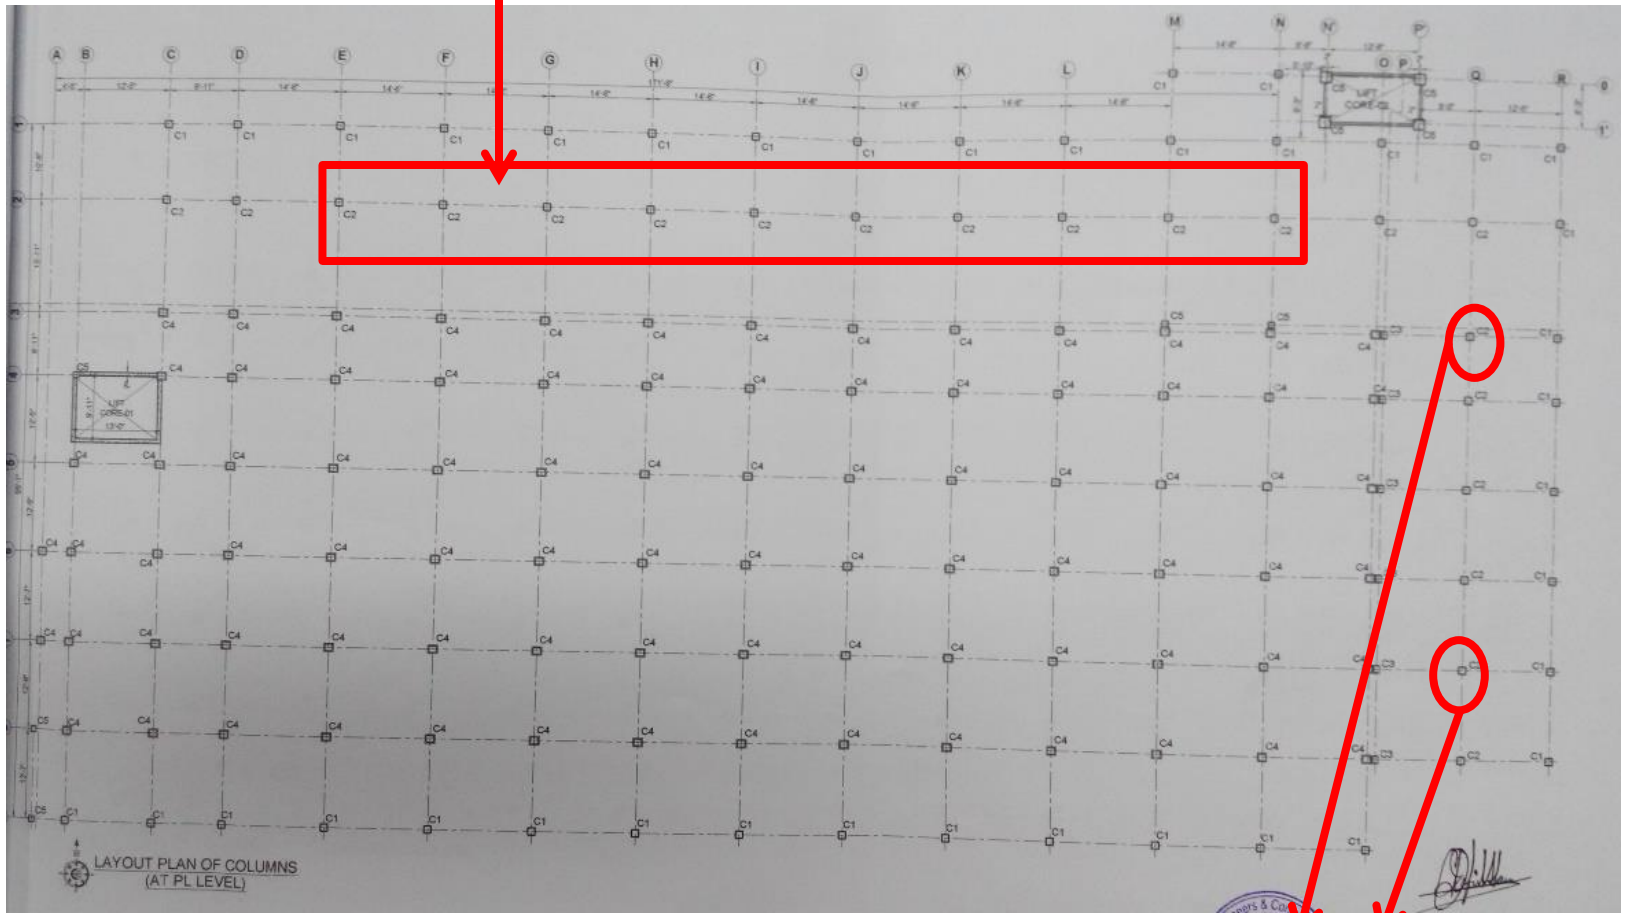
Overstressed Columns

High stress on column.

Highly Overstressed columns

High stress on column

High stress on column

- Maintain 1 kPa load on this area (page 4) of all floors.
- Area shown on page 4 of 7th floor and roof cannot be used and cordon the construction work of toilet block before the revision of the detailed engineering assessment and maintain 1Kpa load on other floors.
- Verify insitu concrete stresses by considering existing core data and evaluate concrete strength using ACI code 562.
- Revise Detailed engineering assessment.

- Revise and actively manage a loading plan for all floors within the factory giving consideration to floor capacity and column capacity.
- Detail Engineering Assessment to be revised

- Continue to implement load plan
- Carry out remedial actions raised by Detail Engineering Assessment

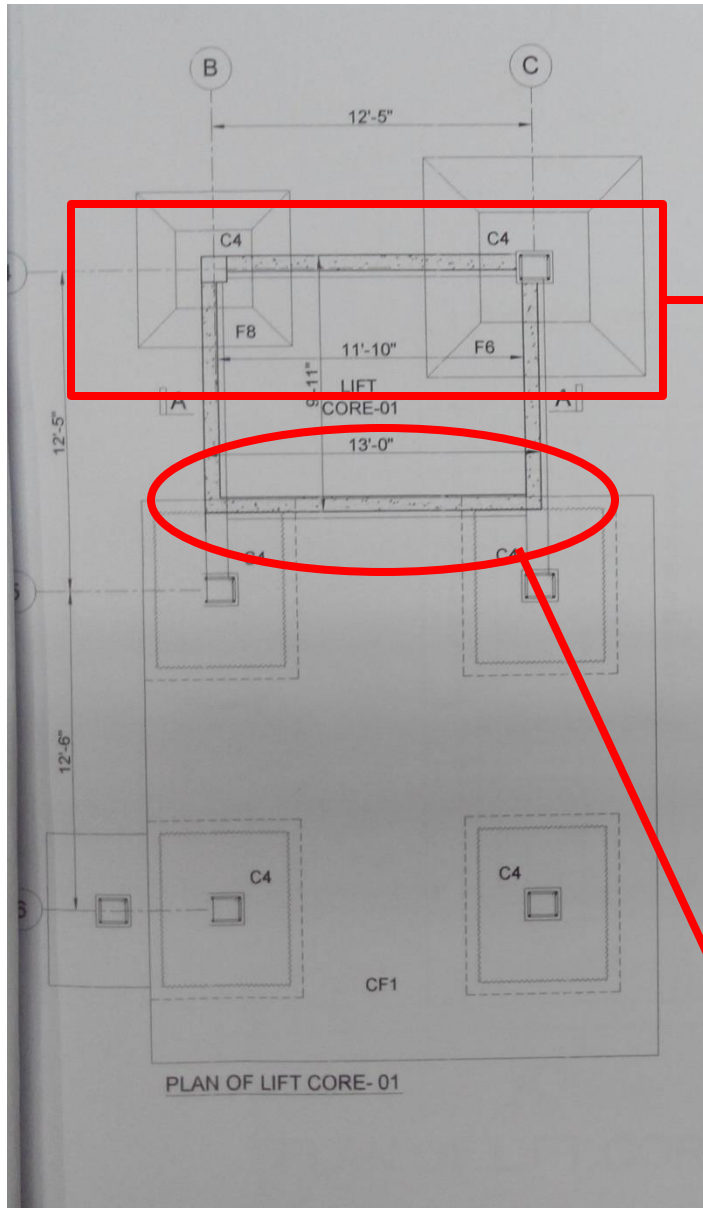
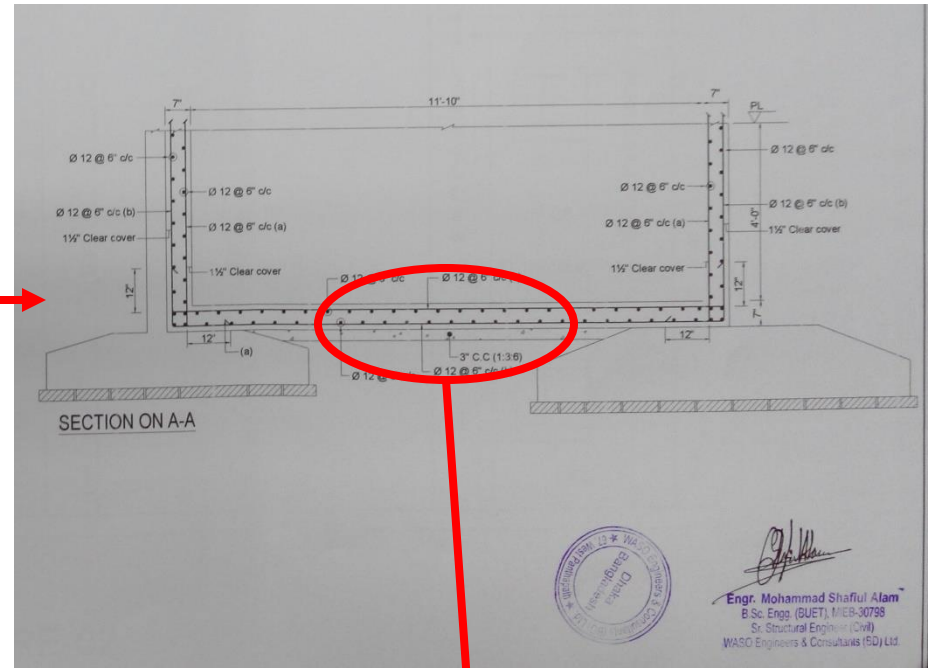
Unusual foundation of shear wall

Support system is not clear

Foundation and load path is not clear.

- Investigate the foundation of shear wall.
- Revise Detail Engineering Assessment and check the foundation adequacy.

- Implement remedial actions raised or suggested by Detailed Engineering Assessment

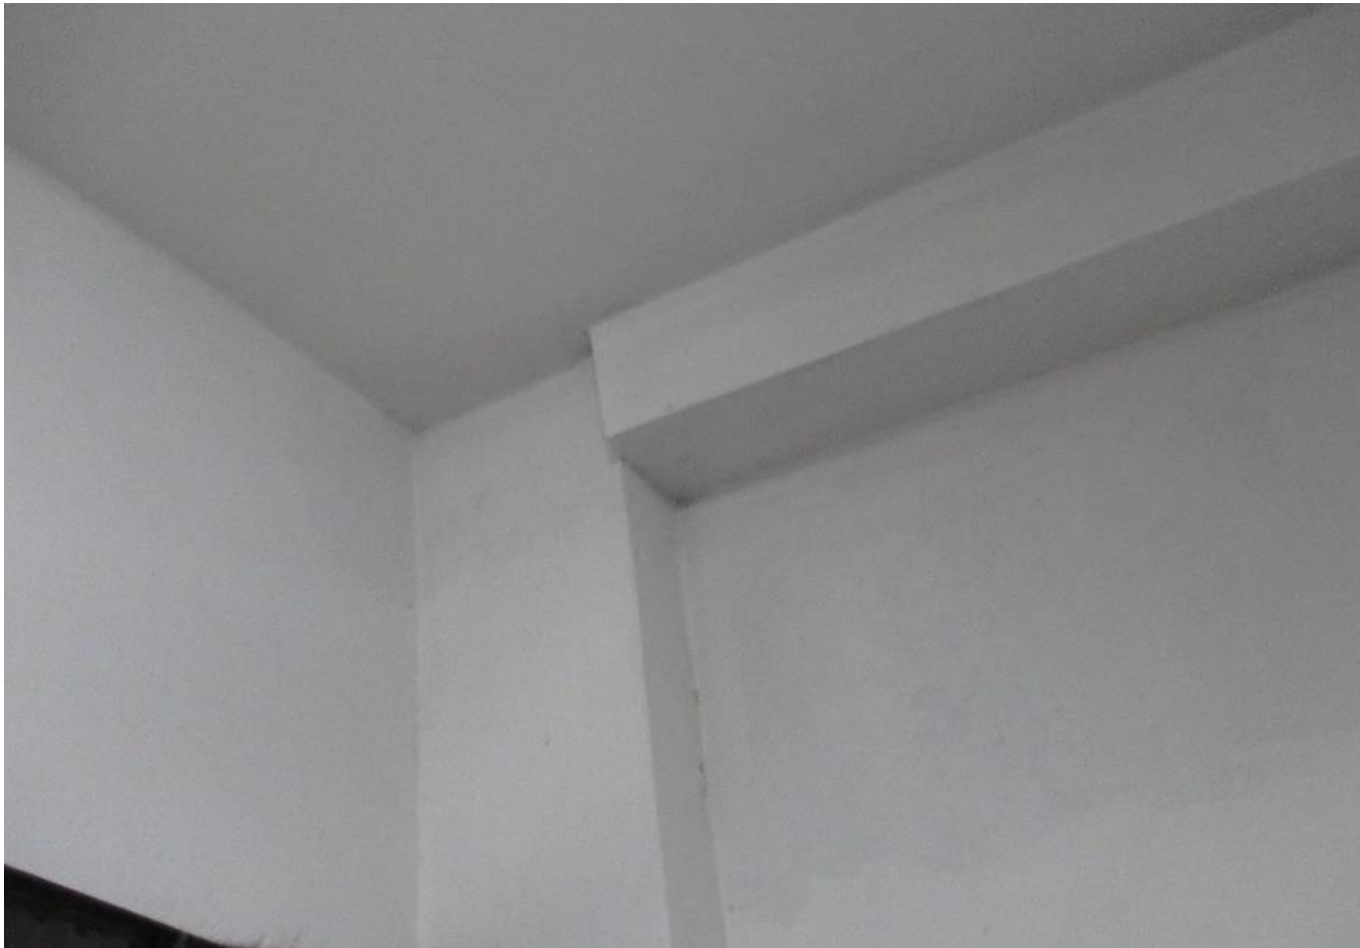
Joint of beams and columns

Beam and column joint on 2nd floor

Connection of beams with columns and load path needs to be checked

- Check reinforcement details of those beams.(take pictures during investigation)
- Revise Detailed Engineering Assessment.

- Implement remedial actions raised or suggested by Detailed Engineering Assessment

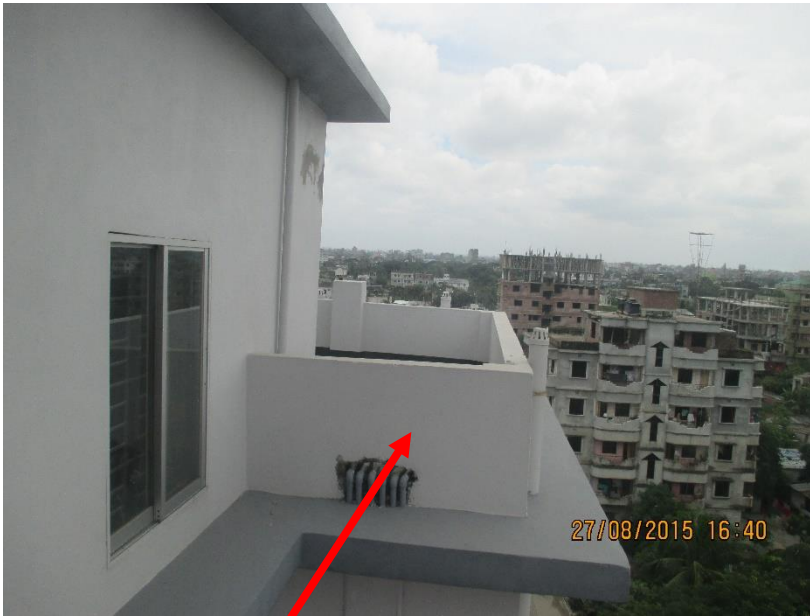
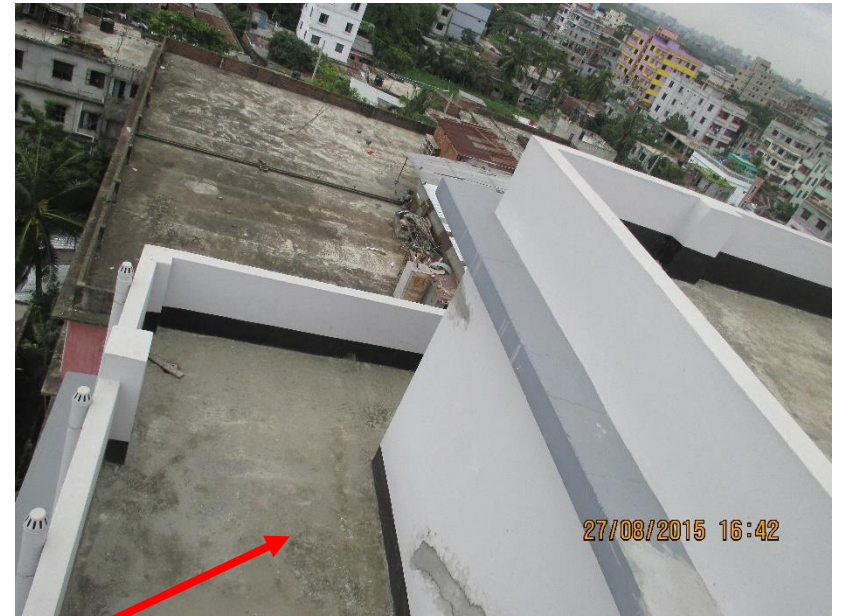
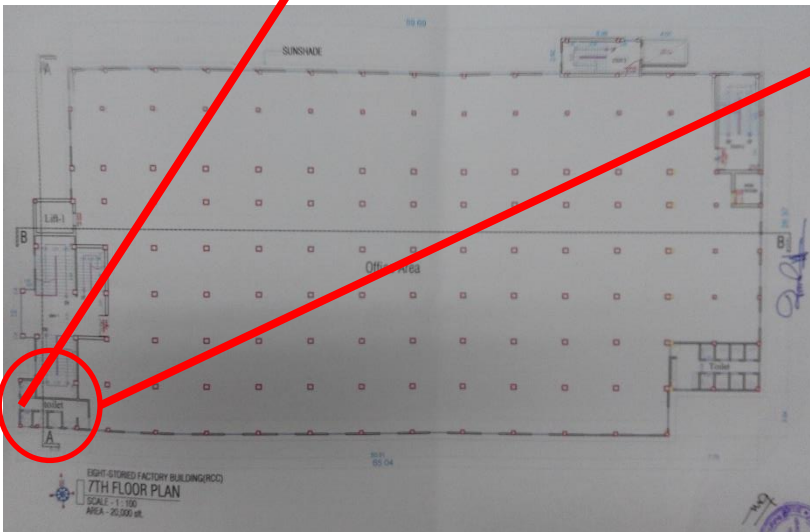
Inconsistencies of drawings and As built construction.

Architectural drawings of 7th floor plan don't match with actual situation.

- Update of As-built architectural and structural drawings.

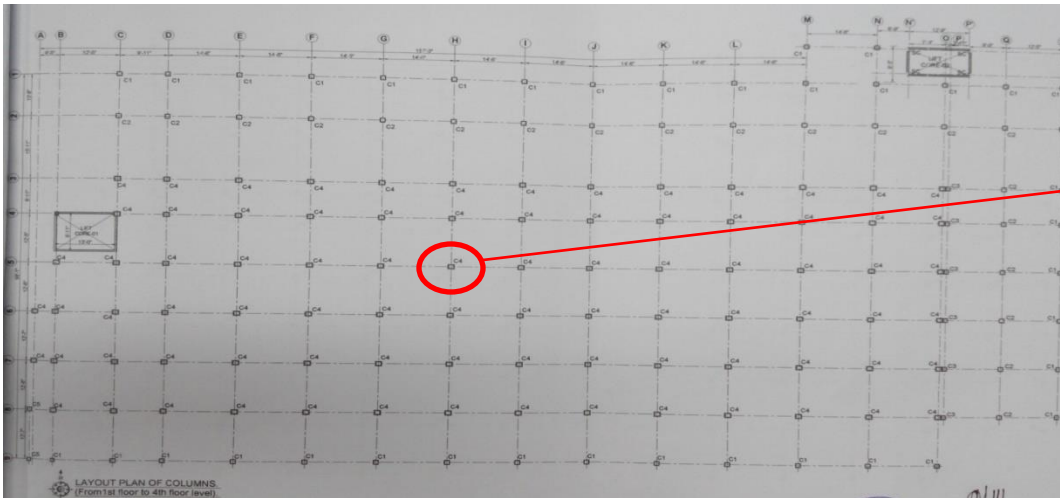
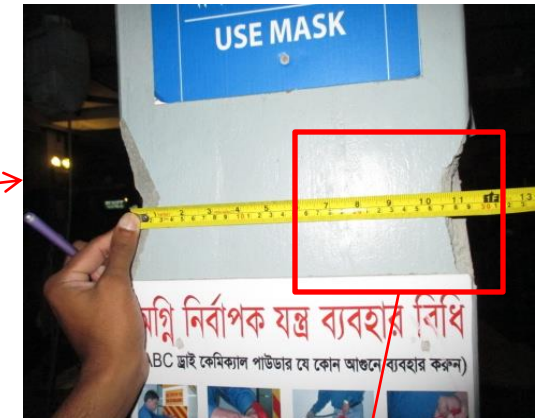
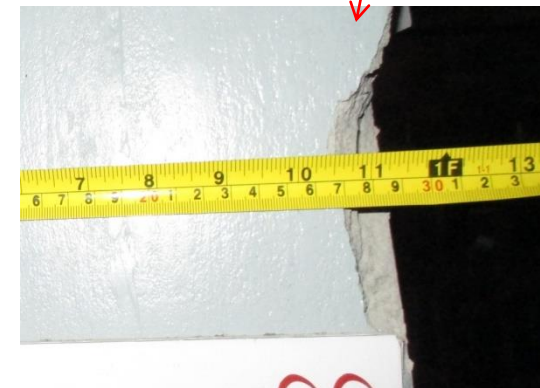
Size of some columns on site was found to be less than the that of the provided drawings.

Indicated column appears to be 11 inch without plaster where drawing states 12 inch.

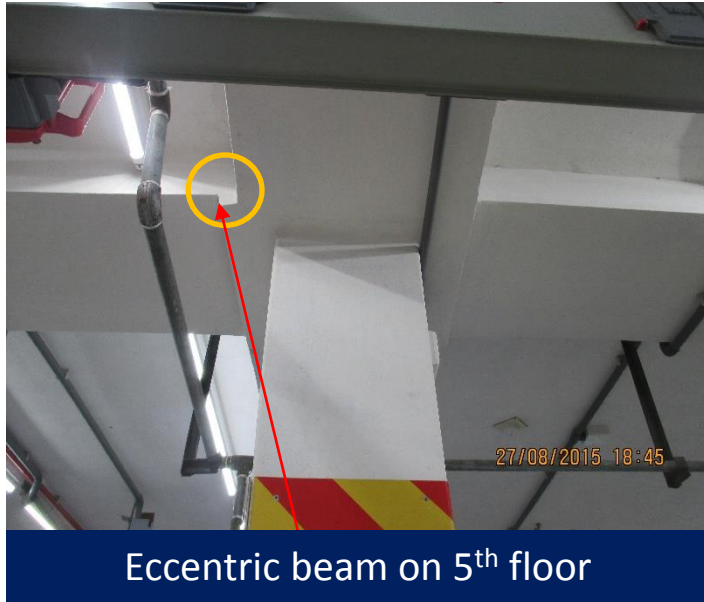
In layout plan of grade beam extra columns was shown on GL level in grid line 3, but in foundation layout it was shown as single column on isolated pad footing.

In drawing, in the Grid O & P, two columns exist with no gap between them upto 5th Floor. But the foundation section does not show foundation for two columns.

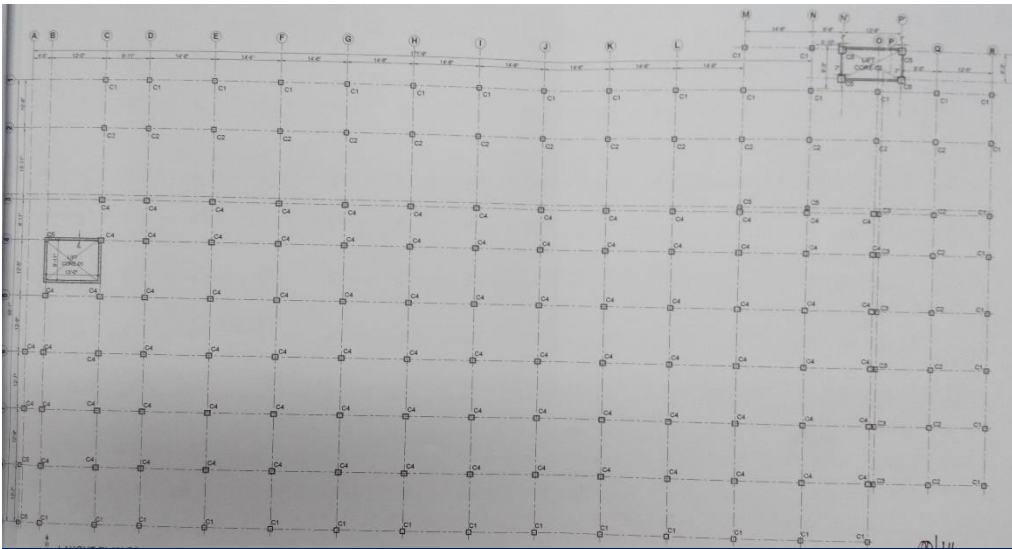
Layout plan of Column

In column schedule column type C6 is shown as provided below PL but location was not shown on any drawings.

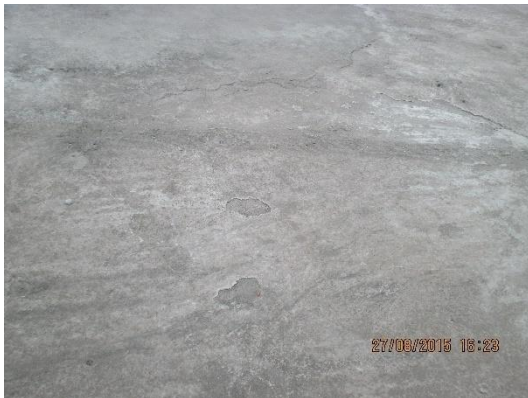
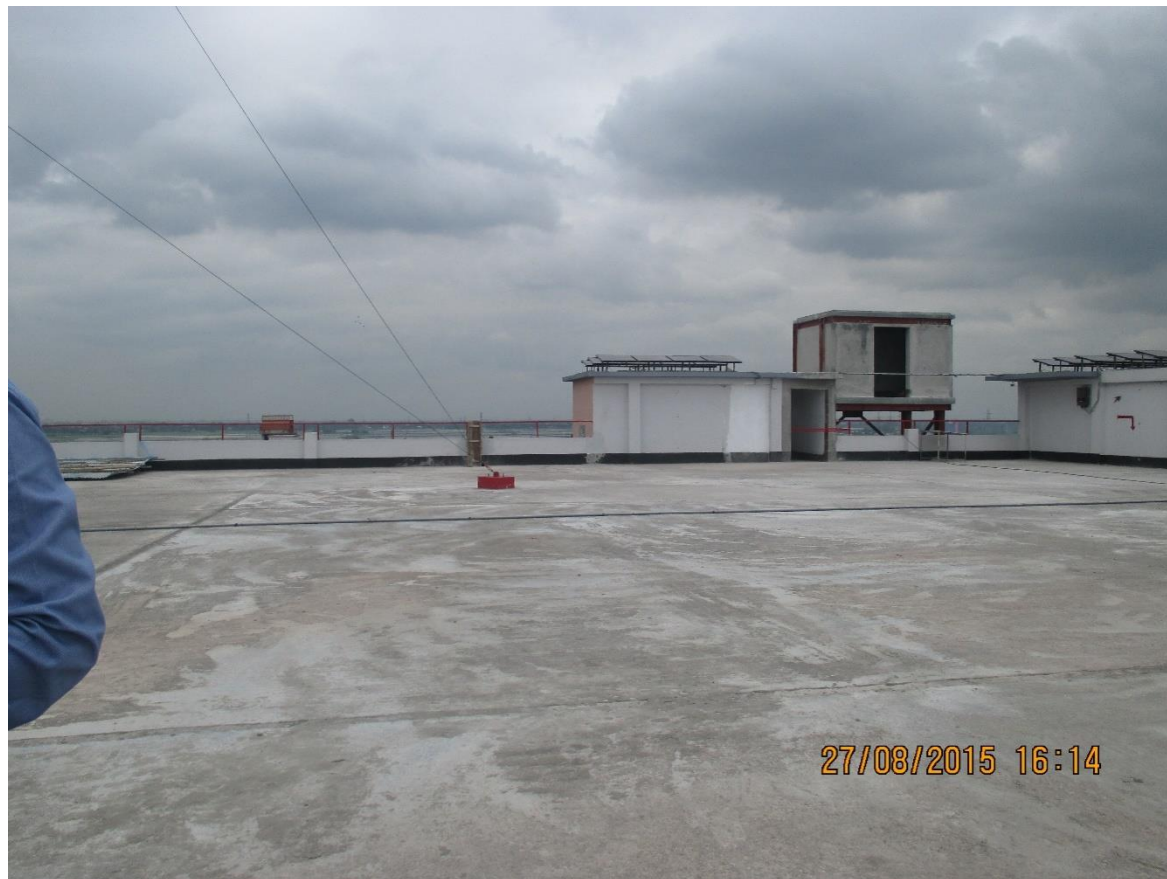
No water proofing membrane appears on roof.

No water proofing was found on roof

- Provide water proofing layer considering the serviceability of the building.(should be done after completing all other remediation suggested in revised DEA)

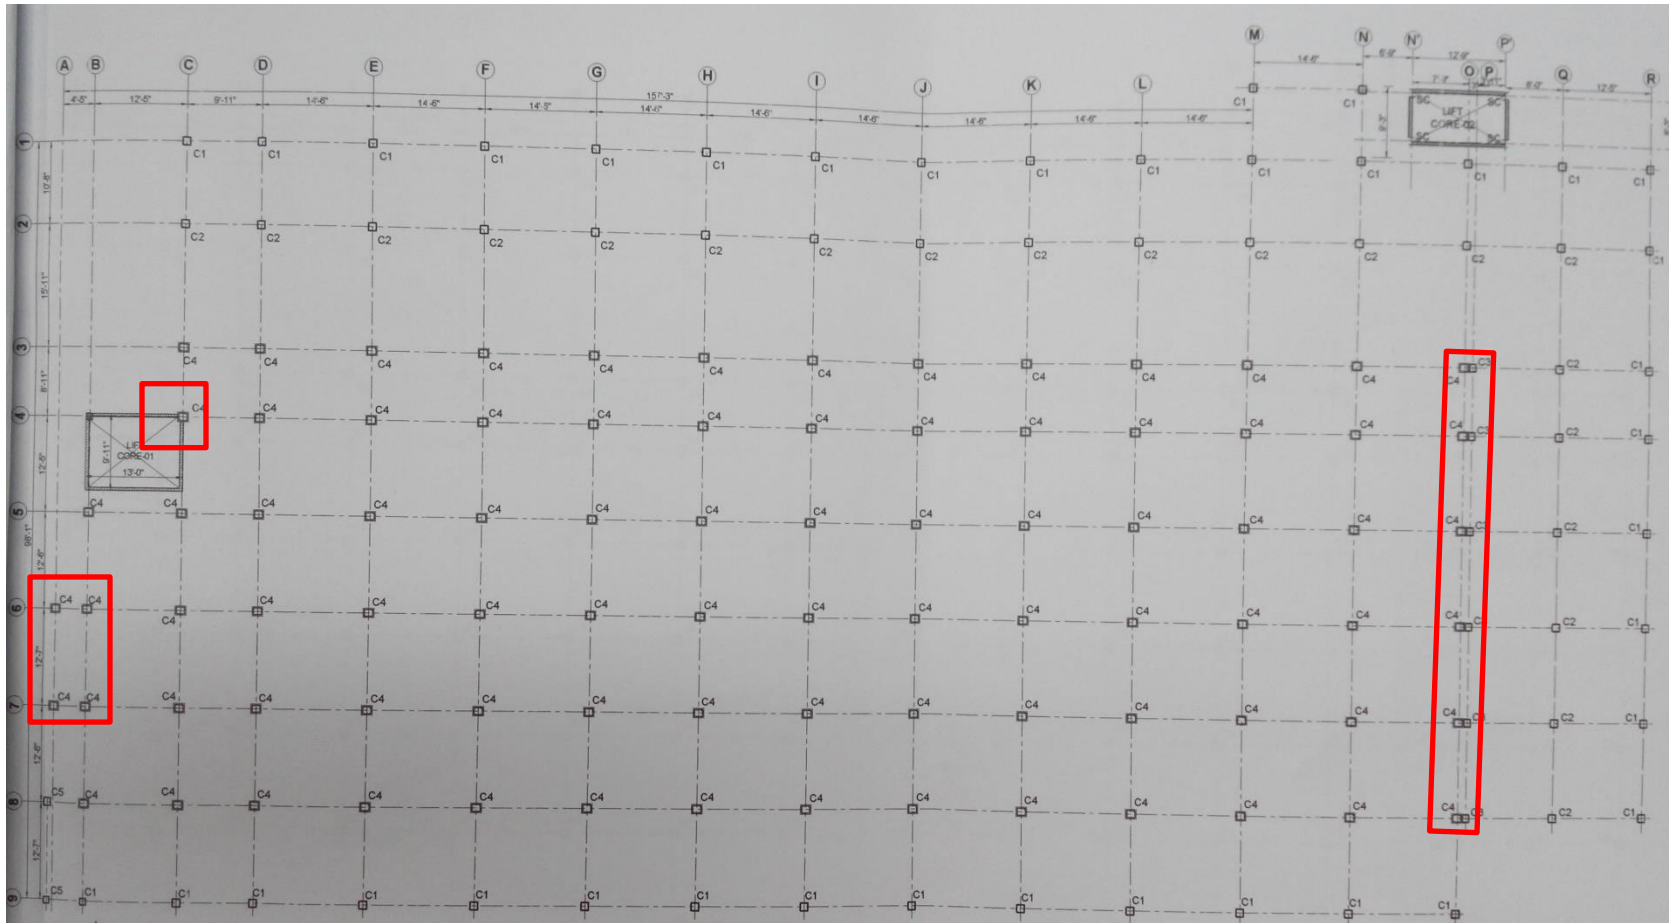
Layout plan of column 1st to 3rd floor

As per recommendations of “Sahidullah and new associates” all C4 columns needs to be retrofitted. But indicated(above drawing) C4 columns was not found retrofitted.

- Revise the DEA considering actual situation.

- Carry out the remedial measures of those columns if necessary or recommended by DEA after the acceptance of the revised DEA by ACCORD.

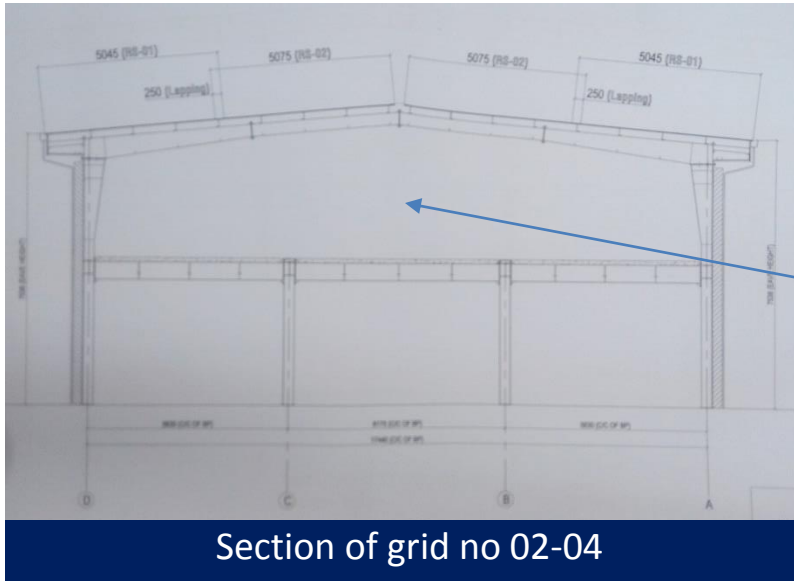
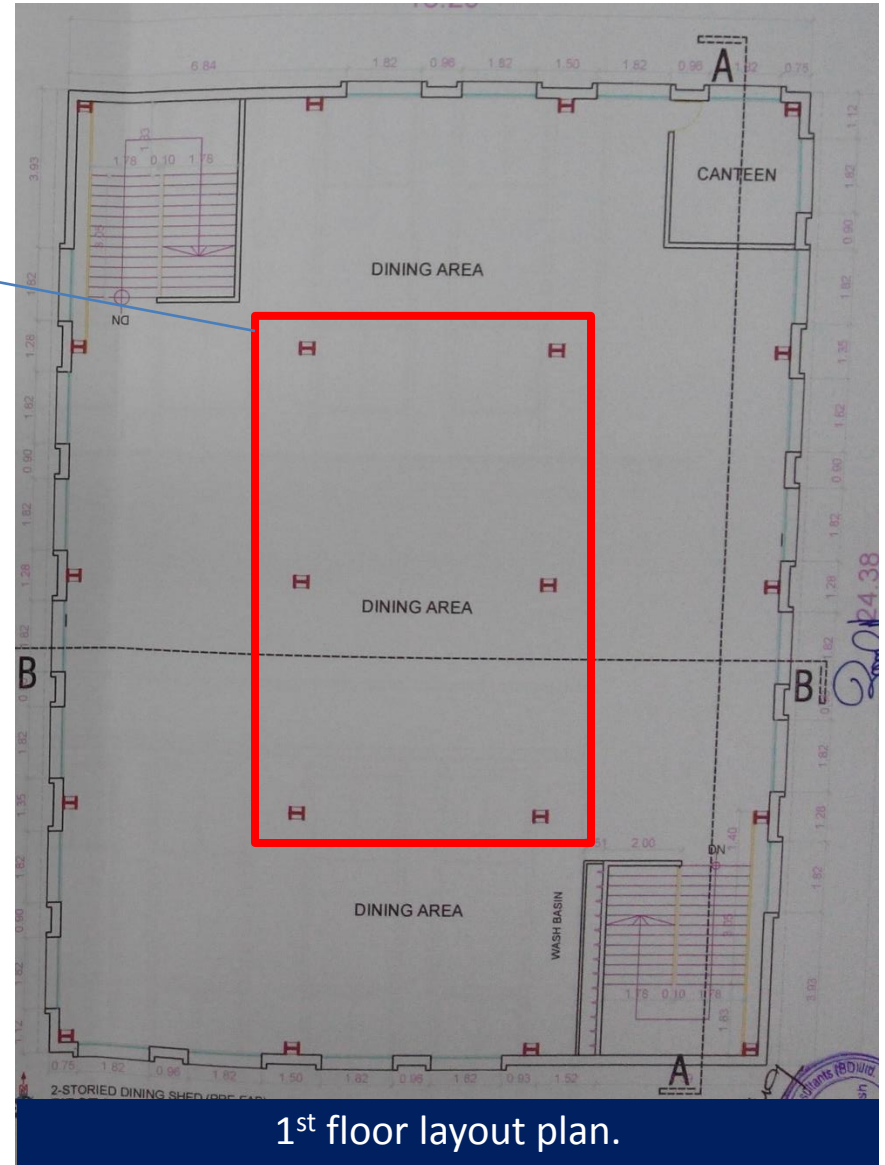
Inconsistency of drawings

Indicated columns do not exist in the 1st floor.

- Building Engineer to update As built drawings

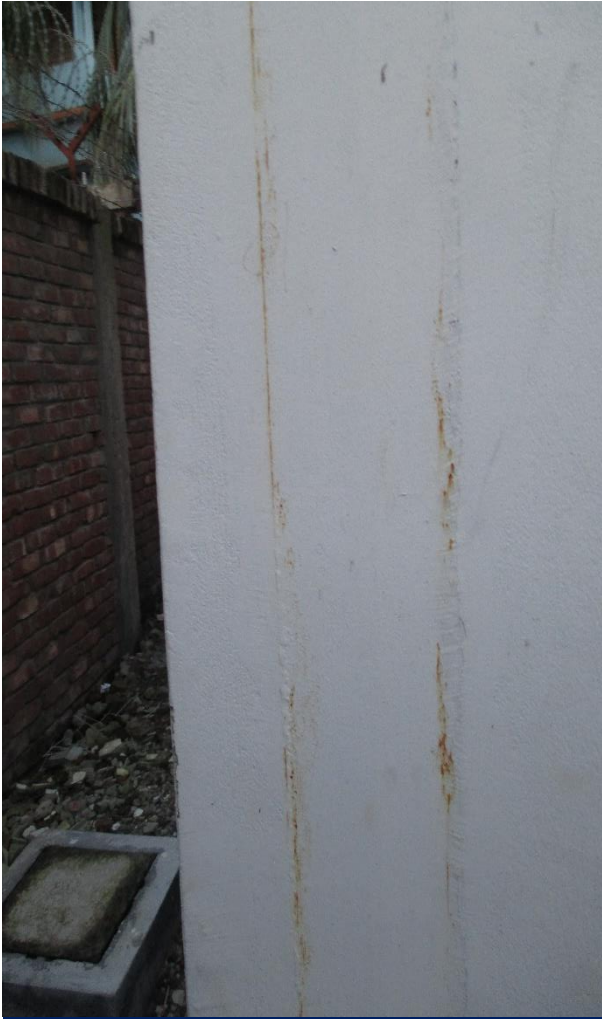
Steel corner Column

A Steel column found instead of Reinforced concrete column

Steel corner column was observed instead of Reinforced Column

- Define the load path and check the connection details.
- Check the adequacy of that column.

- Carry out recommendations suggested by the engineer.

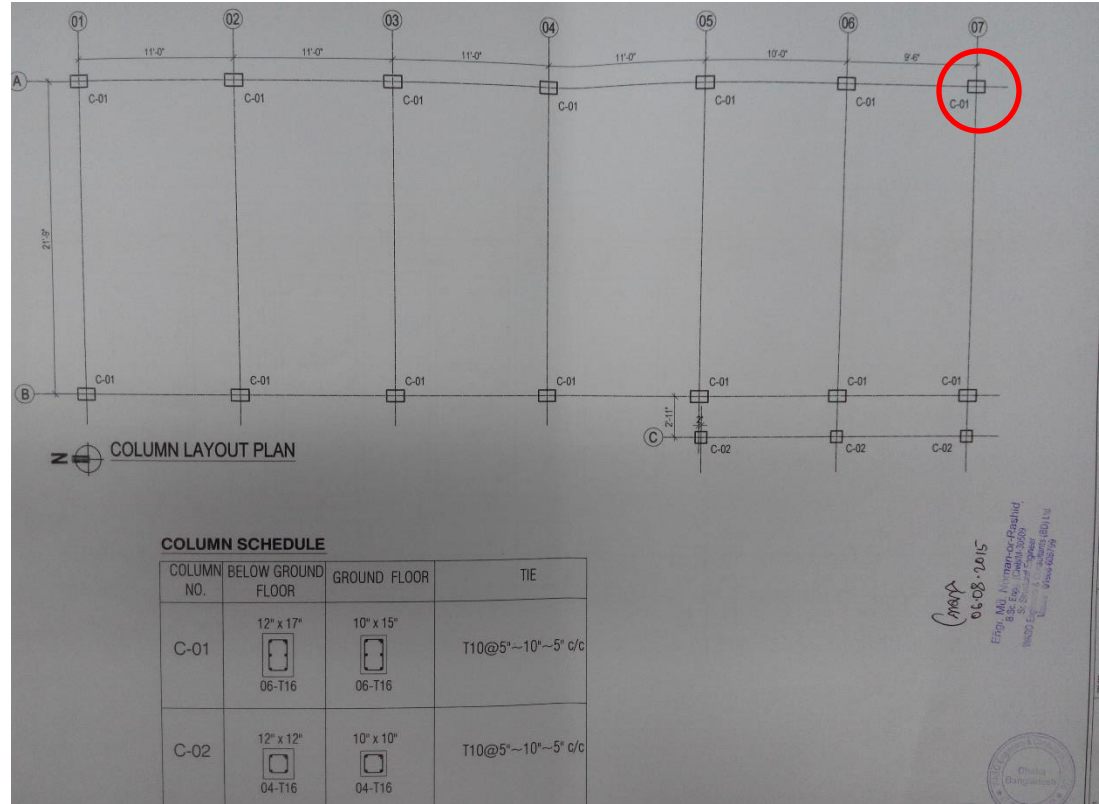
Column layout showing RC column in detail.

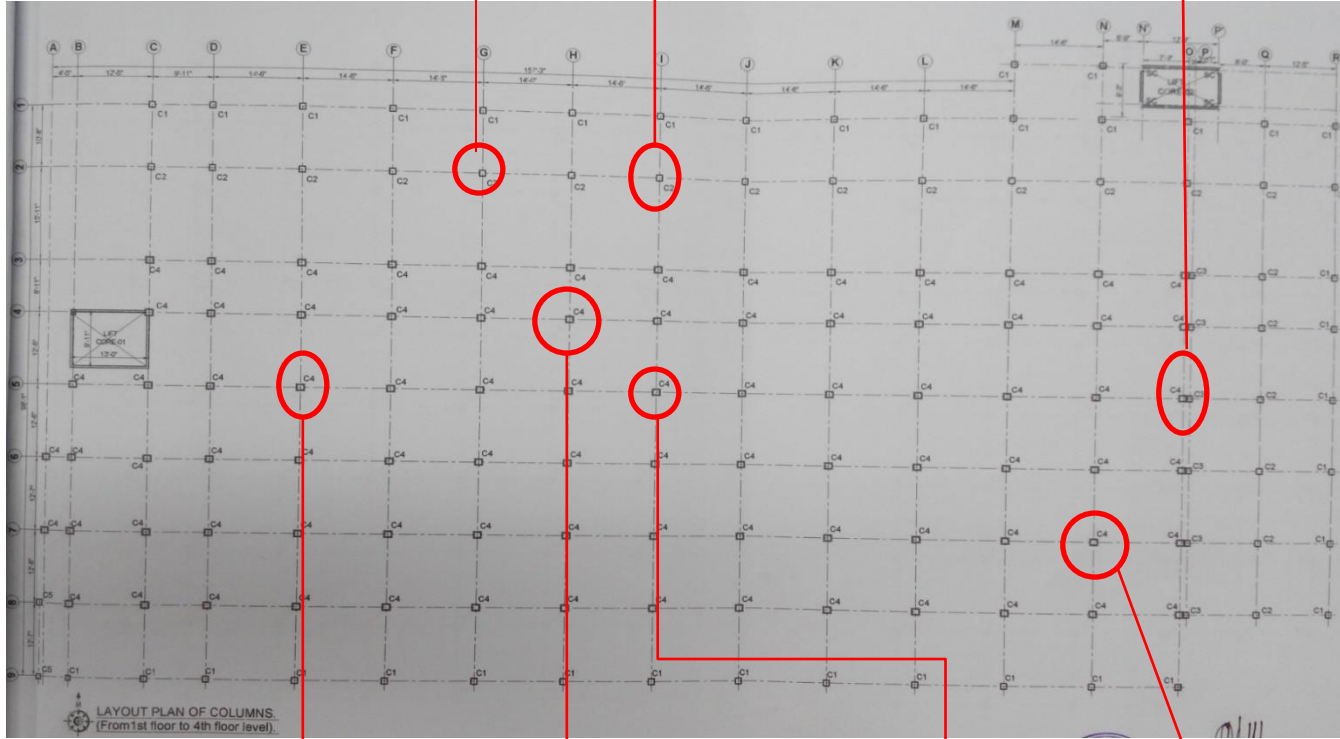
Test points

Brick aggregate in GF

Brick aggregate in 4th Floor

Brick aggregate in GF with no gap between the columns

Stone aggregate was found on the Ground floor (retrofitted columns)

Brick aggregate in 5th Floor

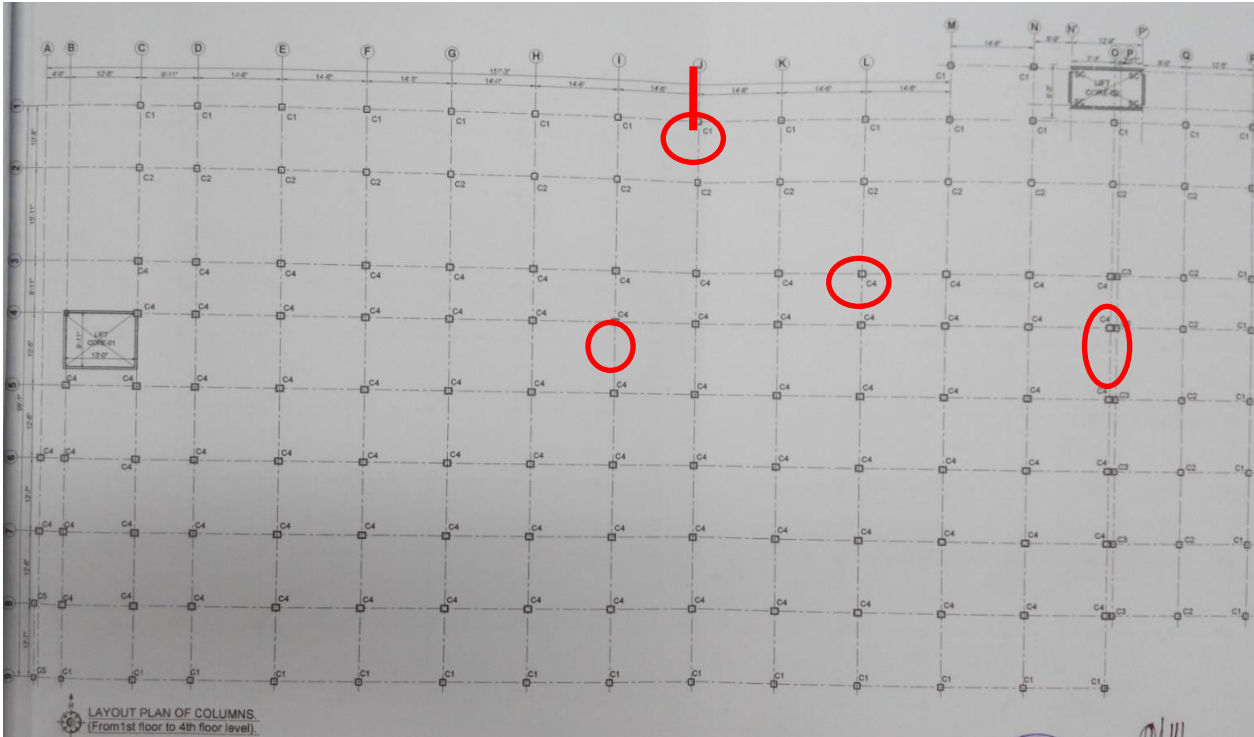
Test Point (Rebar Scanning)

Indicated points at different floors were scanned. No mismatch was found with the provided drawing.
