# **FIRE SAFETY INSPECTION REPORT**

## **NETWORK CLOTHING LTD.**

**ACCORD ID: 12170**

## **Fire Safety Inspection Report Network Clothing Ltd.**

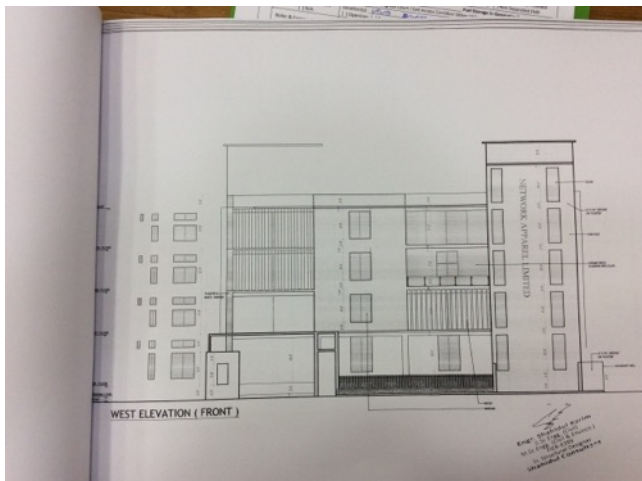
Building section plan.

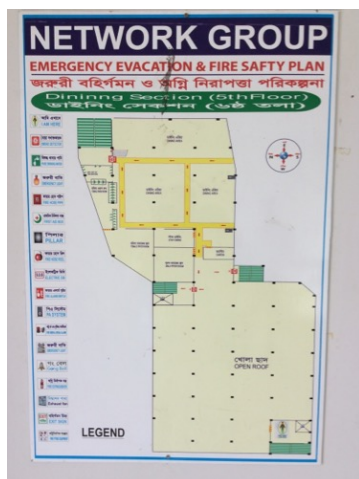
Emergency evacuation plan

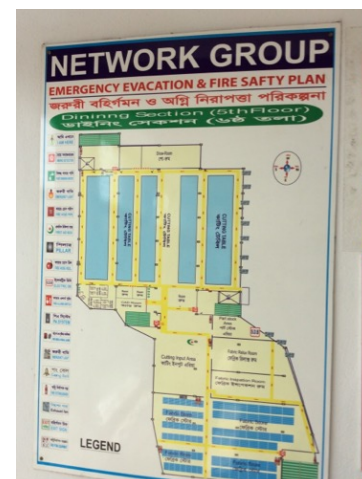
Emergency evacuation plan

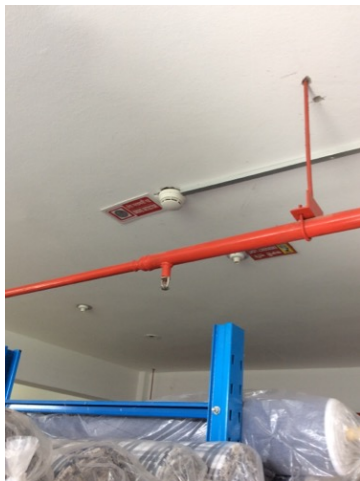
Partial automatic sprinkler protection was provided in the building for the storage room on 4th floor. However, automatic sprinkler protection is not required based on the height of the highest occupiable floor. Sprinkler installation is not per NFPA 13. No records or assertions of regular testing or maintenance of the automatic sprinkler system were provided.

Sprinkler piping

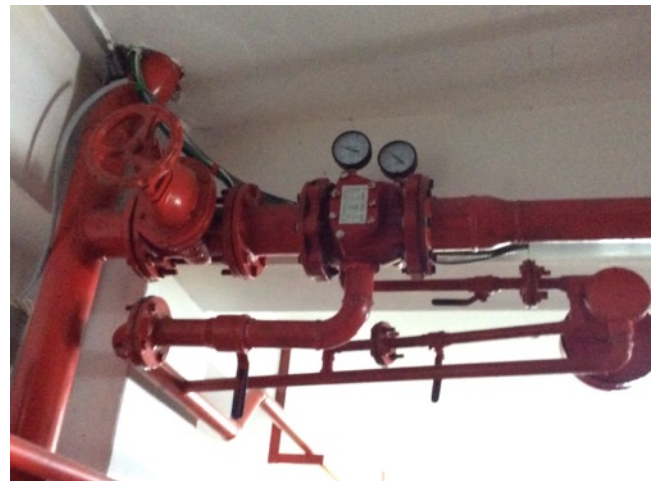
Sprinkler piping

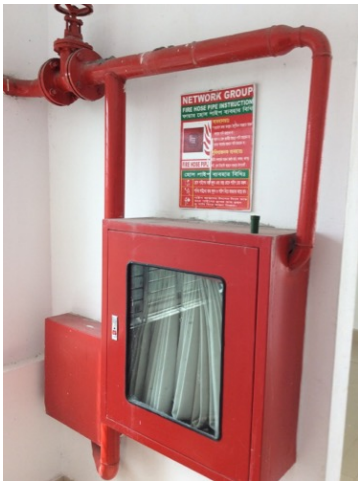
A Class III standpipe system was provided in the building. Hose cabinets with 1.5 in. hoses were provided adjacent to exit stair entrances and 2.5 in. standpipe hose connections were provided within the exit stairs. The factory building was over 10 m (33 ft) and requires a Class III standpipe system. Records of regular testing or maintenance of the standpipe system were provided however they were not in accordance with NFPA 25.

Hose cabinet

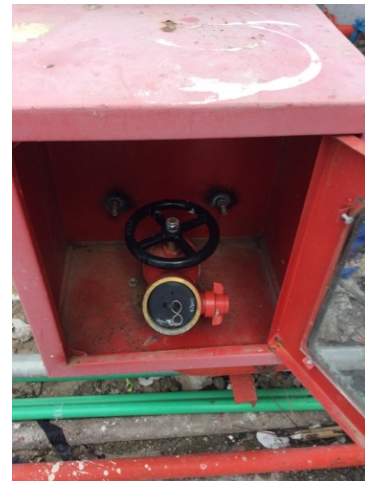
65mm hose connection

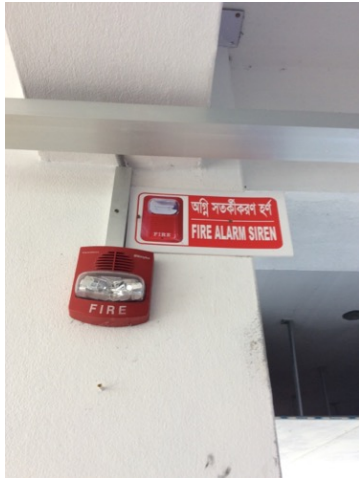
Visual and audible notification appliances

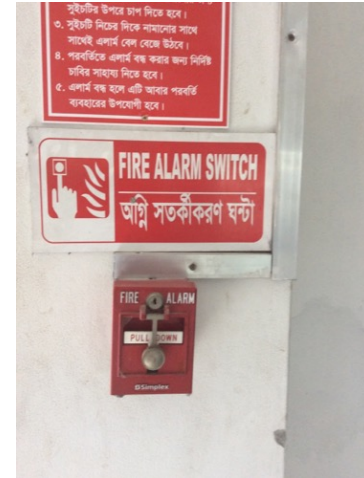
Manual pull alarm

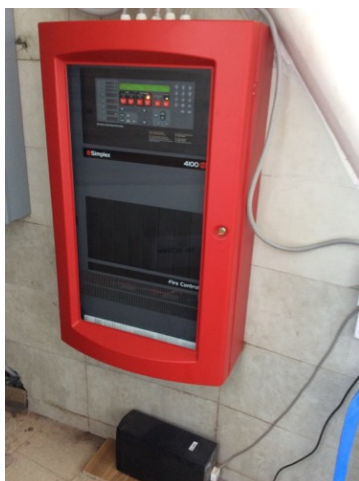
The building had an addressable fire alarm system built around a Simplex alarm panel. The system supported smoke detectors, heat detectors, manual pull stations and horn with strobe units installed throughout the building. A functional test was conducted on the system during the inspection. Records of regular testing or maintenance of the fire alarm system were provided however they were not in accordance with NFPA 72.

Fire alarm panel

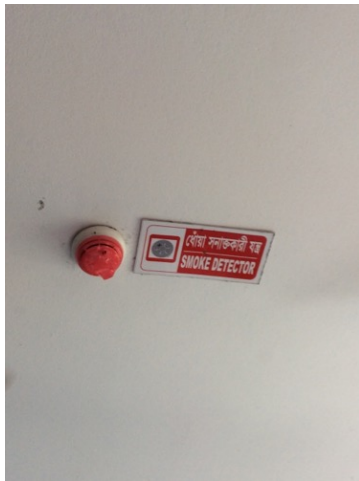
Interconnected smoke and heat detectors were located in various places throughout the factory. These detectors were tied into the fire alarm system. In the event they detect smoke or heat, they will send a signal to the fire alarm control panel to activate the fire alarm. Several smoke detector still has the cover on the unit. Records of regular testing or maintenance of the fire detection system were provided however they were not in accordance with NFPA 72.

Smoke detector

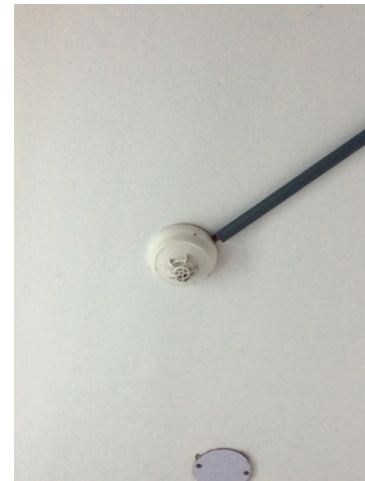
Heat detector

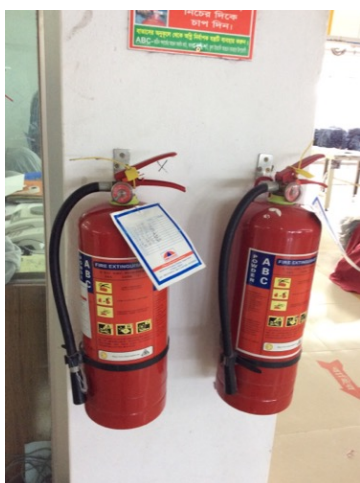
Dry chemical extinguisher

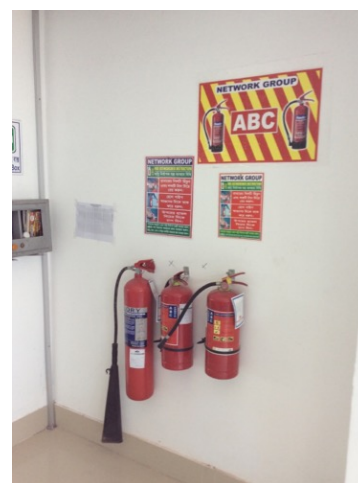
Dry chemical and CO fire extinguisher

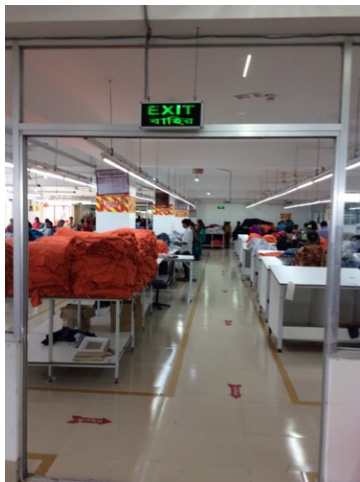
Directional exit sign

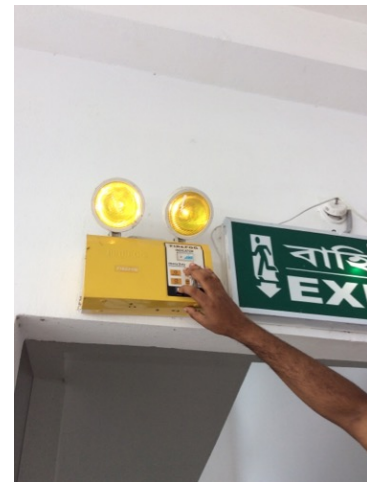
Exit sign and emergency light

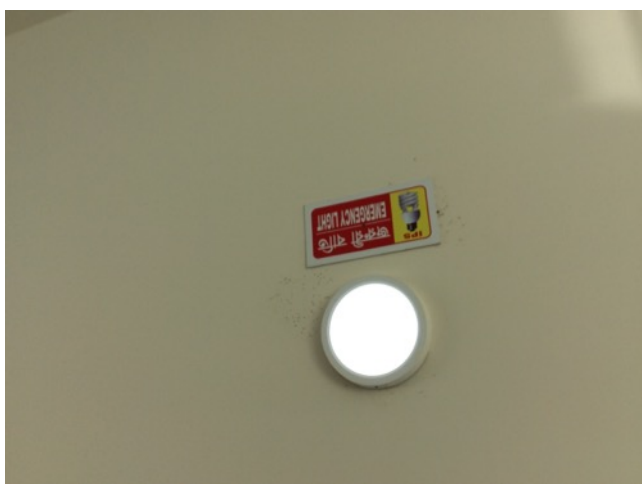
Emergency lighting appliances (battery pack driven) were located inside and outside the exit enclosure walls. There were multiple LED lights that had an alternate “Instant Power Supply” (IPS) on each floor. Upon random testing of these units, some were not in working order. Each floor had a number of illuminated exit signs, a mix of directional and non-directional, located along the exit access and at exits. The factory management reported that these are all serviced by normal electricity as well as by multiple “Instant Power Supply” (IPS) units. Assertions of regular testing or maintenance of the emergency lighting system were made however no records were provided.

IPS powered emergency light

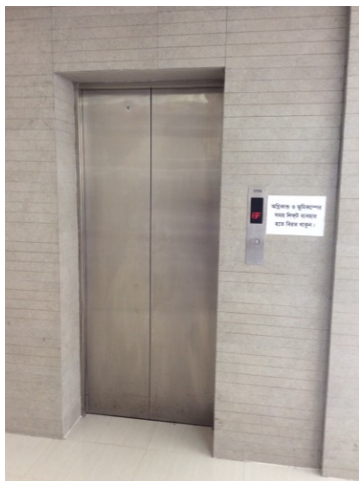
There was an elevator that serves all floors. Emergency signage was provided outside the elevators on all floors. No switch was provided near the elevator that may allows firefighters to use the elevators in the event of a fire. The elevator shaft and doors was provided with proper fire-rated separations. No elevator recall was provided.

Elevator

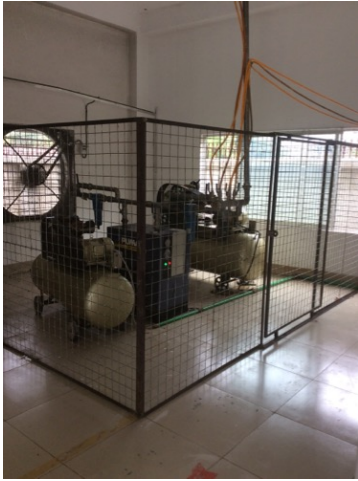
Two (2) compressors serve the building. They were located in the utility building. The building had proper fire-rated separations.

Compressor units

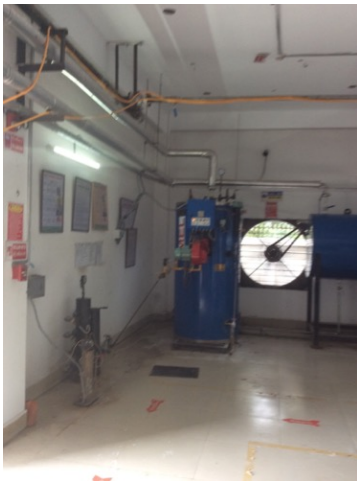
Single boiler serves the building. It was located in the utility building. The building had proper fire-rated separations.

Gas fired boiler

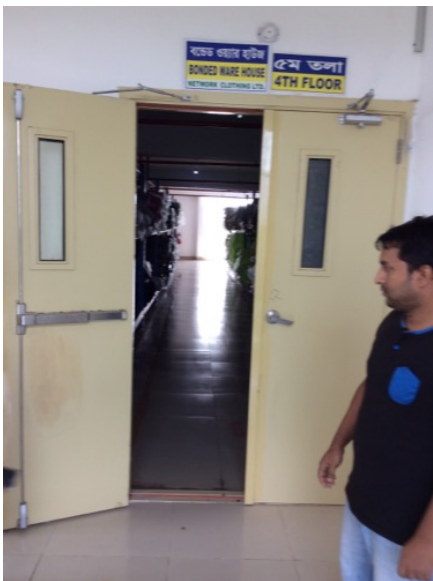
| No. | Category | Finding | Recommendation | Remediation Timeframe |
|---|---|---|---|---|
| F-1 | Fire Rated Construction | Proper certification was not available for fire rated doors installed in the exit stair and storage room. | Submit proper certifications for installed fire doors to the ACCORD for approval. If not available, or certification is not approved, install new, properly certified fire rated doors in accordance with ACCORD direction. | Immediately |

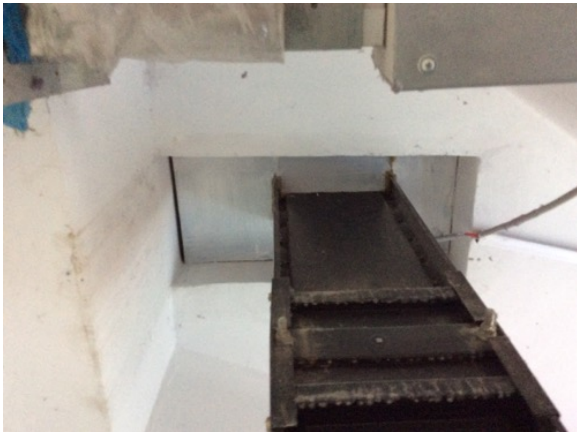
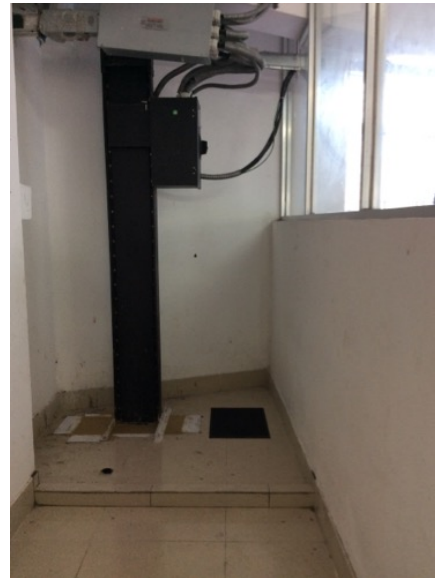
| No. | Category | Finding | Recommendation | Remediation Timeframe |
|---|---|---|---|---|
| F-2 | Fire Rated Construction | Unsealed electrical shafts are located in the fire-rated floor/ceiling assemblies. | Provide a minimum 2-hr fire-rated shaft to separate the utility risers from each floor level and seal all penetrations in floor/ceiling assemblies to maintain the fire separation. | Within 3 months |

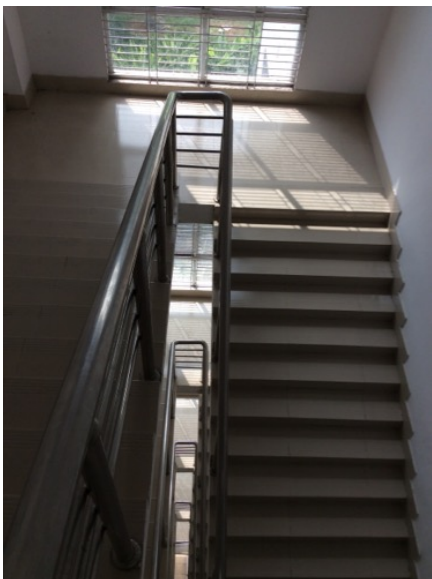
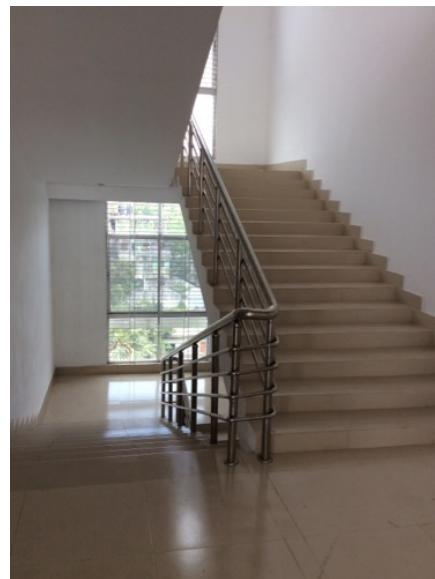
| F-3 | Egress | Handrails are not provided on both sides of the exit stairs. | Provide handrails on both sides of the exit stair. New handrails shall have a minimum height of 865 mm (34 in.) and a maximum height of 965 mm (38 in.) as measured from the leading edge of the tread. Intermediate handrails shall be provided when the stair width exceeds 2.2 m (87 in.) . | Within 3 months |

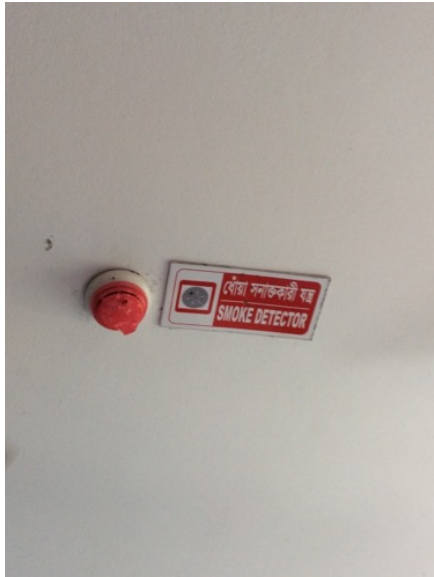
| F-4 | Fire Protection | Several smoke detector still has the cover on the unit. | Remove the smoke detector cover, re-test and maintain the detection system and keep written records on-site, in accordance with NFPA 72 and ACCORD standards. | Immediately |

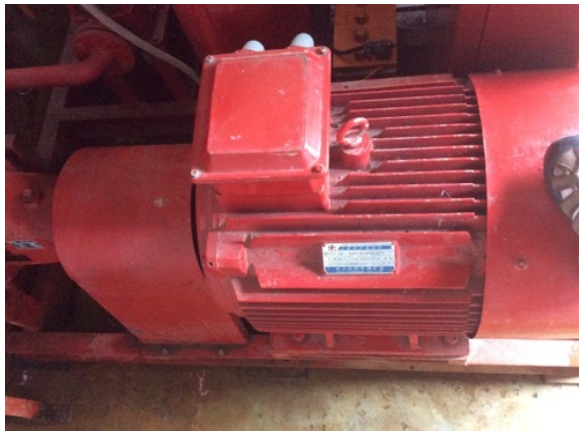
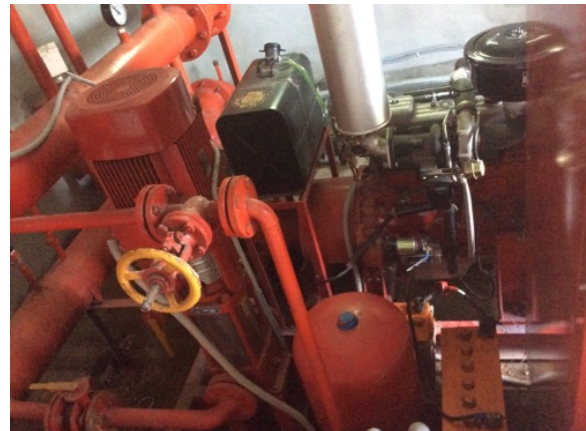
| F-5 | Fire Protection | Fire pump installation requires detailed review to confirm compliance with NFPA 20 and ACCORD standards. | Submit as-built drawings, testing records, equipment certification and other relevant documentation to the ACCORD for review and approval. | Within 1 month |

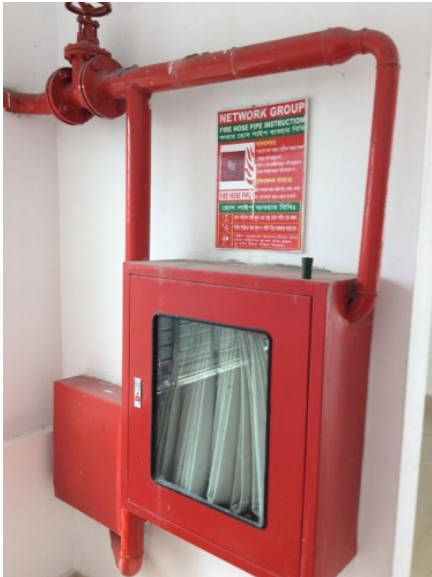
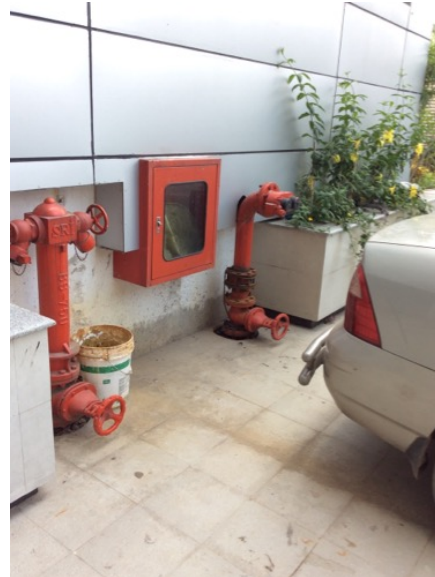
| F-6 | Fire Protection | Standpipe system installation requires detailed review to confirm compliance with NFPA 14 and ACCORD standards. | Submit as-built drawings, testing records, equipment certification and other relevant documentation to the ACCORD for review and approval. | Within 1 month |

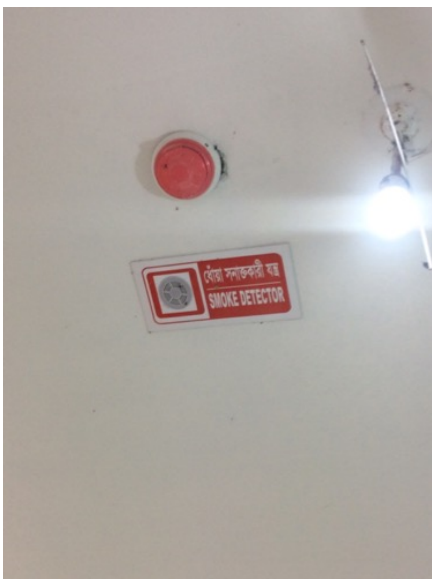
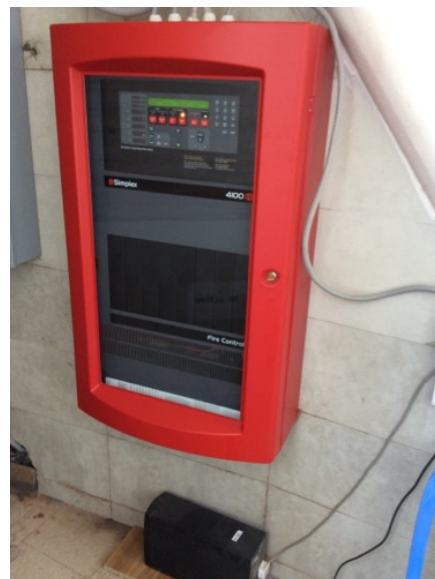
| F-7 | Fire Protection | Fire alarm system installation requires detailed review to confirm compliance with NFPA 72 and ACCORD standards. | Submit as-built drawings, testing records, equipment certification and other relevant documentation to the ACCORD for review and approval. | Within 1 month |

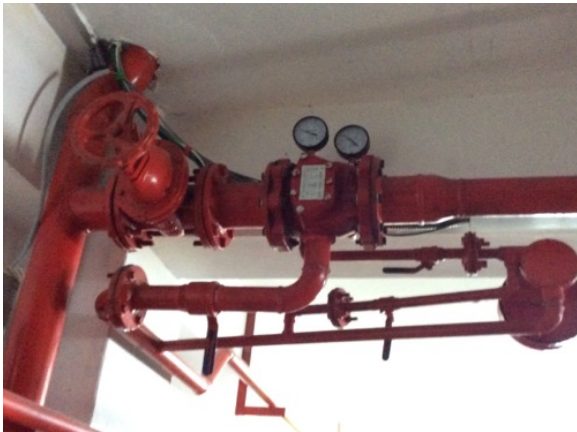
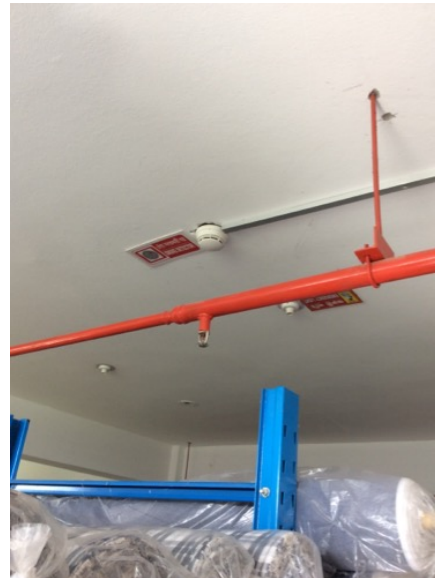
| F-13 | Fire Protection | Sprinkler installation appears to not be in accordance per NFPA 13. | Submit as-built drawings, testing records, equipment certification and other relevant documentation to the ACCORD for review and approval. | Within 3 months |

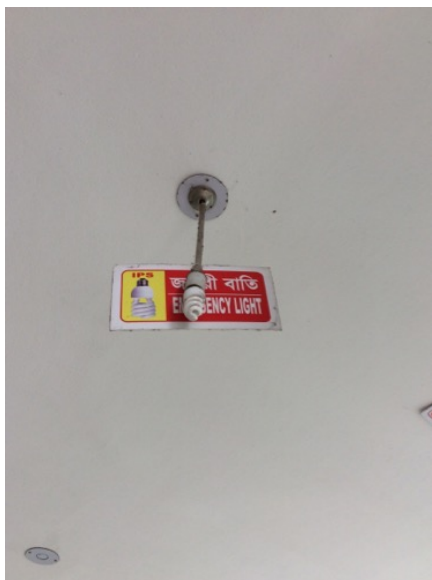
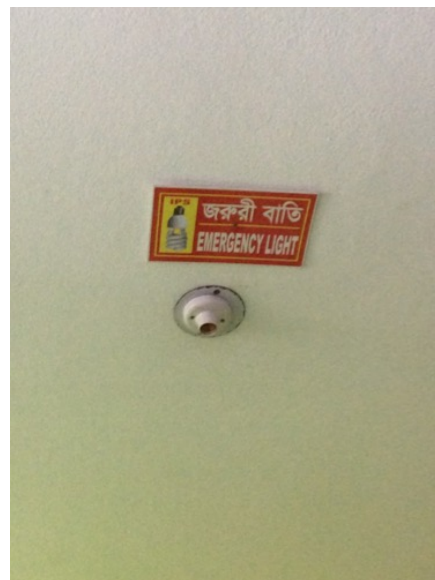
| F-14 | Egress Lighting | Several emergency lighting did not function in test mode (burned out, broken, etc.). | Regularly test the emergency lighting system on each floor and replace/repair lights as needed. | Within 1 month |
