# INITIAL FIRE SAFETY INSPECTION REPORT

**R&G(BD)Garment Co,.Ltd**

**RSC ID: 24682**

R&G (BD) Garment Co, Ltd.

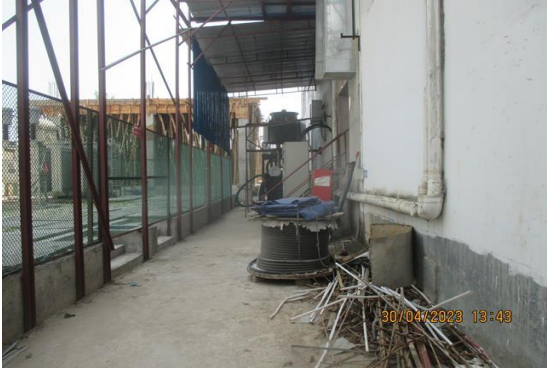
SI No.	Category	Findings	Required Action	Remediation Time Frame
F-1	Fire Rated Construction	The generator located inside of a temporary room is not separated by fire rated construction.	Separate the generator room by a minimum 2-hr fire-rated construction. Seal and/or protect all openings to maintain the required fire separations. When located to the exterior of a building 3m (10 ft.) spatial distance shall be maintained around the generator.	Within 3 months

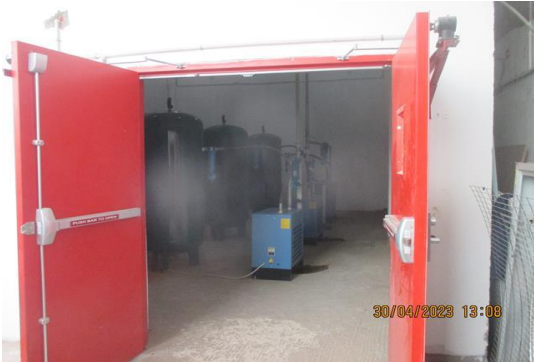
F-2	Fire Rated Construction	The compressor located inside of compressor room is not separated by fire rated construction.	Separate the generator room by a minimum 1-hr fire-rated construction. Seal and/or protect all openings to maintain the required fire separations. When located to the exterior of a building 3m (10 ft.) spatial distance shall be maintained around the generator.	Within 3 months

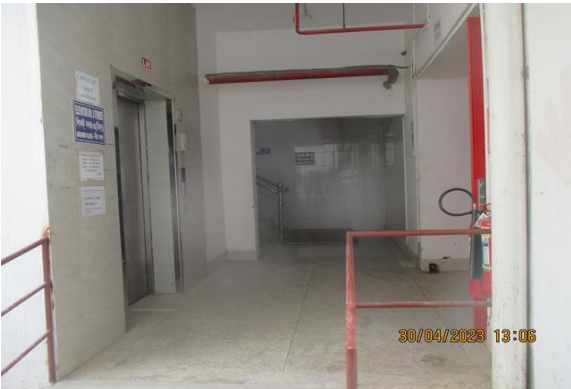
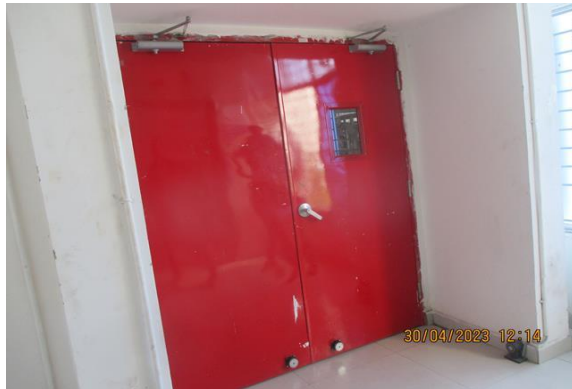
F-3	Fire Rated Construction	Elevator shaft is not fire separated. On ground floor for one elevator it is located inside of a common enclosure of stair without fire separation.	Ensure the elevator shaft is 2-hr fire separated and not in common enclosure of stair. If not possible to ensure separate enclosure then at least ensure the lift landing door opening is minimum 2-hr fire rated.	Within 3 Months
-----	-------------------------	---	--	-----------------

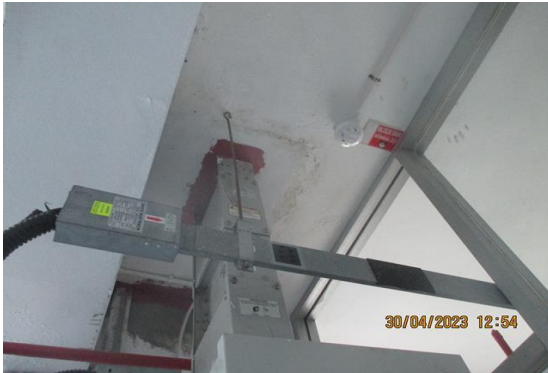
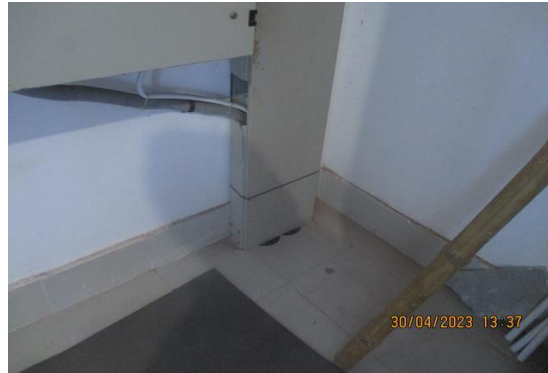
F-4	Fire Rated Construction	Unsealed penetrations and openings are located in the fire-rated floor/ceiling assemblies. (Both Dining and Main building).	Seal all penetrations and openings in floor/ceiling assemblies to maintain the fire separation at least by 3-hr. The used sealer shall be 3rd party certified and installation shall be as per manufacturer's guideline. (Type-1 Construction). or, Provide a minimum 2-hr fire rated shaft to separate the utility risers from each floor level or seal all penetrations and openings in floors/ceiling assemblies by 3-hr fire rated listed/certified materials. The installation of such fire rated materials shall be following certified design.	Within 3 Months
-----	-------------------------	---	---	-----------------

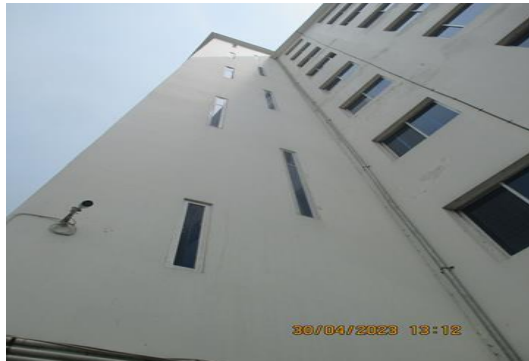
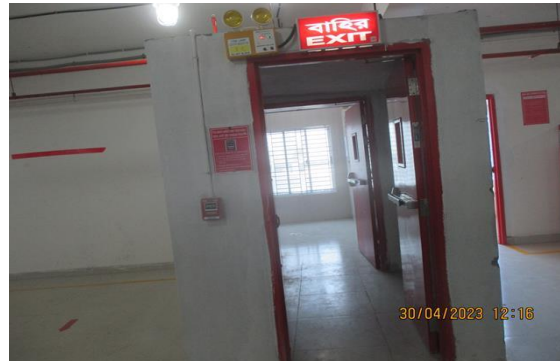
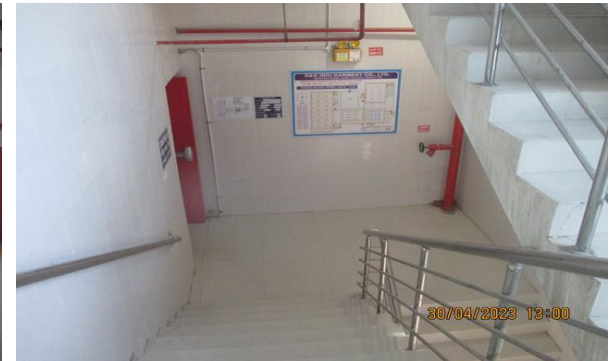
F-5	Means of Egress	<p>The exit stair enclosures are not separated from work areas and other spaces on each floor by fire-rated construction due to non-functionality of fire rated door and unprotected opening.</p>	<p>The exit stair enclosure shall be provided a minimum of 2- hr. fire resistance rating for the buildings. Ensure minimum 1.5 hr. fire rated door and seal all penetrations and openings by 2 hr. fire rated fire rated barrier construction for the buildings.</p> <p>Provide a fire-resistive rated assembly between the exterior exit stairs and the building up to 10 ft. beyond the end of the stair to achieve the required separation. The rated assembly shall be approved and/or designed by a qualified fire protection engineer.</p> <p>Ensure that the fire doors are self-closing and positive latching and that they are provided with fire exit (panic) hardware where serving production floors. If fire doors are required to be held open for functional reasons, provide automatic closing devices tied to the fire alarm system.</p>

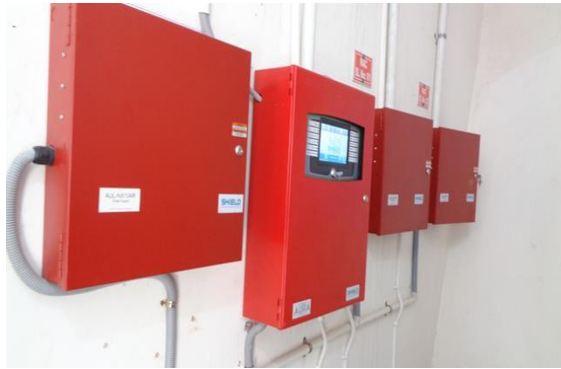
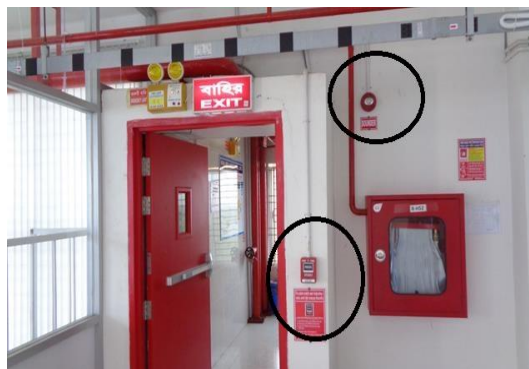
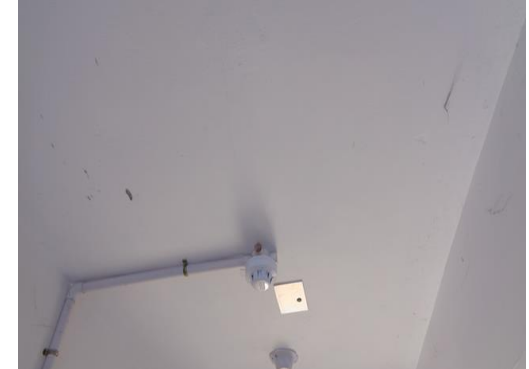
F-11	Egress lighting(ITM)	Inspection, testing, and maintenance for the exit sign and emergency lighting system was not in accordance with The RSC Technical Guidelines (Standard).	Inspect, test and maintain the exit sign and emergency lighting system in the accordance with The RSC Technical Guidelines (Standard). Keep written records on-site.	Within 1 month
F-12	Fire Alarm & Detection System (FADS)	Automatic fire alarm & detection system installation requires detailed review to confirm compliance with NFPA 72 and RSC Technical Guidelines (Standard).	<p>Design &amp; Installation of Fire Alarm &amp; Detection system shall be in accordance with RSC Technical Guidelines (Standard) and NFPA 72. Submit design, documents and calculations to RSC for review prior installation/modification.</p> <p>After installation the owner shall contact the RSC for witness of conducting the final acceptance testing of the fire detection &amp; alarm system installation.</p> <p>Also inspect, test and maintain the fire alarm system, and keep written records on-site, in accordance with NFPA 72.</p>	Design Review within 3 months and installation 2 months after review.

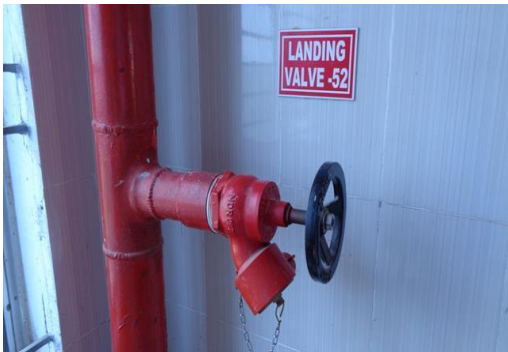
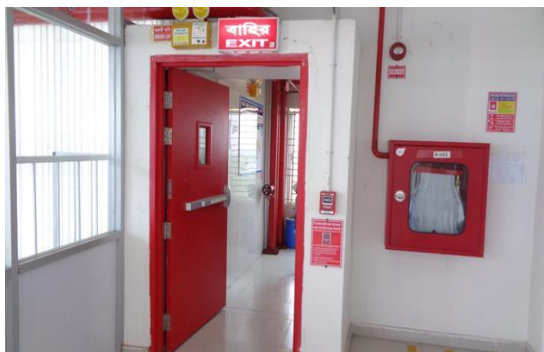
F-13	Fire Detection System (ITM of FADS)	Inspection, testing, and maintenance for the fire alarm system is not in accordance with NFPA 72 or as per RSC Technical Guidelines (Standard).	Inspect, test and maintain the fire alarm system, and keep written records on-site, in accordance with table 14.3.1 of NFPA 72 or as per RSC Technical Guidelines (Standard).	Within 1 month after installation.
F-14	Fire Protection System(Standpipe)	Standpipe system installation requires detailed review to confirm compliance with RSC Technical Guidelines (Standard) and NFPA-14. (Dining Building)	Submit the standpipe system drawing to RSC for review. Once reviewed, install or modify the standpipe system throughout the building in accordance with RSC Technical Guideline (Standard) and NFPA 14, 20,22 and 24. After installation the owner shall contact the RSC for witness of conducting the final acceptance testing of the standpipe system.	Design Review within 3 months and installation 2 months after review.

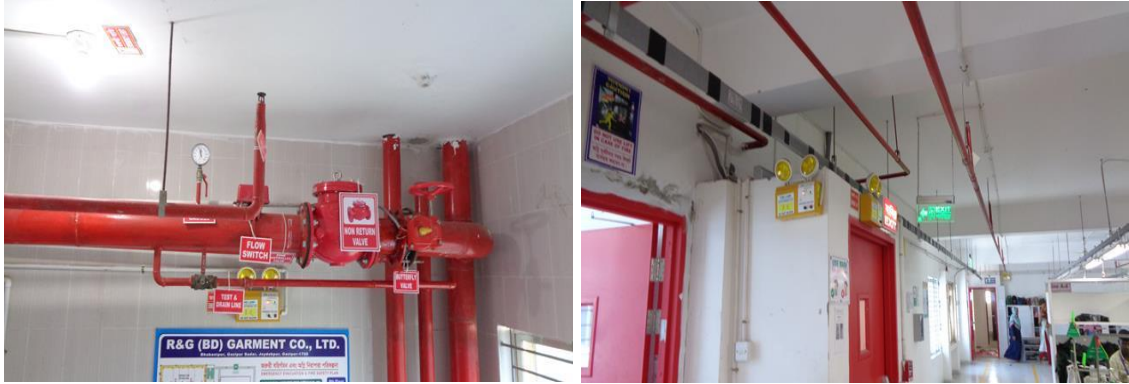
F-15	Fire Protection System(Sprinkler)	Sprinkler system installation requires detailed review to confirm compliance with NFPA 13 and the RSC Technical Guidelines (Standard). (Main Building)	Submit the sprinkler system drawing to RSC for review. Once the design is reviewed, install and modify the sprinkler/standpipe system throughout the building in accordance with review comment, RSC Technical guideline (Standard) and NFPA 13,14,20,22 and 24. After installation the owner shall conduct internal testing and commissioning and then contact the RSC for witness of final acceptance testing.	Design Review within 3 months and installation 2 months after review.
