# INITIAL FIRE ASSESSMENT REPORT (FAR)

Factory Name: **Amantex Limited**  
Address: **Boiragirchala Sreepur, Gazipur Sreepur, Gazipur  
Dhaka Bangladesh**  
Assessor: **Bureau Veritas**  
Date: **16 Apr 2014**

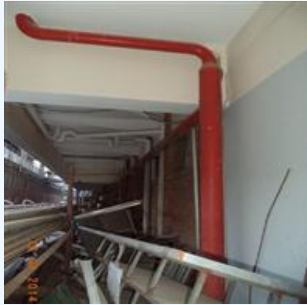
| Question: | Does the building have a Standpipe System? | |
| Non-Compliance Level: | 2 | |

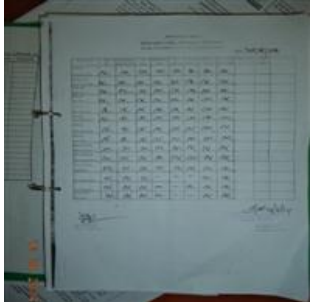
| Question: | Are inspection, maintenance, and testing procedures of the standpipe and hose system documented and up to date? Including inspection and testing of hoses if provided. | |
| Non-Compliance Level: | 2 | |
