# **FIRE SAFETY INSPECTION REPORT**

## **DANNY'S KNITWEAR LTD.**

## **Fire Safety Inspection Report Danny's Knitwear Ltd.**

Danny's Knitwear Ltd. manufacturing complex was surveyed for fire safety on 10/17/2015 by Jensen Hughes.

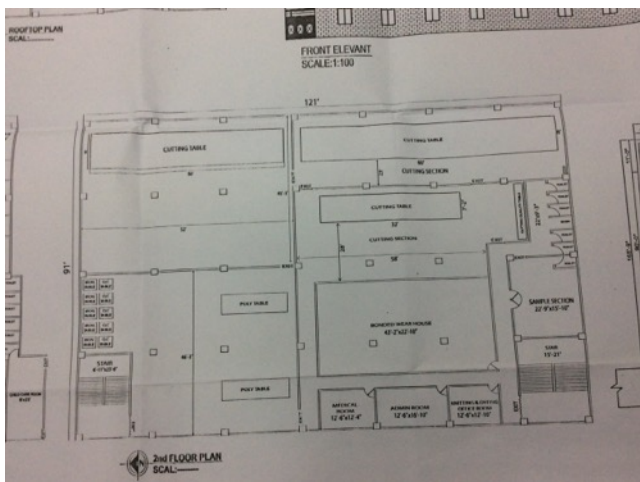
Second floor plan

**Comments** 50 % of the floor area of the 2nd floor were under construction. Reportedly the factory building were planned to be completed as a G+ 5 (six stories) building in the near future.

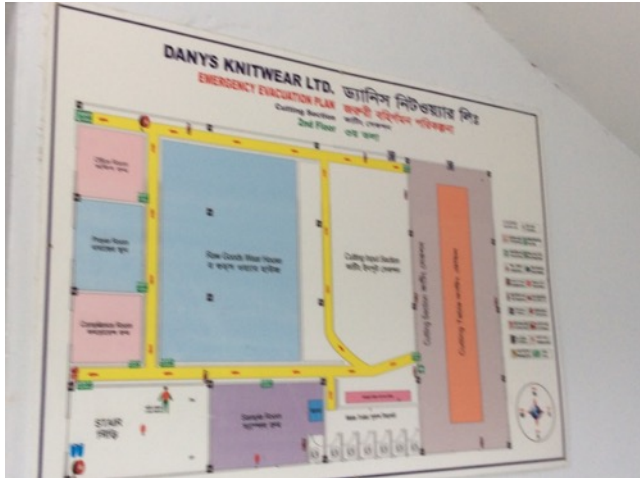
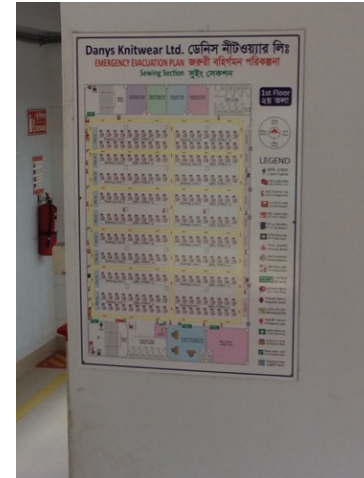
## Emergency evacuation plan

**Emergency Evacuation Plans Provided (Accord 13.3)** Yes

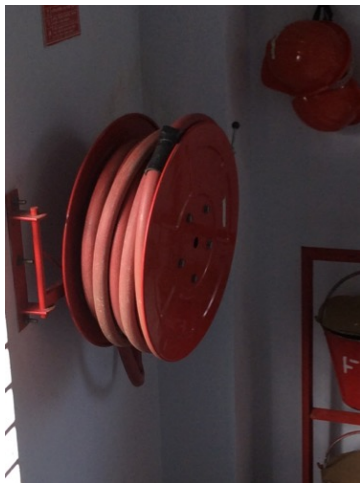
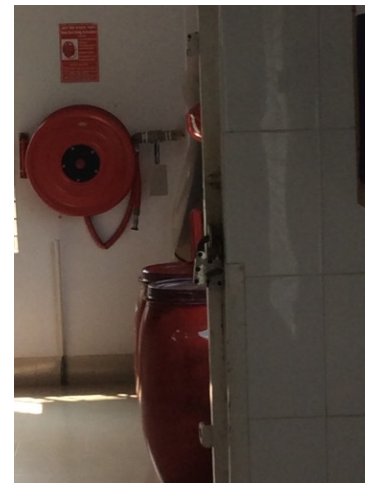
Fire Hose reel

The factory building height was less than 10 m (33 ft) at the highest occupied floor and does not require a standpipe system, however a non-rated standpipe system was provided in the factory. Hose reels with 1.0 in. hoses were provided within the northwest and southwest exit stairs. No records or assertions of regular testing or maintenance of the standpipe system were provided.

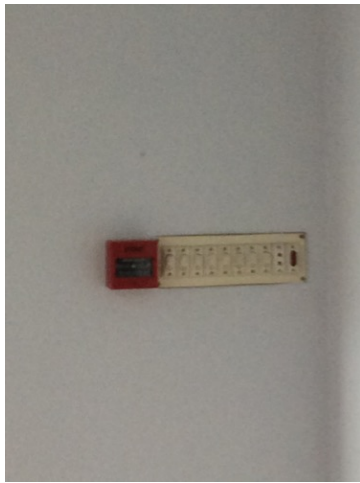
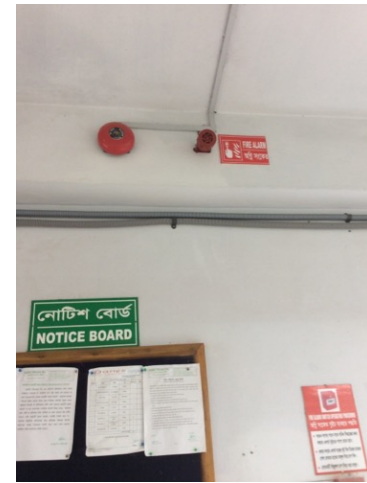
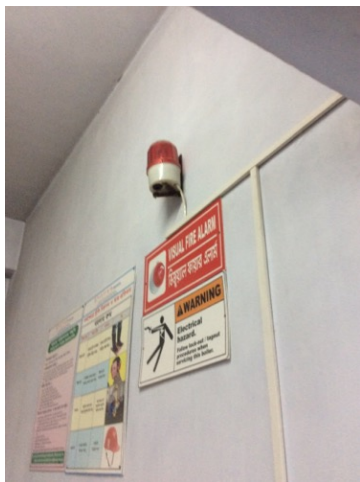
A fire alarm system was provided in the factory building. It consisted of manual alarm switches, horn, bell and beacon units installed throughout the factory. Reportedly, the activation switches on each floor triggers the fire alarm for only the respective floor. No functional test was conducted on the system during the inspection. There was no fire alarm panel or system supervision present during the inspection. No records or assertions of regular testing or maintenance of the fire alarm system were provided.

Manual pull station

Speaker Horn and Bell

Beacon

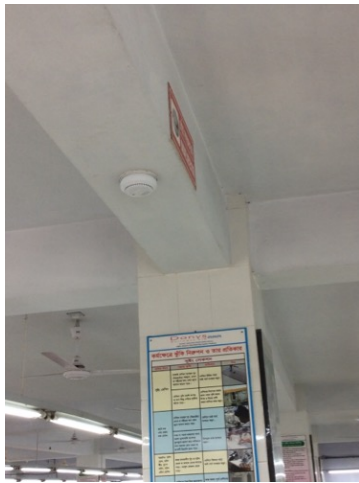
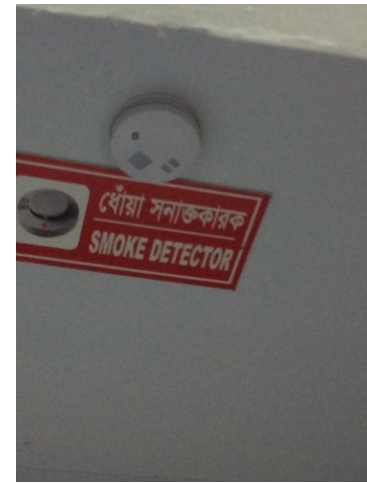
Single station smoke alarm

Single station smoke alarms were located in various places throughout the factory. These smoke alarms are not tied into the fire alarm system. In the event they detect smoke, they will provide a local a local alert sound. No records or assertions of regular testing or maintenance of the fire detection system were provided.

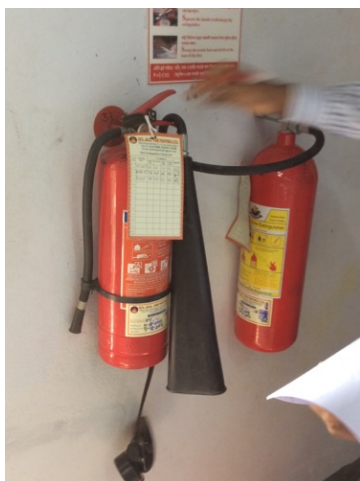
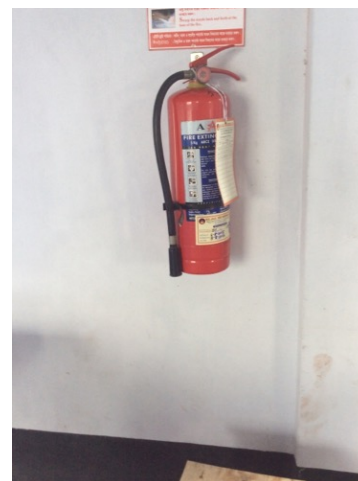
Portable fire extinguishers, consisting of a mix of CO2 and dry chemical extinguishers, were provided throughout the building. Inspection tags shows recent and up to date inspection. No records or assertions of regular testing or maintenance of the portable fire extinguishers were provided.

CO2 portable fire extinguisher

Dry chemical portable fire extinguisher

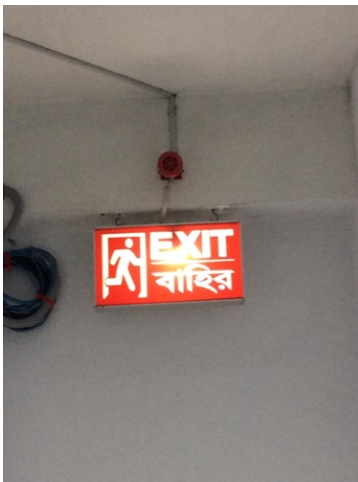
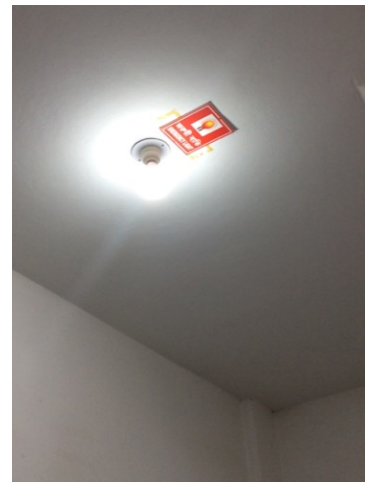
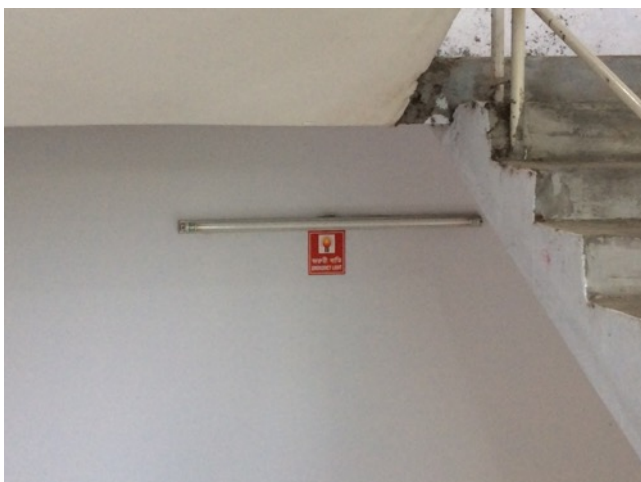
There were multiple florescent lights that had an alternate “Instant Power Supply” (IPS) and generator backup on each floor. Based on the number and location of emergency lighting units, there did not appear to be adequate illumination of the means of egress. Each floor had a number of illuminated exit signs, non-directional, located above exits. The factory management reported that these are all serviced by normal electricity as well as by multiple “Instant Power Supply” (IPS) units. Exits signs were observed to be missing along certain egress paths. There were no records or assertions of regular testing or maintenance of the emergency lighting system.

Exit sign

IPS Powered emergency lighting

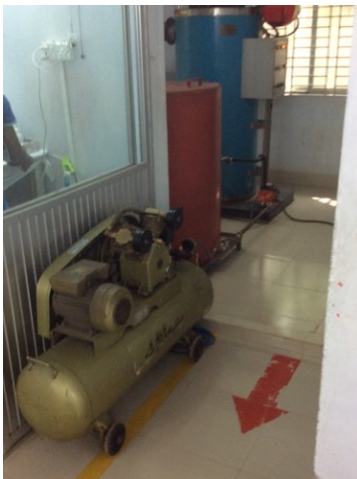
Compressors

Two (2) compressors serve the building. They were located on the ground floor in the north and east side of the building. The building did not have proper fire-rated separations.

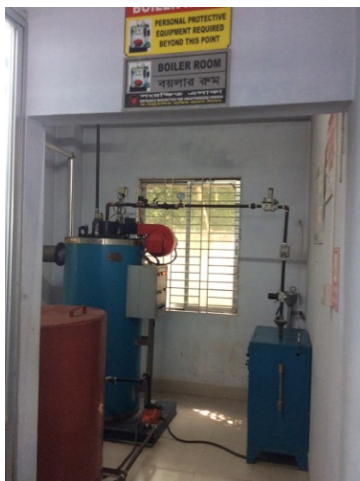
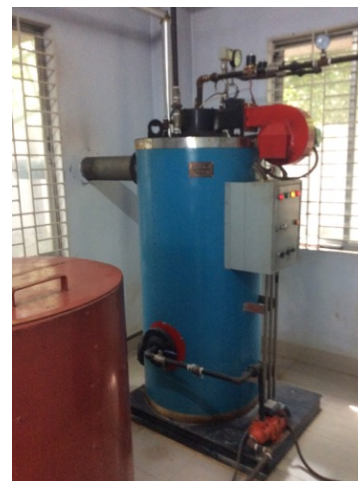
A single (1) boiler serves the building. They were located on the ground floor in the east side of the building. The building did not have proper fire-rated separations.

Boiler room

Boiler

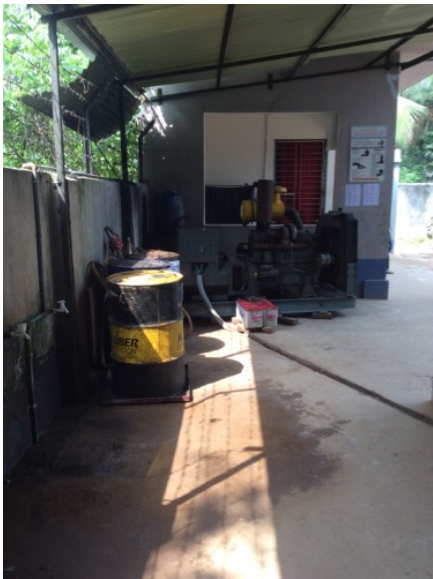
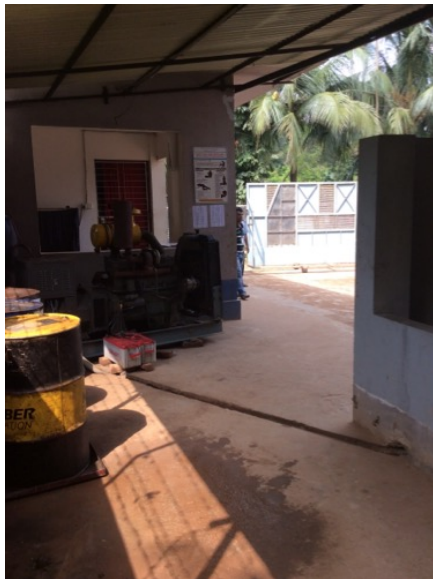
| No. | Category | Finding | Recommendation | Remediation Timeframe |
|---|---|---|---|---|
| F-1 | Fire Rated Construction | Diesel fuel storage was located inside the generator room. | Remove all diesel fuel storage from the generator room and relocate to the exterior such that the diesel fuel storage is at least 10 ft from required egress paths. If located along egress paths or in a utility building, separate the diesel fuel storage with 2-hr fire rated construction. There shall be no diesel fuel storage in a factory production building. | Immediately |

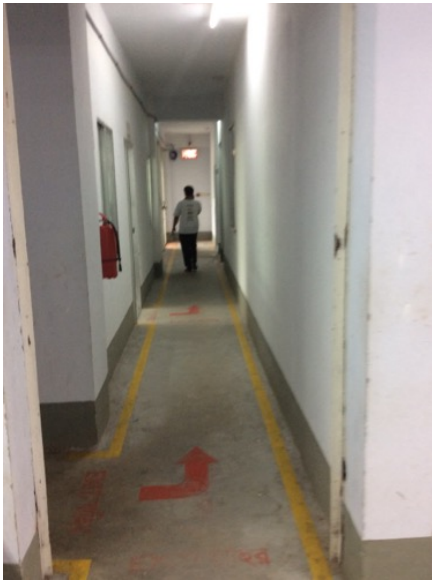
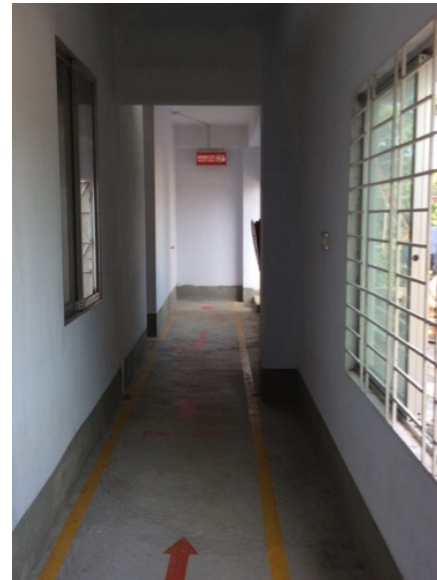
| No. | Category | Finding | Recommendation | Remediation Timeframe |
|---|---|---|---|---|
| F-2 | Fire Rated Construction | Exit access corridors are not provided with 1 hr fire resistance rating or approved NFPA 13 sprinkler system. | Provide exit access corridors with 1 hr fire resistance rating or approved NFPA 13 sprinkler system. | Within 3 months |

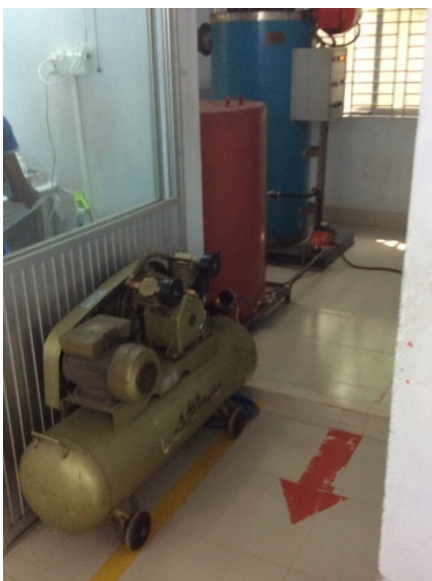
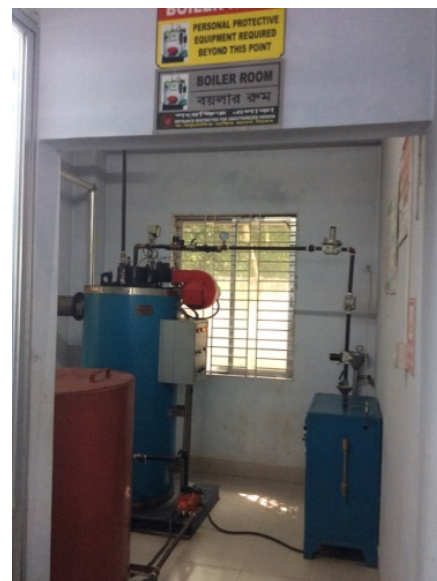
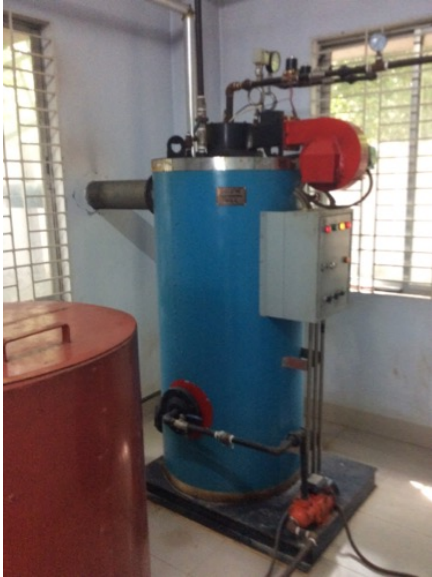
| F-3 | Fire Rated Construction | The boiler and compressor rooms are not separated by fire-rated construction due to openings, non-rated doors, and penetrations on ground floor north side of the building. | Separate the boiler and compressor rooms by a minimum 1-hr fire-rated construction for non-high rise. Seal and protect all openings to maintain the required fire separations. Provide proper ventilation and consult a qualified engineer. | Within 3 months |

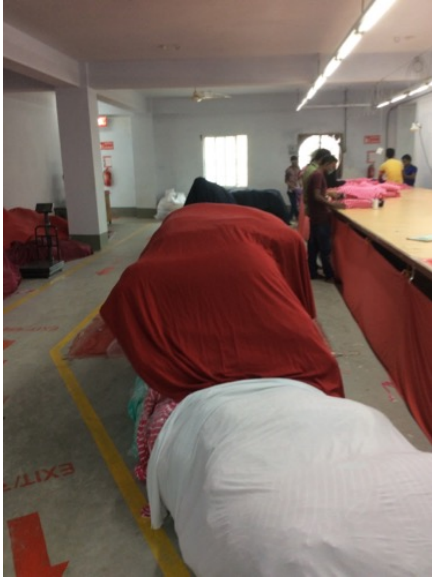
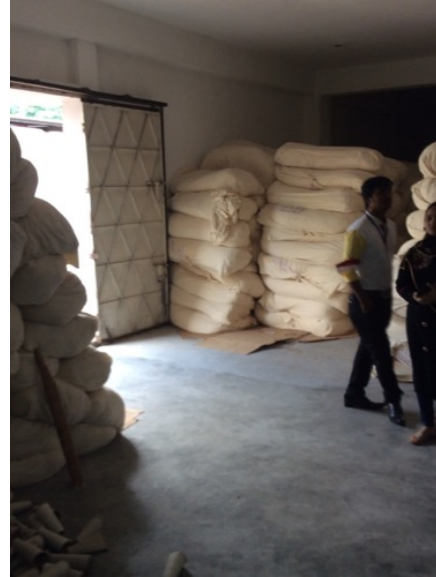
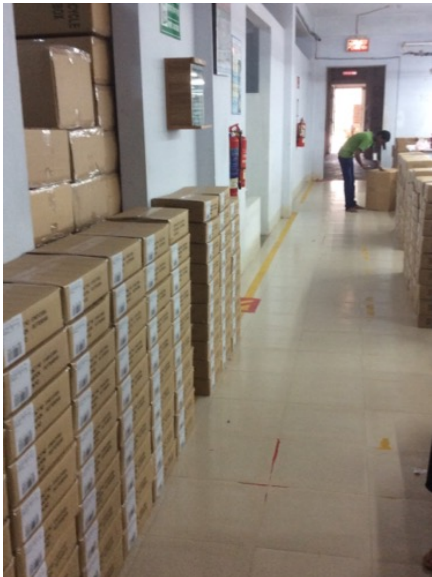
| F-4 | Fire Rated Construction | Areas used for combustible storage open to the factory are not properly defined and not within limits on ground, and 2nd floors. | <p>Provide defined storage areas and limit the storage arrangement as follows:</p> <p>Maximum height of 2.45m (8 ft) and maximum area of 23m<sup>2</sup> (250 ft<sup>2</sup>)</p> <p>AND</p> <p>Separate areas of unenclosed combustible storage by a minimum clear distance of 3m (10 ft).</p> | Within 3 months |

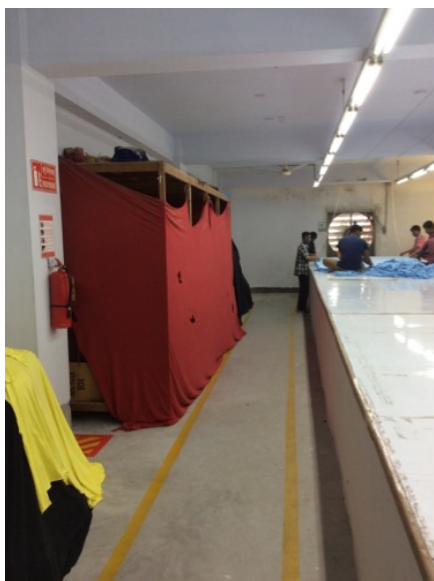
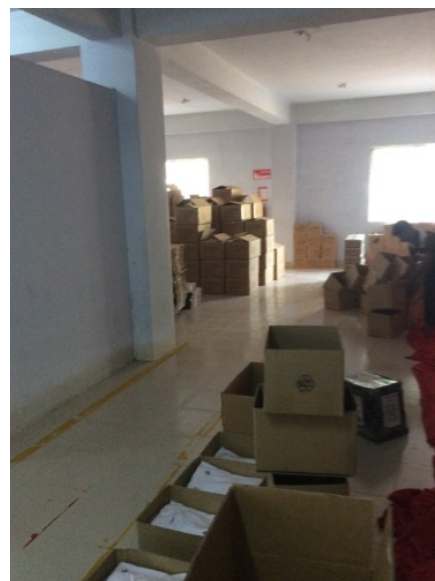
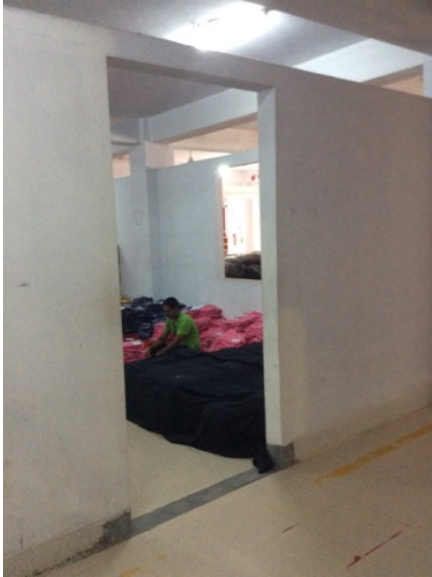
| F-5 | Fire Rated Construction | Rooms used for combustible storage are not separated by a minimum 1-hr fire-rated construction on ground and 2nd floors. | <p>Provide dedicated storage rooms separated by minimum 1-hr fire-rated construction.</p> <p>OR</p> <p>Where separate storage rooms are not feasible, provide defined storage areas and limit the storage arrangement as follows:</p> <p>Maximum height of 2.45m (8 ft) and maximum area of 23m<sup>2</sup> (250 ft<sup>2</sup>)</p> <p>OR</p> <p>If sprinkler protected: maximum height of 3.66m (12 ft) and maximum area of 93m<sup>2</sup> (1000 ft<sup>2</sup>)</p> <p>AND</p> <p>Separate areas of unenclosed combustible storage by a minimum clear distance of 3m (10ft).</p> | Within 3 months |

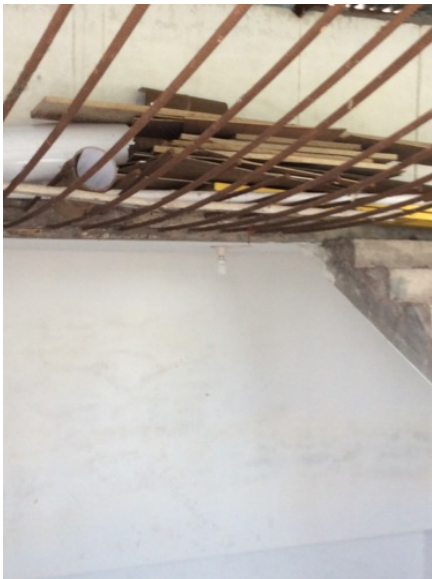
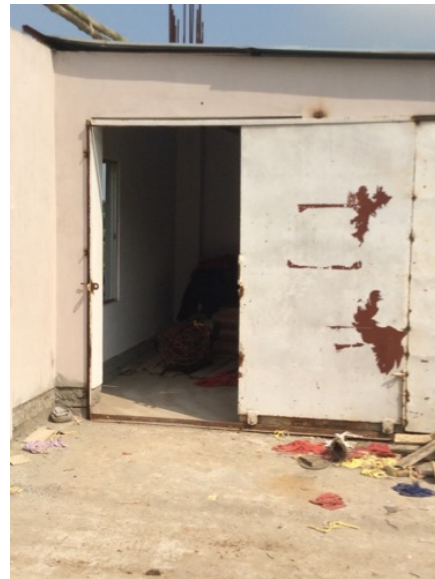
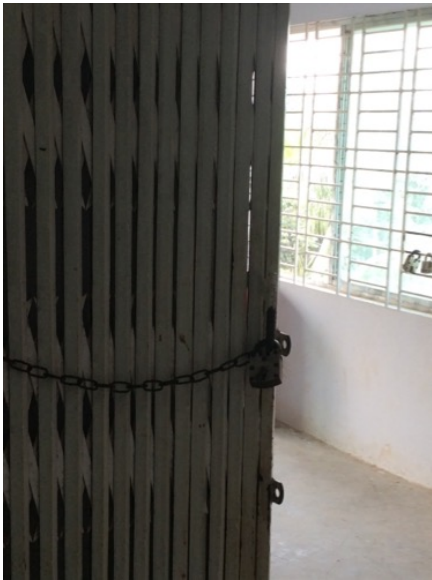
| F-6 | Fire Rated Construction | Exit stairs are not separated from work areas and other spaces on each floor by fire-rated construction due to unprotected openings and penetrations in all exit stairs on all floors. | Separate the exit stairs from from work areas and other building spaces on all floor levels by minimum 1-hr fire-rated construction. Provide minimum 1-hr fire rated doors and seal all unprotected openings and penetrations to maintain the fire separation. | Within 3 months |

Ensure that all fire doors are self-closing and positive latching, and are provided with fire exit (panic) hardware where serving production floors or assembly occupancies. If fire doors are required to be held open for functional reasons, provide automatic-closing devices tied to the fire alarm system.

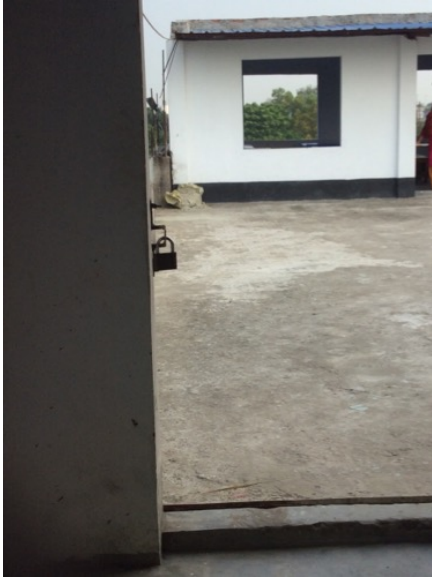
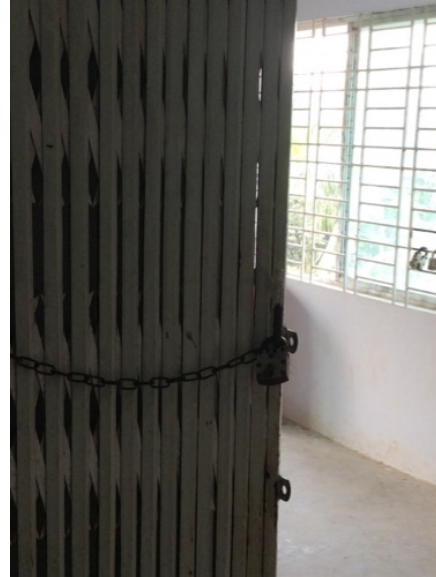
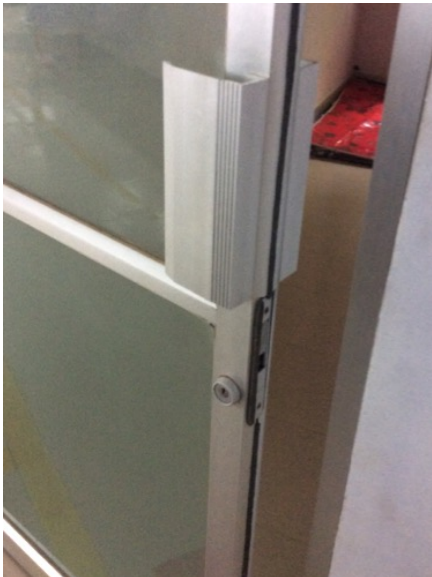
| F-8 | Egress | Egress doors and gates with locking features are provided at building exits, exit stairs, along egress routes, and exit discharge on all floors. All gates were open and unlocked during inspection. | <p>Remove locking features from all egress doors and gates.</p> <p>If locks are required for security reasons, utilize special door locking features complying with ACCORD standard 6.8.2.</p> | Immediately |

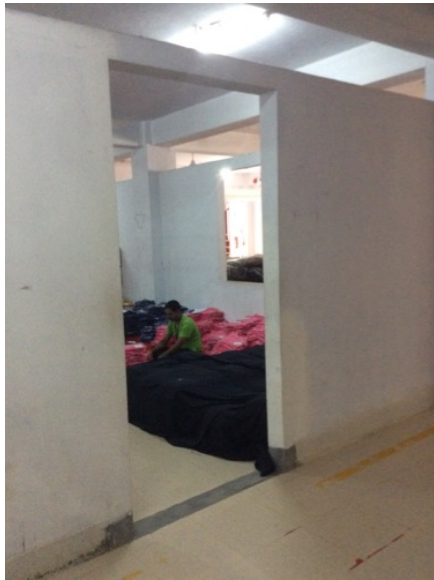
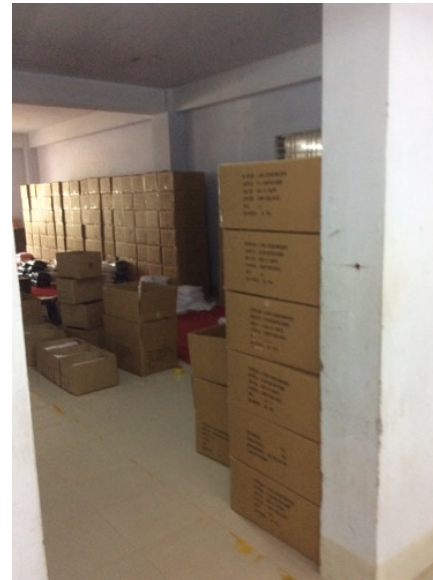
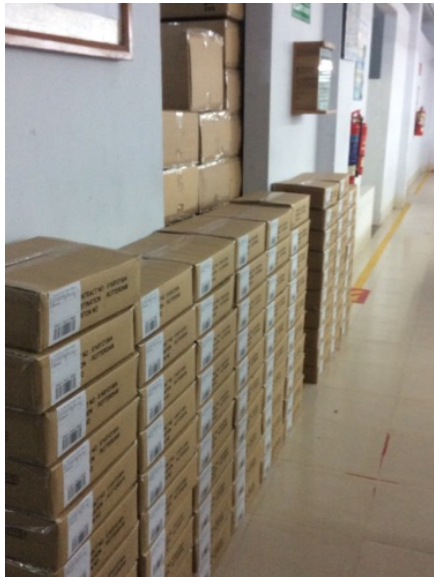
| F-9 | Egress | Storage was located in the egress path on ground and 2nd floors. | Keep egress paths and stairs clear of storage. | Immediately |

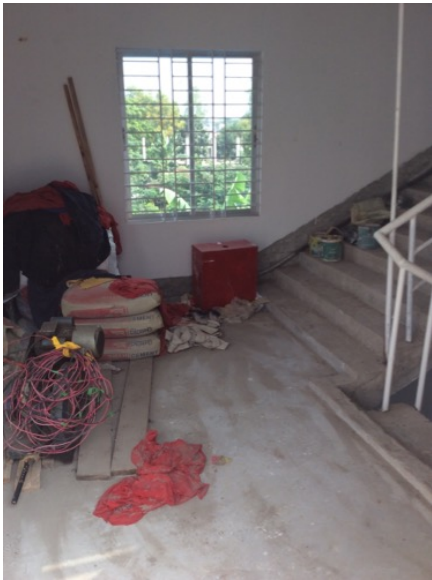
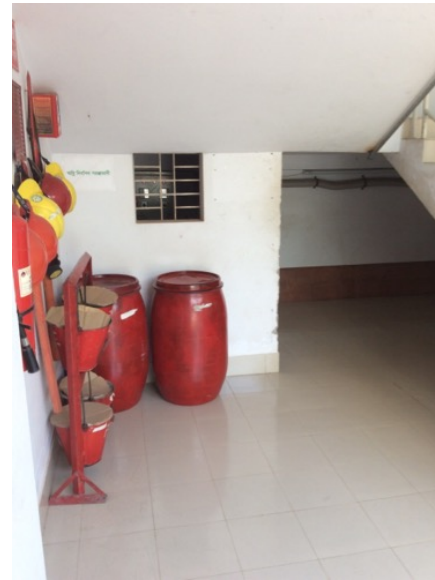
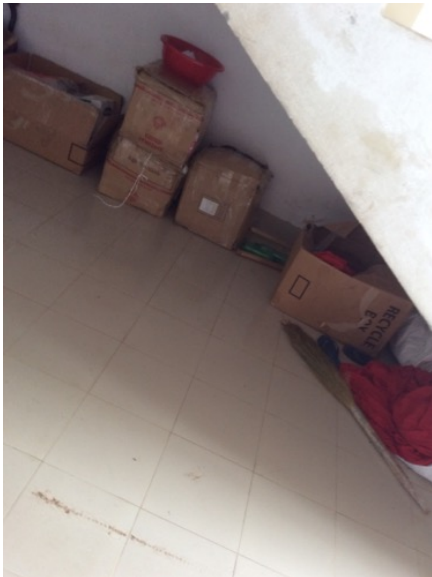
| F-10 | Egress | Storage was located in the exit stair in the northwest exit stair on the 2nd floor and southwest exit stair on ground floor. | Remove all storage from exit stairs. | Immediately |

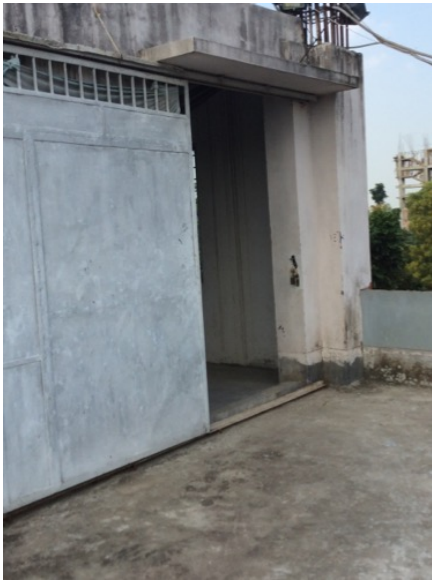
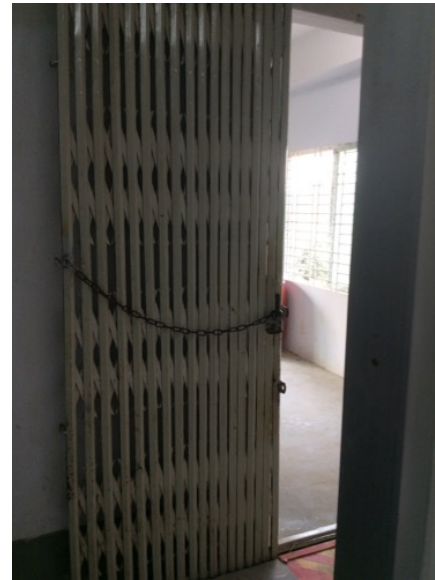
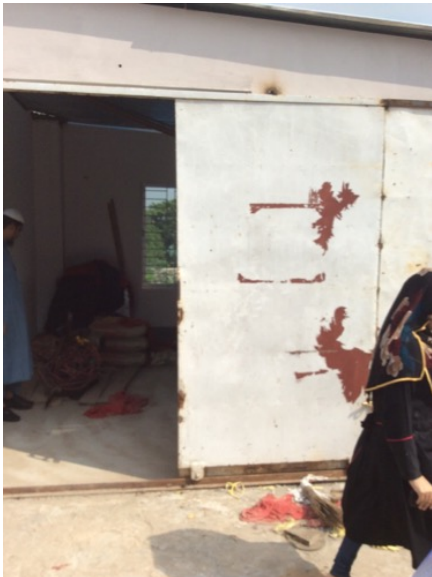
| F-12 | Egress | Collapsible gates and sliding doors are provided at building exits, exit stairs, along egress routes, and exit discharge on all floors. | Replace all gates and sliding doors along the means of egress with side-hinged, swinging egress doors in accordance with ACCORD standard 6.8.1. | Within 1 month |

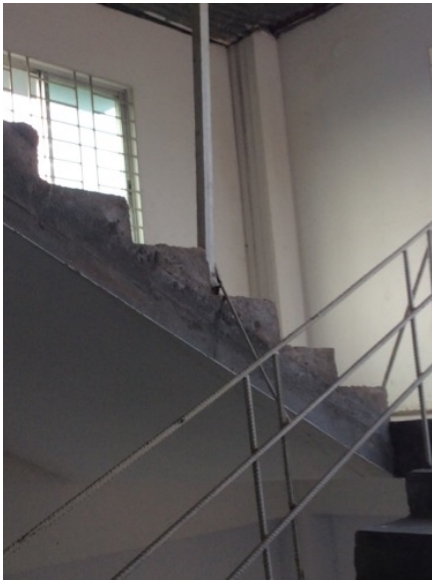
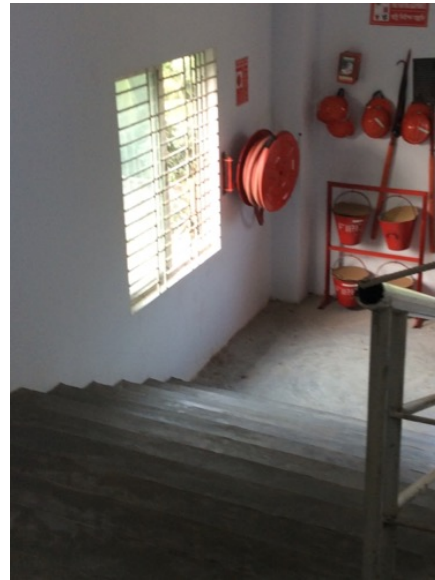
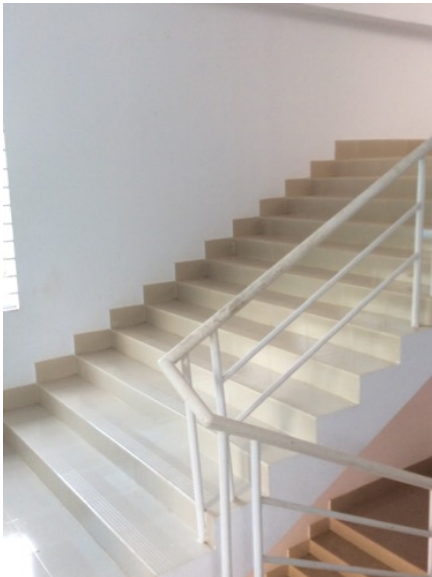
| F-13 | Egress | Handrails are not provided on both sides of the exit stair on all floors | Provide handrails on both sides of the exit stair. New handrails shall have a minimum height of 865 mm (34 in.) and a maximum height of 965 mm (38 in.) as measured from the leading edge of the tread. Intermediate handrails shall be provided when the stair width exceeds 2.2 m (87 in.) . | Within 3 months |

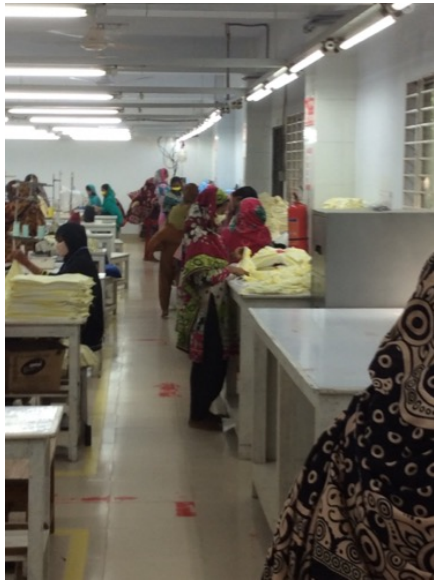
| F-14 | Egress | The width of egress aisles is less than 36-in on 2nd floor. | Provide minimum aisle widths of 36-in. | Within 3 months |

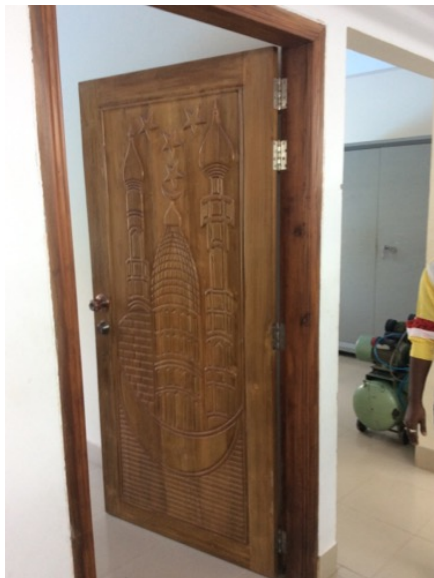
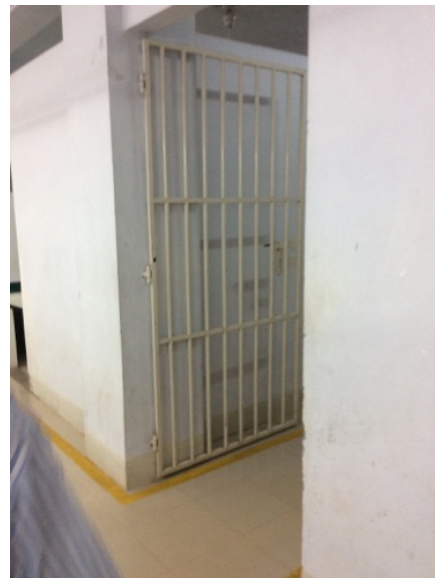
| F-15 | Egress | Egress door serving does not swing in the direction of egress travel in the store room on ground floor and accounts room on 1st floor. | Modify the egress door to swing in the direction of egress travel. | Within 3 months |

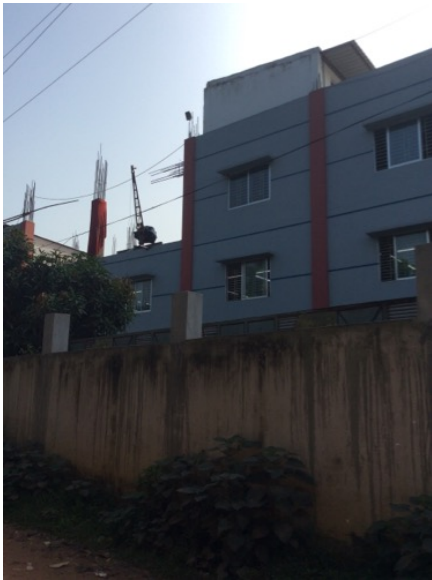
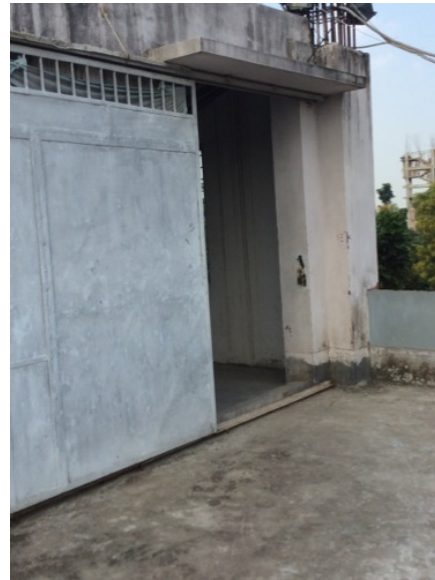
| F-16 | Egress | Occupiable roof is not provided with an adequate parapet or guard rail. | All occupiable roofs shall be provided with parapets or guards with a minimum height of 1067 mm (42 in.) | Within 3 months |

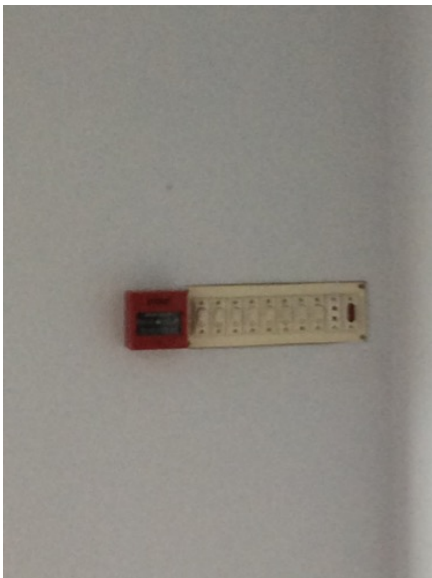
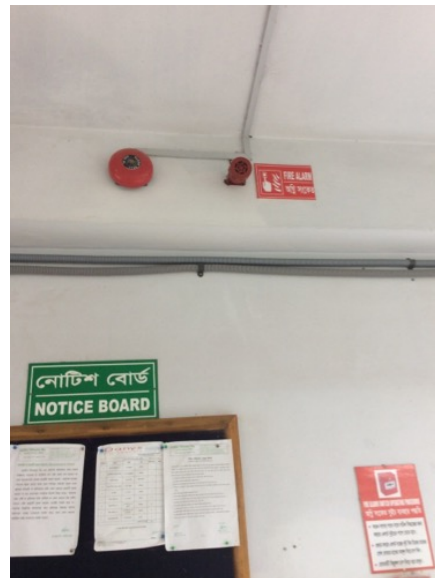
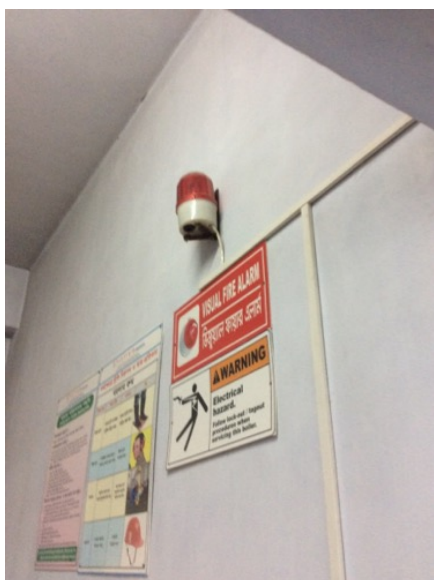
| F-17 | Fire Protection | The fire alarm system is antiquated, not a listed system and does not provide alarm and notification features consistent with acceptable standards. | Replace the fire alarm system with a new, listed automatic fire alarm system in accordance with NFPA 72 and ACCORD standards. | Design within 4 months, install within 9 months |

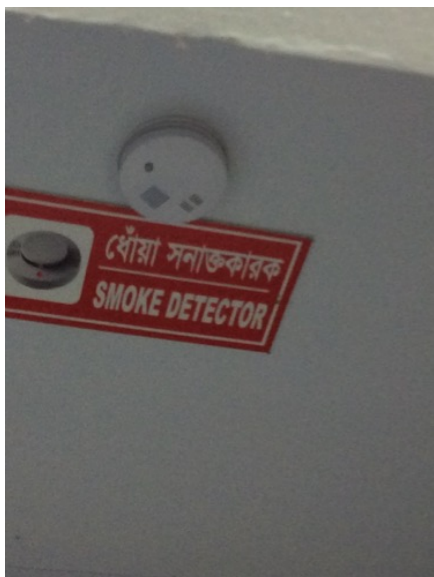
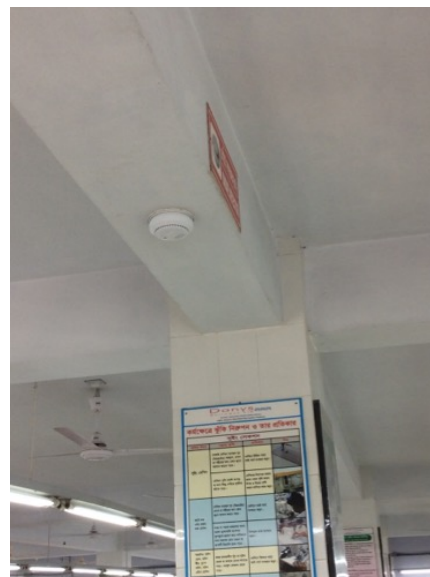
| F-22 | Fire Protection | The building is equipped with single-station smoke alarms. Smoke alarm activation sounds only a local alarm and does not provide automatic fire alarm notification of occupants. | Remove single-station smoke alarms. Provide automatic smoke detection throughout the building, tied into the fire alarm system, in accordance with NFPA 72 and ACCORD standards. | Within 9 months |

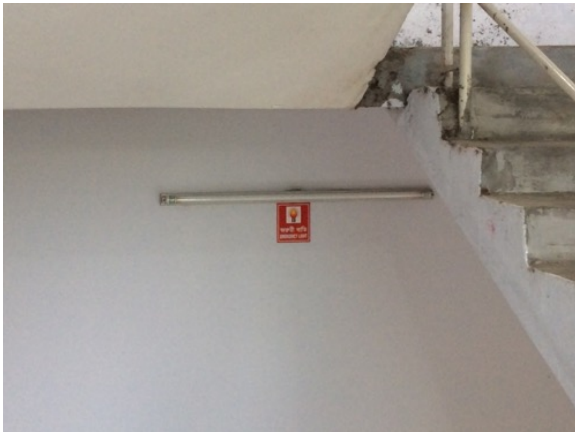
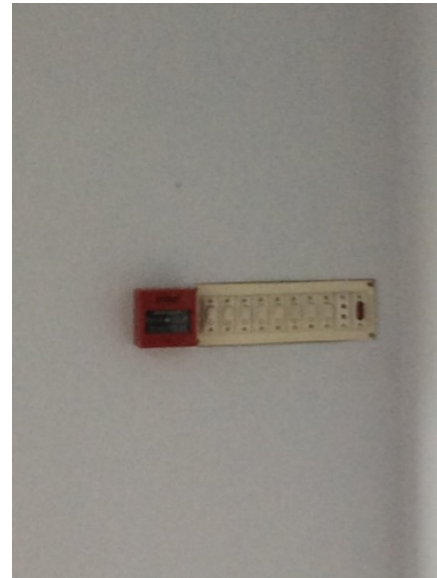
| F-23 | Egress Lighting | Manual on-off switch is provided for emergency lighting units on all floors. | Remove manual on/off switches from emergency lighting units to prevent them from being switched off. | Within 1 month |
