# INITIAL FIRE SAFETY INSPECTION REPORT

**Aman Graphics & Designs Ltd. (Extension)**

**RSC ID: 24595**

**Nazimnagar, Hemayetpur, Savar, Dhaka**

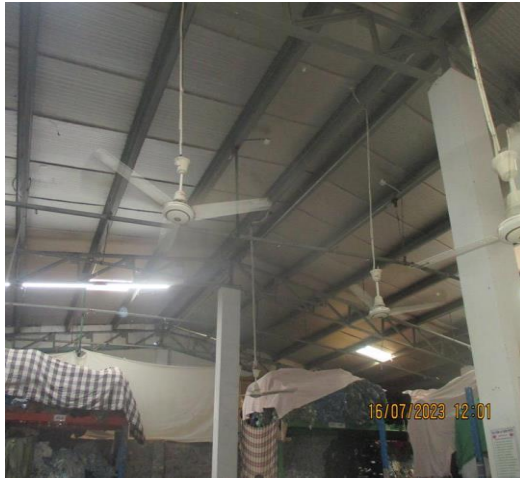
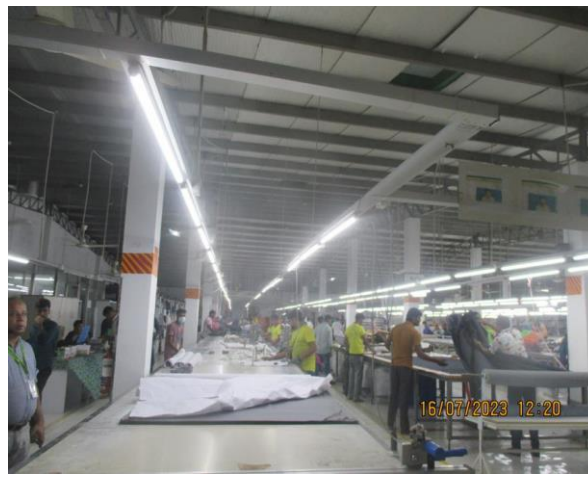
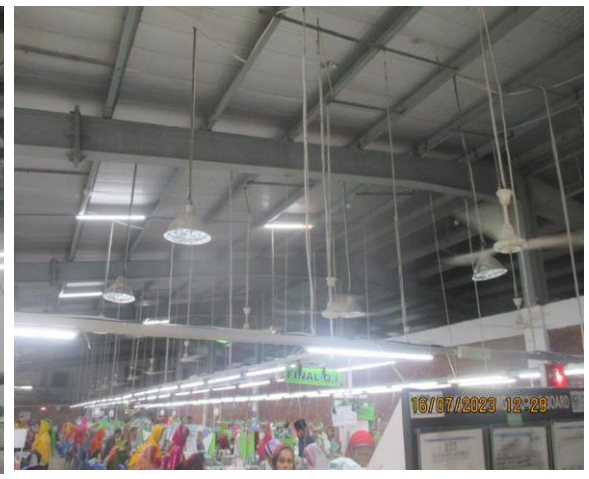
| SI No. | Category | Findings | Required Action | Remediation Time Frame |
|---|---|---|---|---|
| F-1 | Fire Rated Construction | <p>The main structural elements of the buildings are constructed by steel which is non-rated and were found in exposed condition without any fire protection. (Interim Structure).<br/> <b>Location:</b> Shed-4, 5 &amp; 6.</p> | The buildings are interim steel structure which shall be type-I or II construction. So, provide require rating in the structural elements of the buildings following table 3.2.4, 3.1.9 and 3.3.1 of BNBC-2006. | Within 6 months |

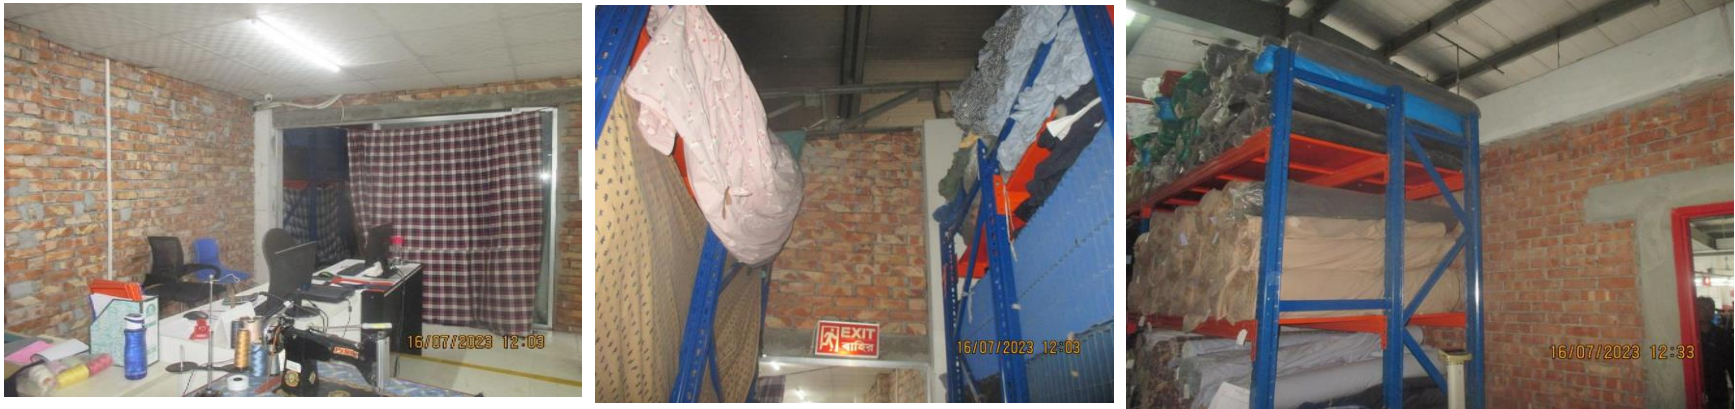
| F-2 | Fire Rated Construction | Room used for combustible storage are not separated by fire rated construction.<br><b>Location:</b> Shed-5 & 6. | Provide dedicated storage rooms separated by minimum 1-hr fire-rated construction. | Within 3 months |

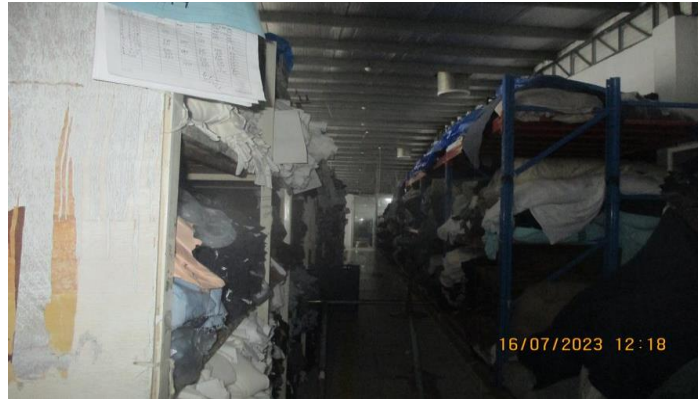
| F-3 | Fire Rated Construction | Areas used for combustible storage open to the factory are not separated by fire rated construction.<br><b>Location:</b> Shed-4 | <p>Provide defined storage areas and limit the storage arrangement as follows:</p> <ul style="list-style-type: none"> <li>- Maximum height of 2.45m (8ft.) and maximum area of 23m<sup>2</sup> (250 ft<sup>2</sup>).</li> <li>- If sprinkler protected: maximum height of 3.66m (12ft.) and maximum area of 93m<sup>2</sup> (1,000 ft<sup>2</sup>).</li> </ul> <p>Separate areas of unenclosed combustible storage by a minimum clear distance of 3m (10ft.).</p> | Within 3 months |

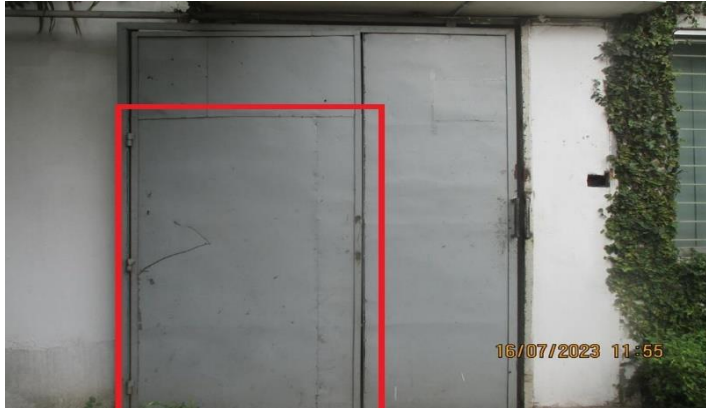
| F-6 | Means of Egress | Headroom on main exits were found less than 6 ft 8 inch.<br><b>Location:</b> Shed-4 & 5. | Headroom on means of egress shall not be less than 6 ft 8 inch. | Within 1 month |

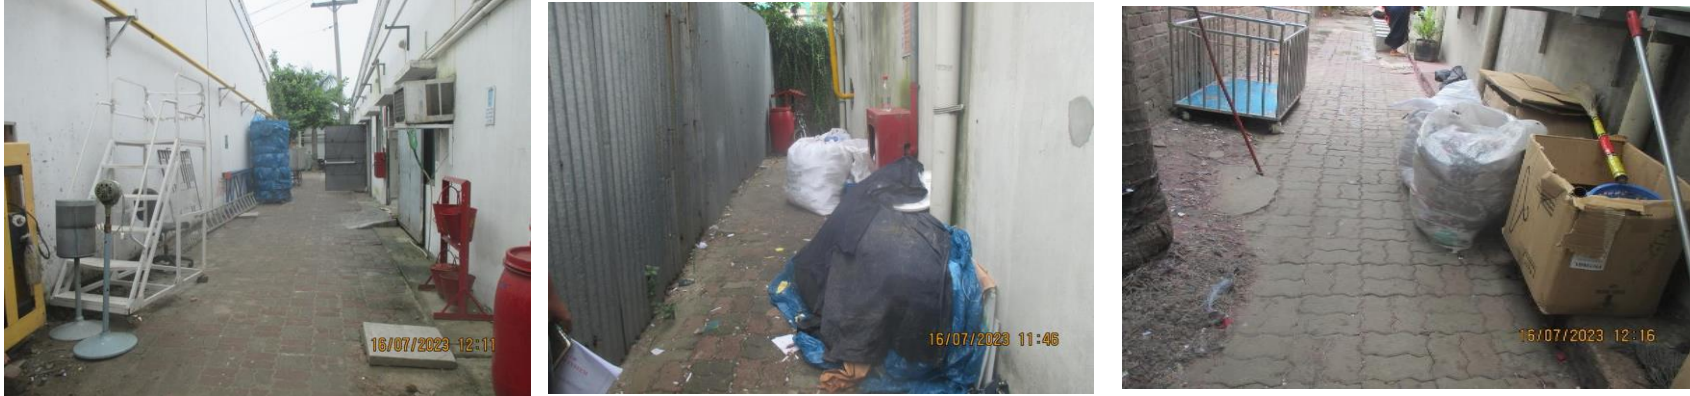
| F-7 | Means of Egress | Egress path was found obstructed by storage.<br>Location: shed- 4 & 5. | Keep egress paths clear and unobstructed. | Immediately |

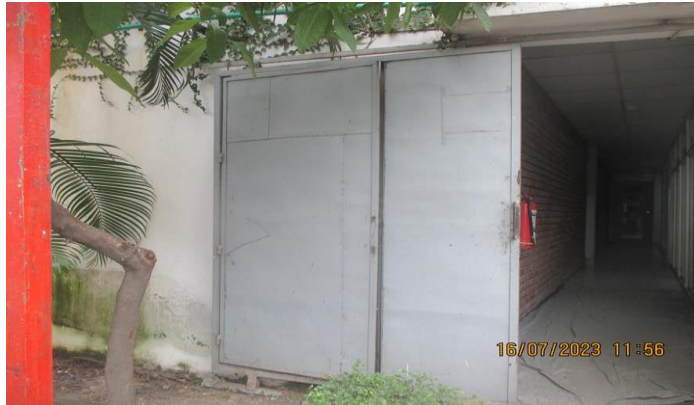
| F-8 | Means of Egress | Sliding doors are provided at building exits.<br><b>Location:</b> Shed-4 & 5. | Replace all collapsible and sliding doors along the means of egress with side-hinged, swinging egress doors. | Within 1 month |

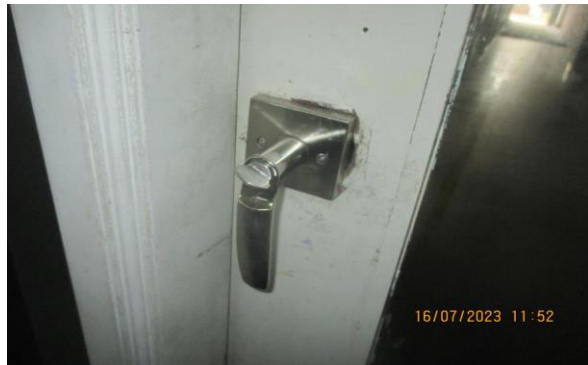
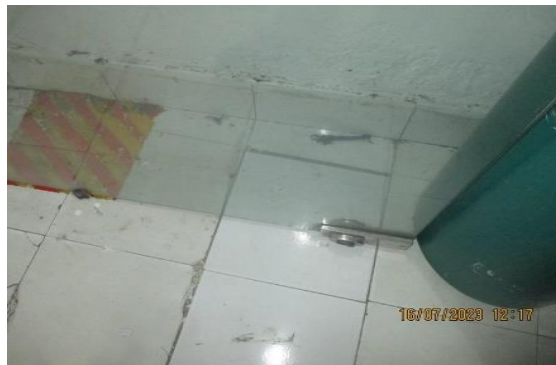
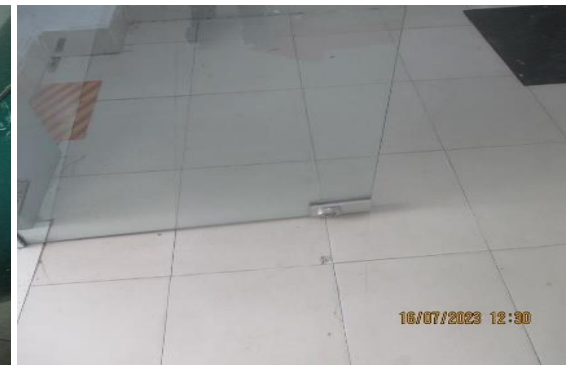
| F-9 | Means of Egress | <p>Egress gates with non-complaint locking features are provided at building exits.</p> <p><b>Location:</b> Shed-4, 5 &amp; 6.</p> | <p>Remove locking features from all egress doors and gates. If locks are required for security reasons, utilize special door locking features complying with NFPA 101.</p> | Immediately |

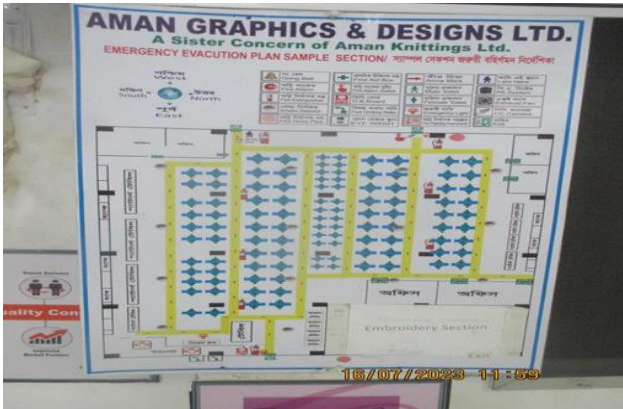
| F-11 | Means of Egress | Fire evacuation maps were not updated in some areas.<br><b>Location:</b> Shed-4, 5 & 6. | Updated fire evacuation maps shall be posted at the entrance to each exit. | Within 1 month |

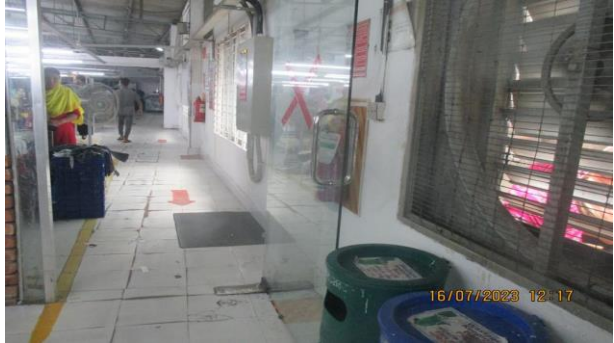
| F-13 | Egress Lighting | <p>Based on the number and location of emergency lights observed, adequate illumination levels are not anticipated along egress routes.</p> <p><b>Location:</b> Shed-4, 5 &amp; 6.</p> | <p>Test the emergency lighting system on each floor and provide additional emergency fixtures to provide adequate illumination along the means of egress. Provide a minimum illumination of 10 lux at the floor level within exit stairs and exit discharge paths and minimum 2.5 lux along exit access aisles.</p> | Within 1 month |

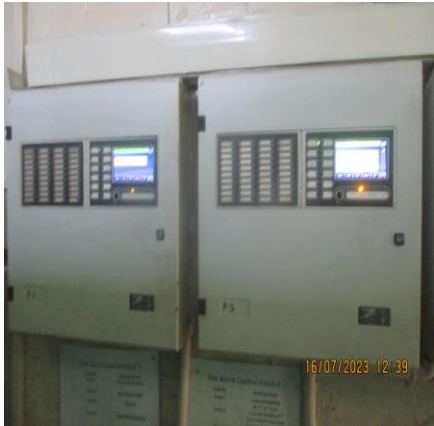
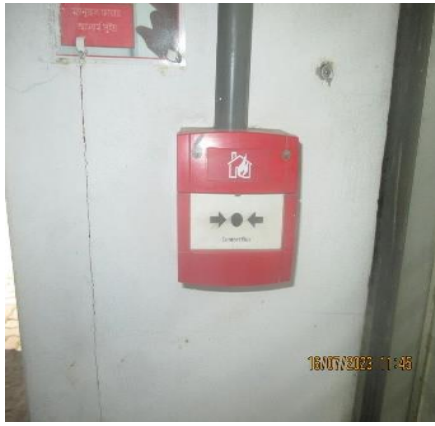
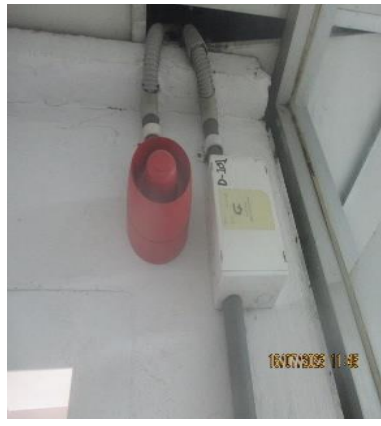
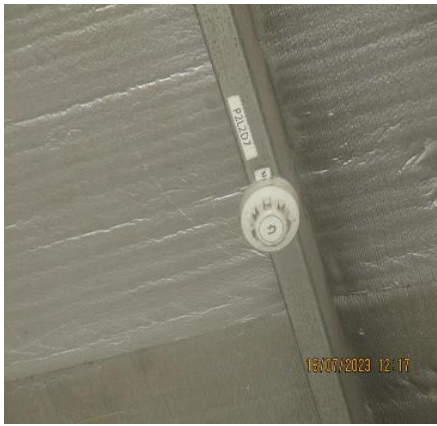
| F-16 | Fire Alarm and Detection System (FADS) | <p>The fire alarm system installation requires detailed review to confirm compliance with NFPA 72 and RSC technical guidelines (standard).</p> <p><b>Location:</b> Shed-4, 5 &amp; 6.</p> | <p>Submit as-built drawings, testing records, equipment certification and other relevant documentation to the RSC for review.</p> <p>Once reviewed, install or modify the fire detection and alarm system (where required) throughout the building in accordance with RSC technical guidelines (standard and NFPA 72. The factory management shall contact RSC to conduct the final acceptance testing after the installation, testing &amp; commissioning.</p> | <p>Design- within 1 Month</p> <p>Modification if required- within 3 Months</p> |
