# INITIAL FIRE SAFETY INSPECTION REPORT

## DNV Clothing (Extension)

**RSC ID: 24769**

**ADDRESS: Plot No. 100/101, AEPZ, Adamjee Nagar, Siddhirgonj**

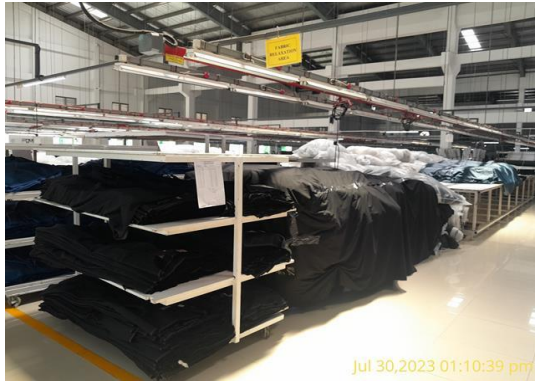
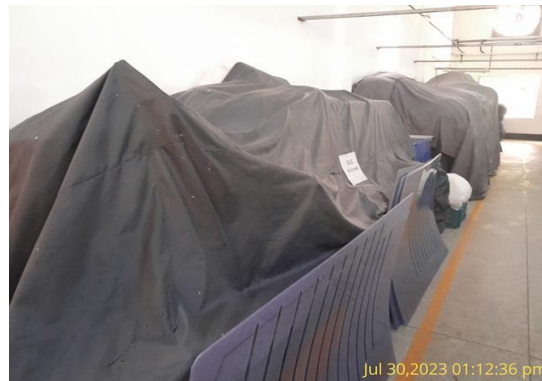
| F-2 | Fire Rated Construction | <p>Areas used for in-process storage of combustible materials are open to the surrounding occupancy.</p> <p>Location: Ground floor production building-2.</p> | <p>Provide defined storage areas and limit the storage arrangement as follows:<br/> Maximum height of 2.45 m and maximum area of 23 m<sup>2</sup> and is separated by a minimum 3.0 m (10ft) from other storage areas and they do not exceed 10 percent of the building area of the story in which they occur. If sprinkler protected, Maximum height 12 ft (3.66 m) and maximum area of 1000 ft<sup>2</sup> (93 m<sup>2</sup>) and separated by a at least 25 ft (7.62 m) from other storage areas and does not constitute more than 10 percent of the building area or 4000 ft<sup>2</sup> (372 m<sup>2</sup>) of the sprinklered area, whichever is greater.<br/> or,<br/> Enclose the storage area from the surrounding occupancy with a minimum 1 hour fire rated construction.</p> | Within 3 months |

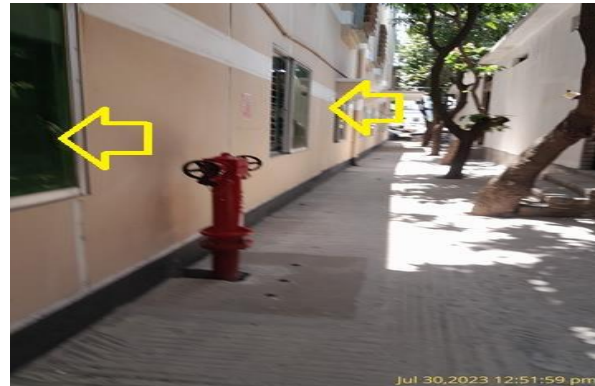
| F-3 | Mean of Egress | <p>The exit discharge path was less than 10 ft wide and was not separated from the building interior.</p> <p>Location: North side of production building -2</p> | <p>Seal all penetrations and openings to the interior of the building along the discharge path, up to a height of 10 ft. to provide a minimum 2-hr fire separation.</p> | <p>Within 3 months</p> |

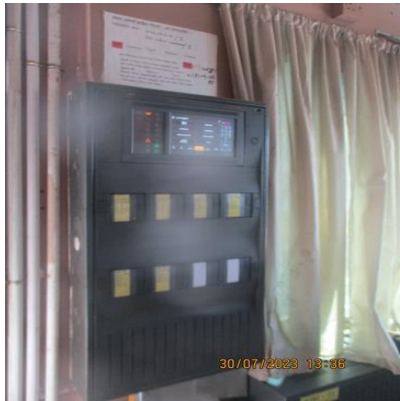
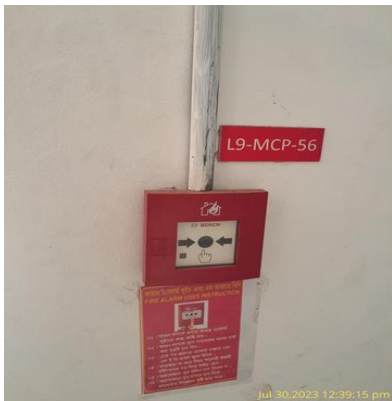
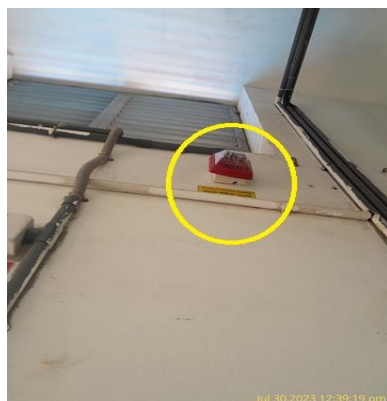
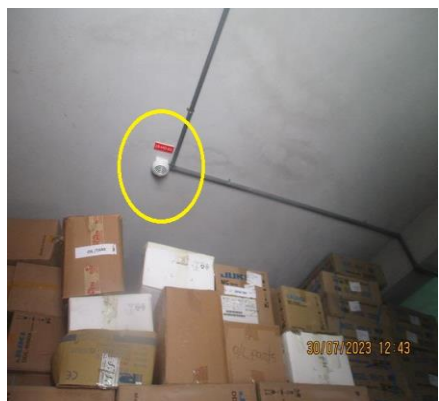
| F-4 | Fire Alarm & Detection System (FADS) | Addressable fire alarm & detection system installation requires detailed review to confirm compliance with NFPA 72 and RSC standard. | <p>Submit design, documents and calculations to RSC for review prior and based on the review modify the system if there is any.</p> <p>After installation the owner shall contact the RSC for witness of conducting the final acceptance testing of the fire detection &amp; alarm system installation.</p> <p>Also inspect, test and maintain the fire alarm system, and keep written records on-site, in accordance with NFPA 72.</p> | Design Review within 1 month and modification within 3 months (If require) |

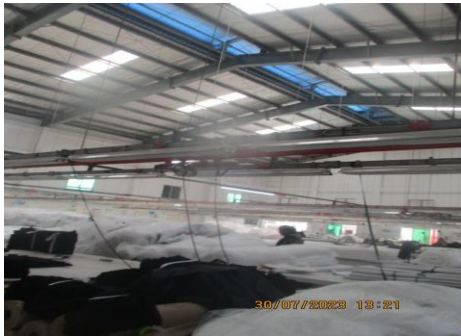
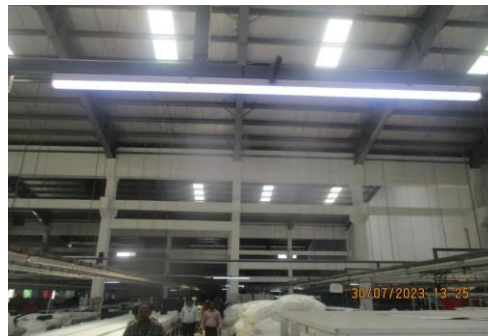
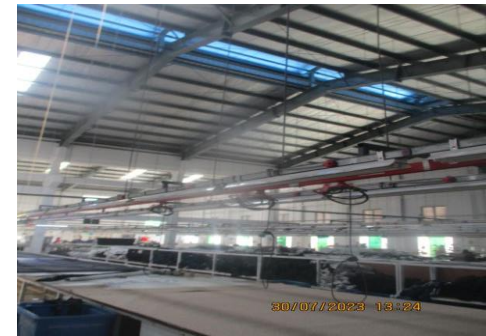
| F-6 | Fire Rated Construction. | The main structural element (Rafter) of the building is constructed by steel which is non-rated and were found in exposed condition. The vertical load bearing column were found RCC. | The building shall be type-I or II construction. So, provide require rating in the structural elements of the building. Consult with a qualified fire protection engineer. BNBC 2020, Part 3, Table 3.1.7 | Within 6 months |
