# INITIAL FIRE SAFETY INSPECTION REPORT

**Kenpark Bangladesh Apparel (Pvt.) Ltd.(K-5) (Extension)**

**RSC ID: 24555**

**Date: 14/09/2023**

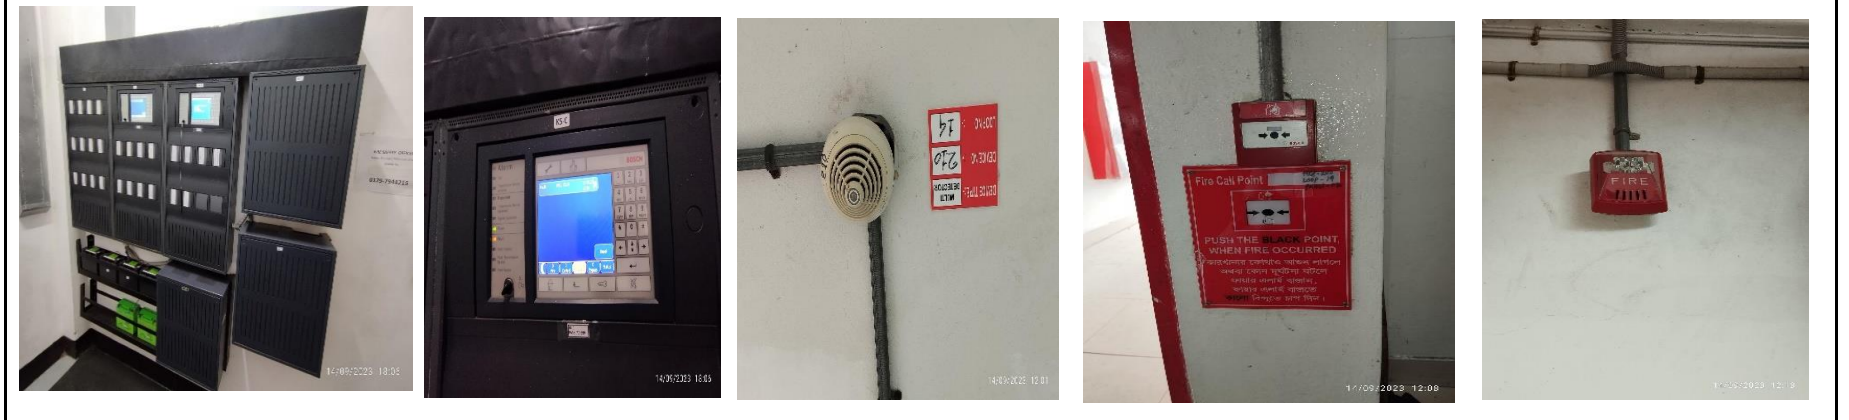
| SI No. | Category | Findings | Required Action | Remediation Time Frame |
|---|---|---|---|---|
| 1 | Fire Alarm & Detection System (FADS) | The fire alarm and detection system installation requires detailed review to confirm compliance with NFPA 72 and RSC standard. | Submit the fire alarm system design to RSC for review. Once the design is reviewed, install and modify the fire detection and alarm system throughout the building in accordance with review comment, RSC Technical Guidelines (Standard) and NFPA 72.<br><br>After installation the owner shall conduct internal testing and commissioning and then contact the RSC for witness of final acceptance testing. | Within 2 months for review and 04 months for installation |

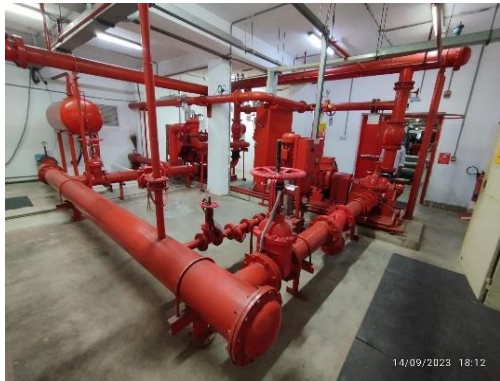
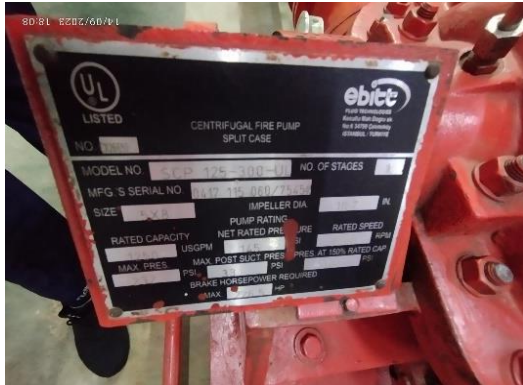
| 2 | Fire Suppression System (SUPS) | The fire pump set installation requires detailed review to confirm compliance with NFPA 20 and RSC standard. | <p>Submit the fire pump system drawing to RSC for review. Once reviewed, install, or modify the pump system throughout the building in accordance with RSC Technical Guideline (Standard) and NFPA 20, 22 and 24.</p> <p>After installation the owner shall contact the RSC for witness of conducting the final acceptance testing of the standpipe system.</p> | Within 2 months for review and 04 months for installation |

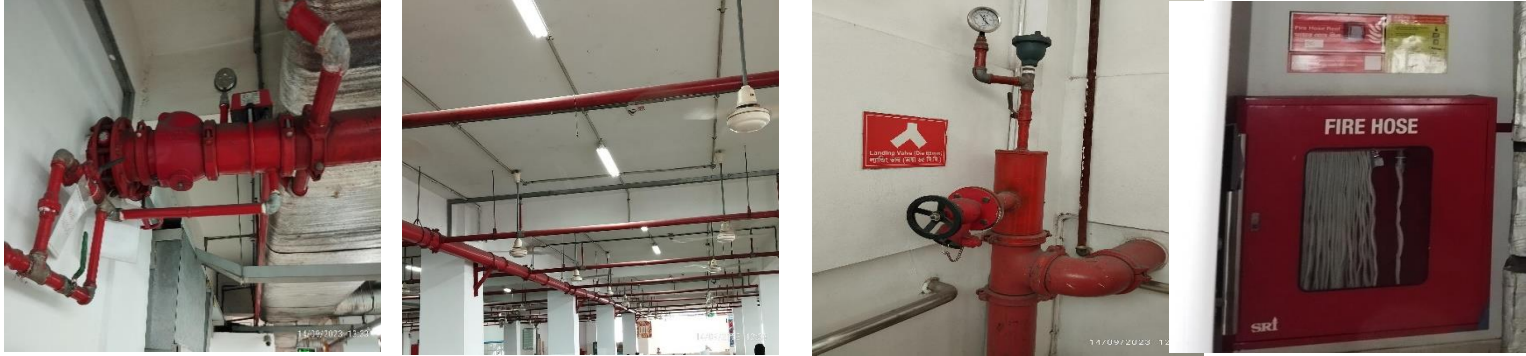
| 3 | Fire Suppression System (SUPS) | The firefighting system (sprinkler & standpipe) installation requires detailed review to conform compliance with NFPA 13, 14. | <p>Submit the fire standpipe and sprinkler system drawing to RSC for review. Once reviewed, install, or modify the pump system throughout the building in accordance with RSC Technical Guideline (Standard) and NFPA 13, 14, 20,22 and 24.</p> <p>After installation the owner shall contact the RSC for witness of conducting the final acceptance testing of the standpipe system.</p> | Within 2 months for review and 04 months for installation |

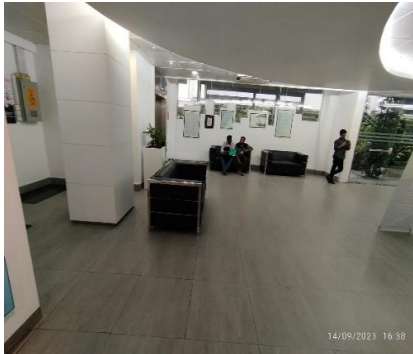
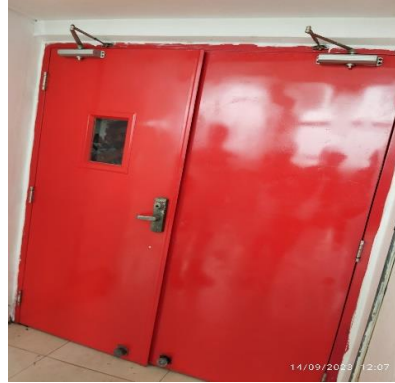
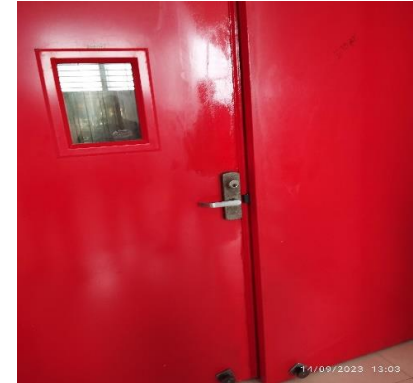
| 4 | Fire Rated Construction | The exit stairs are not separated from work areas, other spaces on each floor by fire-rated construction. Several fire doors were not latching properly and stair-B not separated from office facility and DB at ground floor. | <p>The exit stair enclosure shall be provided with a minimum a minimum of 2- hr. fire resistance rating. Provide 1.5 hr. fire rated door and seal all penetrations and openings by 2 hr. fire rated fire rated barrier construction.</p> <p>Ensure that the fire doors are self-closing and positive latching and that they are provided with fire exit (panic) hardware where serving production floors. If fire doors are required to be held open for functional reasons, provide automatic closing devices tied to the fire alarm system.</p> | Within 3 Months |

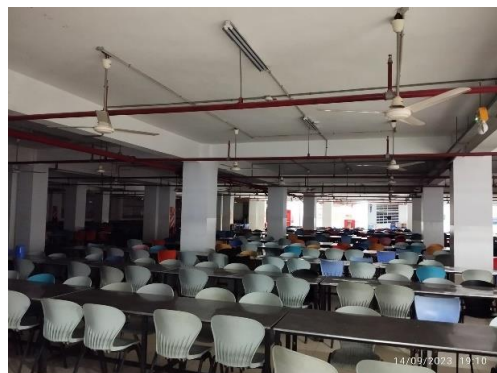
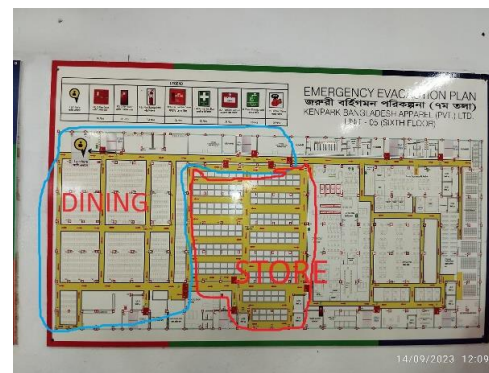
| 5 | Fire Rated Construction | <p>Dining capacity at 6th floor (reported more than 700 occupant) is not separated from storage as well as sewing section of 5th floor with fire-rated construction.</p> <p>The factory has separated the dining area from storage by gypsum board and 5th floor slab constructed by concrete which does not meet BNBC table 3.2.1.</p> <p>Location: 7-storied building on 6th floor.</p> | <p>To classify the occupancy as E4, it's necessary to limit the occupant load to 300 or below. Afterward, ensure a three-hour fire separation from other occupancies. Openings within such fire barriers shall be protected by opening protectives having a fire protection rating of not less than 3 hr.</p> <p>Additionally, ensure that there are two safe and direct exits available for the dining facilities, or consider relocating them to a dedicated building.</p> | Within 3 Months |

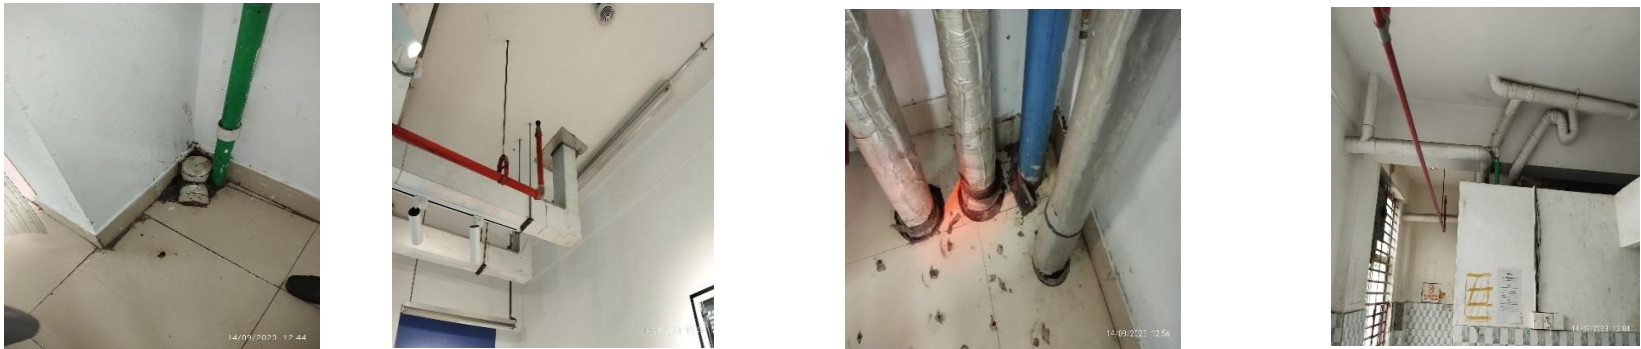
| 6 | Fire Rated Construction | <p>Unsealed floor penetrations through utility, sewerage line and expansion joints are located in the fire-rated floor/ceiling assemblies. The factory has installed fire stop sealant to seal the expansion joints penetration.</p> <p>Location: 7-storied building at Several floor</p> | <p>Seal all penetrations in floor/ceiling assemblies by a listed through-penetration fire stop system tested in accordance with ASTM E814 or approved alternative standard to maintain minimum 3-hr. fire resistance rating. Installation shall be as per manufacturer published installation guideline and the certification authority guideline to ensure the fire-rating. Keep ready product datasheet, design method and certificate on site for verification.</p> | Within 3 months |
| <p>The row contains four photographs documenting the fire safety issue. From left to right: 1. A green vertical pipe penetrating a floor/ceiling assembly with visible gaps around the base. 2. A red horizontal pipe with a fire stop sealant applied around its penetration point. 3. A close-up of multiple pipes (blue, grey, and red) with fire stop sealant applied around their base. 4. A red horizontal pipe with a fire stop sealant applied around its penetration point, with a white box and a yellow ladder visible in the background.</p> | | | | |

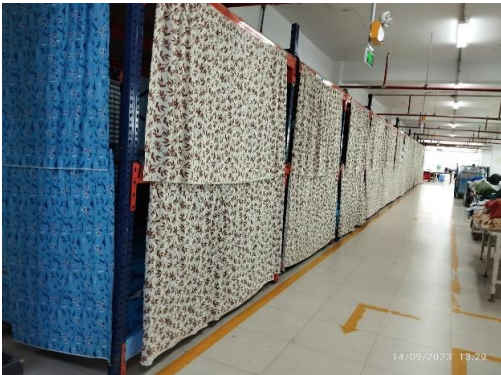
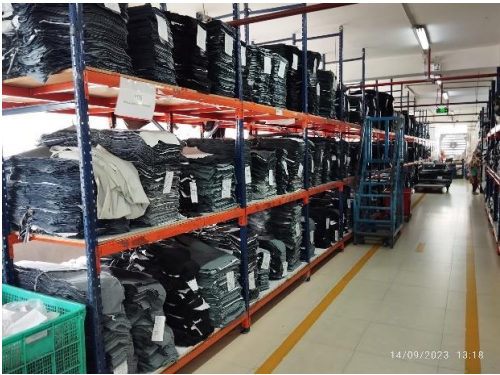
| 7 | Fire Rated construction | <p>Areas used for in-process storage of combustible materials are open to the surrounding occupancy.<br/>Location:7-storied building at 3rd floor</p> | <p>Provide defined storage areas and limit the storage arrangement as follows:</p> <p>Maximum height of 2.45 m and maximum area of 23 m<sup>2</sup> and is separated by a minimum 3.0 m (10ft) from other storage areas and they do not exceed 10 percent of the building area of the story in which they occur.</p> <p>or,</p> <p>If sprinkler protected, Maximum height 12 ft (3.66 m) and maximum area of 1000 ft<sup>2</sup> (93 m<sup>2</sup>) and separated by a at least 25 ft (7.62 m) and does not constitute more than 10 percent of the building area or 4000 ft<sup>2</sup> (372 m<sup>2</sup>) of the sprinklered area, whichever is greater. or,</p> <p>Enclose the storage area from the surrounding occupancy with a minimum 1 hour construction.</p> | Within 3 months |

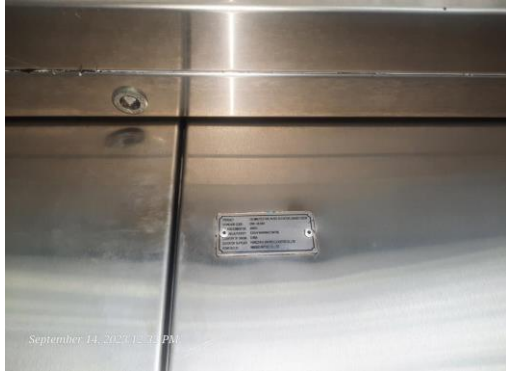
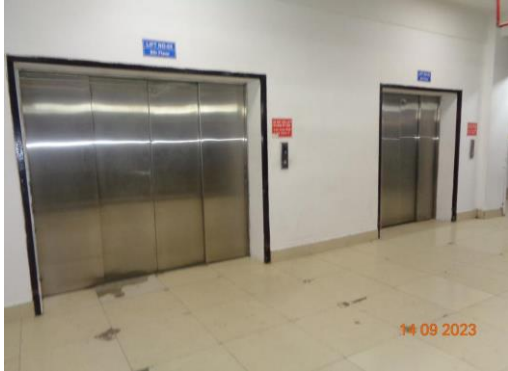
| 8 | Fire Rated construction | Elevators open inside the factory production floors. The factory initially provided a TUV certificate for the elevator landing, but no credible listing mark was found on the elevator. Subsequently, the factory sent an Exova Warringtonfire certification, which is required to undergo review and on-site verification with the landing. | Provide a minimum 2-hr fire-rated shaft and 1.5-hr fire rated lift landing doors or 1.5-hr rated opening protection from each floor level and seal all penetrations in floor/ceiling assemblies to maintain the fire separation. | Within 3 Months |

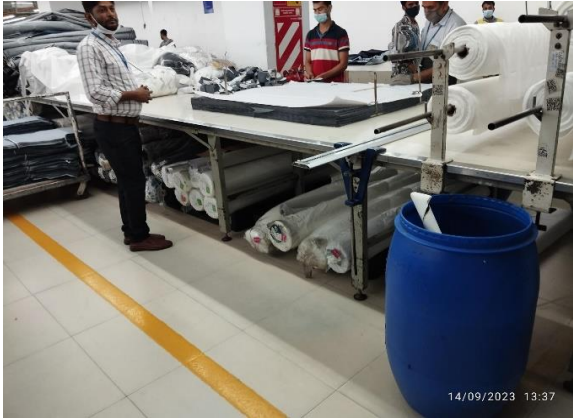
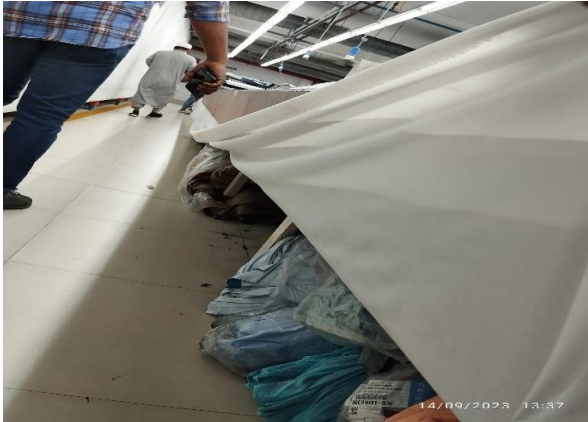
| 12 | Fire Rated Construction | Storages were found underneath the cutting tables. | Remove all storages from underneath the cutting tables. | Within 3 months |

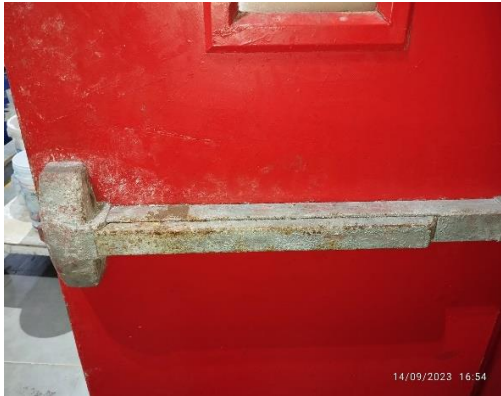
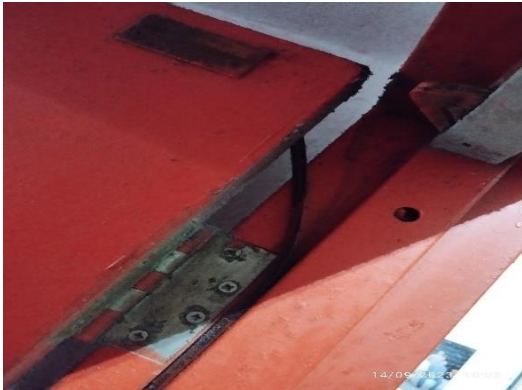
| 13 | Chemical Store | <p>The chemical storage area is not properly separated by fire-rated construction because of the damaged fire door.</p> <p>Location: 7-storied building at ground floor</p> | <p>Separate the chemical storage room by 4-hr fire rated construction. Seal all penetrations and protect the openings to maintain the required fire separations. Keep 16-points MSDS of all chemicals in the storage area.</p> | Within 3 months |

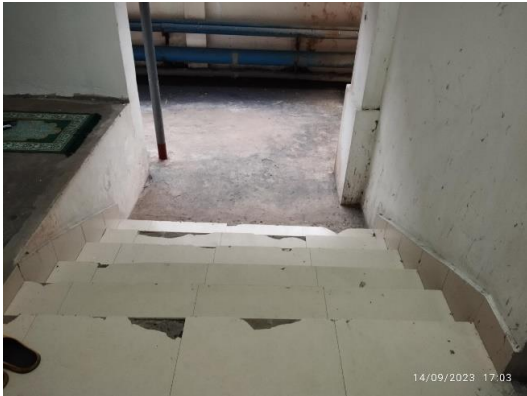
| 14 | Means of Egress | <p>Handrails were not provided on both sides of the exit discharge stair.</p> <p>Location: 7-storied building on ground floor Stair E&amp;F.</p> | <p>Provide handrails on both sides of the exit stair. Intermediate handrails shall be provided when the stair width exceeds 2.2 m (87 in.). New handrails shall have a minimum height of 865 mm (34 in.) and a maximum height of 965 mm (38 in.) as measured from the leading edge of the tread.</p> | Within 1 Month |

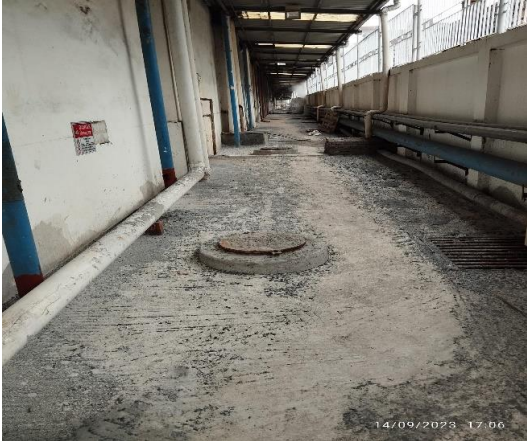
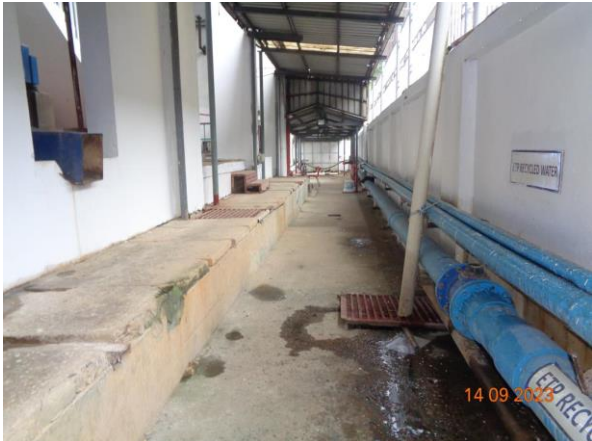
| 15 | Means of Egress | Uneven path of travel and blockage was observed in exit access. | Remove unnecessary items and level exit path to the public way. | Within 1 Month |

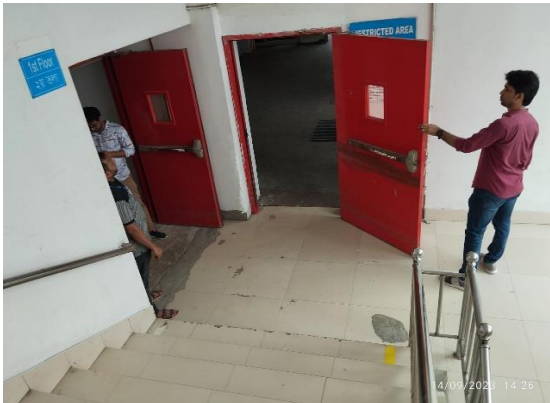
| 16 | Means of Egress | <p>The utility room door open onto the stair landing in a way that it reduces the landing width to less than the stair width.</p> <p>Location : 7-storied building on 1st floor</p> | <p>Modify the egress door so that it opens in the direction of the exit path. Ensure that, when opened, the door leaf in a means of egress leaves not less than one-half of the required width of the stair unobstructed.</p> | Within 3 Months |

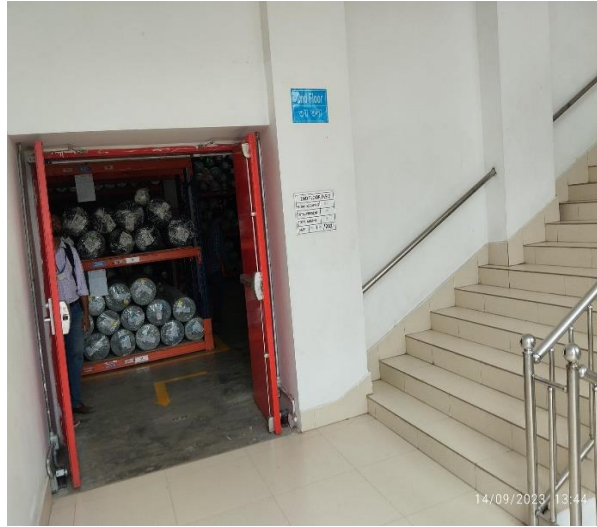
| 17 | Fire Rated Construction | <p>Storage room/areas discharges directly into the exit stair enclosure.</p> <p>Location: 7-storied building</p> | <p>Openings from exit enclosure to storage room, generator and transformer spaces shall be provided with a vestibule with fire rated construction and openings.</p> <p>Provide a 1.5 hr. fire rated door on the exit stair side and a 1-hr. fire rated door on the Store, generator, sub-station room side. Ensure that the fire rating of the vestibule construction matches that of the exit stair enclosure as per RSC standard 6.14.3.</p> | Within 3 months |

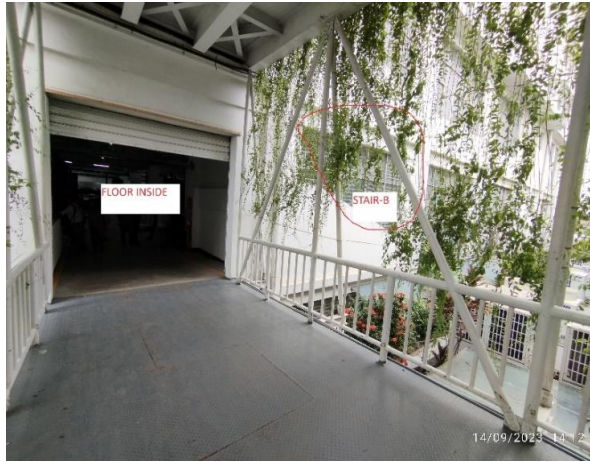
| 18 | Fire Rated Construction | <p>The exterior exit stair-B is not properly separated from the building.</p> <p>Location:7-storied building on 1st floor</p> | <p>Where nonrated walls or unprotected openings enclose the exterior of the stairway and the walls or openings are exposed by other parts of the building at an angle of less than 180 degrees (3.14 rad), the building exterior walls within 3050 mm (10 ft) horizontally of a nonrated wall or unprotected opening shall have a fire-resistance rating of not less than 1 hr. Openings within such exterior walls shall be protected by opening protectives having a fire protection rating of not less than ¾ hr.</p> | Within 3 months |
