# INITIAL FIRE SAFETY INSPECTION REPORT

**Green Life Knit Composite Ltd. (Extension)**

**RSC ID: 24630**

**Date: 10th September 2023**

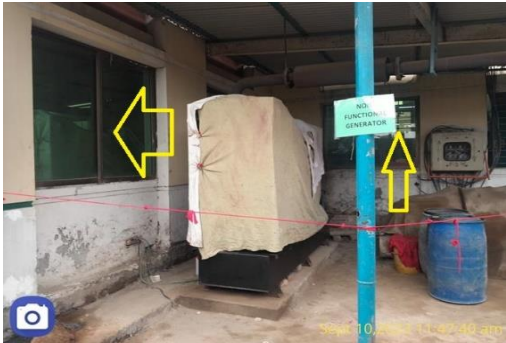
| SI No. | Category | Findings | Required Action | Remediation Time Frame |
|---|---|---|---|---|
| F-1 | Fire Rated Construction. | Generator is not separated from production & chemical store due to unprotected opening.<br><br>Location: South side of ground floor. | Generator shall be separated from other occupancies by a minimum 2-hr fire rated construction (wall, floor, slab etc.). Seal all penetrations and openings (door, window etc.). | Within 3months |

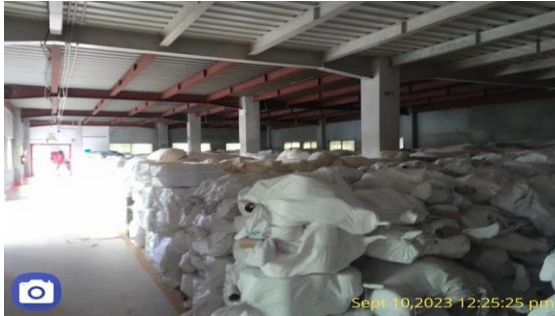
| F-2 | Fire Rated Construction | <p>Rooms used for storage of combustible materials are not separated from the surrounding</p> <p>Location: First floor of washing building.</p> | Rooms used for storage of combustible materials shall be separated from the surrounding occupancy with a minimum 1 hour construction. | Within 3 months |

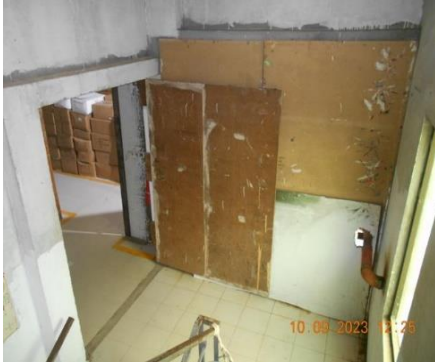
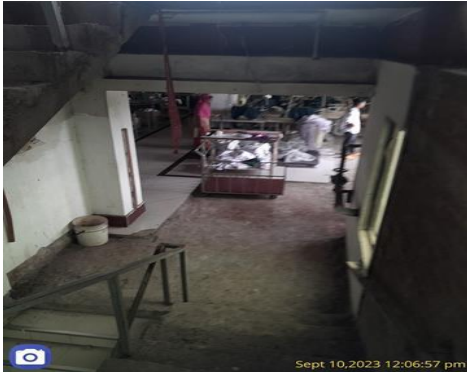
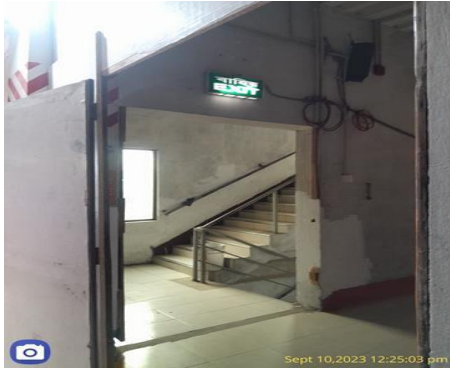
| F-4 | Mean of Egress | <p>The exit stairs are not separated from [work areas, other spaces] on each floor by fire rated construction due to unprotected opening.<br/>Location: 3 Storied washing building.</p> | <p>The exit stair enclosure shall be provided with a minimum 1-hr fire resistance rating with 1- hr. fire rated door and seal all penetrations and openings by 1 hr. fire rated materials for buildings with 3 or fewer stories. The exit stair enclosure shall be provided with a minimum of 2- hr. fire resistance rating with 90 minutes opening protection for buildings 4 or more stories.</p> <p>Ensure that the fire doors are self-closing and positive latching and that they are provided with fire exit (panic) hardware where serving production floors. If fire doors are required to be held open for functional reasons, provide automatic closing devices tied to the fire alarm system.</p> <p><b>Openings from exit enclosure to storage spaces shall be provided with a vestibule with fire rated construction as per RSC Technical Guideline (Standard) V1-6.14.3 .</b></p> | Within 3months |

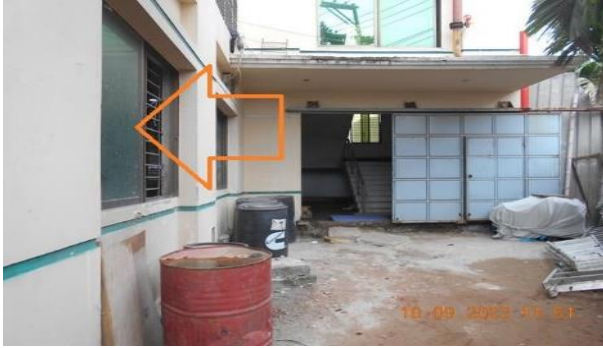
| F-5 | Mean of Egress | <p>The exit discharge path [south side exit] is less than 10 ft wide and is not separated from the building interior.</p> <p>Location: South side exit if 3 storied washing building.</p> | Seal all penetrations and openings to the interior of the building along the discharge path, up to a height of 10 ft. to provide a minimum 1-hr fire separation | Within 3months |

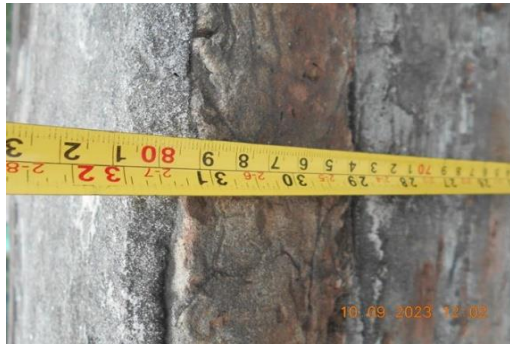
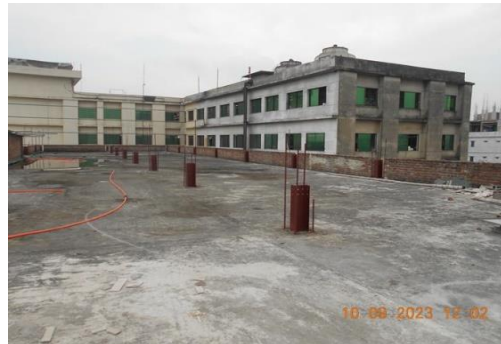
| F-6 | Mean of Egress | <p>Parapets or guards are provided in occupied roof which is less than 1067mm (42 inch).</p> <p>Location: 3 storied washing building</p> | Provide parapets or guards with a minimum height of 1067mm (42 inch.). | Within 3months |

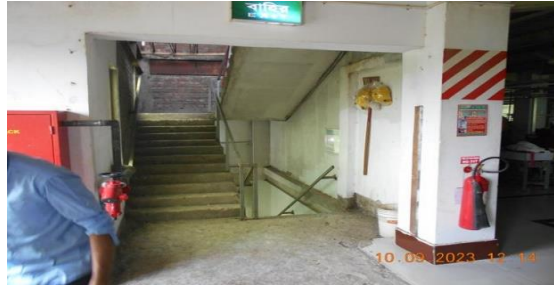
| F-8 | Mean of Egress | <p>Width of exit stairs are less than 1.5 m (60 in.).</p> <p>Location: West side exit stair of 3 storied washing building.</p> | <p>Provide exit stair minimum clear and unobstructed width of 1.5 m (60 in.) in accordance with RSC Technical Guideline (Standard) V1-6.5.6.2.1.</p> | Within 4months |

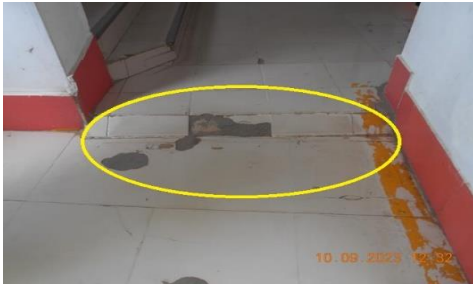
| F-12 | Mean of Egress | Uneven slopewas found on first floor north side exit. | Provide proper level of exit of north side. Remove all types of tripping hazards of the means of egress. Means of egress shall be maintained continuously free and clear of all obstructions | Within 1 month |

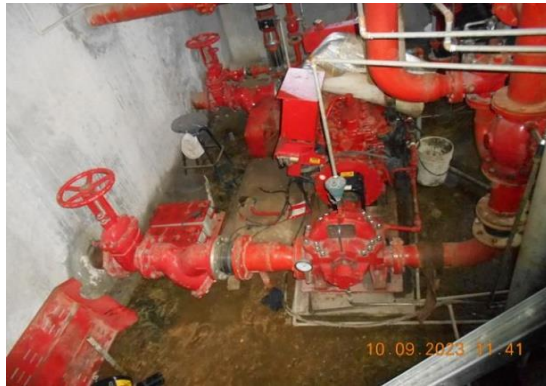
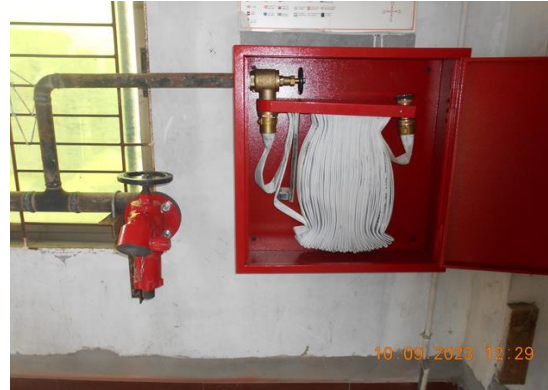
| F-18 | Fire Protection System(Standpipe) | Standpipe system installation requires detailed review to confirm compliance with NFPA 14 ,20 ,22 & 24 or as per RSC standard.<br>Location: 3 storied washing building | Submit the standpipe system drawing to RSC for review.<br><br>Once the design is reviewed, install and modify the standpipe system throughout the building in accordance with review comment, RSC Standard and NFPA 14,20,22 and 24.<br><br>After installation the owner shall conduct internal testing and commissioning and then contact the RSC for witness of final acceptance testing. | Design Review within 1 month and modification within 3 months (If require). |

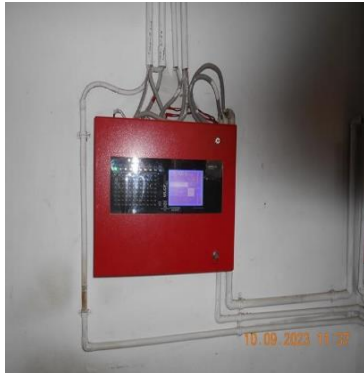
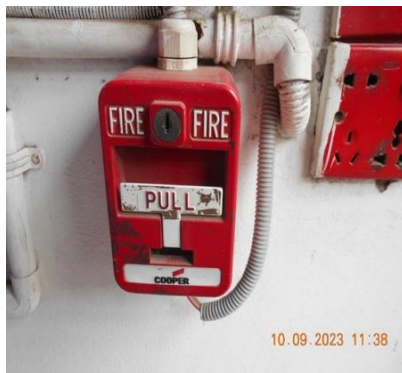
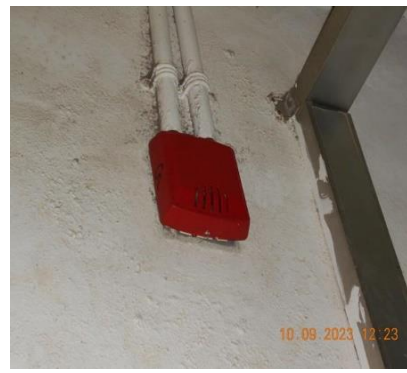
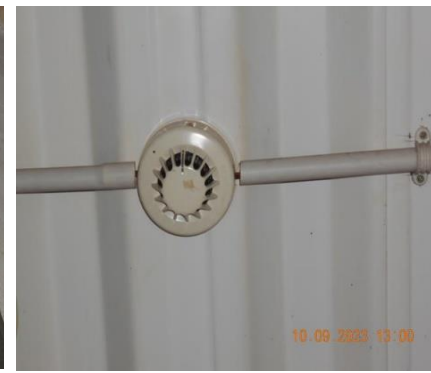
| F-21 | Fire Alarm & Detection System (FADS) | Addressable fire alarm & detection system installation requires detailed review to confirm compliance with NFPA 72 and RSC standard. | <p>Submit design, documents and calculations to RSC for review prior and based on the review modify the system if there is any.</p> <p>After installation the owner shall contact the RSC for witness of conducting the final acceptance testing of the fire detection &amp; alarm system installation.</p> <p>Also inspect, test and maintain the fire alarm system, and keep written records on-site, in accordance with NFPA 72.</p> | Design Review within 1 month and modification within 3 months (If require). |

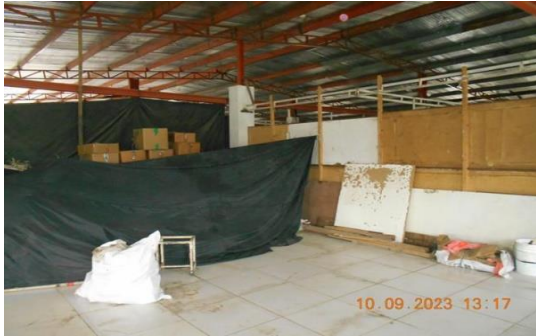
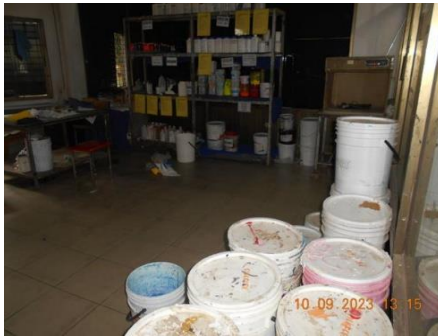
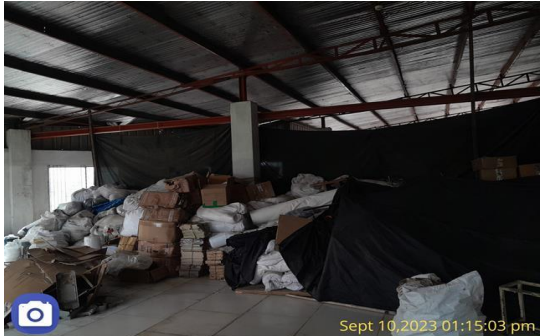
| SI No. | Category | Findings | Required Action | Remediation Time Frame |
|---|---|---|---|---|
| F-24 | Fire Rated Construction | <p>Rooms used for storage of combustible materials are not separated from the surrounding</p> <p>Location: 2nd of printing building.</p> | <p>Rooms used for storage of combustible materials shall be separated from the surrounding occupancy with a minimum 1 hour construction.</p> | Within 3 months |

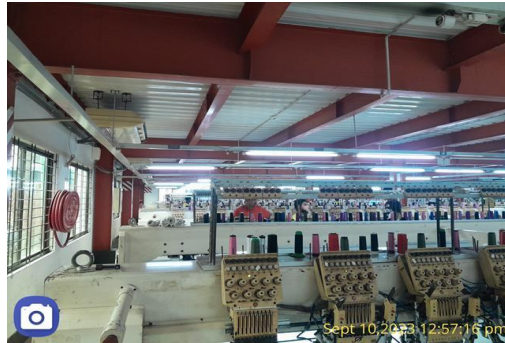
| SI No. | Category | Findings | Required Action | Remediation Time Frame |
|---|---|---|---|---|
| F-25 | Fire Rated Construction. | <p>3-Storied Printing &amp; Embroidery building is steel construction which appears to be nonrated and were found in exposed condition</p> <p>Location: 3-Storied Printing &amp; Embroidery building</p> | <p>The building is a steel structure which shall be type-I or II construction. So, provide require rating in the structural elements of the building. Consult with a qualified fire protection engineer. Follow BNBC 2006-Table 3.2.4, 3.1.9 and 3.3.1 as reference.</p> | Within 6months |

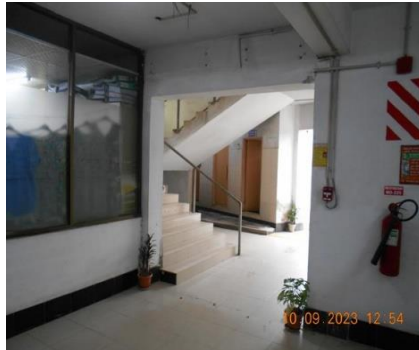
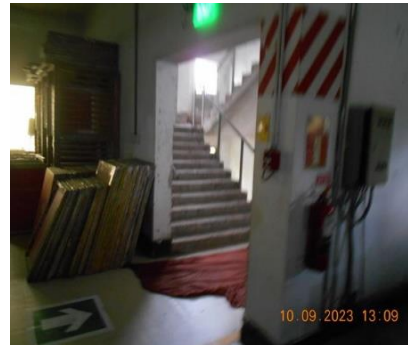
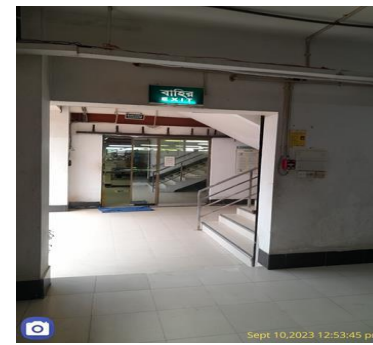
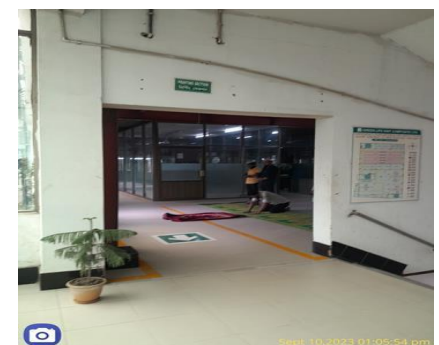
| F-26 | Mean of Egress | <p>The exit stairs are not separated from [work areas, other spaces] on each floor by fire rated construction due to unprotected opening.<br/>Location: 3-Storey Printing &amp; Embroidery building.</p> | <p>The exit stair enclosure shall be provided with a minimum 1-hr fire resistance rating with 1- hr. fire rated door and seal all penetrations and openings by 1 hr. fire rated materials for buildings with 3 or fewer stories. The exit stair enclosure shall be provided with a minimum of 2- hr. fire resistance rating with 90 minutes opening protection for buildings 4 or more stories. Ensure that the fire doors are self-closing and positive latching and that they are provided with fire exit (panic) hardware where serving production floors. If fire doors are required to be held open for functional reasons, provide automatic closing devices tied to the fire alarm system.</p> | Within 3months |

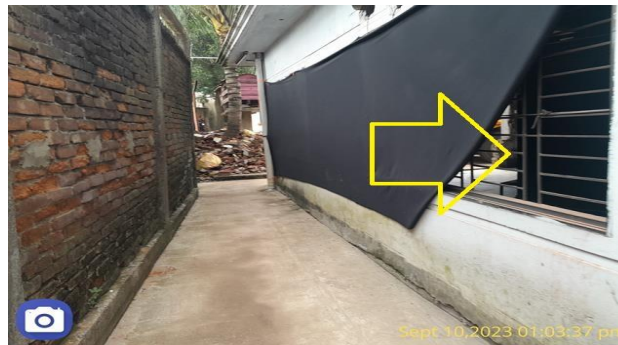
| F-27 | Mean of Egress | <p>The exit discharge path [south side exit] is less than 10 ft wide and is not separated from the building interior.</p> <p>Location: South side exit if 3 storied printing building</p> | <p>Seal all penetrations and openings to the interior of the building along the discharge path, up to a height of 10 ft. to provide a minimum 1-hr fire separation</p> | Within 3months |

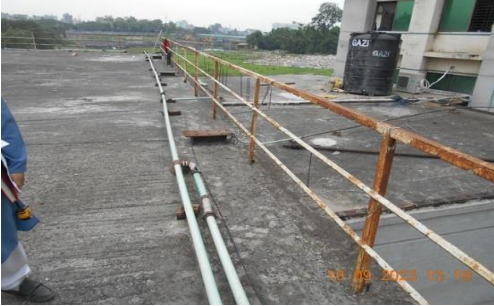
| F-28 | Mean of Egress | <p>Parapets or guards are provided in occupied roof which is less than 1067mm (42 inch).</p> <p>Location: 3 storied printing building.</p> | Provide parapets or guards with a minimum height of 1067mm (42 inch.). | Within 3months |

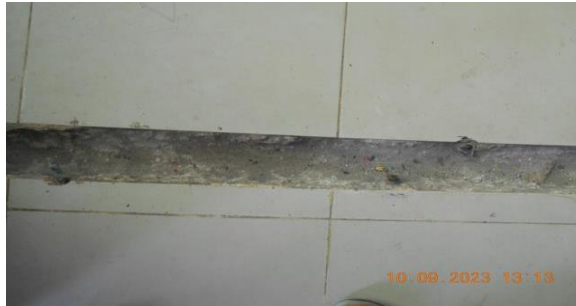
| F-34 | Mean of Egress | Tripping hazard was observed means of egress.<br>Location: first floor north side of 3 storied printing building. | Remove all types of tripping hazards of the means of egress. Means of egress shall be maintained continuously free and clear of all obstructions | Within 1 month |

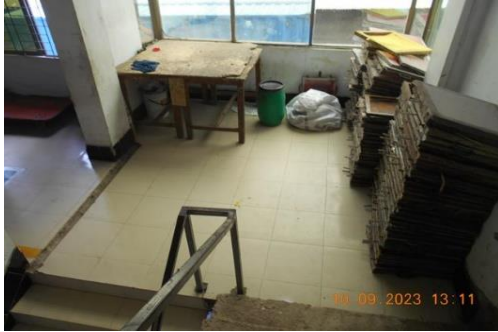
| F-35 | Mean of Egress | storage are located at first floor north side exit stair. | Remove the storage from exit stair | Immediately |

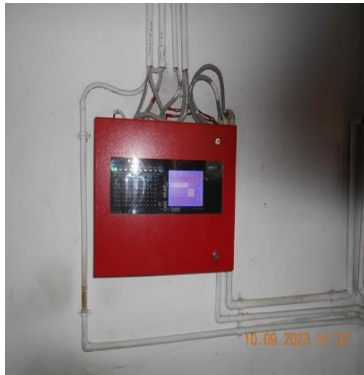
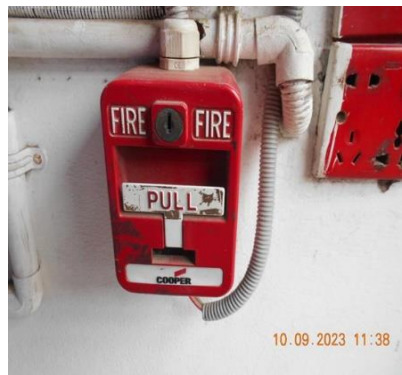
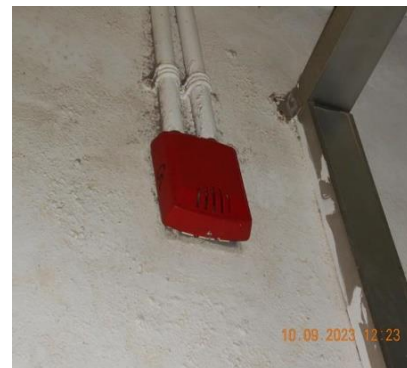
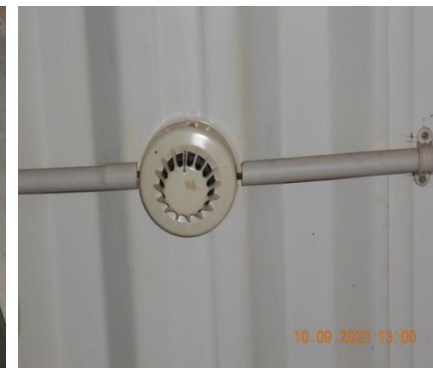
| F-41 | Fire Alarm & Detection System (FADS) | Addressable fire alarm & detection system installation requires detailed review to confirm compliance with NFPA 72 and RSC standard. | <p>Submit design, documents and calculations to RSC for review prior and based on the review modify the system if there is any.</p> <p>After installation the owner shall contact the RSC for witness of conducting the final acceptance testing of the fire detection &amp; alarm system installation.</p> <p>Also inspect, test and maintain the fire alarm system, and keep written records on-site, in accordance with NFPA 72.</p> | Design Review within 1 month and modification within 3 months (If require). |
