INITIAL FIRE SAFETY INSPECTION REPORT

Ayesha Clothing Company Ltd. (Printing Unit -2)

RSC ID: 24787

Fire Safety Inspection Report

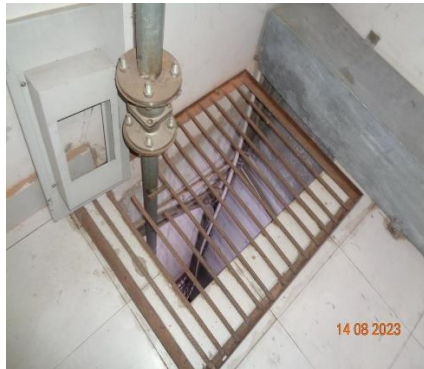
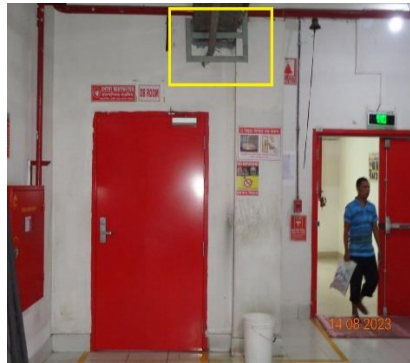
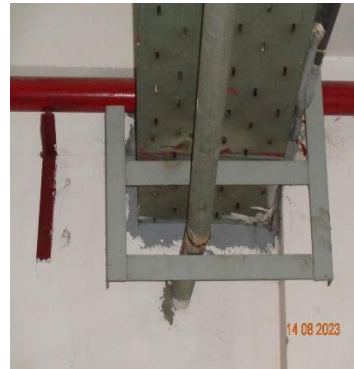
SI No.	Category	Findings	Required Action	Remediation Time Frame
F-01	Fire-Rated Construction	<p>Unsealed penetrations and openings are located in the fire-rated floor/ceiling assemblies due to Electric cable riser.</p> <p>Location: Printing Unit-2 Building.</p>	<p>Seal all penetrations and openings in floor/ceiling (full thickness of the floor/ceiling: minimum 3 hr.) assemblies by third-party certified fire rated materials to maintain the fire resistance rating. Provide a minimum 3-hr fire rated shaft to separate the utility risers from each floor if required.</p> <p>Penetrations of fire resistive rated assemblies shall be protected with listed through penetration fire stop system tested in Accordance with ASTM E814 in Accordance with RSC standard 4.7.</p>	Within 3 months

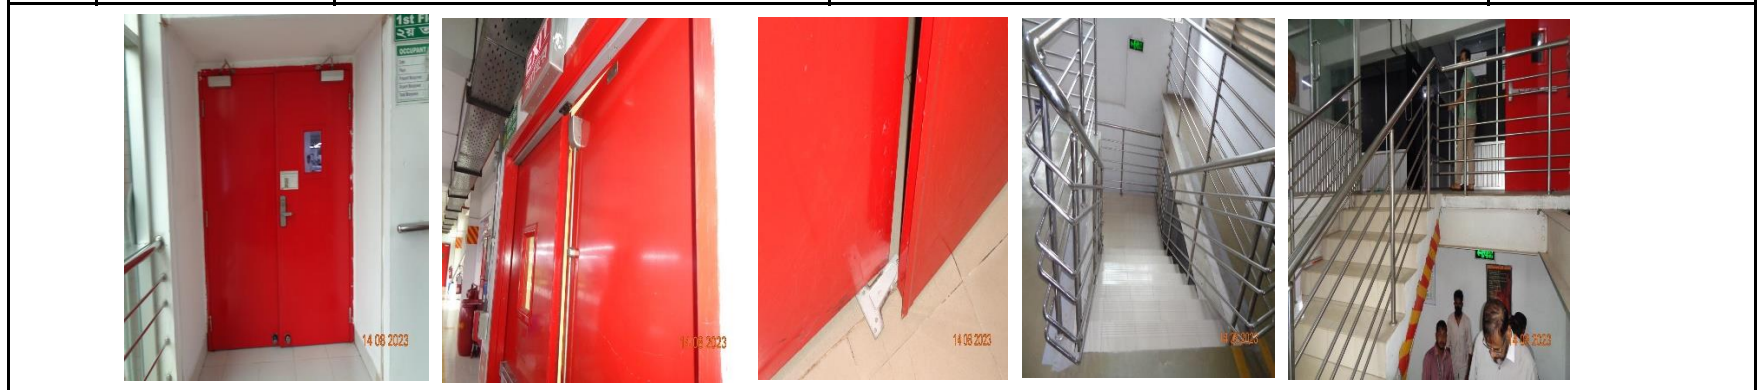
F-02	Fire-Rated Construction	<p>The exit stair enclosures are not separated from work areas and other spaces by fire-rated construction due to unprotected openings on 1st floor and non functionality of fire doors at other floors.</p> <p>Location: Printing Unit-2 Building.</p>	<p>Stair shall be enclosed with a minimum 2-hr fire-rated construction. Seal all unprotected openings and provide minimum 1.5 -hr. fire rated doors to separate the exit stairs from work areas and other building spaces on all floor levels.</p> <p>Ensure that the fire doors are self-closing, positive latching and that they are provided with fire exit (panic) hardware where serving production floors. If fire doors are required to be held open for functional reasons, provide automatic-closing devices tied to the fire alarm system.</p>	Within 3 months
------	-------------------------	--	--	-----------------

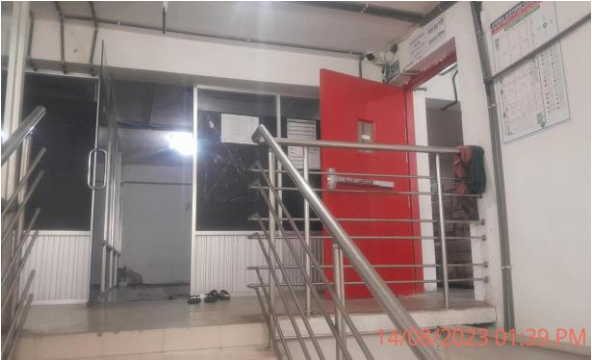
F-03	Fire-Rated Construction	<p>Openings from exit enclosures to storage areas was not provided with vestibules on 1st floor.</p> <p>Located: Printing Unit-2 Building.</p>	<p>Openings from exit enclosures to storage areas, basements, transformer rooms, generator rooms and boiler rooms shall be provided with vestibules in accordance with RSC Technical Guideline (Standard)-6.14.3.</p> <p>Provide a 1.5 hr. fire rated door on the exit stair side and a 1-hr. fire rated door on the storeroom/storage side. Ensure that the fire rating of the vestibule construction matches that of the exit stair enclosure.</p>	Within 3 months

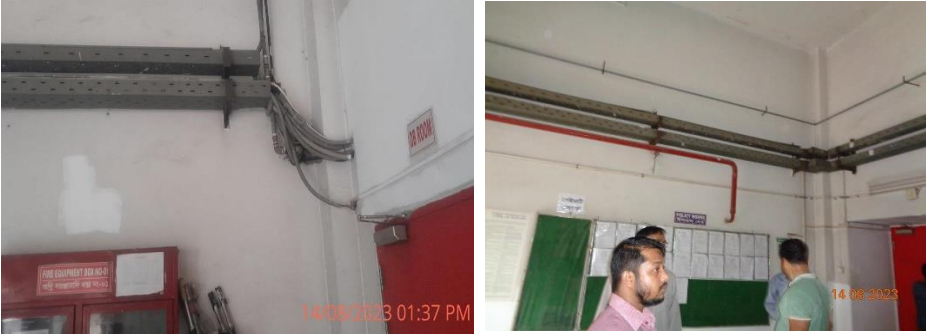
F-04	Fire-Rated Construction	Unsealed penetrations and openings are located in exit stair enclosures through cable riser. Location: Ground floor of Printing Unit-2 Building.	Seal all penetrations and openings in exit stair enclosure walls to maintain the fire separation.	Within 3 months

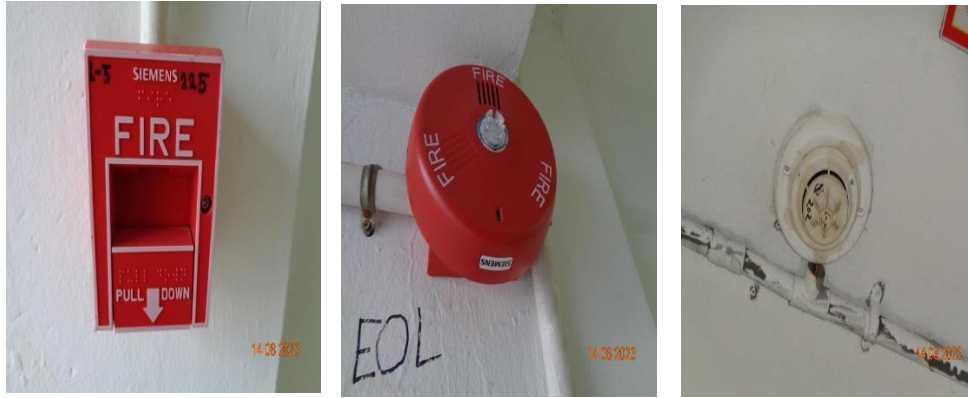
F-08	Fire Alarm and Detection System (FADS)	The fire alarm system installation requires detailed review to confirm compliance with NFPA 72 and RSC technical guidelines (standard).	<p>Submit as-built drawings, testing records, equipment certification and other relevant documentation to the RSC for review.</p> <p>Once reviewed, install or modify the fire detection and alarm system (where required) throughout the building in accordance with RSC technical guidelines (standard) and NFPA 72. The factory management shall contact RSC to conduct the final acceptance testing after the installation, testing & commissioning.</p>	Design Review within 2 months and modification within 4 months (If require).
------	--	---	--	--

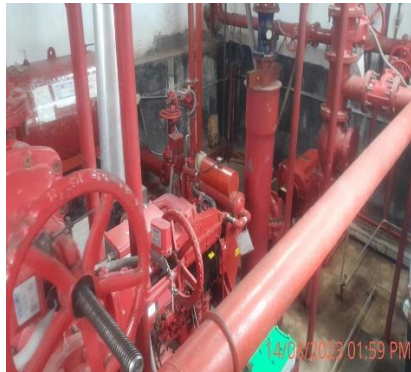
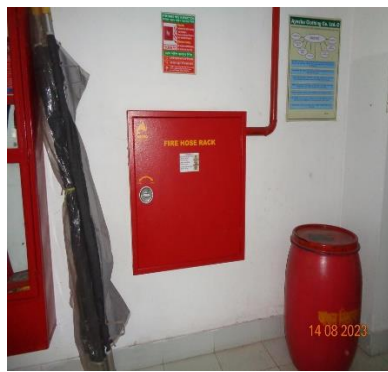
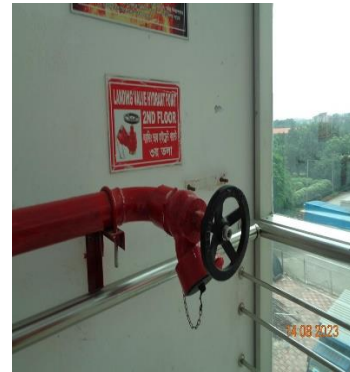
F-09	Inspection, Testing and Maintenance of FADS.	Inspection, testing and maintenance for the fire detection and alarm system was not in accordance with NFPA 72 and RSC Technical Guideline (Standard).	Inspect, test and maintain the fire alarm system and keep written records on-site, in accordance with Table-14.3.1 of NFPA 72.	Within 1 Month after installation.
F-10	Fire Protection System (SUPS)	Standpipe system and fire pump installation requires detailed review to confirm compliance with NFPA 14, 20, 22, 24 and RSC Technical Guideline (Standard).	Submit the standpipe system drawing to RSC for review. Once reviewed, install or modify the standpipe system throughout the building in accordance with RSC Technical Guideline (Standard) and NFPA 14 and 20. The factory management shall contact RSC to conduct the final acceptance testing after the installation, testing & commissioning.	Design Review within 2 months and modification within 4 months (If require).
