# INITIAL FIRE SAFETY INSPECTION REPORT

## Topway Industries Limited

**Plot: 19-20, Sector: 04, Road No. 04, CEPZ, Chattogram, Bangladesh**

# Fire Safety Inspection Report

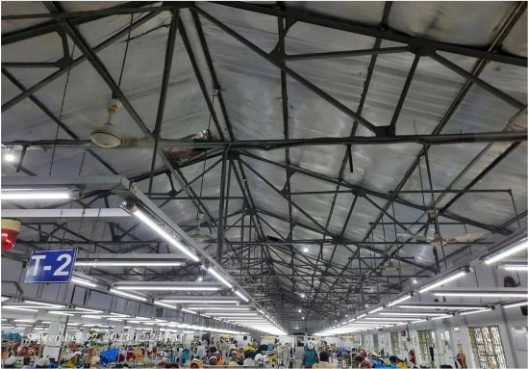
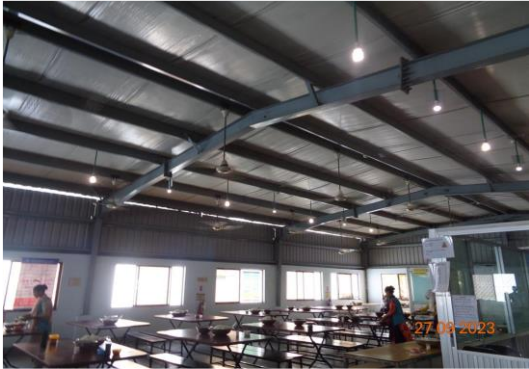
SI No.	Category	Findings	Required Action	Remediation Time Frame
F-01	Fire Rated Construction	The buildings are made of steel and found exposed without any fire protection which is defined as non-rated construction and a violation of BNBC-2006. Location: Building - 01 and Building - 02	<p>Construction must be of type 1 or type 2 (See BNBC 2006 Part 3 Table 3.2.4, page 10356 and Part 3, Table 3.1.9, page 10319).</p> <p>Provide/ensure required fire rating on the structural elements by following Section 4.4 and Table 4.4.1 of the RSC Technical Guideline (standard) V1 or Table 3.3.1 and Table 4.1.1 from BNBC 2006. Consult a qualified fire protection engineer to design the rated construction barriers.</p>	Within 6 months
<div style="display: flex; justify-content: space-around;">

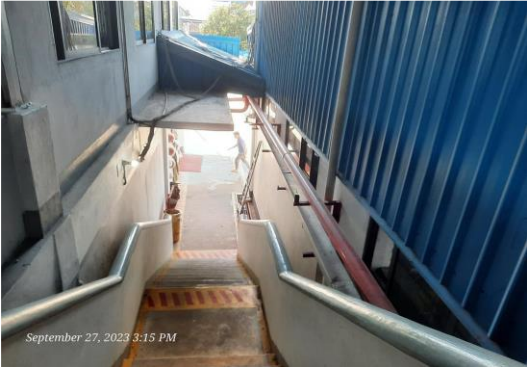
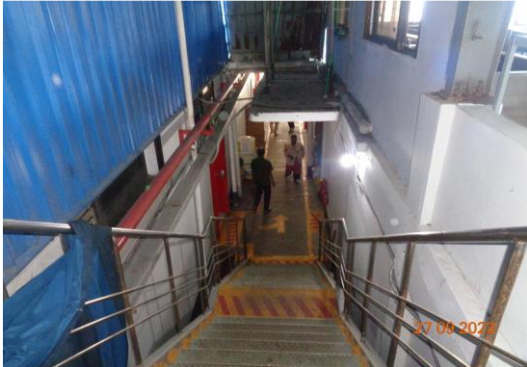
F-02	Fire Rated Construction	The exit stairs lack separation from dining and other spaces due to non-rated structure, unprotected openings and penetrations. Location: Building - 02	<p>Stair shall be enclosed with a minimum 1-hr fire-rated construction. Seal all unprotected openings and provide minimum 1-hr fire rated doors to separate the exit stairs from work areas and other building spaces on all floor levels. Ensure that the fire doors are self-closing, positive latching and that they are provided with fire exit (panic) hardware where serving production floors.</p> <p>Openings from exit enclosure to storage areas shall be provided with a vestibule with fire rated construction and openings. Ensure that the fire rating of the vestibule construction matches that of the exit stair enclosure.</p> <p>If fire doors are required to be held open for functional reasons, provide automatic-closing devices tied to the fire alarm system.</p>	Within 3 months

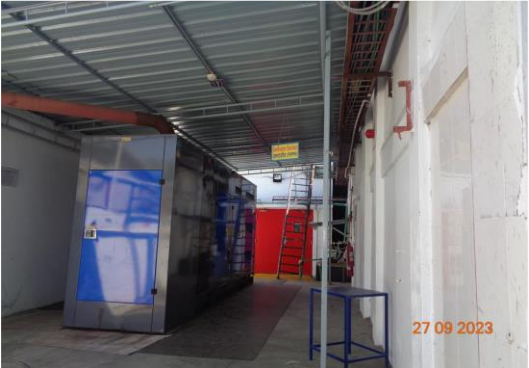
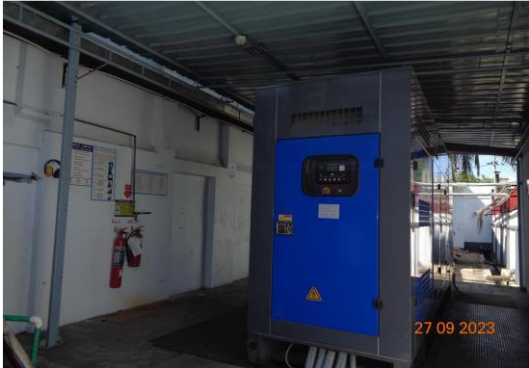
F-04	Fire Rated Construction	<p>Generator room is located less than spatial distance of 3 m (10 ft) from the production building but not properly separated by fire rated construction.</p>	<p>Generator room shall be separated from other occupancies by a minimum 2-hr fire rated construction (wall, floor, slab etc.). Seal all penetrations and openings (door, window etc.) should be protected by 1.5-hr fire rated materials to maintain the fire separation if required. All exhaust systems shall discharge to the exterior of the building in a safe location.</p> <p>Or</p> <p>Relocate it to exterior of the building and maintain a minimum 3m (10 ft.) spatial separation distance from the building.</p>	Within 3 months

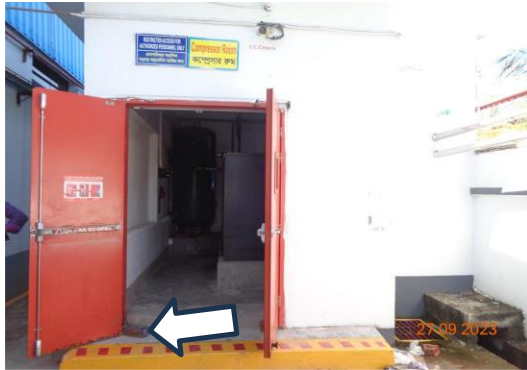
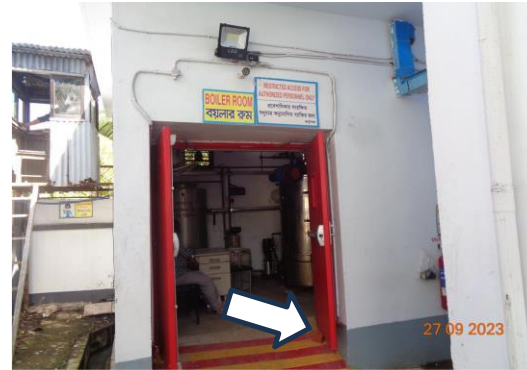
F-05	Fire Rated Construction	Boiler and compressor rooms are located less than a spatial distance of 3 m (10 ft) from the store shed (building - 03) but not properly separated by fire-related construction.	<p>Boilers or other heat producing equipment shall be separated from other occupancies by a minimum 1-hr fire rated construction (wall, floor, slab etc.). Seal all penetrations and openings (door, window etc.) should be protected by 0.75-hr (45 min) fire rated materials to maintain the fire separation if required. All exhaust systems shall discharge to the exterior of the building in a safe location.</p> <p>Or</p> <p>Relocate it to exterior of the building and maintain a minimum 3m (10 ft.) spatial separation distance from the building.</p>	Within 3 months
------	-------------------------	--	--	-----------------

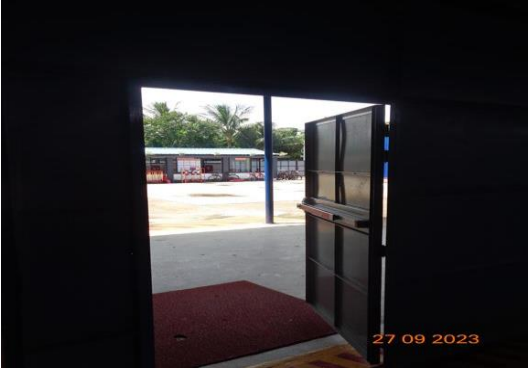
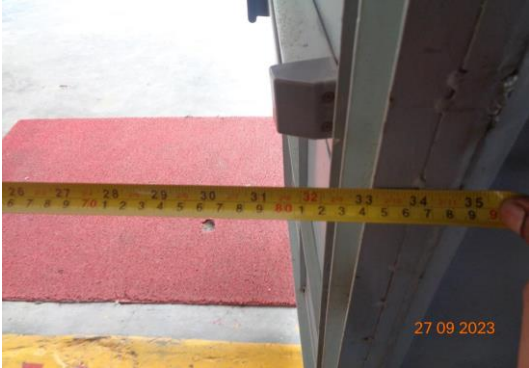
F-06	Means of Egress	The doors in a means of egress have a width less than the required minimum of 1 meter (39 inches). Location: Building - 01	Doors in a means of egress shall have a minimum width of 1 m (39 in.).	Within 3 months

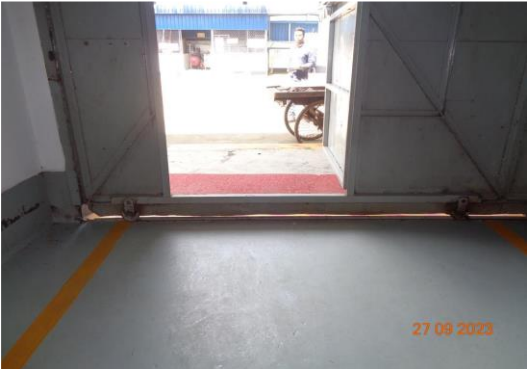
F-07	Means of Egress	Abrupt changes in the elevation of walking surfaces were observed, not meeting the RSC Technical Guidelines (Standard) <sup>1</sup> V1.0 Section 6.3.4. Location: Building - 01	Abrupt changes in elevation of walking surfaces shall not exceed ¼ in. unless provided with a beveled slope of 1 in 2 that do not exceed ½ in. Changes greater than ½ in. shall meet the requirements for RSC Technical Guidelines (Standard) <sup>1</sup> V1.0 Section 6.3.5.	Within 1 month

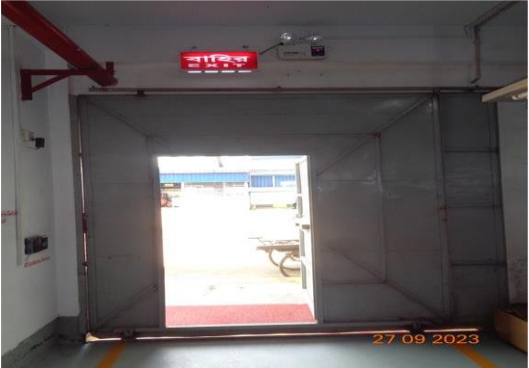
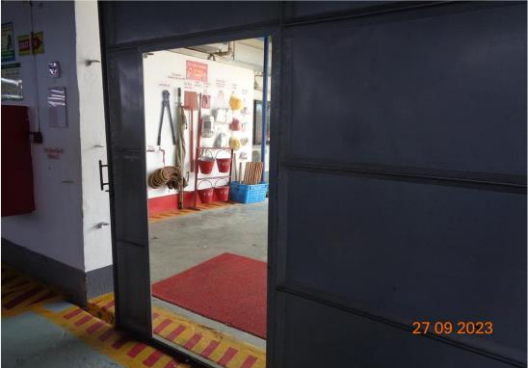
F-08	Means of Egress	The headroom on the doors is less than 2.03 m (6 ft 8 in.). Location: Building - 01	All means of egress shall have a minimum ceiling height of 2.3 m (7 ft 6 in.) with projections from the ceiling not less than 2.03 m (6 ft 8 in.).	Within 3 months
<div style="display: flex; justify-content: space-around;">

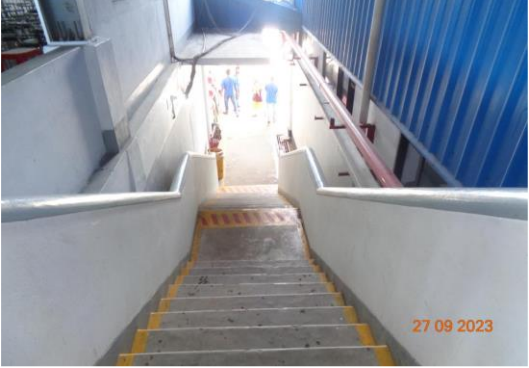
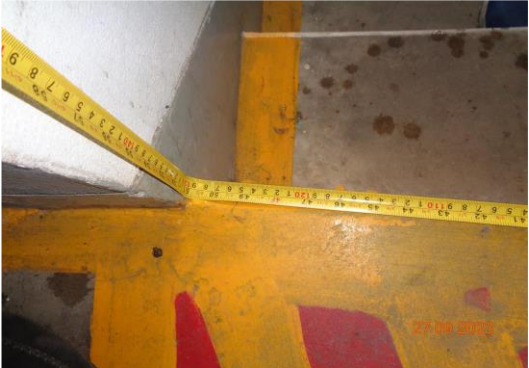
F-09	Means of Egress	The stairs have a width less than the required minimum of 1.5 meter (60 inches). Location: Building - 02	Stairs shall have a minimum width of 1.5 m (60 in.)	Within 6 months
<div style="display: flex; justify-content: space-around;">

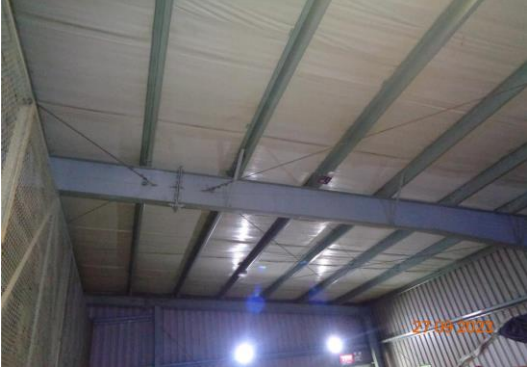
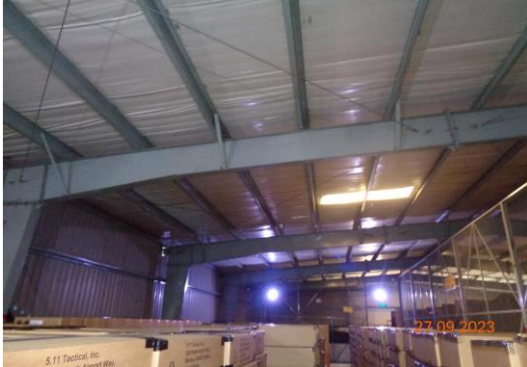
SI No.	Category	Findings	Required Action	Remediation Time Frame
F-13	Fire Rated Construction	The building is made of steel and found exposed without any fire protection which is defined as non-rated construction and a violation of BNBC-2006. Location: Building - 03	<p>Construction must be of type 1 or type 2 (See BNBC 2006 Part 3 Table 3.2.4, page 10356 and Part 3, Table 3.1.9, page 10319).</p> <p>Provide/ensure required fire rating on the structural elements by following Section 4.4 and Table 4.4.1 of the RSC Technical Guideline (standard) V1 or Table 3.3.1 and Table 4.1.1 from BNBC 2006. Consult a qualified fire protection engineer to design the rated construction barriers.</p>	Within 6 months
<div style="display: flex; justify-content: space-around;">

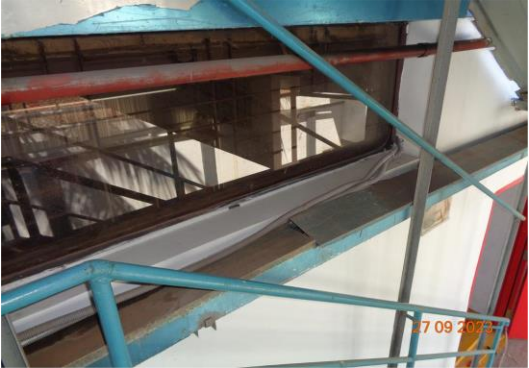
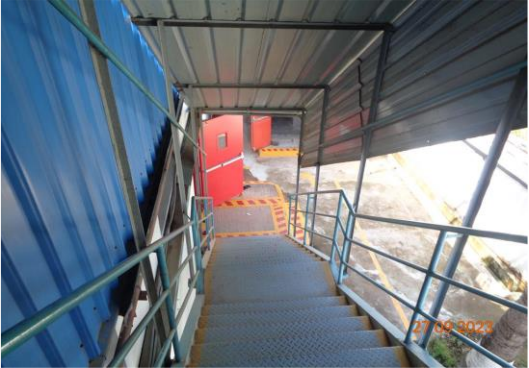
F-14	Fire Rated Construction	<p>The exterior exit stair lacks separation due to unprotected openings and non-rated structure. Location: Building - 03</p>	<p>Stair shall be enclosed with a minimum 1-hr fire-rated construction. Seal all unprotected openings and provide minimum 1-hr fire rated doors to separate the exit stairs from work areas and other building spaces on all floor levels. Ensure that the fire doors are self-closing, positive latching and that they are provided with fire exit (panic) hardware where serving production floors.</p> <p>If fire doors are required to be held open for functional reasons, provide automatic-closing devices tied to the fire alarm system.</p> <p>The rating of the exterior wall shall extend 3.05 m (10 ft) beyond the ends of the stair structure.</p>	Within 3 months

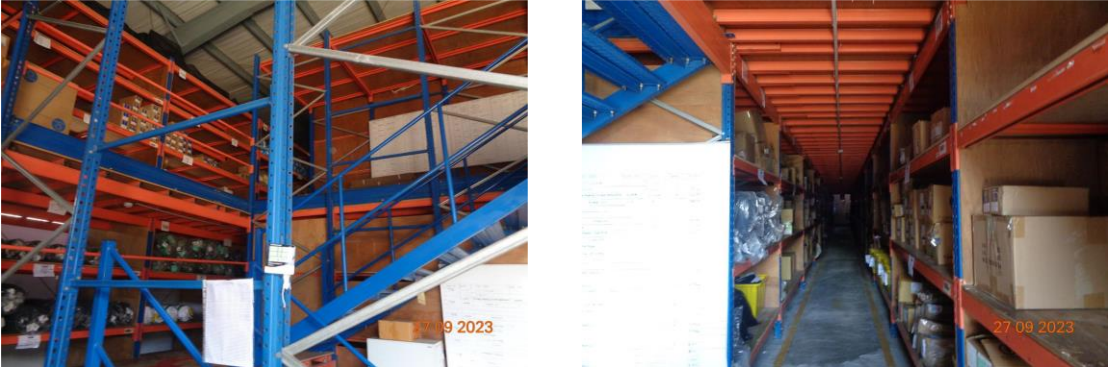
F-15	Fire Rated Construction and Means of Egress	The upper deck portion (1st floor) fails to meet the RSC building standard and BNBC 2006 requirements for floor-to-floor separation, stair separation, and related criteria. Location: Building - 03	The floor must adhere to the RSC building standards and BNBC 2006 regulations regarding fire separation and egress features.	Within 4 months

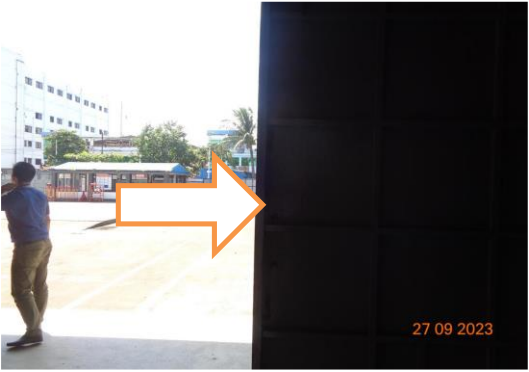
F-17	Means of Egress	Sliding type doors have provided along means of egress (door). Location: Building - 03	All doors in a means of egress shall be of the side--hinged swinging type. Roll--down and sliding gates and shutters shall not be allowed. Doors serving an occupant load of more than 50 shall swing in the direction of egress travel.	Within 1 month
<div style="display: flex; justify-content: space-around; align-items: center;">

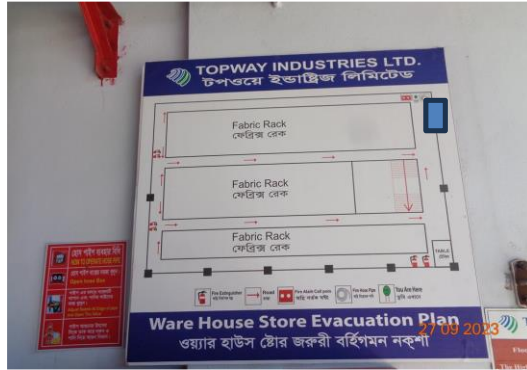
F-18	Means of Egress	A single means of exit has been provided, exceeding the maximum travel distance requirement. Location: Ground Floor, Building - 03	Provide additional exit to maintain maximum travel distance of 30m (100 ft). Or Maintain maximum 30 occupants having a travel distance of 30m (100 ft).	Within 3 months
------	-----------------	--	---	-----------------

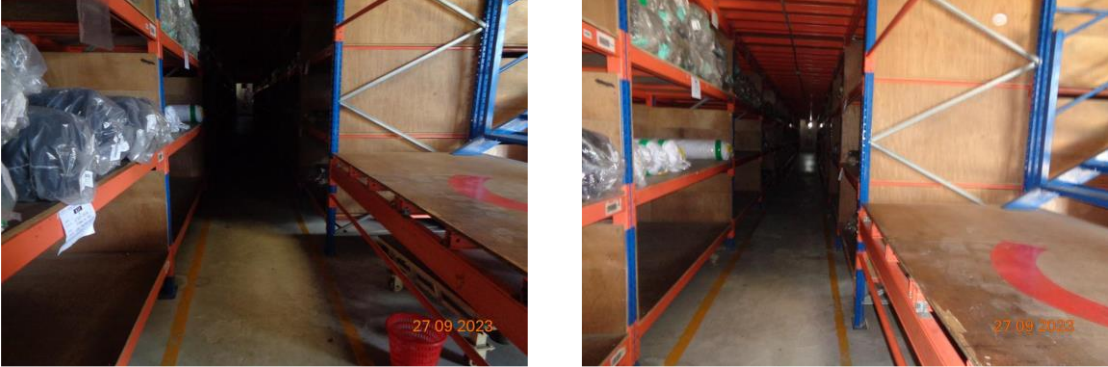
F-20	Egress lighting	Based on the number and location of emergency lights observed, adequate illumination levels are not anticipated along egress routes. Location: Building - 03	Test the emergency lighting system on each floor and provide additional emergency fixtures to provide adequate illumination along the means of egress. Provide a minimum illumination of 10 lux at the floor level within exit stairs and exit discharge paths and minimum 2.5 lux along exit access aisles.	Within 3 months

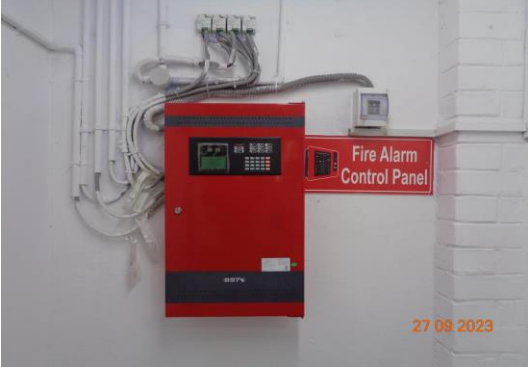
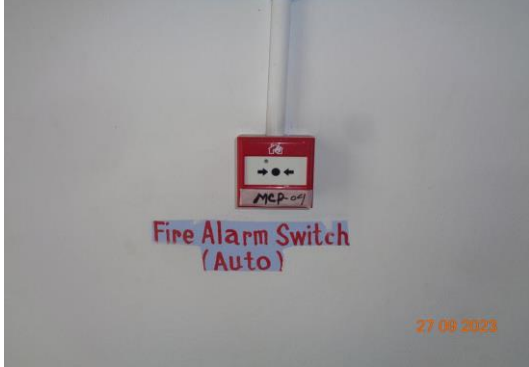
SI No.	Category	Findings	Required Action	Remediation Time Frame
F-22	Fire Alarm & Detection System (FADS)	Fire alarm and detection system installation complete which requires detailed review to confirm compliance with NFPA 72 and RSC Technical Guidelines (Standard). (for all structures)	<p>Submit the fire alarm system design to RSC for review. Once the design is reviewed, install and modify the fire detection and alarm system throughout the building in accordance with review comment, RSC Technical Guidelines (Standard) and NFPA 72.</p> <p>After installation the owner shall conduct internal testing and commissioning and then contact the RSC for witness of final acceptance testing.</p>	Design within 2 month and modification/ installation with 4 months
<div style="display: flex; justify-content: space-around;">
