# INITIAL FIRE SAFETY INSPECTION REPORT

**Factory Name: Cottonex Fashions Limited**

**RSC ID: 24906**

**Plot No. 12 & 13, Kalurghat Heavy Industrial Area, Mohara, Chandgaon, Chattogram-4208, Bangladesh**

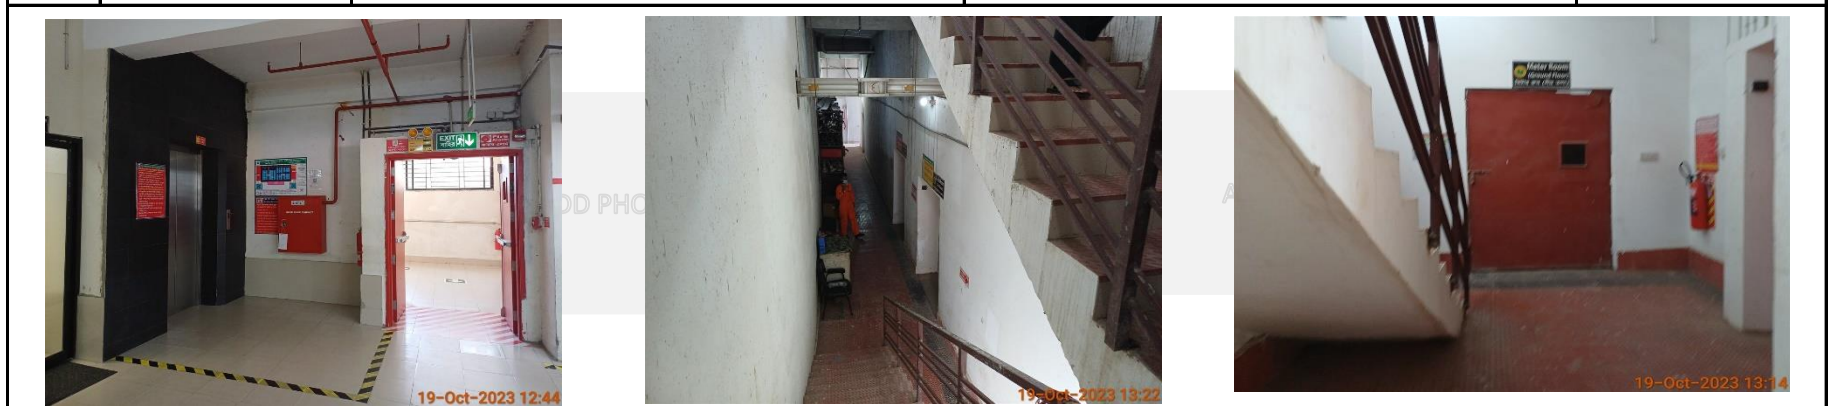
SI No.	Category	Findings	Required Action	Remediation Time Frame
F-1	Fire Rated Construction	The exit stairs are not separated from work areas, other spaces on each floor by fire-rated construction and opening protective. Unsealed penetration is found from utility area to stair inclosure at utility building.	Provide minimum 2-hr fire rated construction and Seal all unprotected openings to separate the exit stairs from work areas and other spaces on all floor levels by 90 minutes for 2 hr construction. Ensure that the fire rated doors are self-closing and positive latching and that they are provided with fire exit (panic) hardware. If fire rated doors are required to be held open for functional reasons, provide automatic closing devices tied to the fire alarm system.	Within 3 months

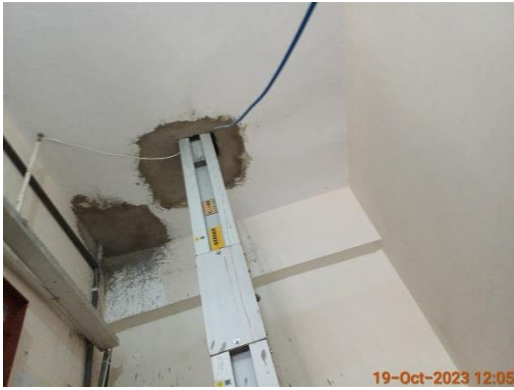
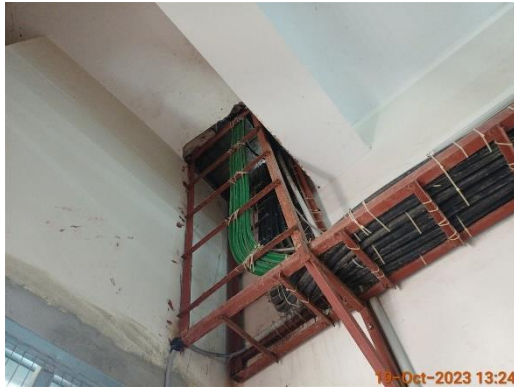
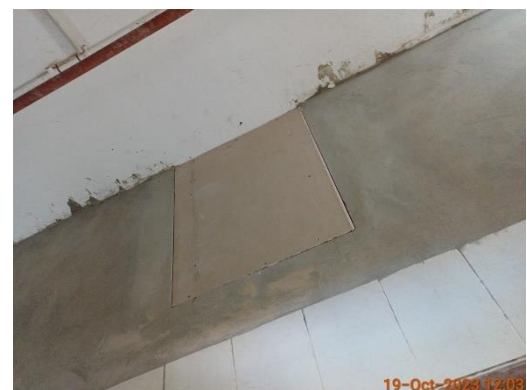
F-2	Fire Rated Construction	Floors to floor penetration due to PVC pipe in toiler area, BBT and Cable riser are not properly separated by fire rated construction at all floor.	Seal all penetrations and openings in floor/ceiling assemblies by a listed through-penetration fire stop system tested in accordance with ASTM E814 or approved alternative standard to maintain minimum 3-hr. fire resistance rating. Installation shall be as per manufacturer published installation guideline and the certification authority guideline to ensure the firerating. or, Provide a minimum 2-hr fire rated shaft to separate the penetrations/openings from each floor if required.	Within 6 months
-----	-------------------------	---	--	-----------------

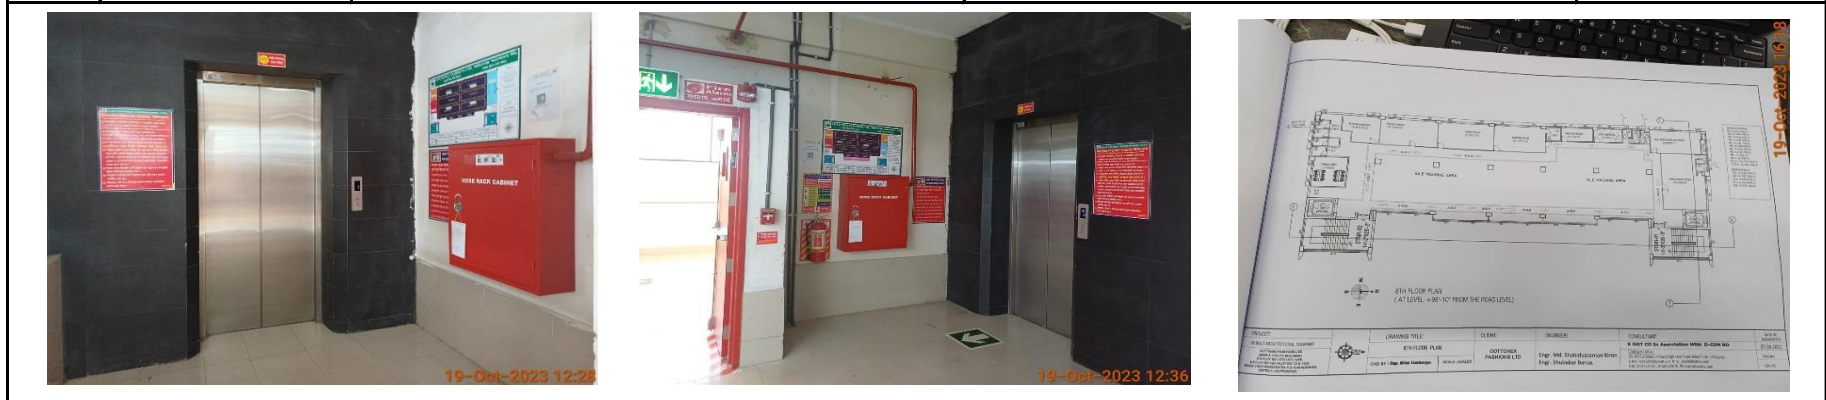
F-3	Fire Rated Construction	Elevator shafts are directly open into the inside of production floor which is not separated by fire rated doors. Also no credible documents of lift doors were found during the inspection.	Elevator shaft shall be separated from production area by 2 hours fire rated construction and opening protective.	Within 6 months
-----	-------------------------	--	---	-----------------

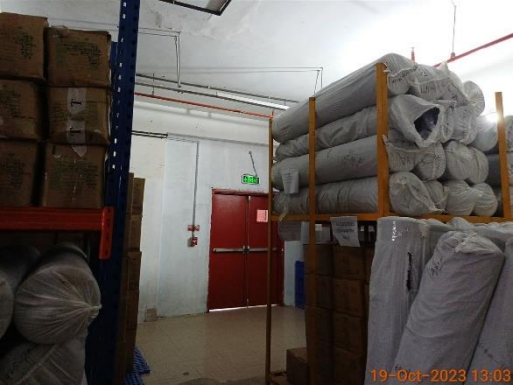
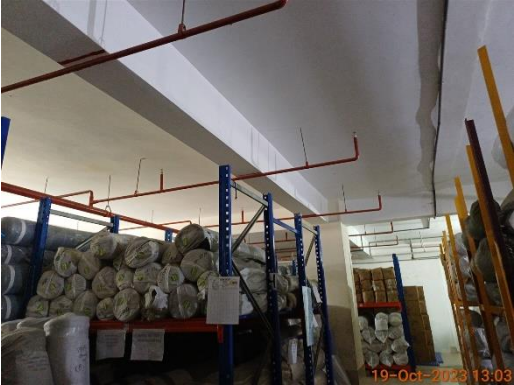
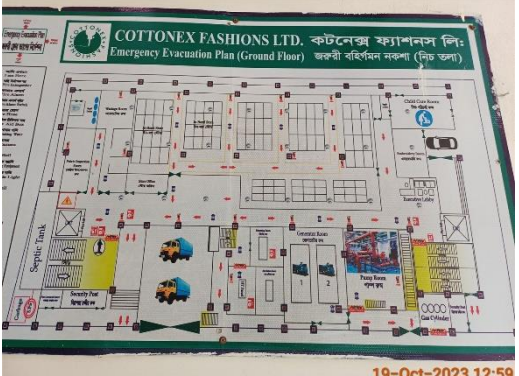
F-4	Fire Rated Construction	Storage discharges directly into the exit stair discharge at both the stairs on ground floor.	Openings from exit enclosure to storage room, generator and transformer spaces shall be provided with a vestibule with fire rated construction and openings.	Within 4 months
-----	-------------------------	---	--	-----------------

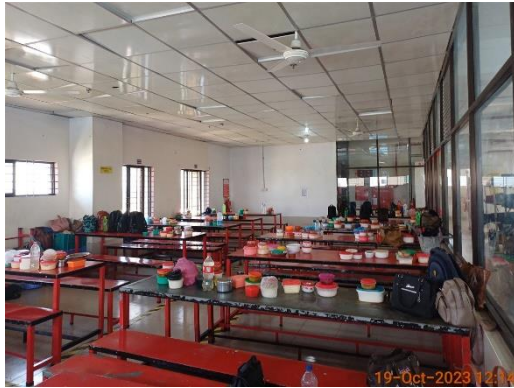
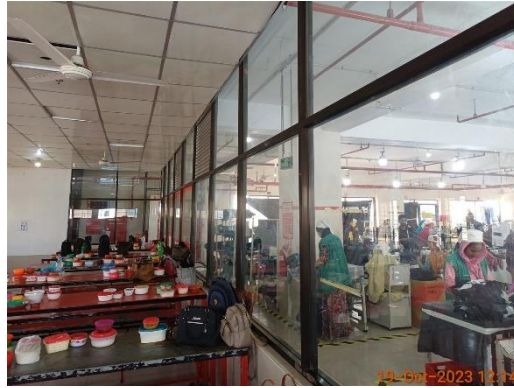
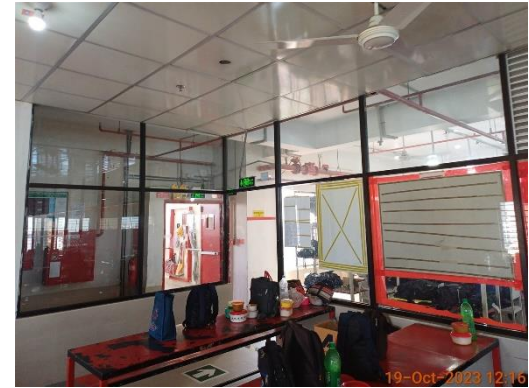
<p>F-5</p>	<p>Fire Rated Construction</p>	<p>Dining area (E4) at 4th, 5th and 6th floors are not separated by fire rated construction and opening protective from adjacent production areas. And also the exits are not leaded directly to the exit stairwell or corridor.</p>	<p>Dining area(E4) need to be separated from production area by 3-hr. fire rated construction and opening protective. Provide required exits that lead directly to the street or exit stairwell or leading to a corridor or open space.</p>	<p>Within 3 months</p>

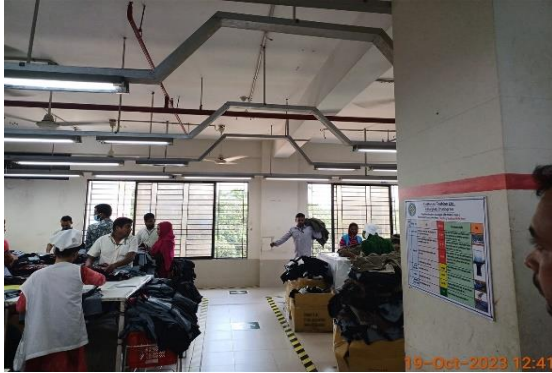
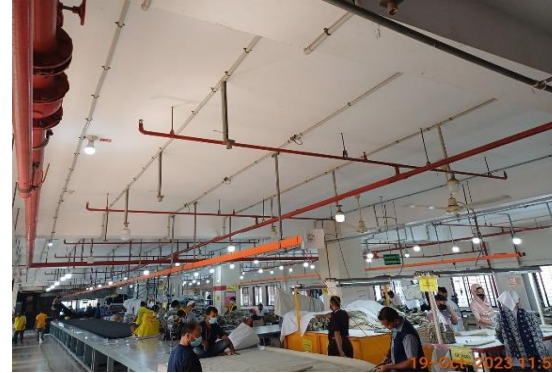
F-6	Egress Lighting	Exit signs are not provided at few exits during the inspection. Also, directional signs are not provided where direction of the path of travel to an exit has changed.	Lighted exit signs shall be placed at entrance to an exit. Additional directional exit signs shall be placed throughout the facility anywhere the continuation of the egress is not obvious. Lighted exit signs shall be provided with either battery backup or uninterruptable power supply systems and shall be continuously illuminated.	Within 1 month
-----	-----------------	--	---	----------------

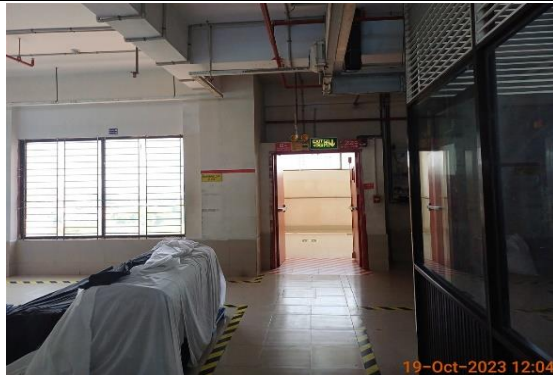
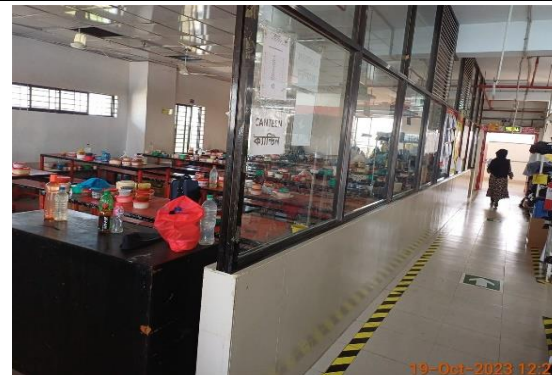
F-7	Egress Lighting	Based on the number and location of emergency lights observed, adequate illumination levels are not anticipated along egress routes.	Test the emergency lighting system on each floor and provide additional emergency fixtures to provide adequate illumination along the means of egress. Provide a minimum illumination of 10 lux at the floor level within exit stairs and exit discharge paths and minimum 2.5 lux along exit access aisles.	Within 1 month
-----	-----------------	--	--	----------------

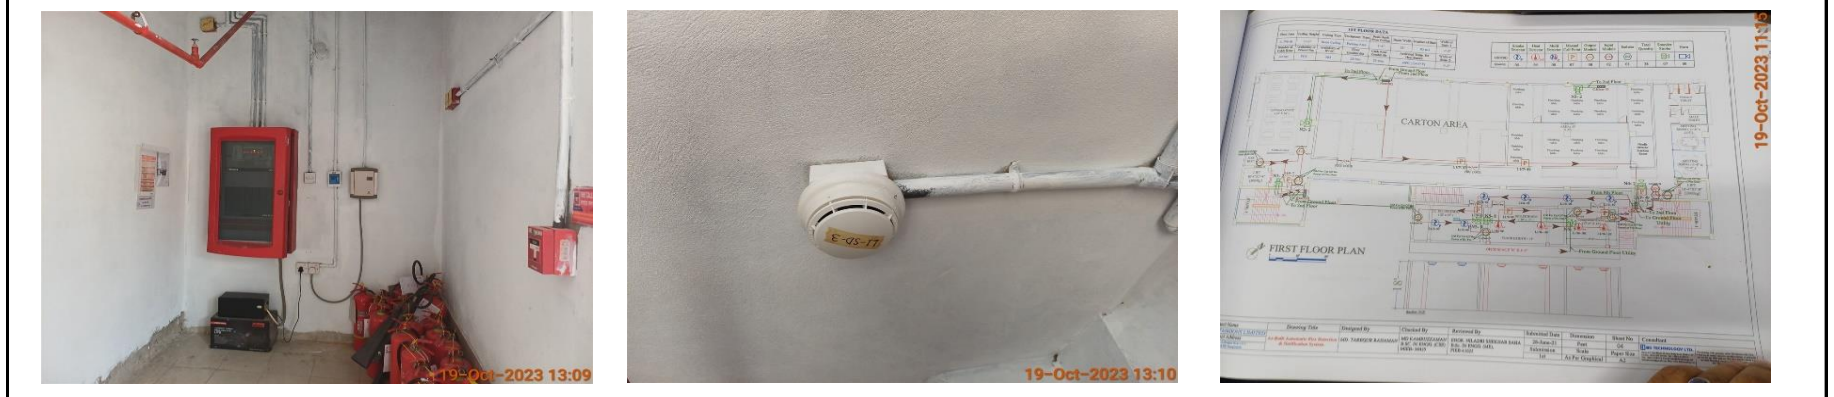
F-10	Fire Alarm & Detection system	Automatic fire alarm and detection system installation complete which requires detailed review to confirm compliance with NFPA 72 and The RSC Technical Guidelines (Standard).	Submit the fire alarm system design to RSC for review. Once the design is reviewed, install and modify the fire detection and alarm system throughout the buildings in accordance with review comment, Accord/ RSC Technical Guidelines (Standard) and NFPA 72. After installation the owner shall conduct internal testing and commissioning and then contact the RSC for witness of final acceptance testing. Also inspect, test and maintain the fire alarm system, and keep written records on-site, in accordance with Table-14.3.1 of NFPA 72.	Design Review within 2 months and installation within 4 months
------	-------------------------------	--	--	--

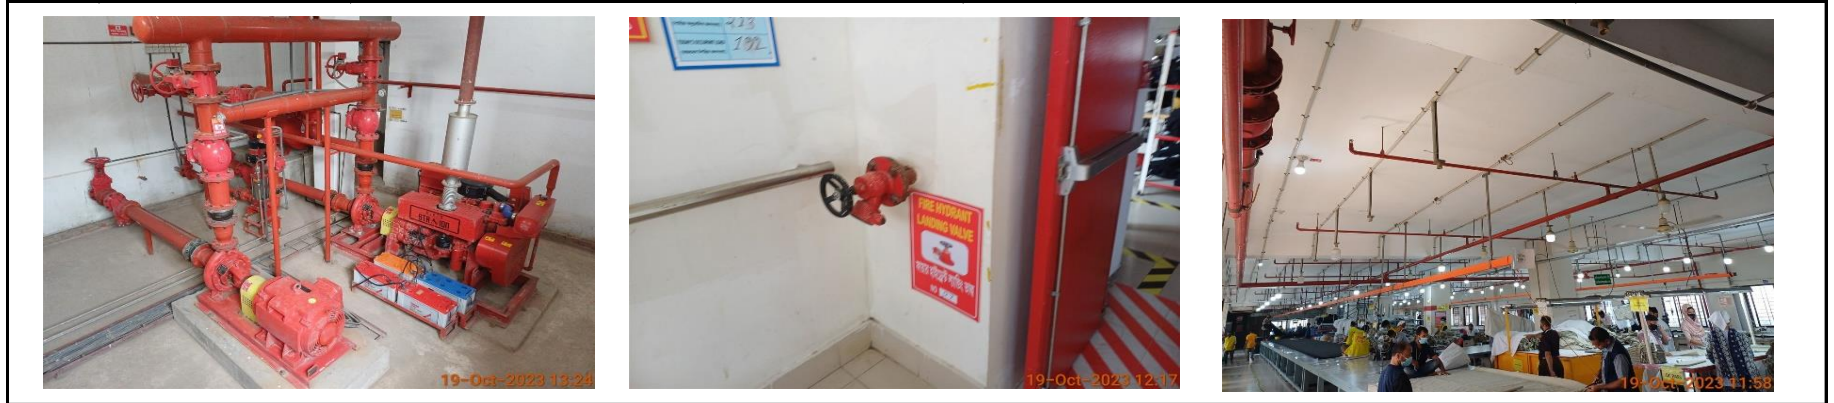
F-11	ITM of Fire Alarm & Detection system	Inspection, testing and maintenance for the fire alarm system is not in accordance with NFPA 72 and The RSC Technical Guidelines (Standard).	Inspect, test and maintain the fire alarm system and keep written records on-site, in accordance with NFPA 72 and The RSC Technical Guidelines (Standard) and keep written records on-site	Within 1 month (after installation)
F-12	Fire Protection System (Standpipe and Sprinkler)	Standpipe and sprinkler system installation require detailed review to confirm compliance with NFPA 13, 14, 20 and RSC Technical Guideline (Standard).	Submit the standpipe system drawing to RSC for review. Once reviewed, install or modify the standpipe system throughout the building in accordance with RSC Technical Guideline (Standard) and NFPA 13, 14, 20,22 and 24. After installation the owner shall contact the RSC for witness of conducting the final acceptance testing of the standpipe and sprinkler system.	Design Review within 2 months and installation within 4 months.

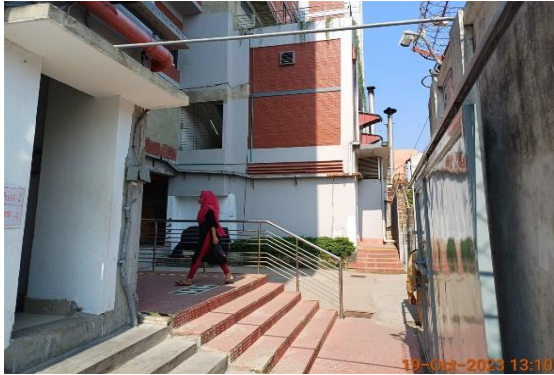
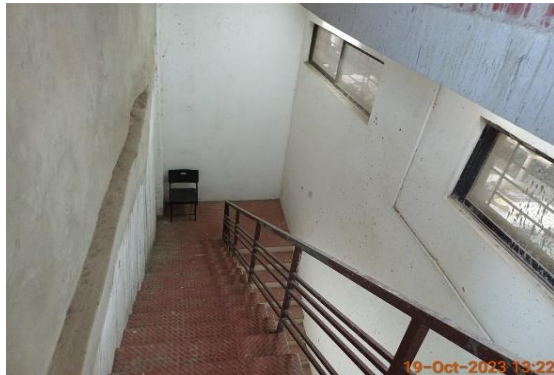
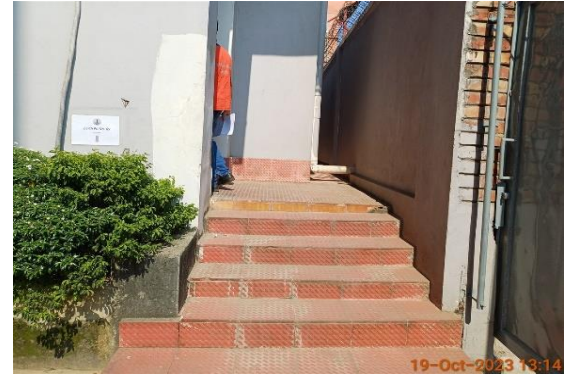
F-16	ITM of Fire Extinguishers	Inspection, testing and maintenance of portable fire extinguishers is not in accordance with NFPA 10.	Inspect, test and maintain the portable fire extinguishers and keep written records onsite, in accordance with NFPA 10 and The RSC Technical Guidelines (Standard).	Within 3 months
F-17	Means of egress	Handrails are not provided at both sides in the exit stair at utility building.	Provide handrails on both sides of the exit stair. New handrails shall have a minimum height of 865 mm (34 in.) and a maximum height of 965 mm (38 in.) as measured from the leading edge of the tread.	Within 3 months

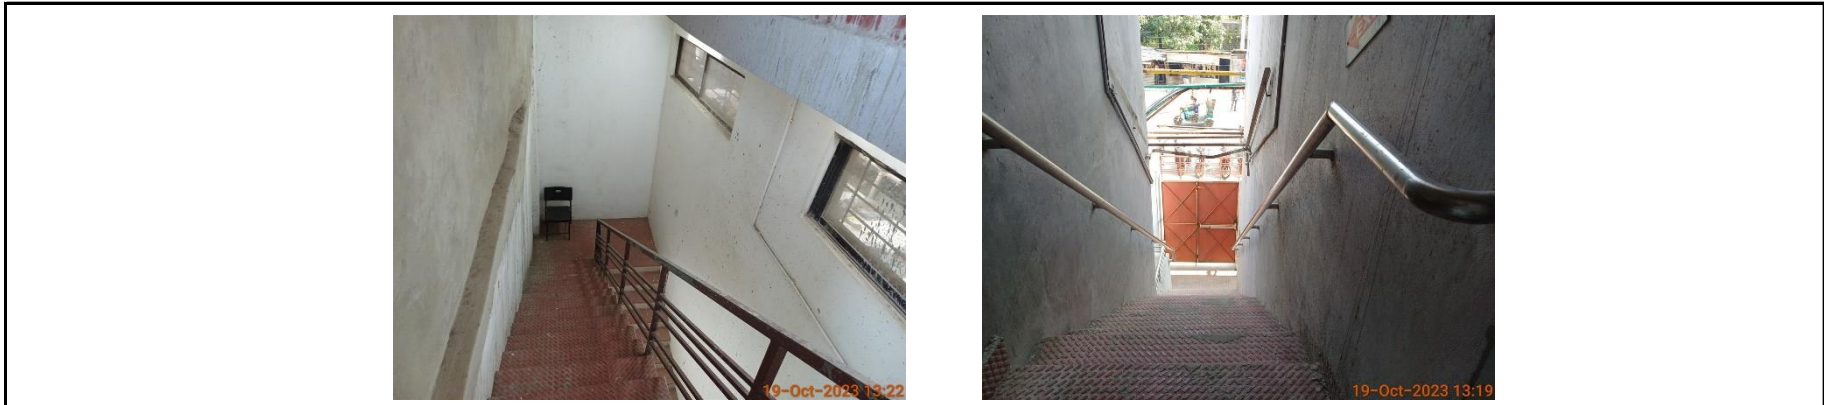
F-18	Means of egress	The stairs serving the utility building have a width less than the required minimum of 1.5 meter (60 inches).	Stairs shall have a minimum width of 1.5 m (60 in.)	Within 6 months
------	-----------------	---	---	-----------------

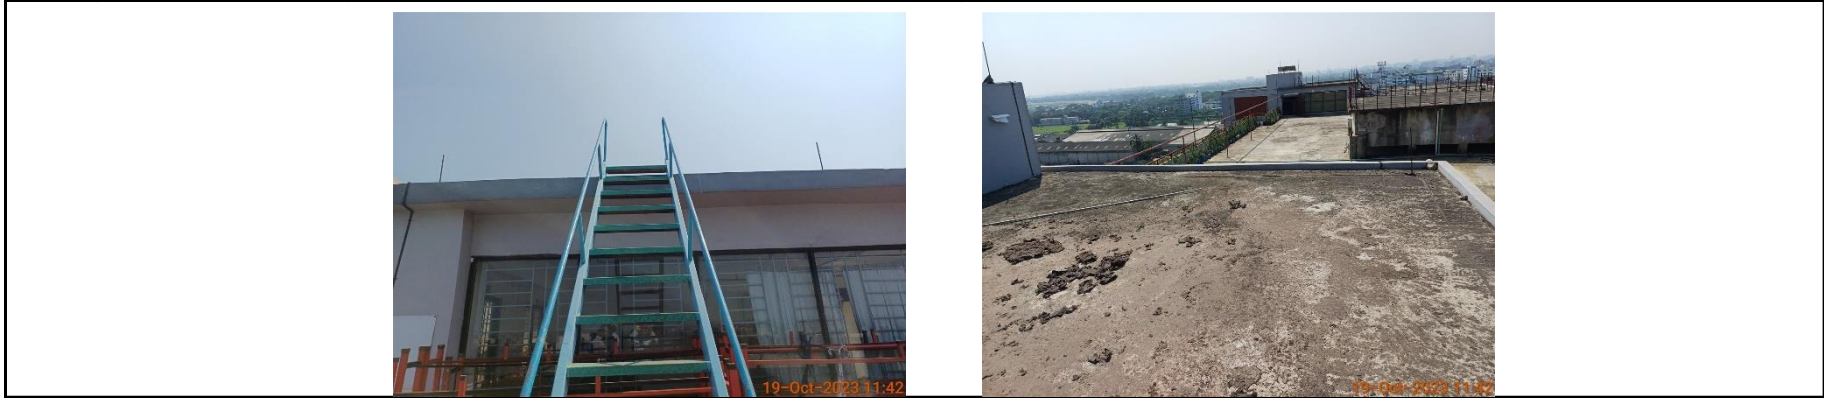
F-19	Means of egress	The occupiable roof was not provided with an adequate guard rail.	All occupiable roofs shall be provided with parapets or guards with a minimum height of 1067 mm (42 in.)	Within 3 months
------	-----------------	---	--	-----------------

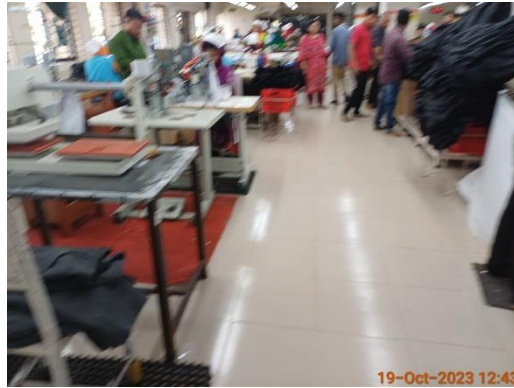
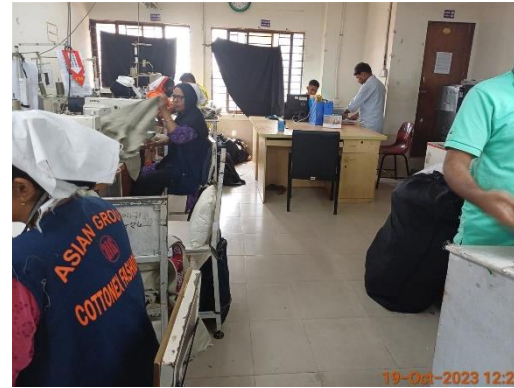
F-20	Means of egress	Stair designation signs and occupant load signs are found missing at required locations.	Provide stair designation sign and occupant load at each floor entrance from the stair to the floor in English and Bengali. Signs shall indicate the name of the stair and the floor level. Signs shall be posted adjacent to the door.	Within 3 months
F-21	Means of egress	Width of aisles is less than 0.9m (36-in.) at few floors and few aisles are not marked properly.	Aisles shall be provided with a minimum unobstructed clear-width of 0.9 m (36 in.).	Within 3 months

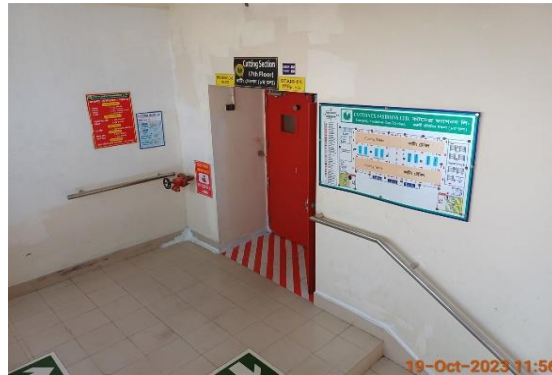
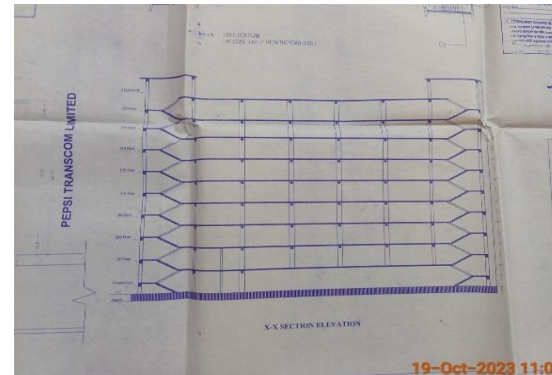
F-22	Means of egress	Exit stairs serve more than 5 stories and do not have required re-entry provisions as per standard.	Every door in a stair enclosure serving more than 5 stories shall be provided with re-entry unless it meets RSC standard 6.8.3.1.	Within 1 month
------	-----------------	---	---	----------------
