# SQ Celsius Ltd. (Unit 3)

Jamirdia, Valuka, Mymemsingh.

9 November 2023

## 1. Building Information

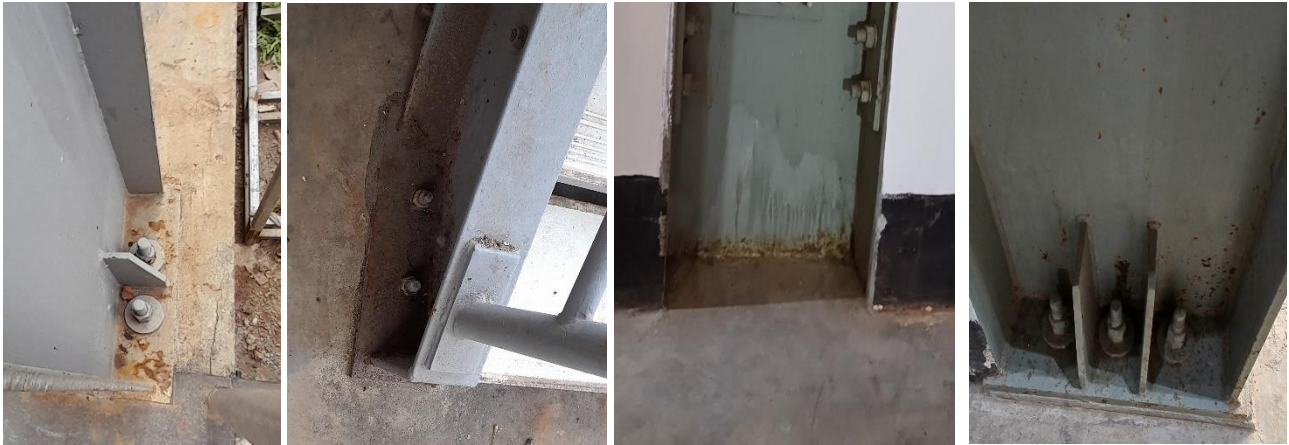
Image of corrosion

**Observation-3:** Corrosion on steel member (Finished Goods Warehouse).

**Description:** Appearance of the corrosion was found at several locations of the steel section. Periodic maintenance is required to protect the steel sections from corrosion.

| Observation | Action Plan | Timeline |
|---|---|---|
| Corrosion on steel member | Remove the corrosion from steel member and apply anti-corrosive coating. | within 6 months |
