INITIAL FIRE SAFETY INSPECTION REPORT

Modiste (Bangladesh) Ltd. (Extension)

RSC ID: 24547

Fire Safety Inspection Report

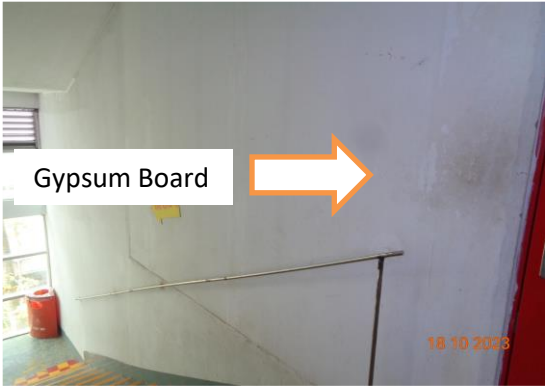
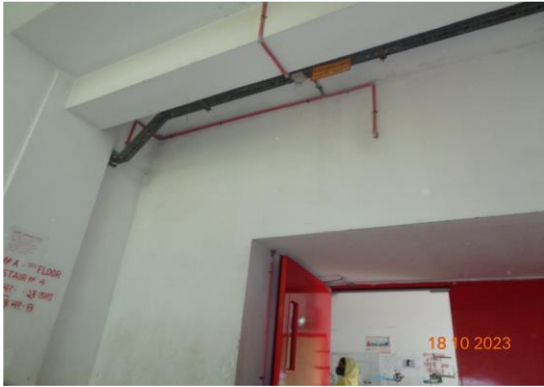
SI No.	Category	Findings	Required Action	Remediation Time Frame
F-01	Fire Rated Construction	The exit stairs lack separation from work areas and other spaces due to unprotected openings and penetrations. The office is separated by gypsum board which is required to be reviewed and verified. Location: Building-A	<p>Stair shall be enclosed with a minimum 1-hr fire-rated construction. Seal all unprotected openings and provide minimum 1-hr fire rated doors to separate the exit stairs from work areas and other building spaces on all floor levels. Ensure that the fire doors are self-closing, positive latching and that they are provided with fire exit (panic) hardware where serving production floors.</p> <p>Openings from exit enclosure to storage areas shall be provided with a vestibule with fire rated construction and openings. Ensure that the fire rating of the vestibule construction matches that of the exit stair enclosure.</p> <p>Penetrations into and through an exit enclosure shall be prohibited with the exception of required exit doors, sprinkler piping, standpipes, electrical raceway for fire alarm equipment, and electrical conduit serving the exit enclosure.</p> <p>If fire doors are required to be held open for functional reasons, provide automatic-closing devices tied to the fire alarm system.</p>	Within 3 months

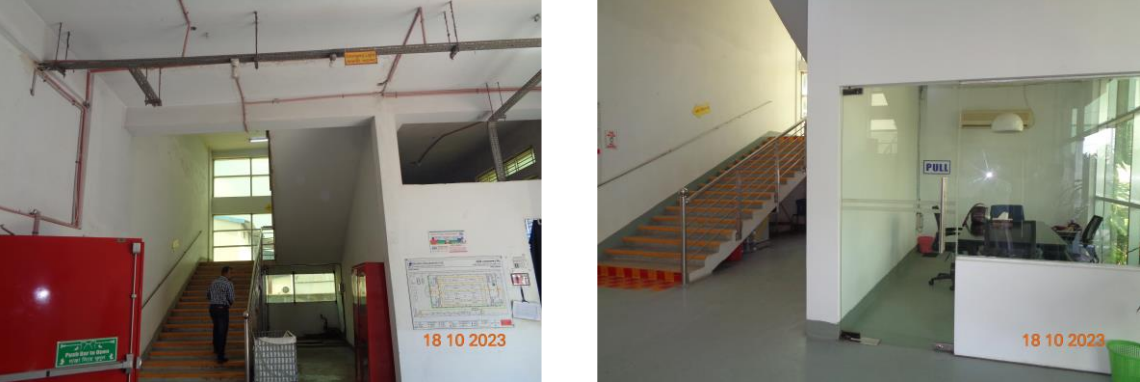
F-02	Fire Rated Construction	Exit stair discharge the occupants inside the building (office, motor) at ground floor. Location: Building-A	Modify stair to discharge directly outside. Or Provide 1-hr fire-rated exit passageway leading directly outside.	Within 3 months

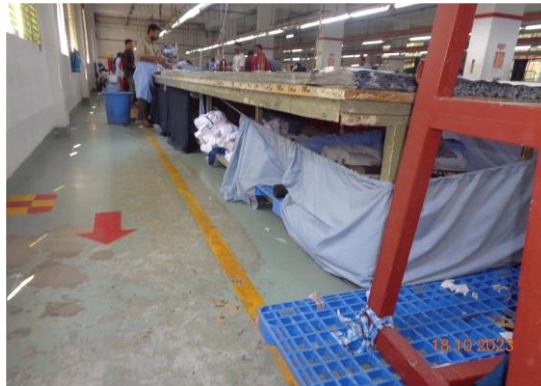
F-03	Fire Rated Construction	Storages were found underneath the cutting tables. Location: Ground Floor of Building-A	<p>Remove all storages from underneath the cutting tables. and Provide defined storage areas and limit the storage arrangement as follows: Maximum height of 2.45 m and maximum area of 23 m² and is separated by a minimum 3.0 m (10ft) from other storage areas and they do not exceed 10 percent of the building area of the story in which they occur. or, If sprinkler protected, Maximum height 12 ft (3.66 m) and maximum area of 1000 ft² (93 m²) and separated by a at least 25 ft (7.62 m) and does not constitute more than 10 percent of the building area or 4000 ft² (372 m²) of the sprinklered area, whichever is greater. or, Enclose the storage area from the surrounding occupancy with a minimum 1 hour construction.</p>	Within 3 months
------	-------------------------	---	---	-----------------

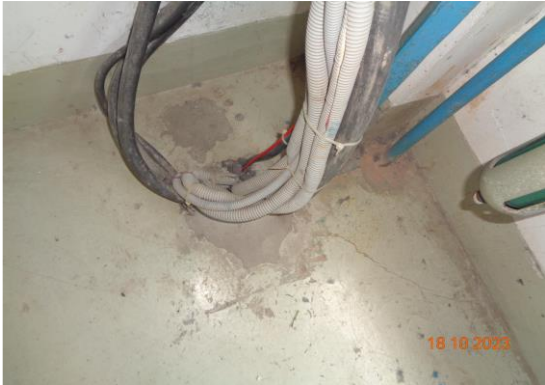
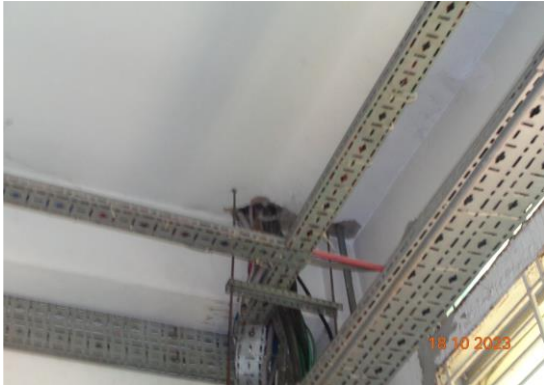
F-04	Fire Rated Construction	Penetrations through floor/ceiling assemblies are found unsealed. Location: Electric Cable (Building-A)	<p>Seal all penetrations and openings in floor/ceiling assemblies by a listed through-penetration fire stop system tested in accordance with ASTM E814 or approved alternative standard to maintain minimum 3-hr. fire resistance rating. Installation shall be as per manufacturer published installation guideline and the certification authority guideline to ensure the fire-rating.</p> <p>or,</p> <p>Provide a minimum 2-hr fire rated shaft to separate the utility risers from each floor if required.</p>	Within 3 months
<div style="display: flex; justify-content: space-around;">

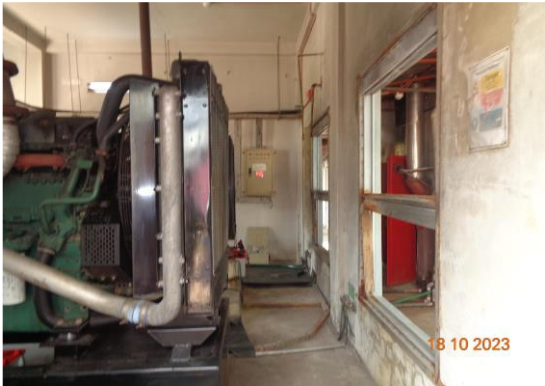
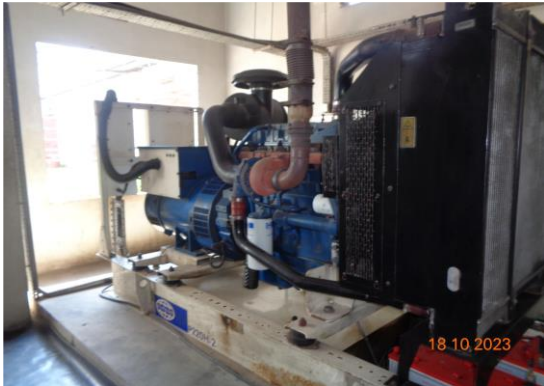
F-05	Fire Rated Construction	Generator room is not properly separated by fire rated construction with other Occupancies/Areas.	<p>Generator room shall be separated from other occupancies by a minimum 2-hr fire rated construction (wall, floor, slab etc.). Seal all penetrations and openings (door, window etc.) should be protected by 1.5-hr fire rated materials to maintain the fire separation if required. All exhaust systems shall discharge to the exterior of the building in a safe location.</p> <p>Or</p> <p>Relocate it to exterior of the building and maintain a minimum 3m (10 ft.) spatial separation distance from the building.</p>	Within 3 months
<div style="display: flex; justify-content: space-around;">

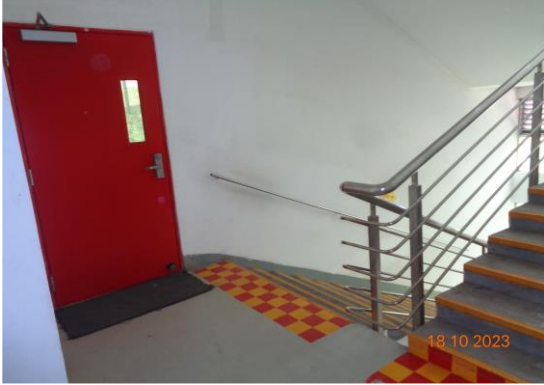
F-07	Means of Egress	The stairs have a width less than the minimum required width (1.5 meter). Location: Building-A	Stairs shall have a minimum width of 1.5 m (60 in.) for all industrial occupancies. Landings with same width as the stair clear width shall be provided at each level and at intermediate landings.	Within 6 months

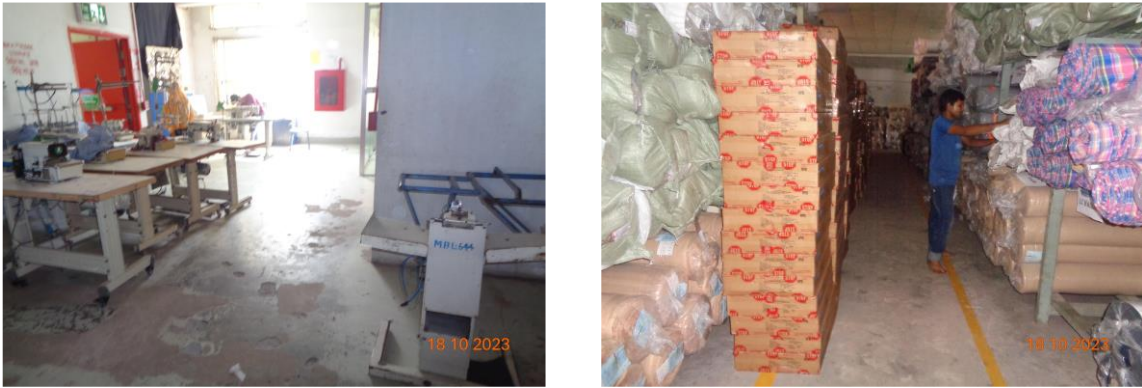
F-08	Means of Egress	The clear width of egress aisles is less than 36-in. Location: Building-A and Store Shed	Provide minimum aisle widths of 36-in.	Within 3 months

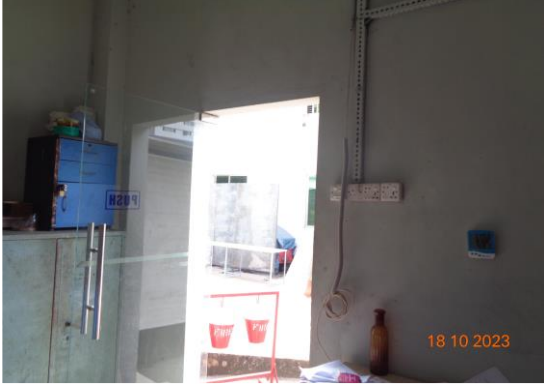
F-11	Egress Lighting	Exit sign not provided at exit. Location: Maintenance room at Building-A	Lighted exit signs shall be placed at entrance to an exit. Additional exit signs shall be placed throughout the facility anywhere the continuation of the egress is not obvious. Lighted exit signs shall be provided with either battery backup or uninterruptable power supply systems and shall be continuously illuminated.	Within 3 months

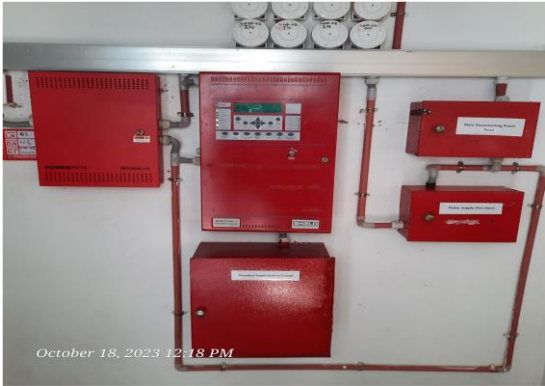
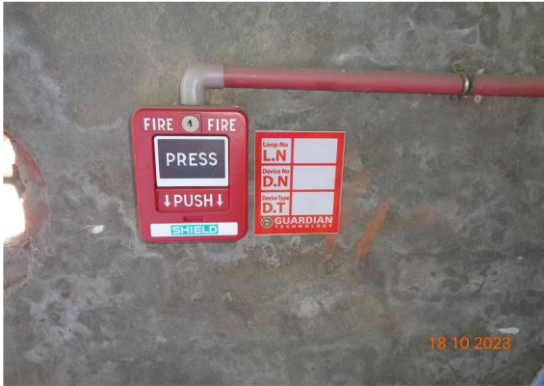
F-15	Fire Alarm & Detection System (FADS)	The factory has installed a fire alarm and detection system that requires a detailed review to confirm compliance with NFPA 72 and RSC Technical Guidelines (Standard).	<p>Submit the fire alarm and detection system design to RSC for review.</p> <p>Once the design is reviewed, install and modify the fire detection and alarm system throughout the building in accordance with review comment, RSC Technical Guidelines (Standard) and NFPA 72.</p> <p>After installation the owner shall conduct internal testing and commissioning and then contact the RSC for witness of final acceptance testing.</p>	Design within 1 month and modification/ installation with 4 months
