Bea-Con Knit Wear Limited (Factory-2) (Extension)

South Salna, Salna Bazar, Gazipur.

3 December 2023

1. Building Information

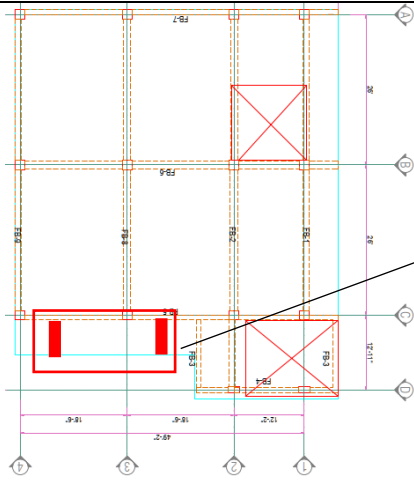
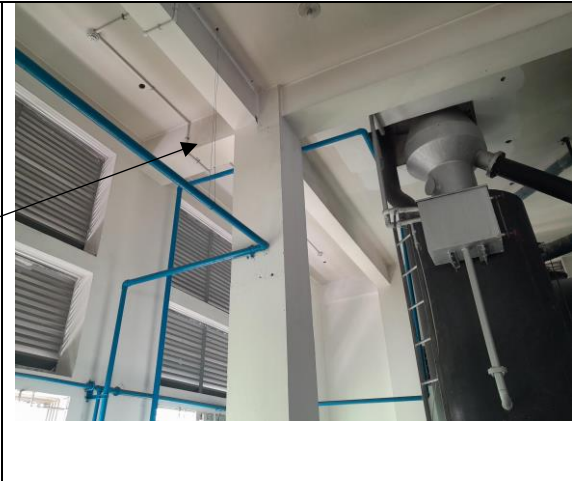
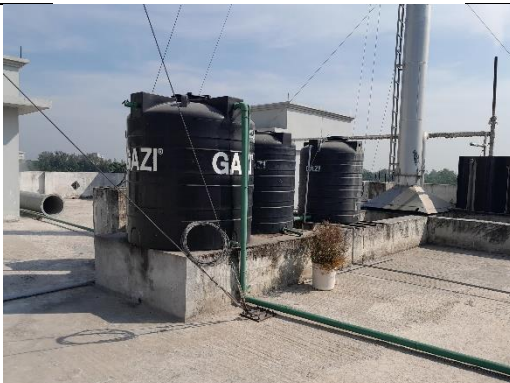
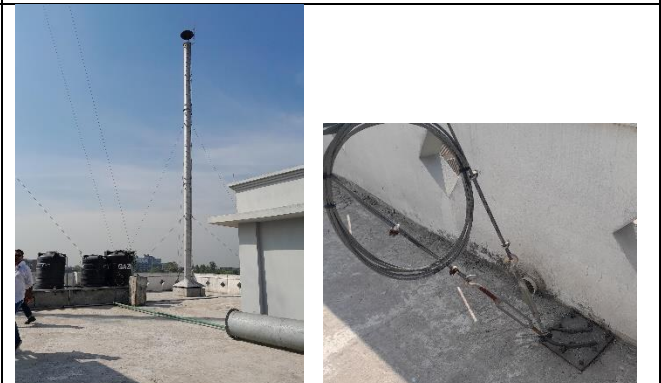
Observation-2: Mismatch in as-built drawing. (Utility Building)

<p>Description: During the inspection, a mismatch was found in the beam layout. Marked cantilever beams were not shown in the as-built drawing. Also, on the roof floor, there are 3 nos plastic water tanks and a boiler chimney anchored with RC column and beam which was not mentioned in the as-built architectural drawing. The building engineer is required to survey the full structure and update the as-built drawing and design report accordingly.</p>

5.	Mismatch in the as-built drawing. (Utility Building)	The building engineer is required to survey the full structure and update the as-built drawing and design report accordingly.	within 6 weeks

6.	Mismatch in the as-built drawing. (Utility Building)	Carry out suggested remedial works if required.	within 6 months
