# INITIAL FIRE SAFETY INSPECTION REPORT

**Factory Name: Aspire Garments Limited (Extension)**

**RSC ID: 24783**

**Factory Address: 491 Dhalla, Singair, manikganj**

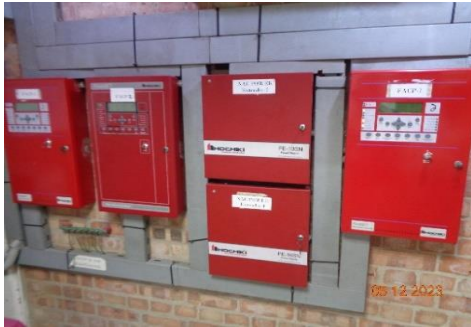
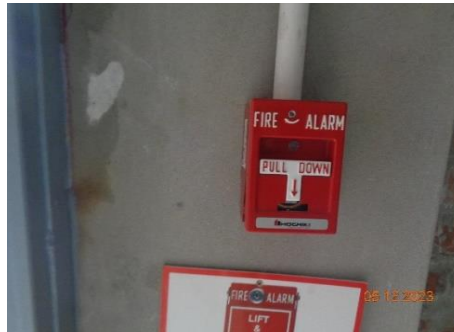
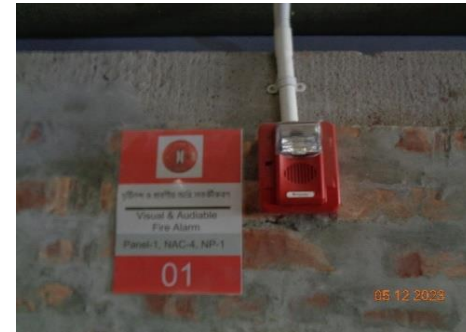
| SI No. | Category | Findings | Required Action | Remediation Time Frame |
|---|---|---|---|---|
| F-1 | Fire Alarm & Detection System (FADS) | The fire alarm and detection system installation requires detailed review to confirm compliance with NFPA 72 and RSC standard. | Submit as-built drawings, testing records, equipment certification and other relevant documentation to the RSC for review and approval/acceptance test. | Design Within 2 months, Installation Within 4 months. |

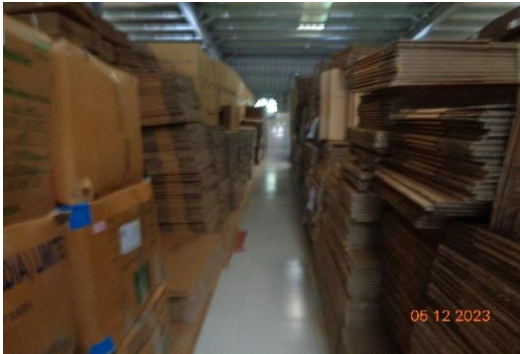
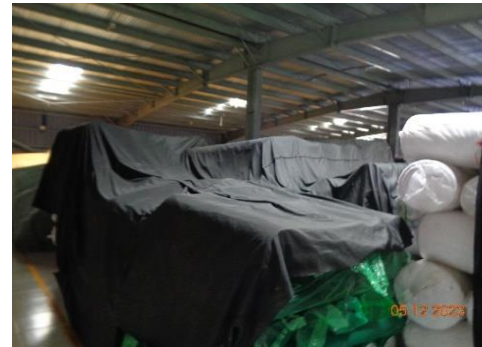
| F-3 | Means of egress | Width of aisled is less than 0.9m (36-in.) or not marked properly at several areas. | Aisles shall be provided with a minimum unobstructed clear- with of 0.9m (36 in). | Within 1 months |
