SHAMS STYLING WEARS LTD (Extension)

Shams Tower, South Shyampur,, Baghbari, Hemayetpur, Savar
(23.789902, 90.257416)

11 December 2023

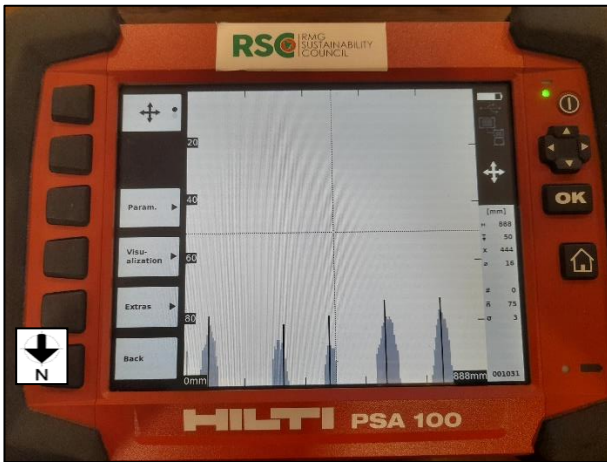
Ferro scan image of one phase

In C1 column, rebars found 5 in one direction instead of 8 (as per the drawing).

Description: During the inspection, in the C1 column, the number of rebars was found 22 instead of 28 (as per the drawing). The building engineer is required to survey the full structure and produce accurate as-built drawings.

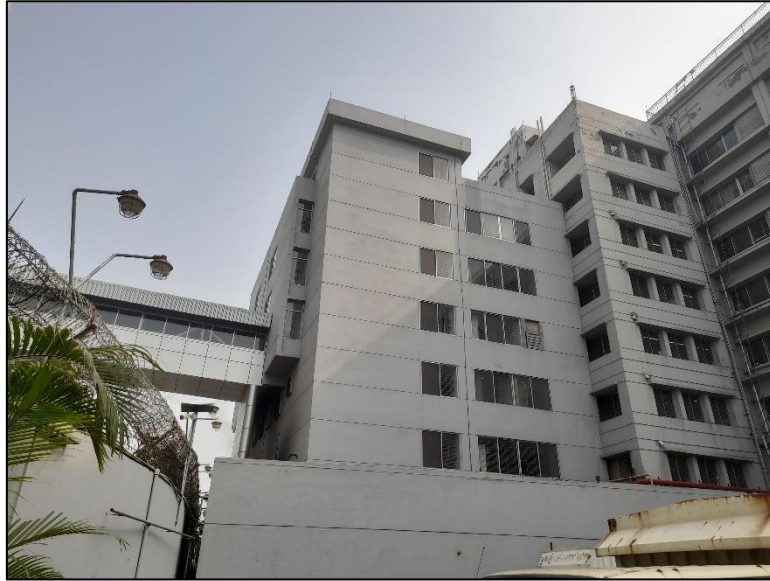
Utility Building

Description: During the inspection, no building permit drawing was available for Utility Building. The building engineer is required to take approval from the concerned authority for the structure.
