# **FIRE SAFETY INSPECTION REPORT**

## **UNIVERSE KNITTING GARMENTS**

**ACCORD ID: 12368**

November 14, 2015

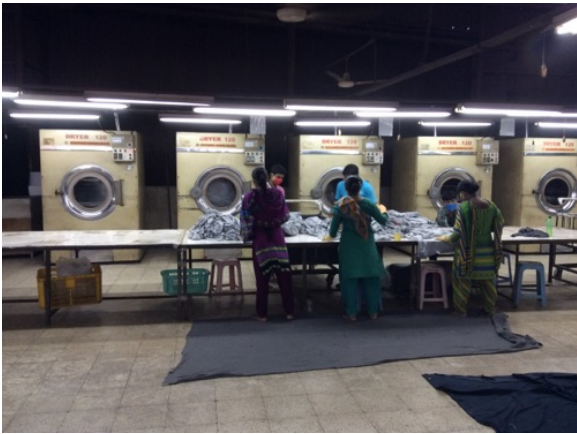
No.	Category	Finding	Recommendation	Remediation Timeframe
F-1	Fire Rated Construction	The industrial dryers are not separated by fire-rated construction due to openings, non-rated doors and penetrations.	Separate the industrial dryer room by a minimum 2-hr fire-rated construction. Seal and/or protect all openings to maintain the required fire separations. Provide proper ventilation and consult with a qualified engineer.	Within 3 months

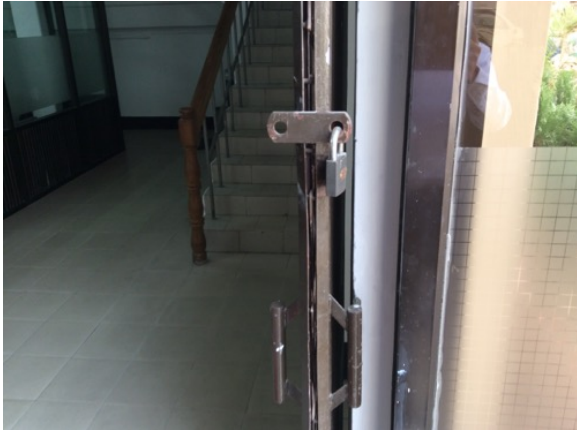
F-2	Egress	Egress doors / gates with locking features are provided at building exits, along egress routes and exit discharge.	Remove locking features from all egress doors / gates.  If locks are required for security reasons, utilize special door locking features complying with ACCORD standard 6.8.2.	Immediately

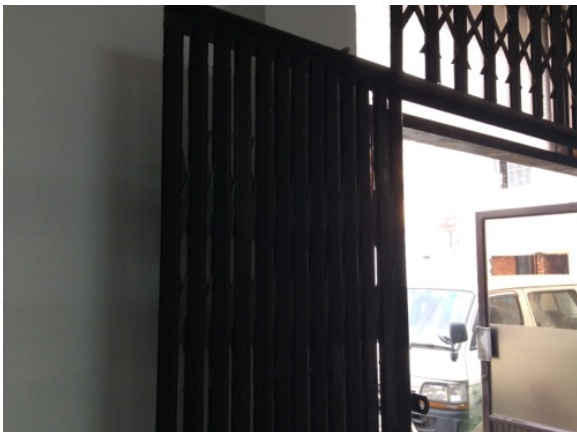
F-3 Egress

Collapsible gates / sliding doors are provided at building exits, along egress routes and exit discharge.

Replace all gates / sliding doors along the means of egress with side-hinged, swinging egress doors in accordance with ACCORD standard 6.8.1.

Within 1 month

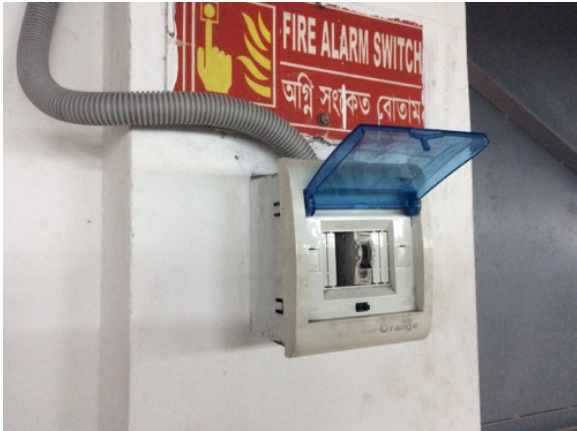
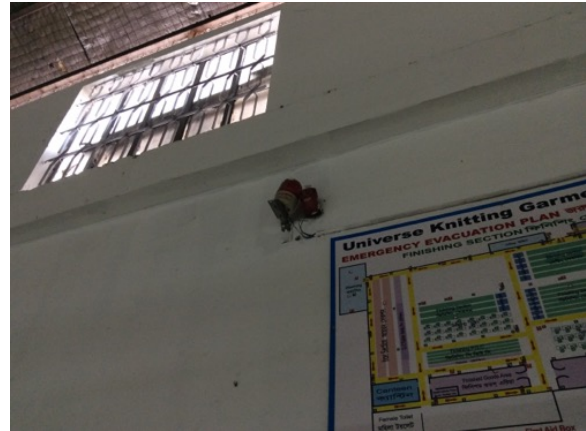
F-4	Fire Protection	The fire alarm system is antiquated, not a listed system and does not provide alarm and notification features consistent with acceptable standards.	Replace the fire alarm system with a new, listed automatic fire alarm system in accordance with NFPA 72 and ACCORD standards.	Design within 4 months, install within 9 months
-----	-----------------	---	---	---
