# KIMBERLEY DESIGN

214/3, Technogpara, Joydebpur, Gazipur.  
(24.003760 N, 90.386295 E)

24th October 2015

## **Discrepancies between Permit Drawings and Site Observations**

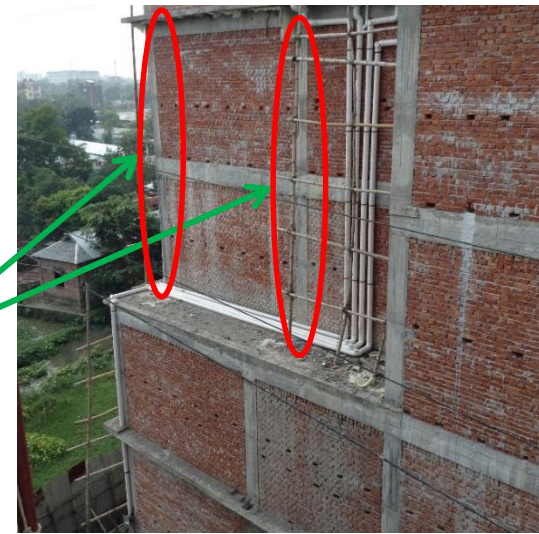
Observed columns which are shifted inwards after the 2<sup>nd</sup> floor.

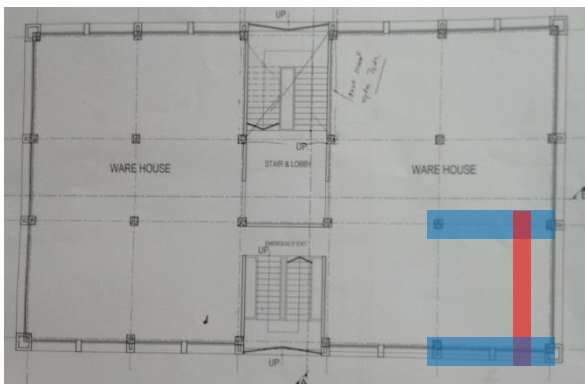
Structural drawing of 1<sup>st</sup> floor

■ Shifted  
Frame  
Beam

■ Transfer  
Beam

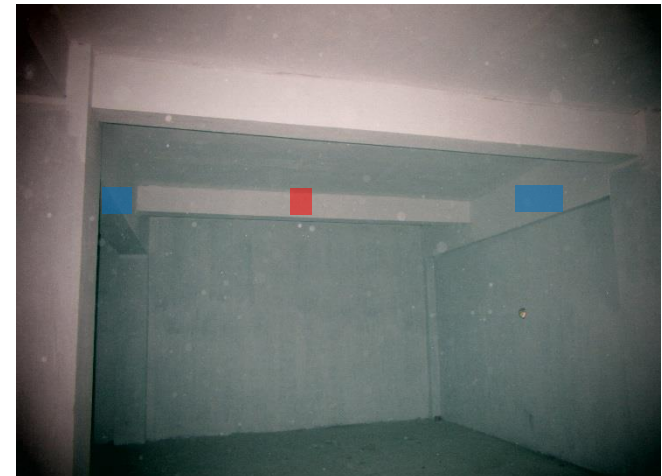
Shifted frame beam and transfer beams which are not present in permit drawings.

**ITEM 1:** Check the adequacy of the Transfer Beams on 2<sup>nd</sup> floor of the Warehouse Building.

| Item No. | Observation | Recommended Action Plan | Recommended Timeline |
|---|---|---|---|
| 1 | Check Adequacy of Transfer Beams at Warehouse Building 2nd floor. | Building Engineer to check and verify the adequacy of the transfer beams at second floor level. | 6-weeks |
| 2 | Check Adequacy of Transfer Beams at Warehouse Building 2nd floor. | Make structural alterations if required by Building Engineer. | 6-months |

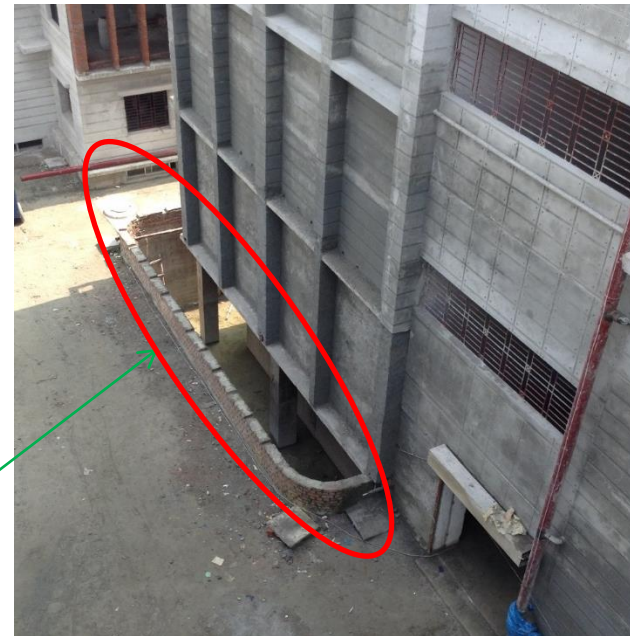
The basement was not shown on the permit drawings. Will be used for water tanks

**ITEM 3:** Structural members in the water tank at the basement level of Warehouse Building should be waterproofed.

| Item No. | Observation | Recommended Action Plan | Recommended Timeline |
|---|---|---|---|
| 5 | Waterproof structural members in water tank Warehouse Building | Structural members inside the basement water tank (fire) should be waterproofed to prevent corrosion. | 6-weeks |

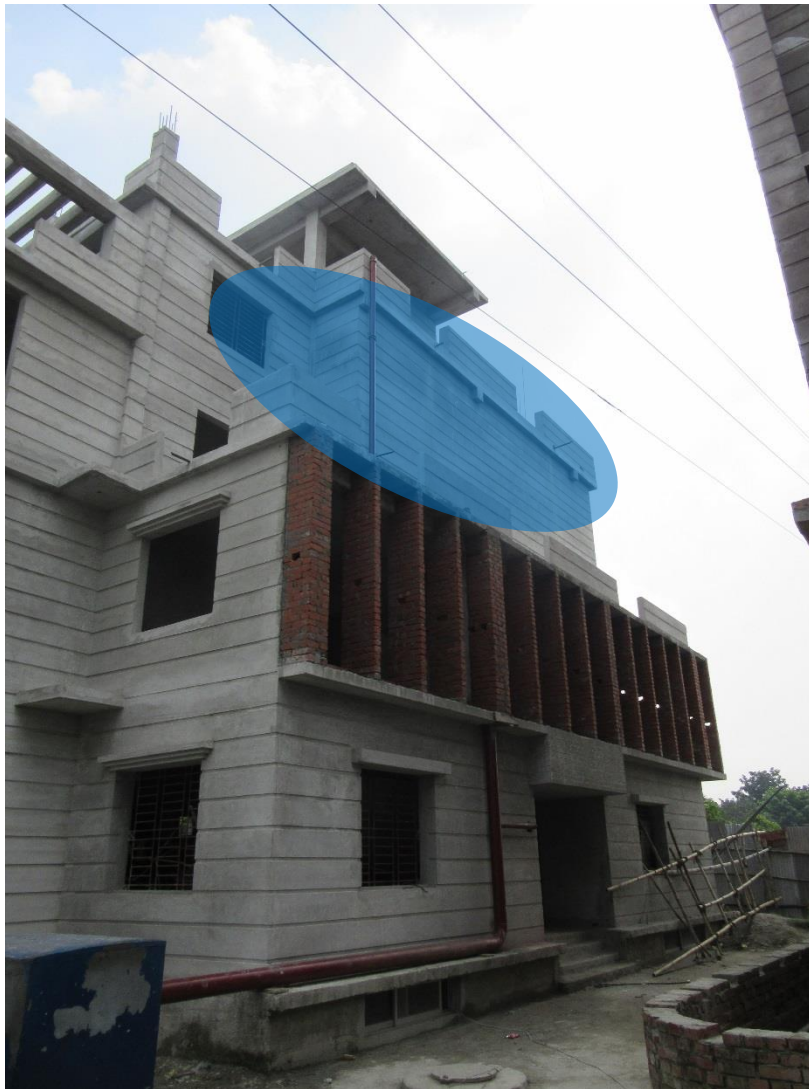
Extra Two Floors not shown on  
Permit Drawings : Basement and  
Marked Floor

**ITEM 2:** Verify the structural capacity of the Medical and Office Building.

| Item No. | Observation | Recommended Action Plan | Recommended Timeline |
|---|---|---|---|
| 3 | Verify the structural capacity of the Medical and Office Building. | Building Engineer to provide detailed drawings and check calculations for the building which has two additional storeys when compared to permit drawings. | 6-weeks |
| 4 | Verify the structural capacity of the Medical and Office Building. | Make structural alterations as required Building Engineer. | 6-months |

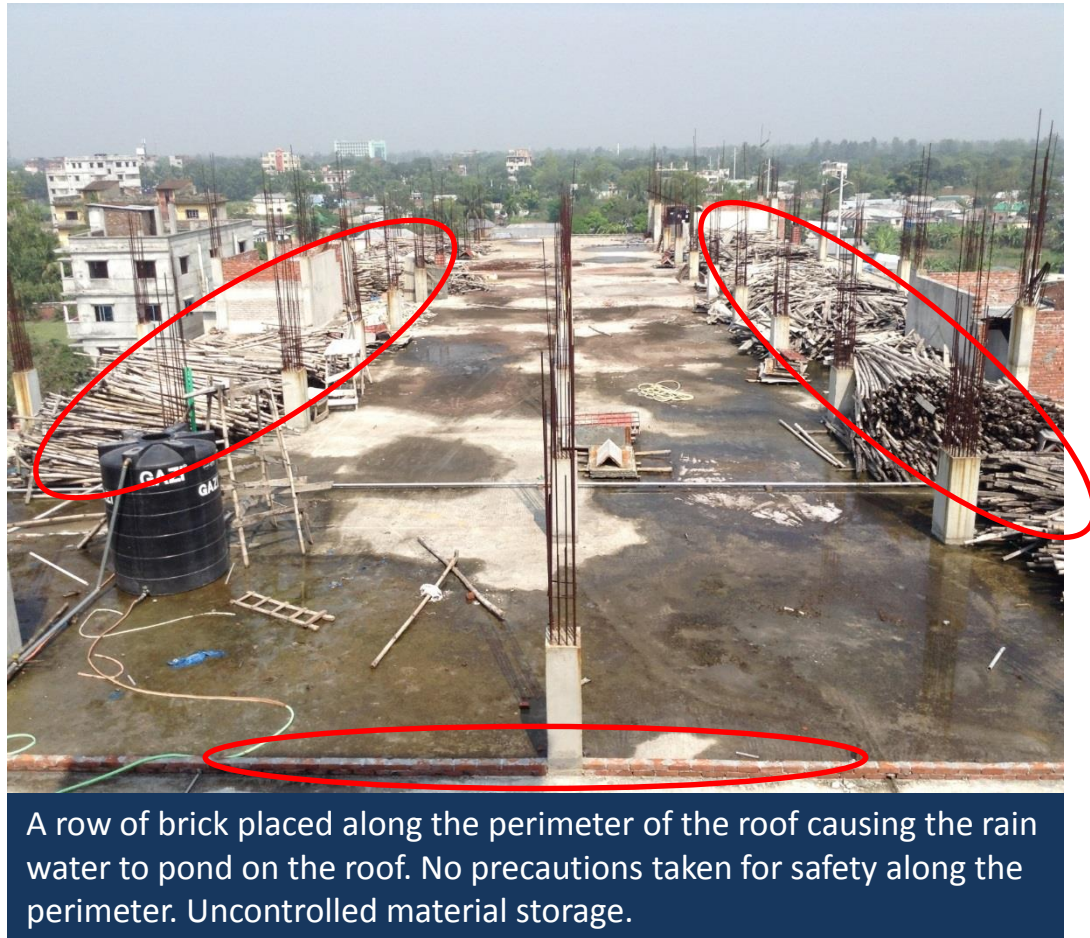
### Factory Building – Top Floor

- Lack of fall protection at building perimeter.
- Uncontrolled storage of construction material.
- Water ponding to be prevented.

- Lack of fall protection at stairs.

**ITEM 5:** Health and Safety precautions should be taken during construction to prevent falls from a height.

| Item No. | Observation | Recommended Action Plan | Recommended Timeline |
|---|---|---|---|
| 7 | Safety Precautions during Construction | Protective measures are lacking at the roof levels and at stairs to prevent falls from a height. Measures should be taken to remove this threat to human life. | Immediate - Now |
